**PATERSON
GROUP**

June 19, 2026
PG6557-LET.01 Revision 4

Subject: **Preliminary Geotechnical Investigation
Proposed Commercial Development
2175 Prince of Wales Drive – Ottawa, Ontario**

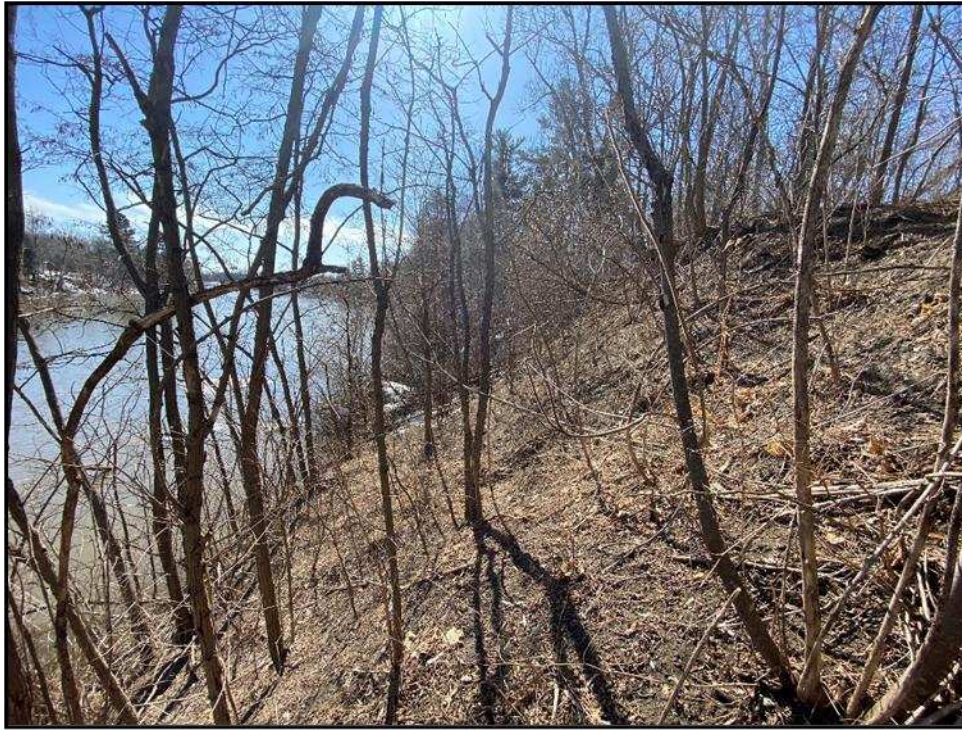
Photo 1: Photograph taken in a southeast direction illustrating some evidence of active erosion.

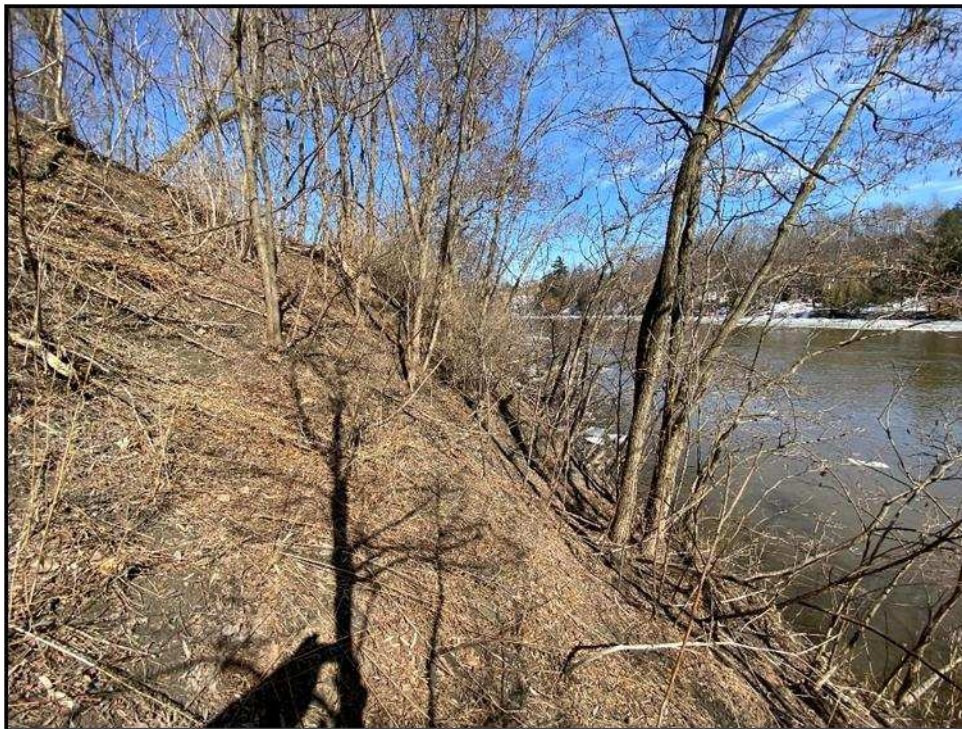
Photo 2: Photograph taken in a northeast direction illustrating some evidence of active erosion along the west bank of the Rideau River.

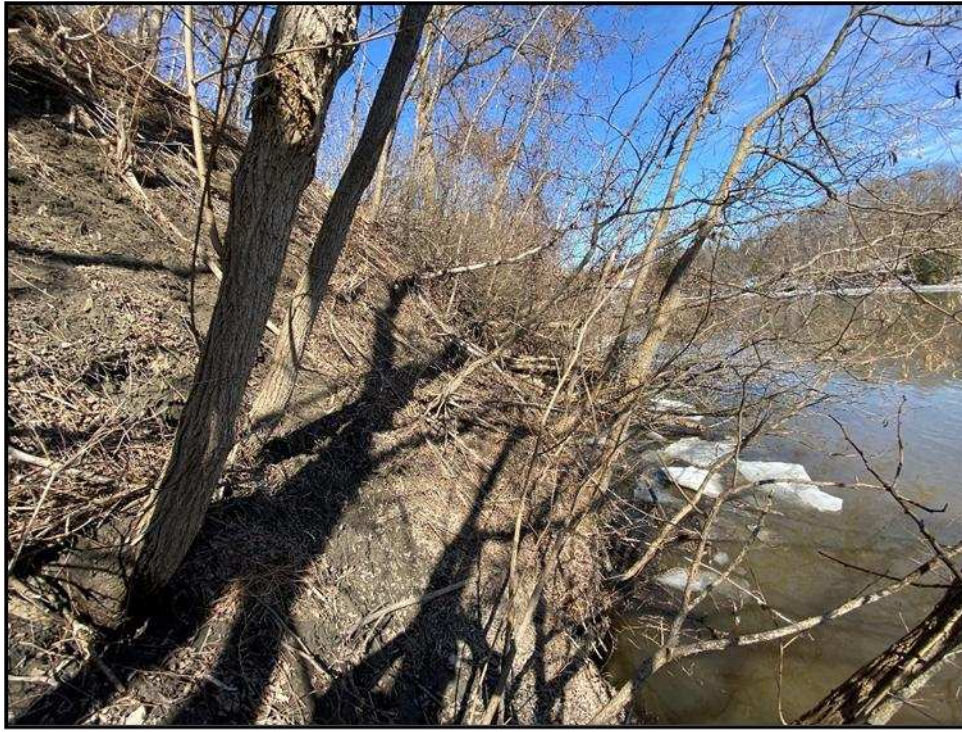
Photo 3: Photograph taken in a northeast direction illustrating some evidence of toe erosion along the west bank of the Rideau River.

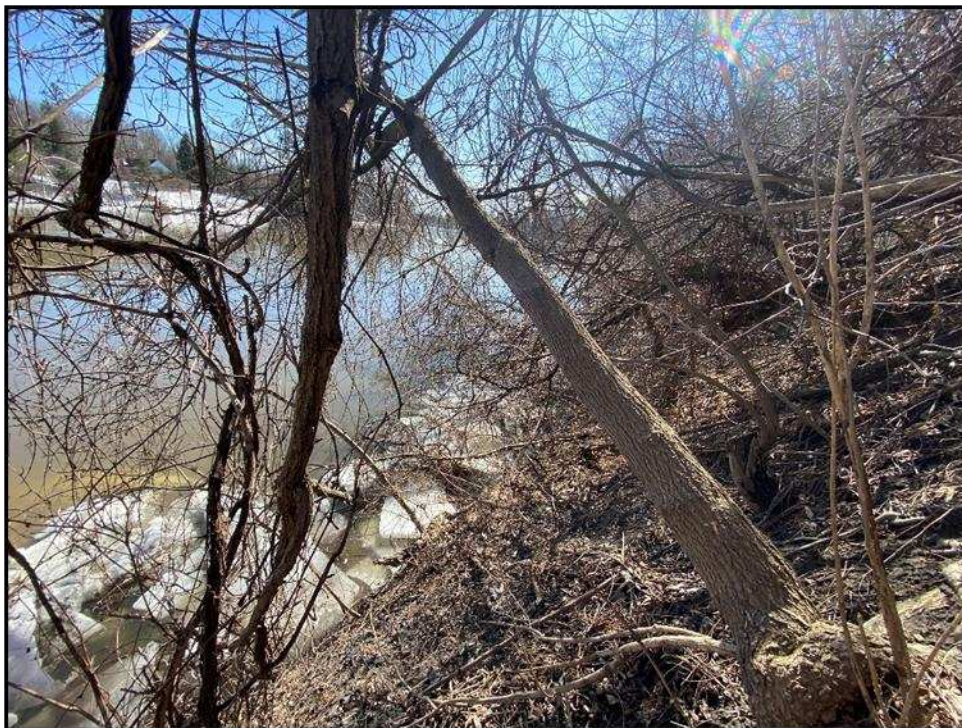
Photo 4: Photograph taken in a southwest direction illustrating some evidence of active erosion along the west bank of the Rideau River.

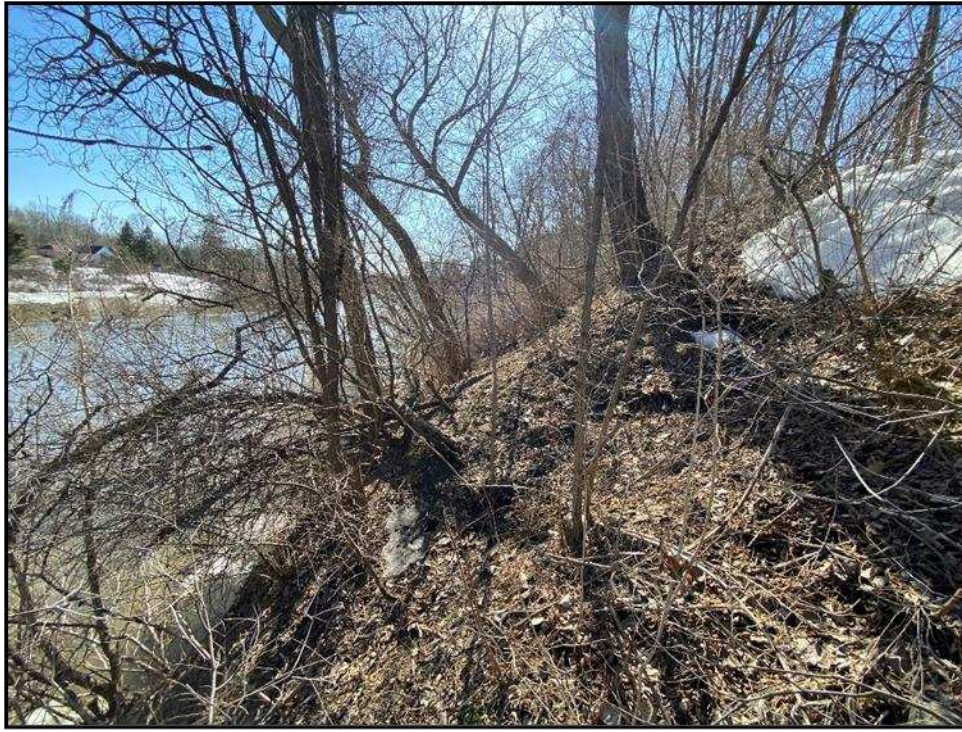
Photo 5: Photograph taken in a southwest direction illustrating some evidence of active erosion along the west bank of the Rideau River.

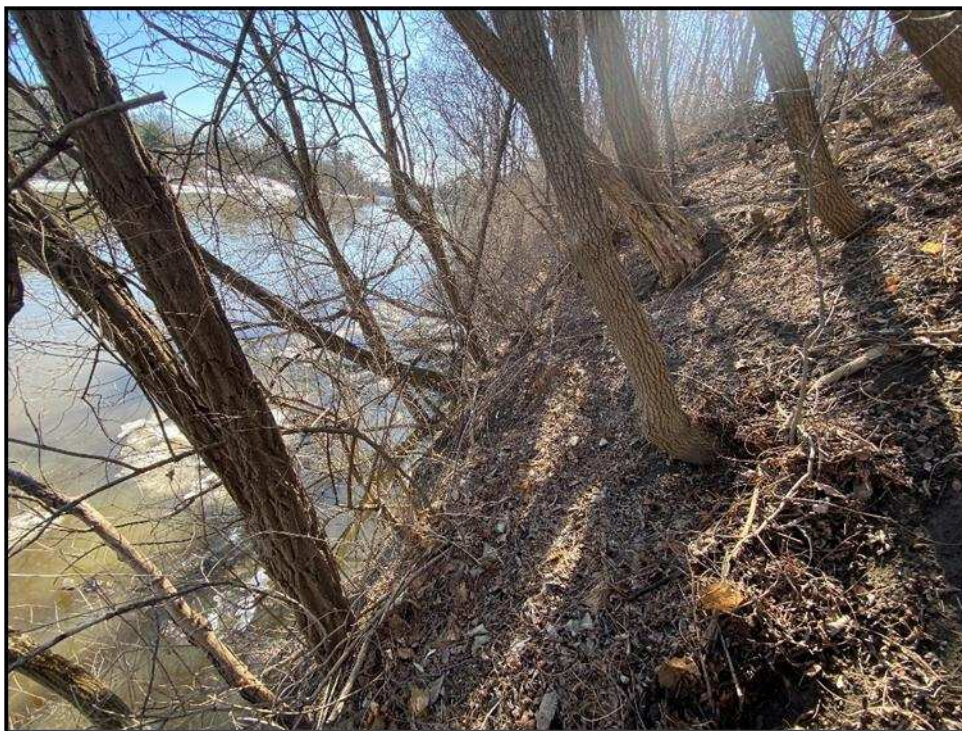
Photo 6: Photograph taken in a southwest direction illustrating some evidence of toe erosion along the west bank of the Rideau River.

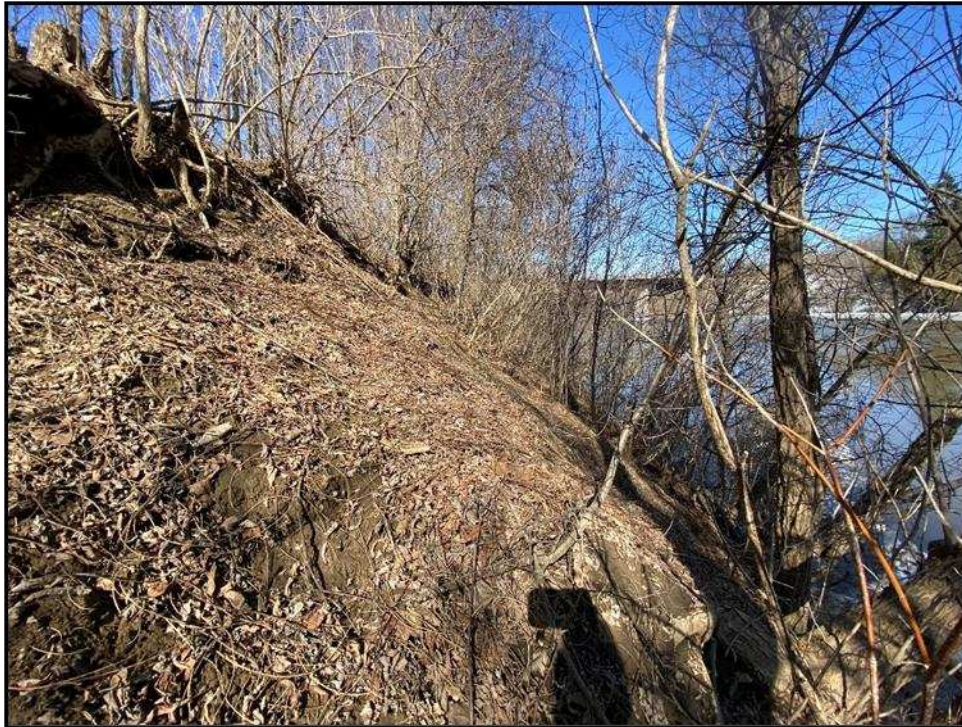
Photo 7: Photograph taken in a northeast direction illustrating some evidence of active erosion along the west bank of the Rideau River.

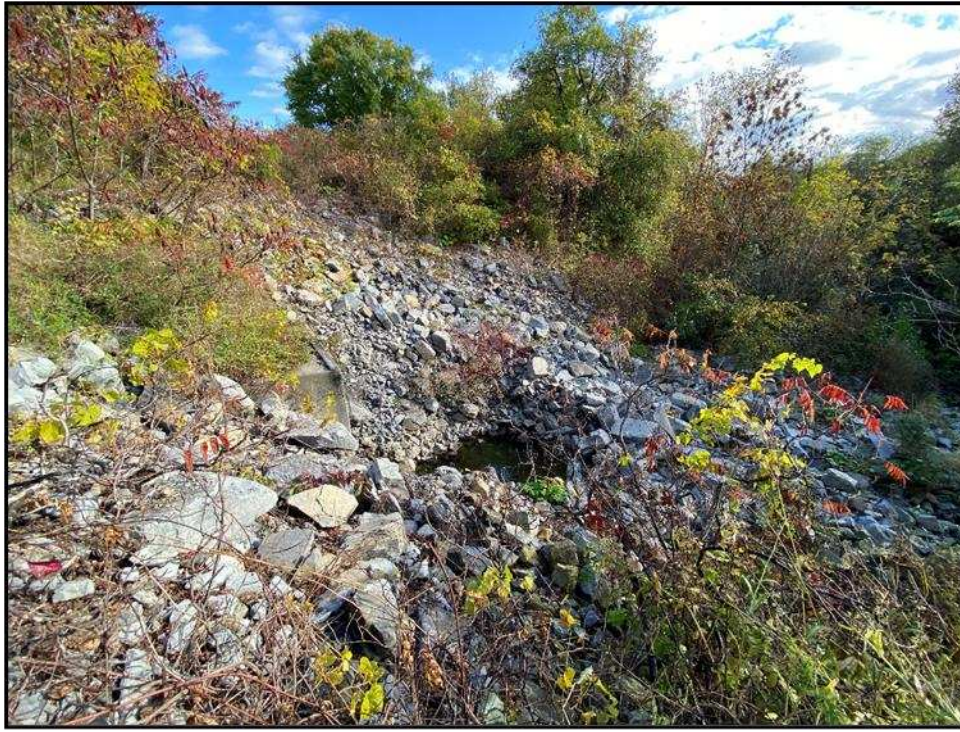
Photo 8: Photograph taken in a northeast direction illustrating the placement of riprap stone around the culvert outlet that discharges into the tributary to the Rideau River.

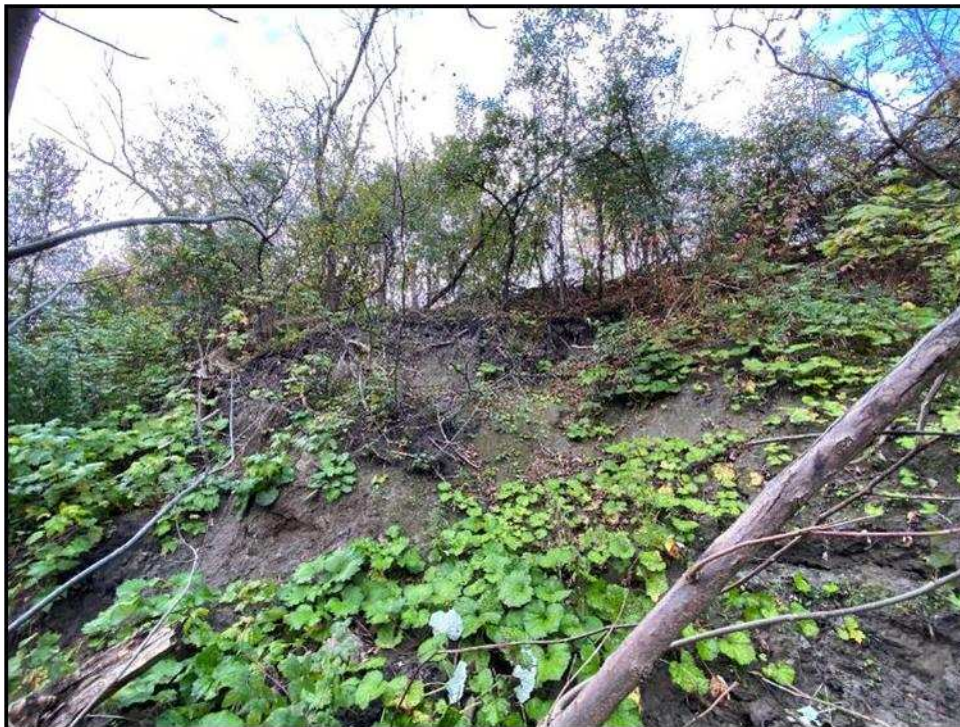
Photo 9: Photograph taken in a south direction along the tributary to the Rideau River illustrating some evidence of historical slip failures along the south banks of the valley corridor.

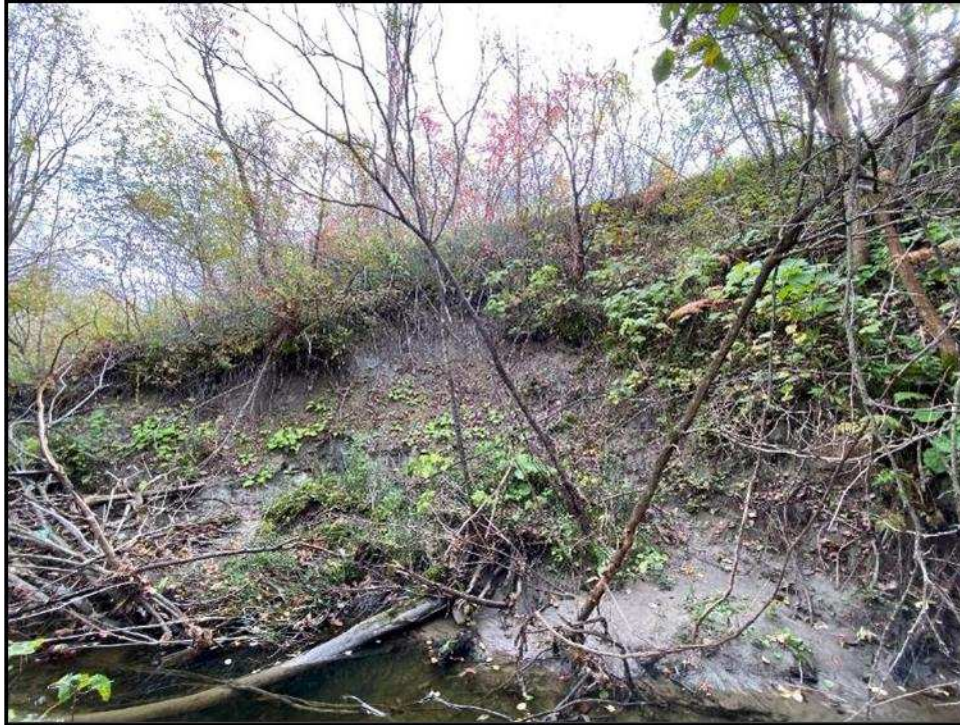
Photo 10: Photograph taken in a south direction along the tributary to the Rideau River illustrating some toe erosion along the base of the valley corridor where the watercourse meets the wall of the valley corridor.

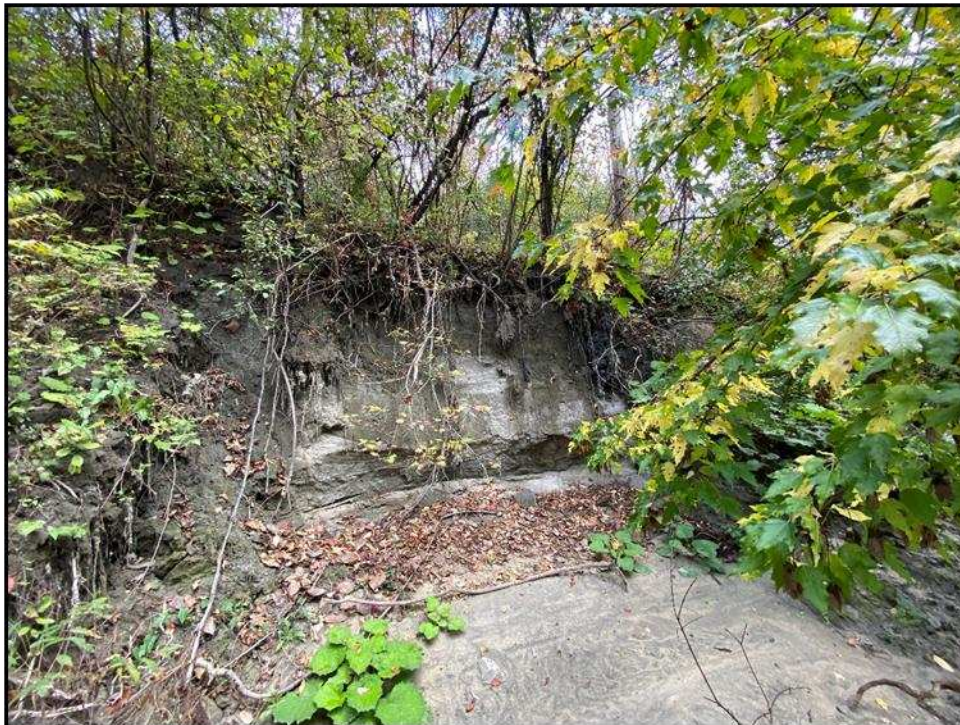
Photo 11: Photograph taken in a north direction along the tributary to the Rideau River illustrating evidence of active erosion along the north bank of the valley corridor.

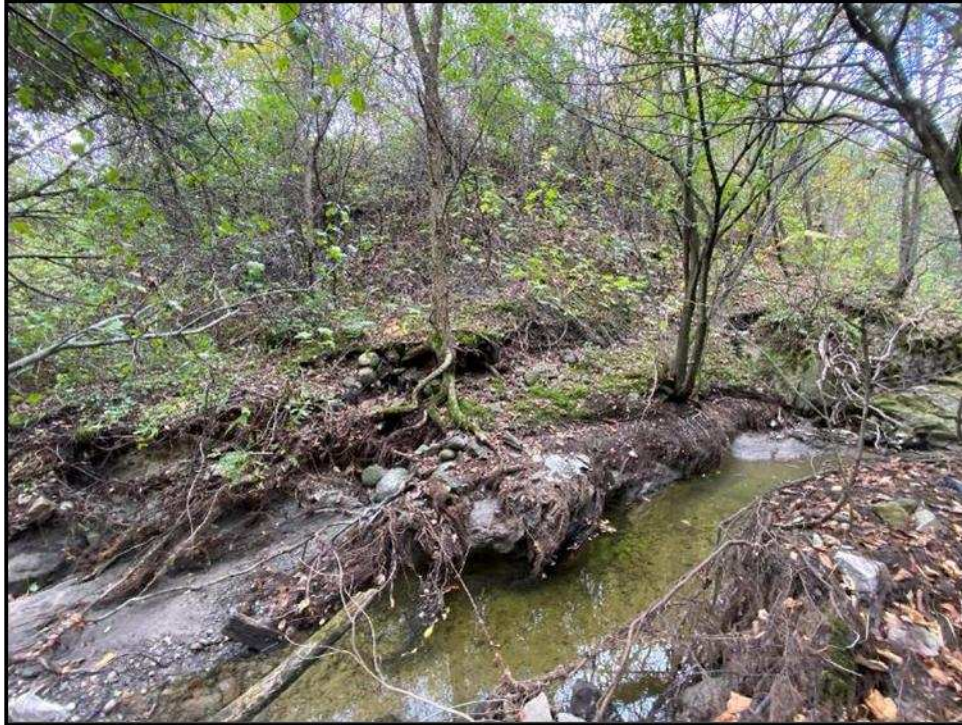
Photo 12: Photograph taken in a south direction along the tributary to the Rideau River illustrating evidence of historical slip failures along the south bank of the valley corridor and evidence of active erosion where the watercourse meets the wall of the valley corridor.

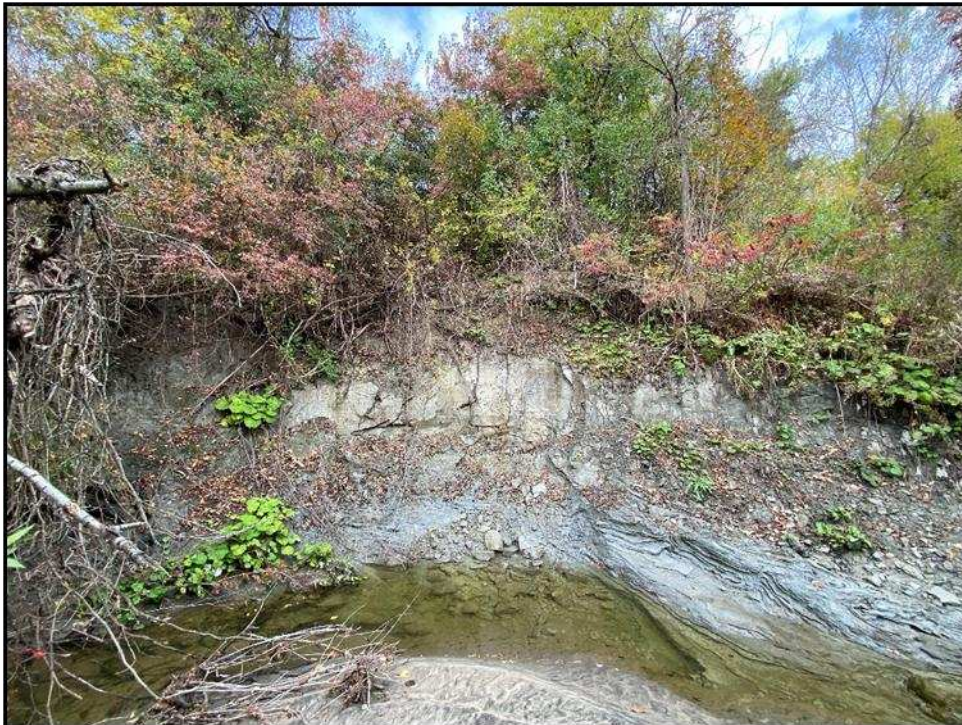
Photo 13: Photograph taken in a north direction along the tributary to the Rideau River illustrating evidence of active erosion.

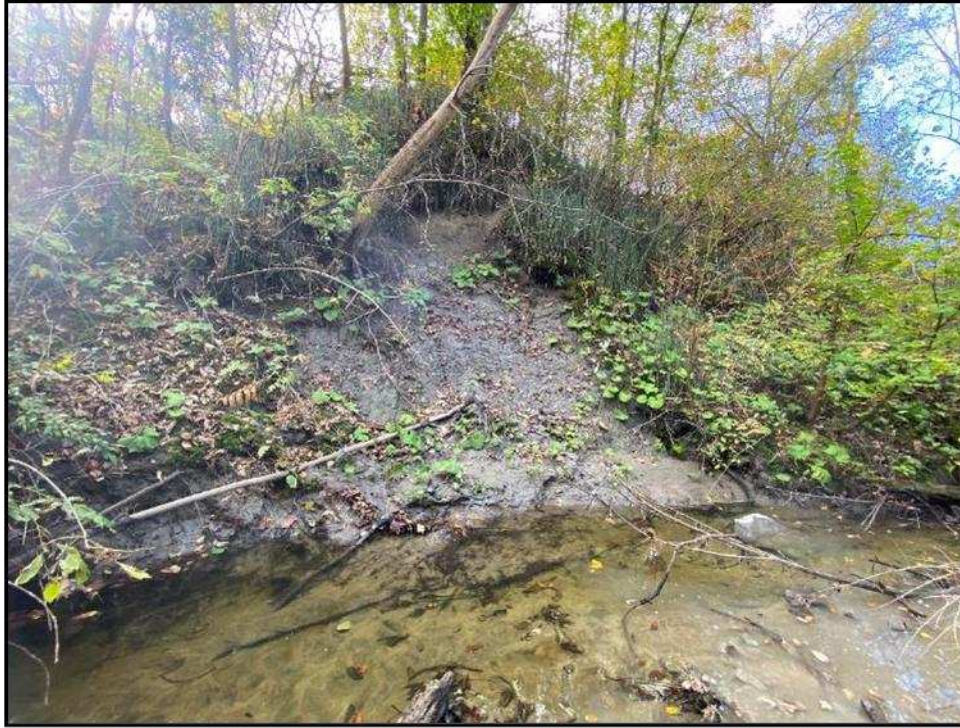
Photo 14: Photograph taken in a south direction along the tributary to the Rideau River illustrating evidence of historical slip failures along the south bank of the valley corridor and evidence of active erosion where the watercourse meets the wall of the valley corridor.

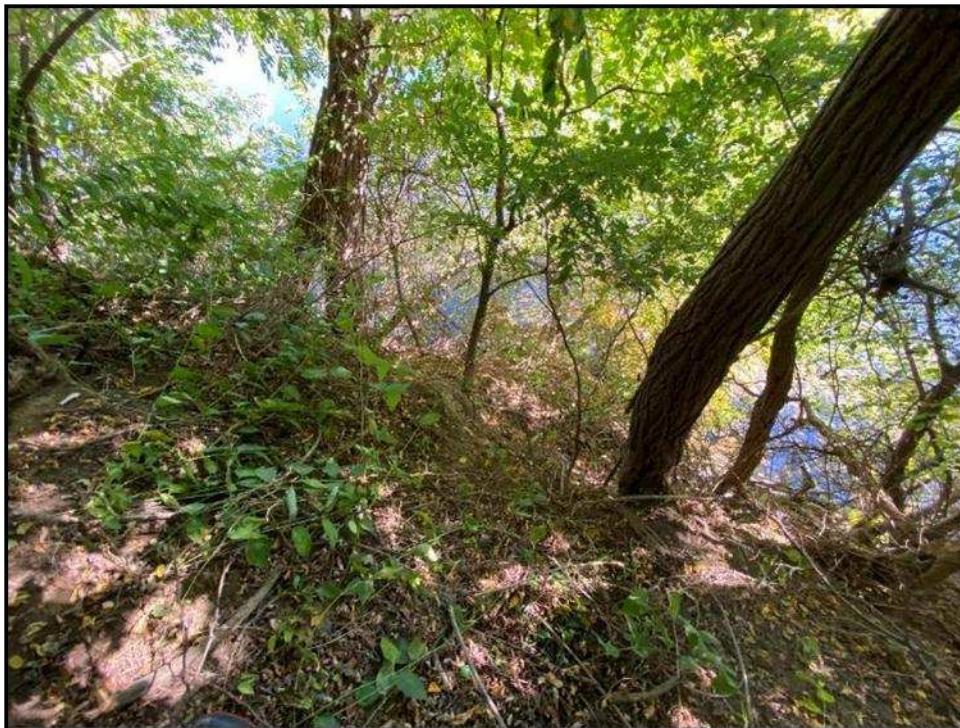
Photo 15: Photograph taken in an east direction over the west bank of the Rideau River showing some active erosion.

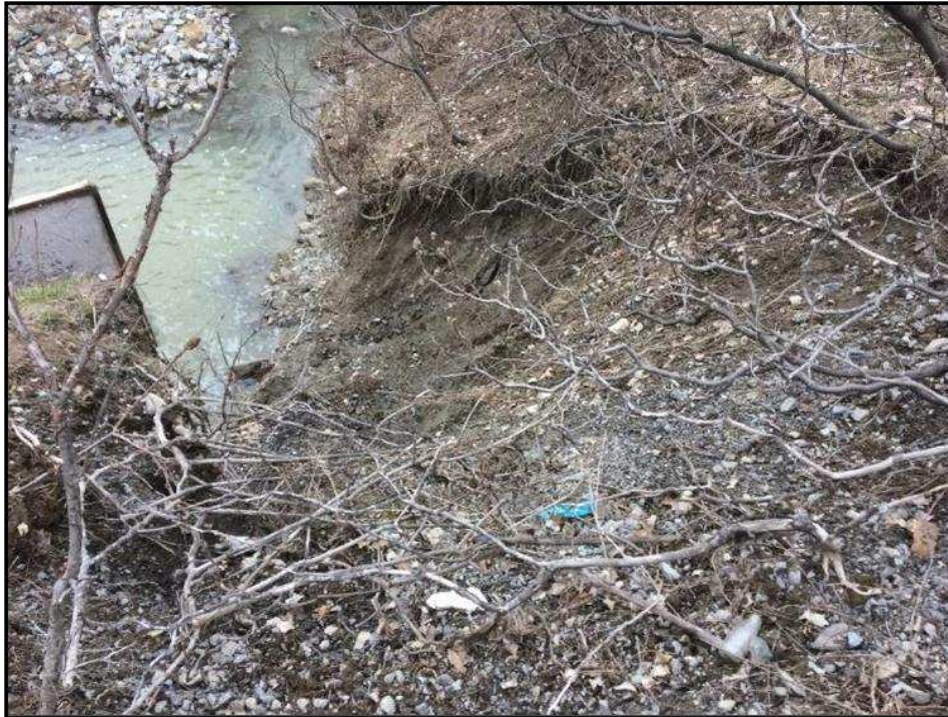
Photo 16: Photograph taken in an east direction illustrating the active erosion and subsequent slip failures adjacent to the concrete box culvert.

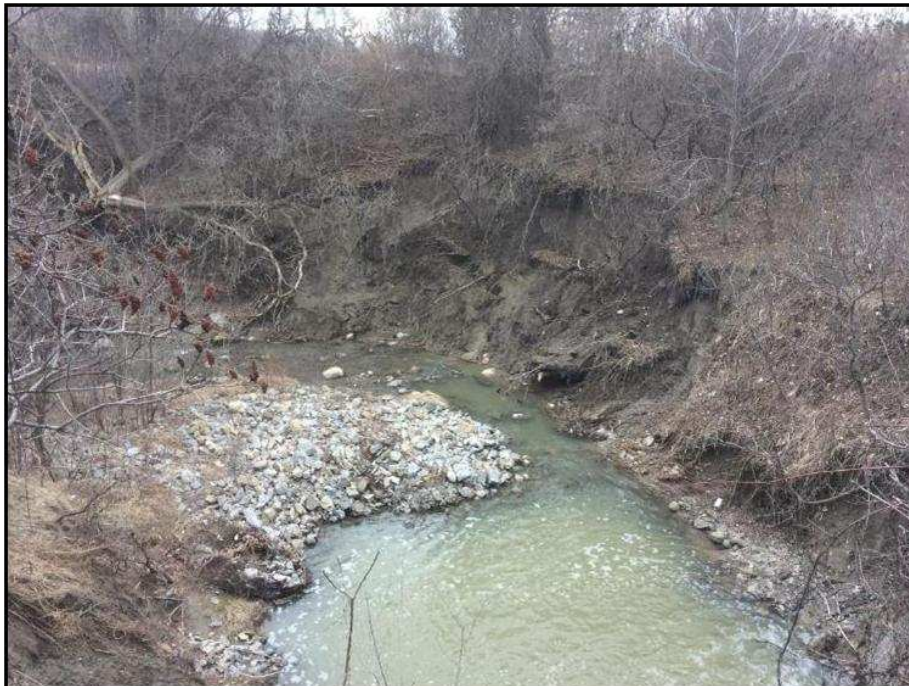
Photo 17: Photograph taken in an east direction from the top of the concrete box culvert illustrating the active erosion and subsequent slip failures along the south bank of the tributary to the Rideau River.

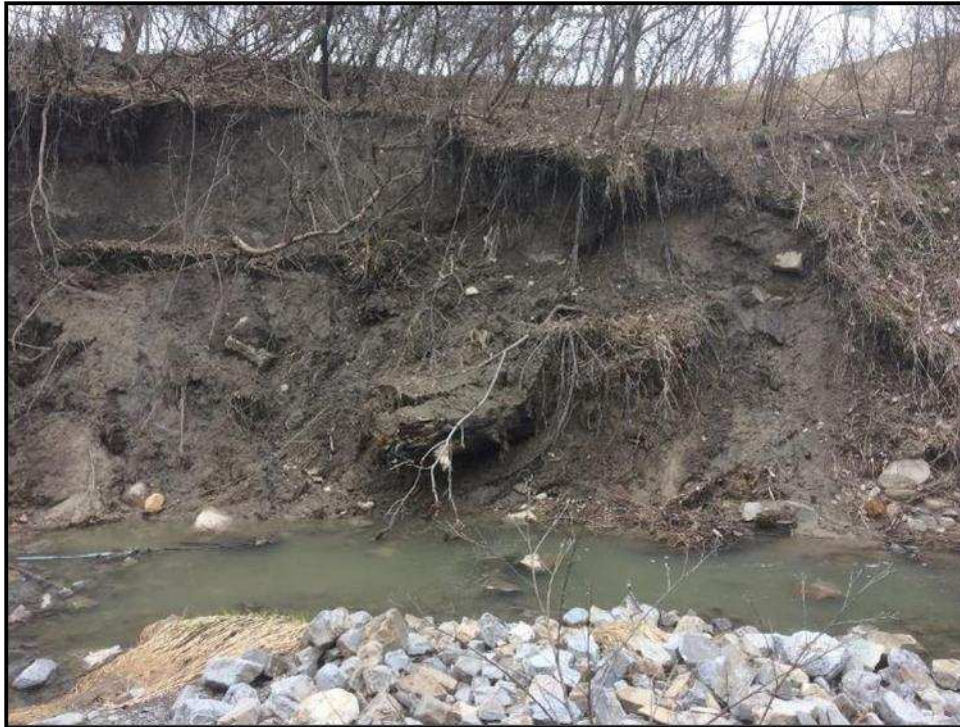
Photo 18: Photograph taken in a west direction to further capture the active erosion and subsequently slip failure presented in the previous photograph.

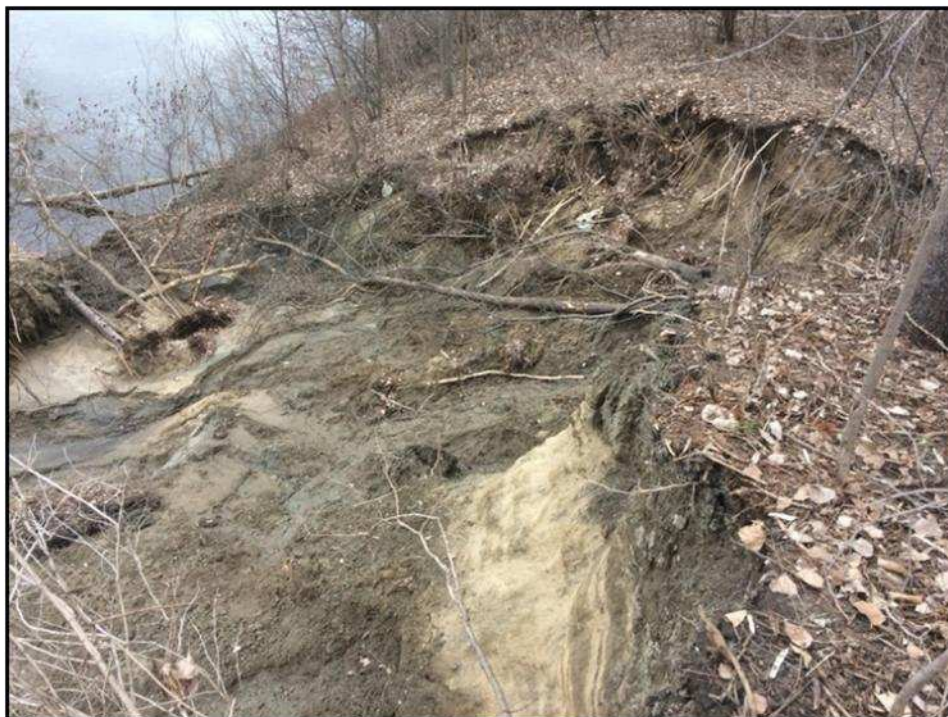
Photo 19: Photograph taken in a south direction illustrating a relatively recent slope failure along the west bank of the Rideau River.

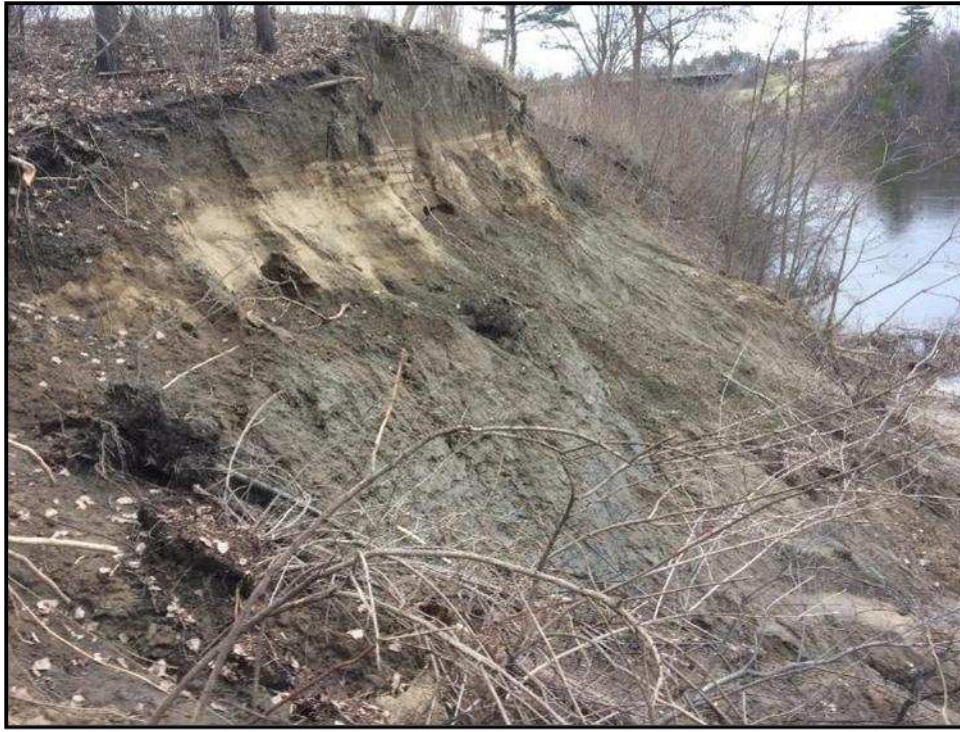
Photo 20: Similar to the previous photograph but taken in a north direction further illustrating the relatively recent slip failure along the west bank of the Rideau River.

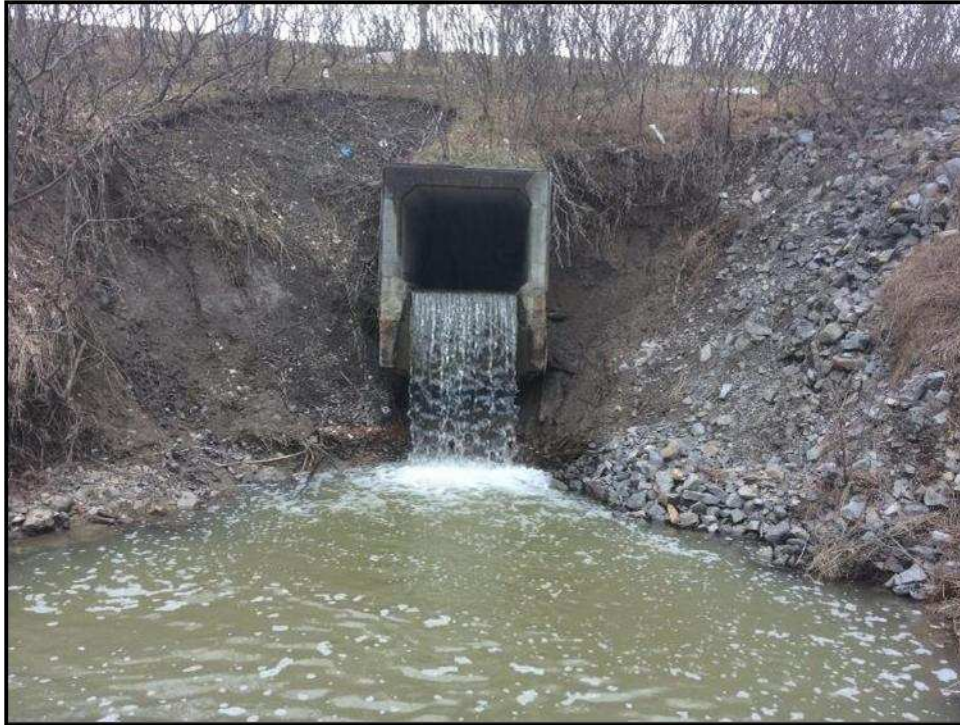
Photo 21: Photograph taken in a west direction on April 17, 2017, illustrating the active erosion and subsequent slip failures adjacent to the concrete box culvert.

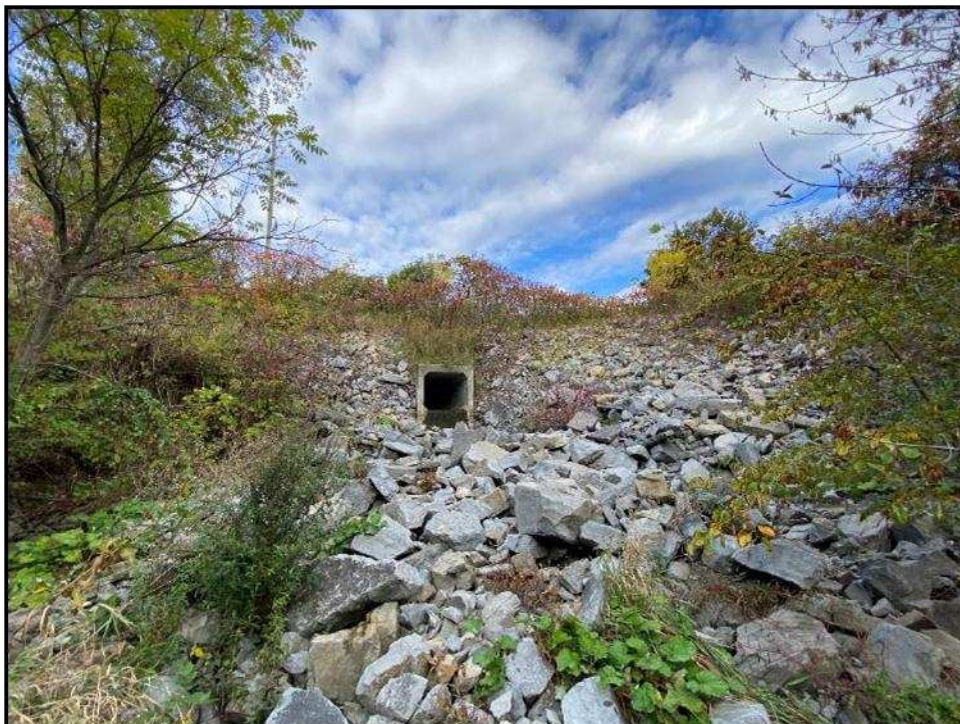
Photo 22: Photograph taken in a west direction on October 8, 2024, illustrating the placement of blast rock fill to mitigate the active erosion near the outlet of the concrete box culvert.

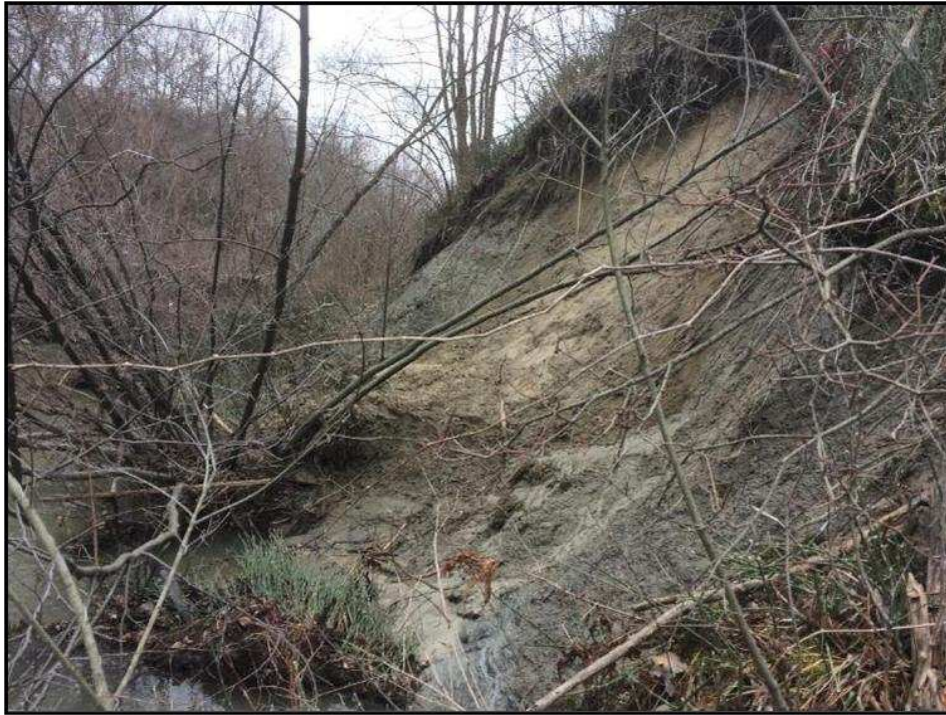
Photo 23: Photograph taken in an east direction on April 17, 2017, illustrating the active erosion and subsequent slip failure along the south bank of the Tributary to the Rideau River.

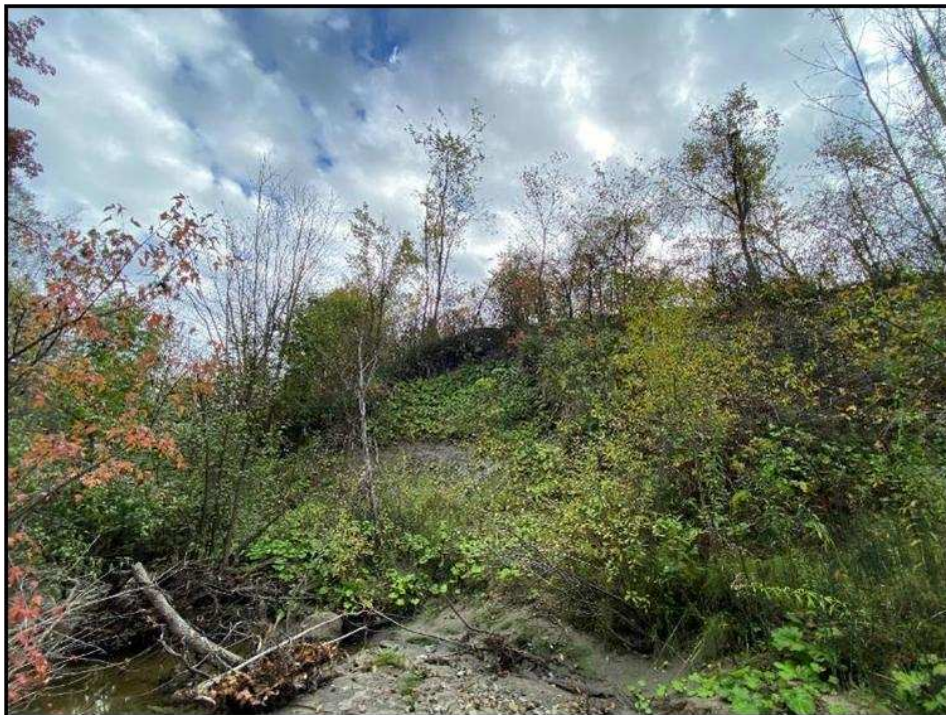
Photo 24: Photograph taken in southeast direction on October 8, 2024, illustrating the active erosion at the toe of the slope and the development of vegetation along the previously identified slip failure.

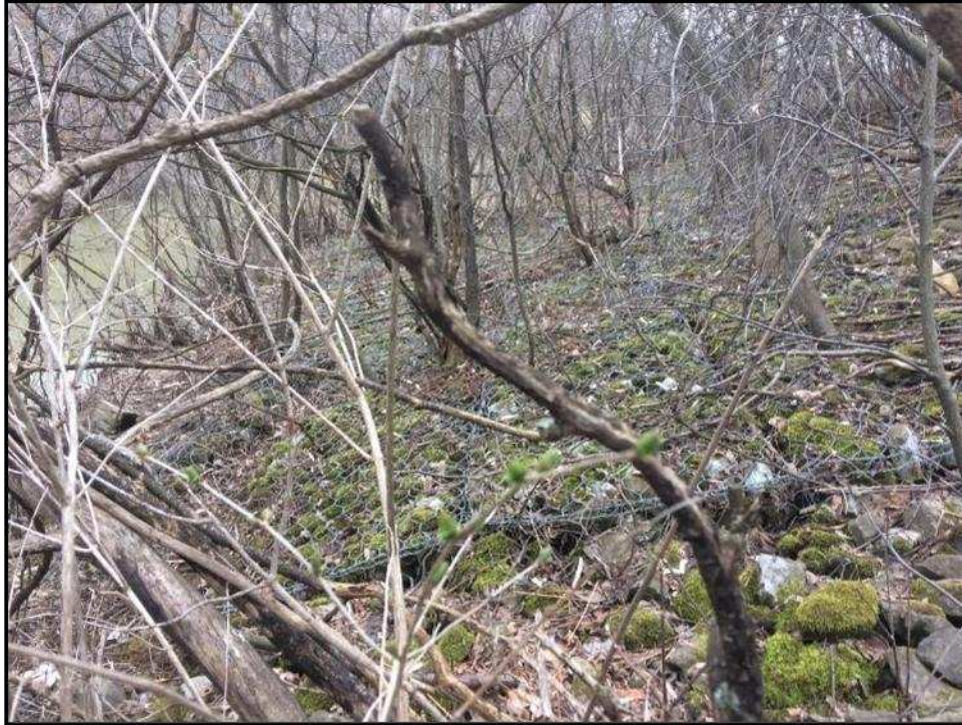
Photo 25: Photograph taken in an east direction on April 17, 2017, illustrating some gabion baskets used to mitigate the active erosion along the south bank of the tributary to the Rideau River.

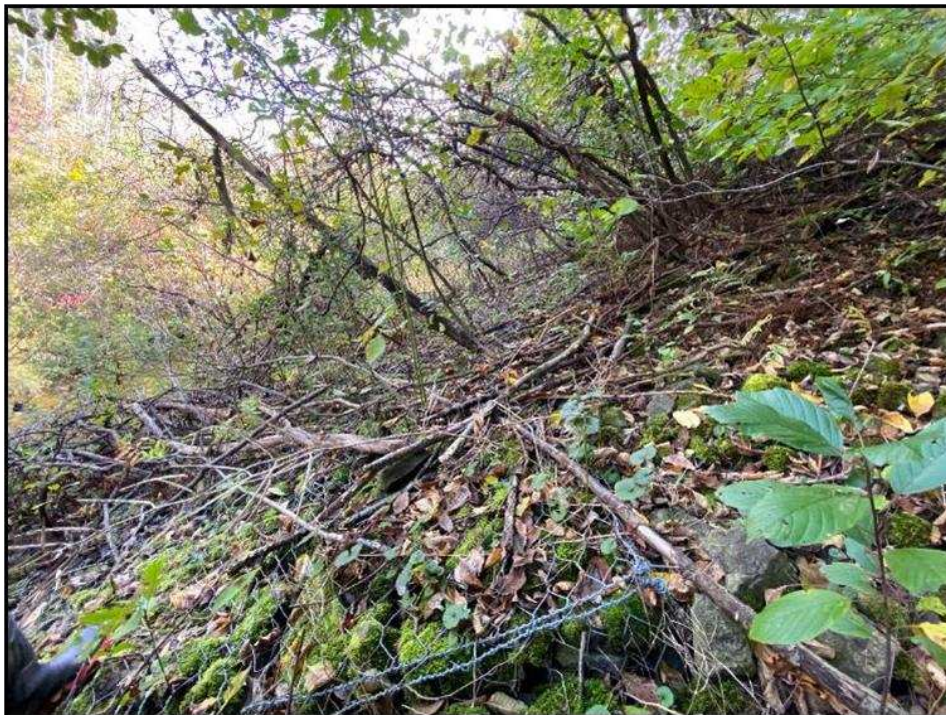
Photo 26: Photograph taken in an east direction on October 8, 2024, validating that the gabion baskets that are continuing to perform as designed.

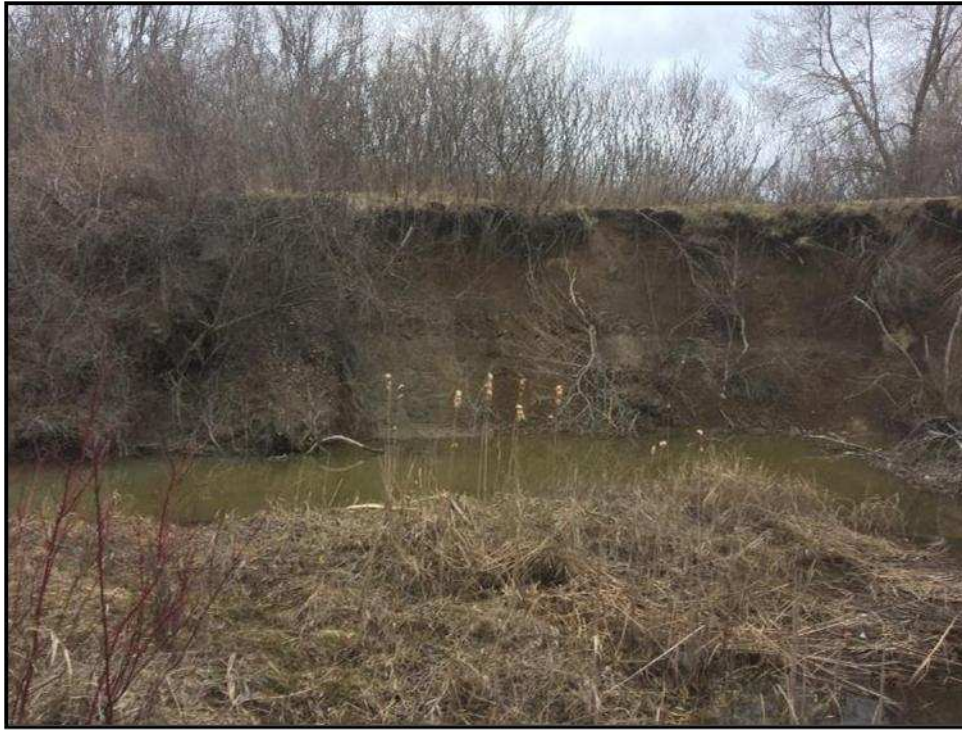
Photo 27: Photograph taken on April 17, 2017, in a northeast direction illustrating the active erosion and subsequent slip failures along the north bank of the tributary to the Rideau River.

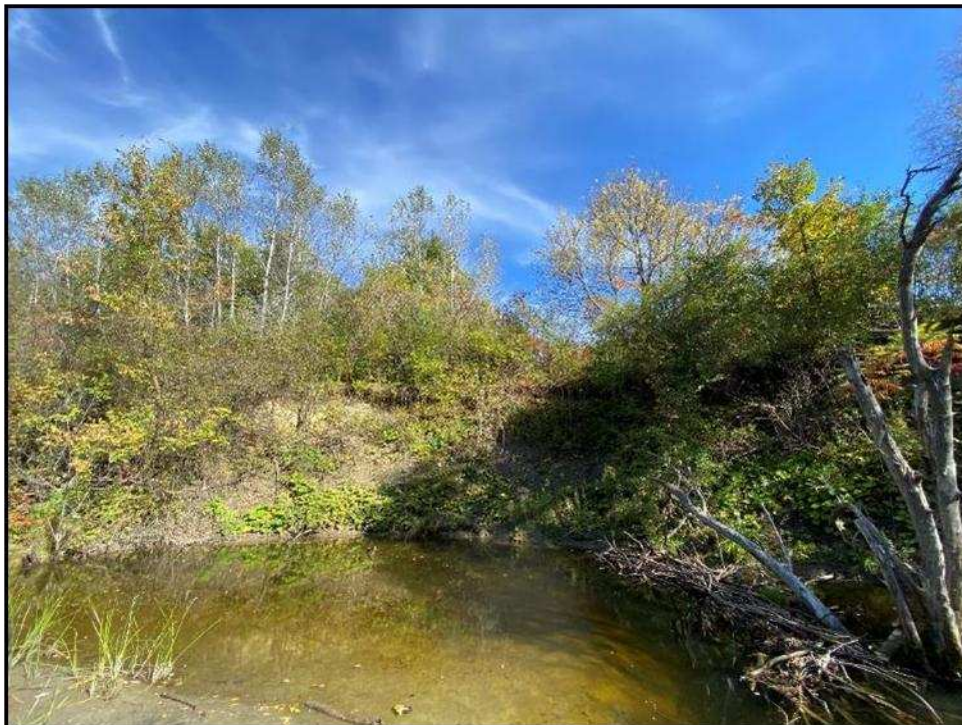
Photo 28: Photograph taken on October 8, 2024, in a northeast direction further documenting the active erosion and historic slope failure that occurred along the north bank of the tributary to the Rideau River.

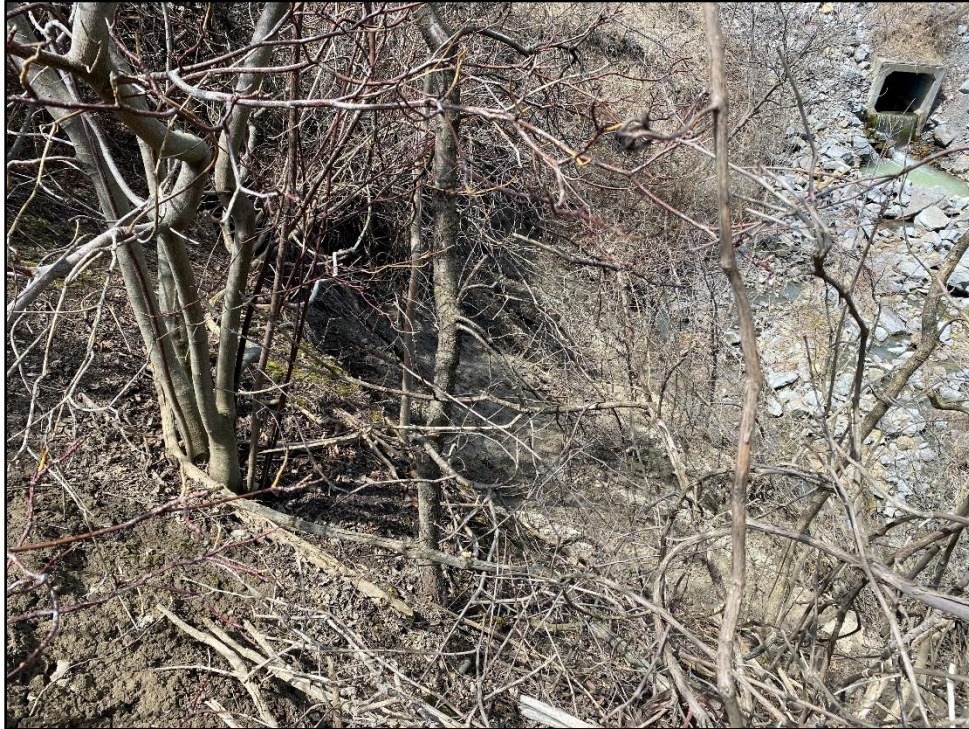
Photo 29: Photograph taken in a north direction illustrating the current state of the slope adjacent to the previously placed blast rock fill near the outlet of the concrete box culvert along the north bank of the tributary to the Rideau River.

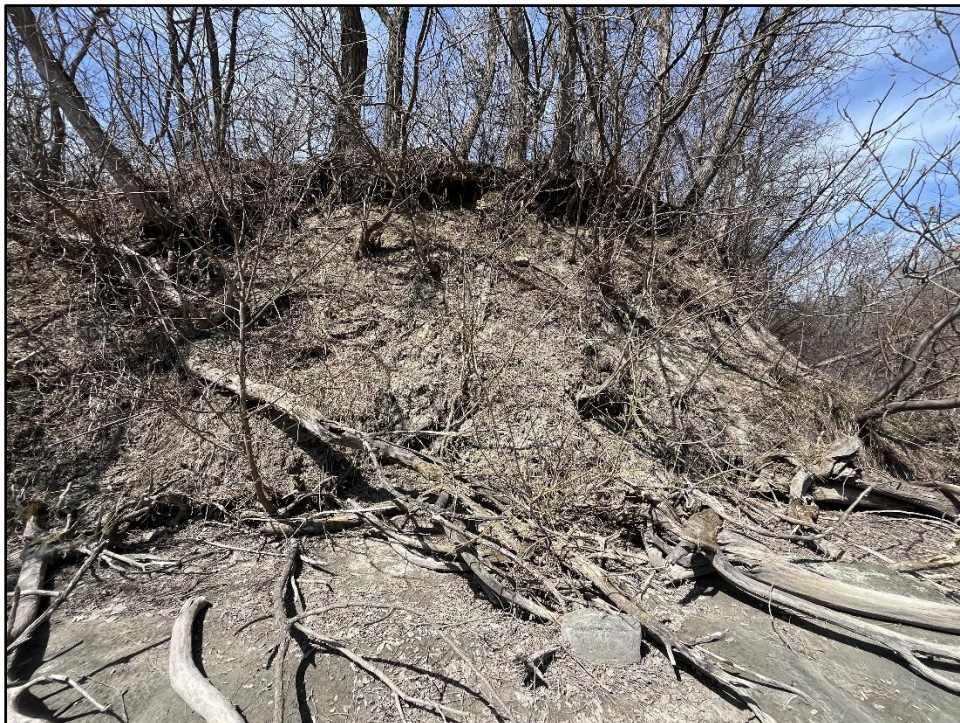
Photo 30: Photograph taken in a west direction from where the tributary connects to the Rideau River, illustrating the active erosion along the northeastern corner slope face.

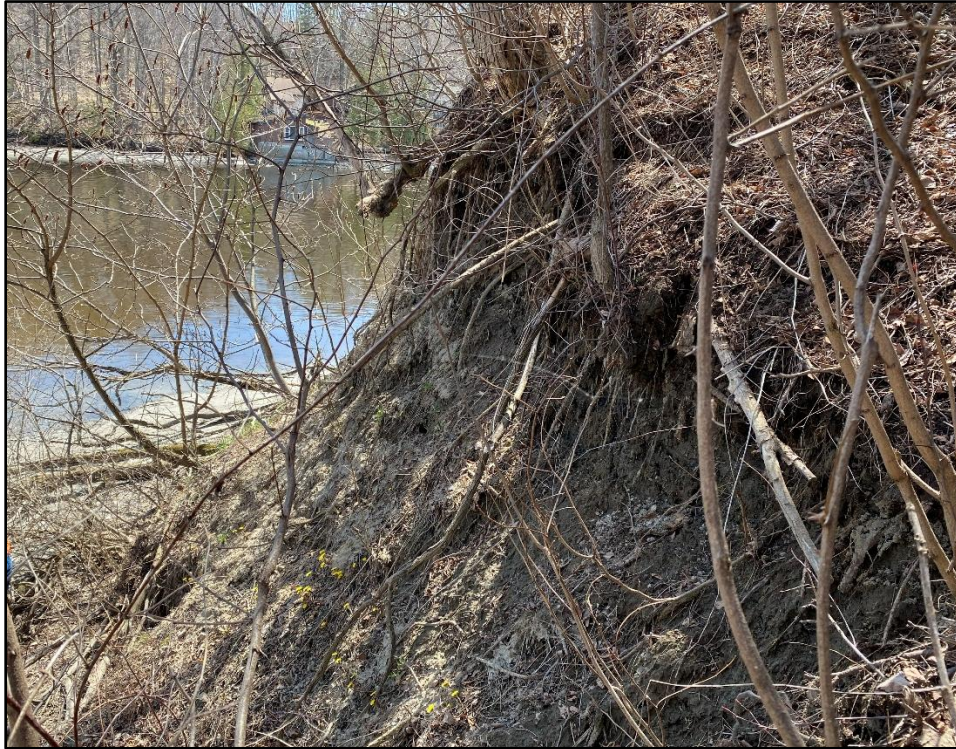
Photo 31: Photograph taken in an east direction illustrating the active erosion along the northeastern corner slope face (Rideau River beyond).
