**PATERSON
GROUP**

June 19, 2026
PG6557-LET.01 Revision 4

Subject: **Preliminary Geotechnical Investigation
Proposed Commercial Development
2175 Prince of Wales Drive – Ottawa, Ontario**

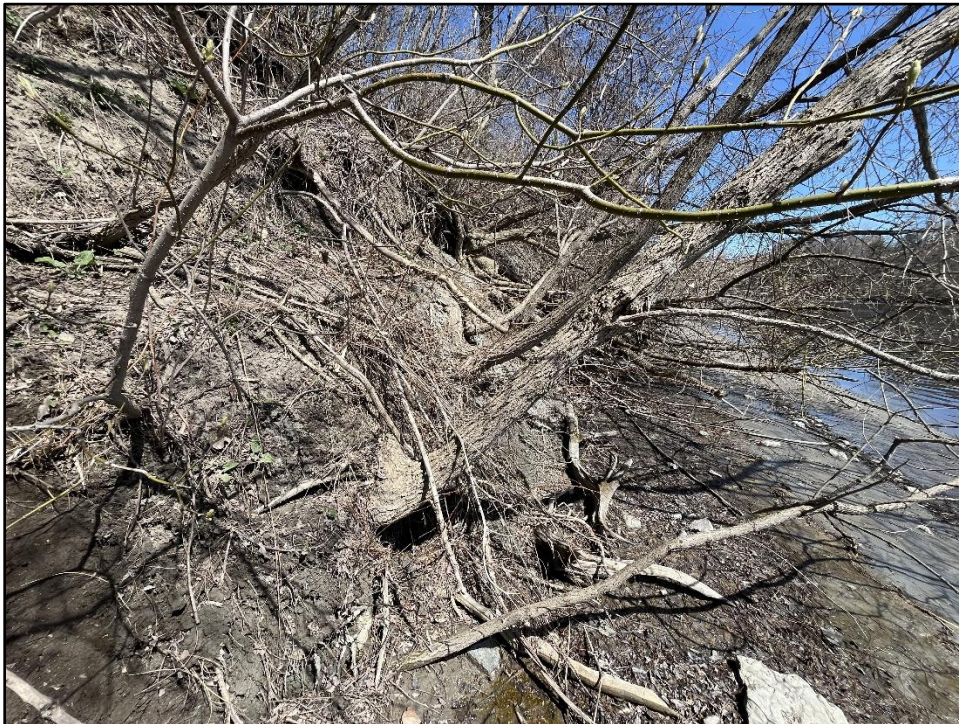
Photo 32: Photograph taken in a north direction at the base of the slope along the Rideau River, illustrating evidence of active erosion along the lower sections of the slope face.

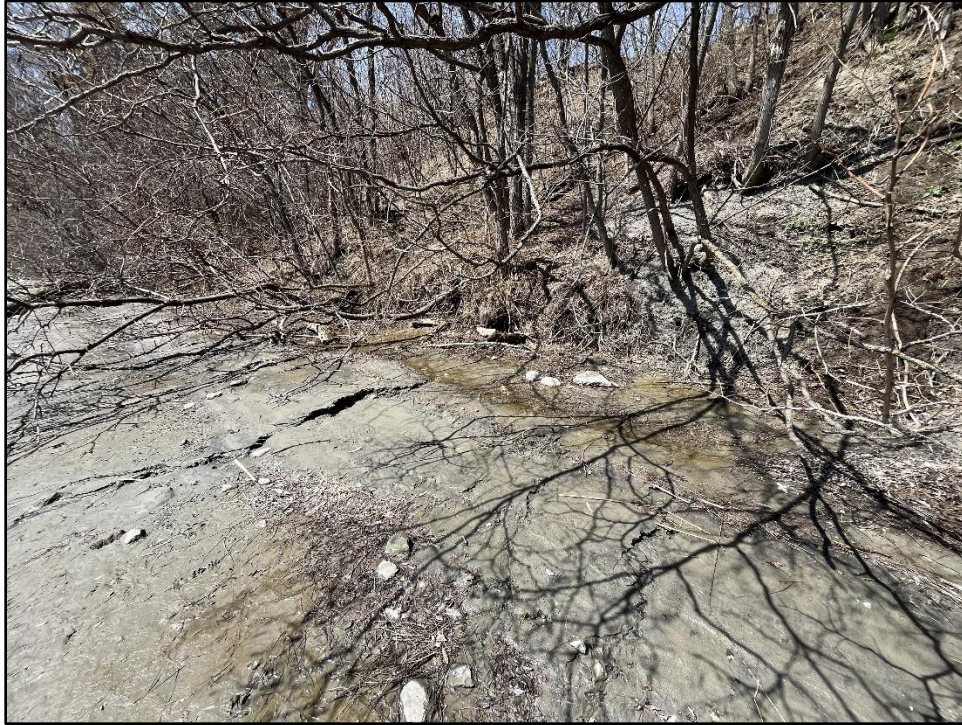
Photo 33: Photograph taken in a southwest direction at the base of the slope along the Rideau River, illustrating evidence of active erosion along the lower sections of the slope face.

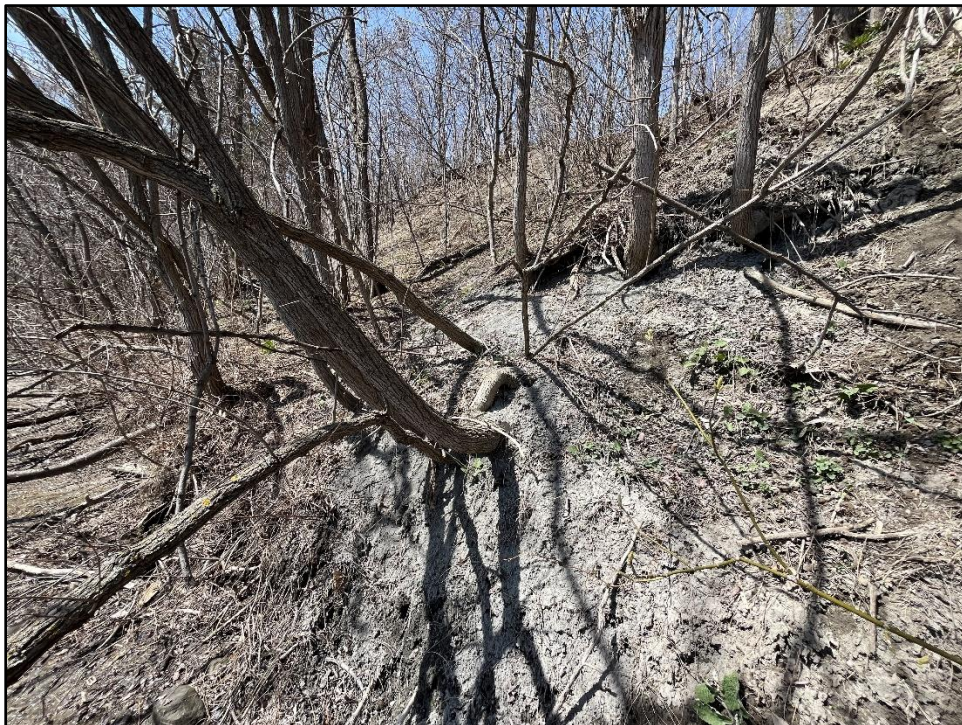
Photo 34: Photograph taken in a southwest direction midway up the slope along the Rideau River, illustrating evidence of active erosion along the lower sections and localized higher sections of the slope face.
