**PATERSON
GROUP**

February 20, 2026
PG6557-LET.01 Revision 2

Subject: **Preliminary Geotechnical Investigation
Proposed Commercial Development
2175 Prince of Wales Drive – Ottawa, Ontario**

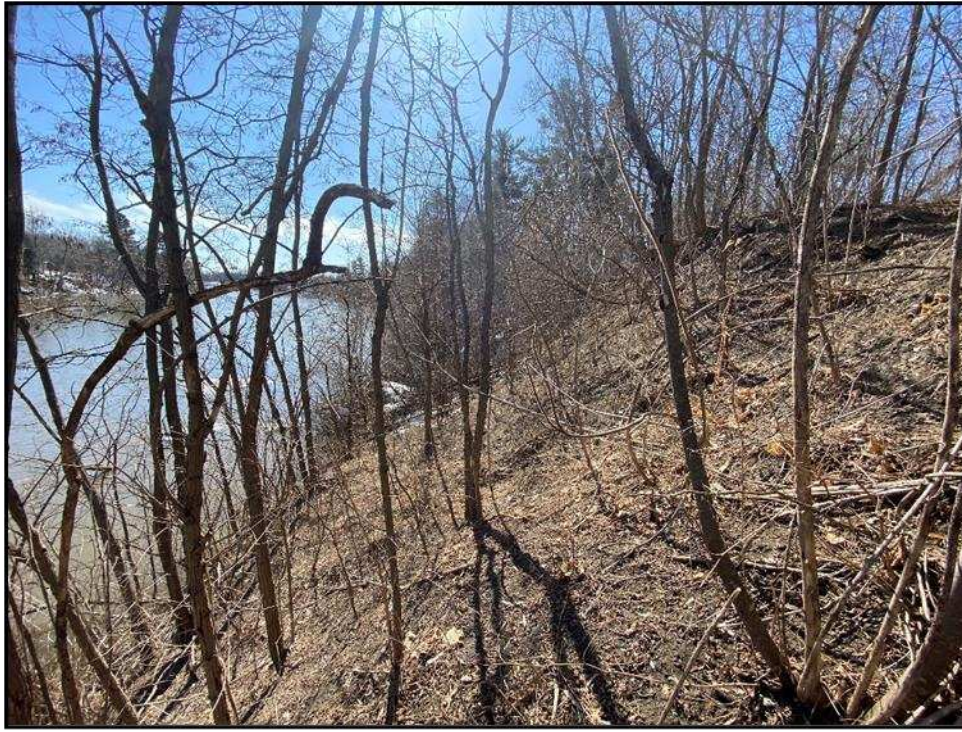
Photo 1: Photograph taken in a southeast direction illustrating some evidence of active erosion.

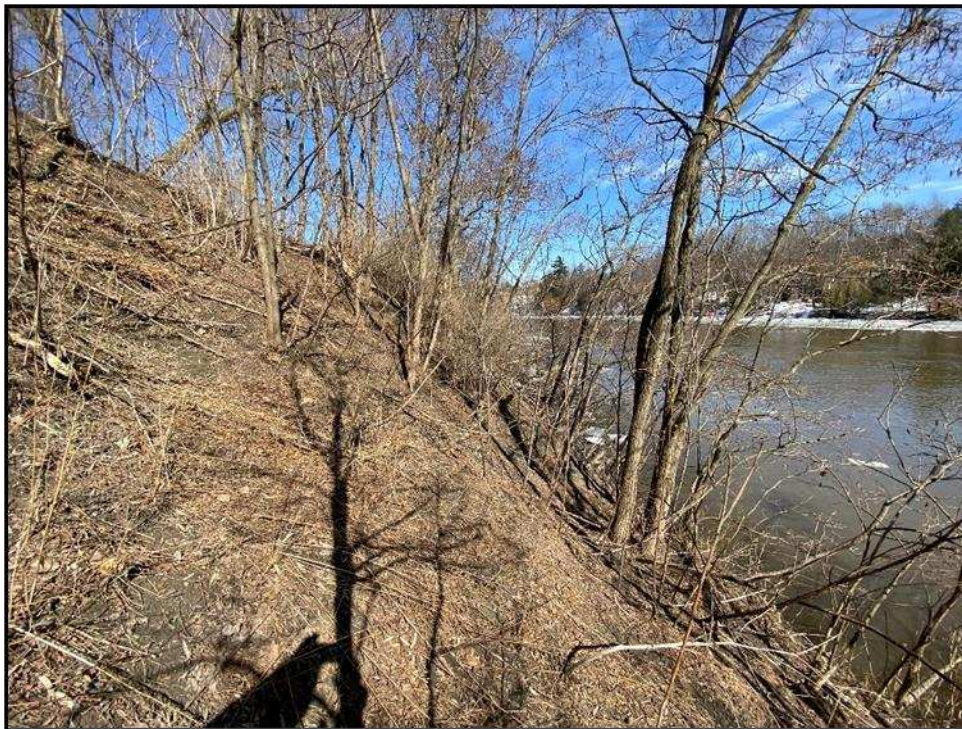
Photo 2: Photograph taken in a northeast direction illustrating some evidence of active erosion along the west bank of the Rideau River.

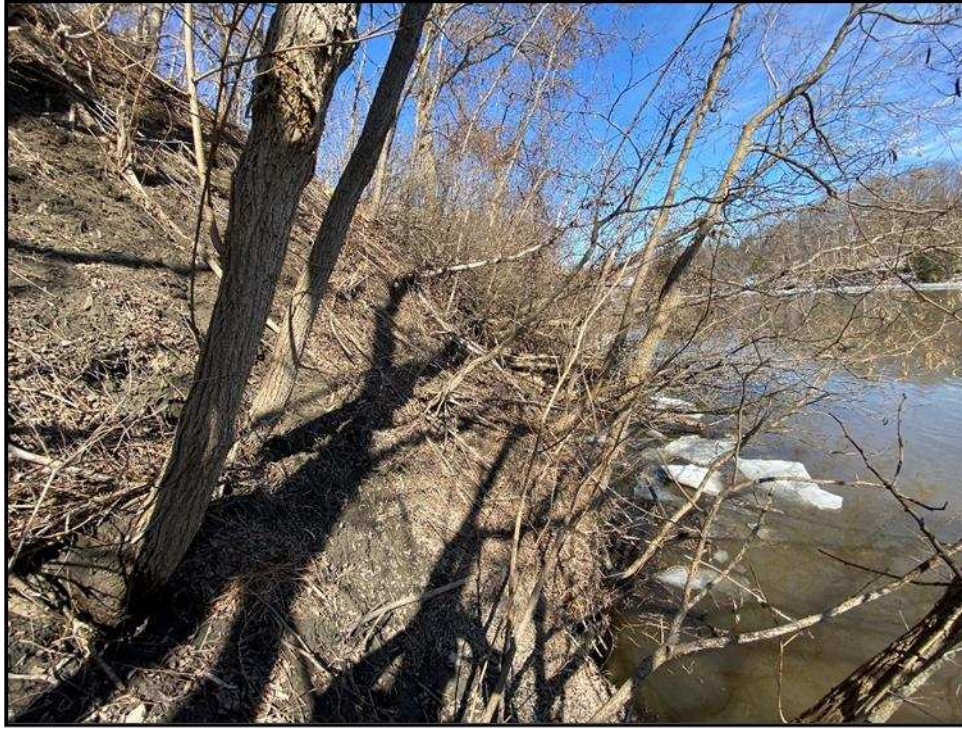
Photo 3: Photograph taken in a northeast direction illustrating some evidence of toe erosion along the west bank of the Rideau River.

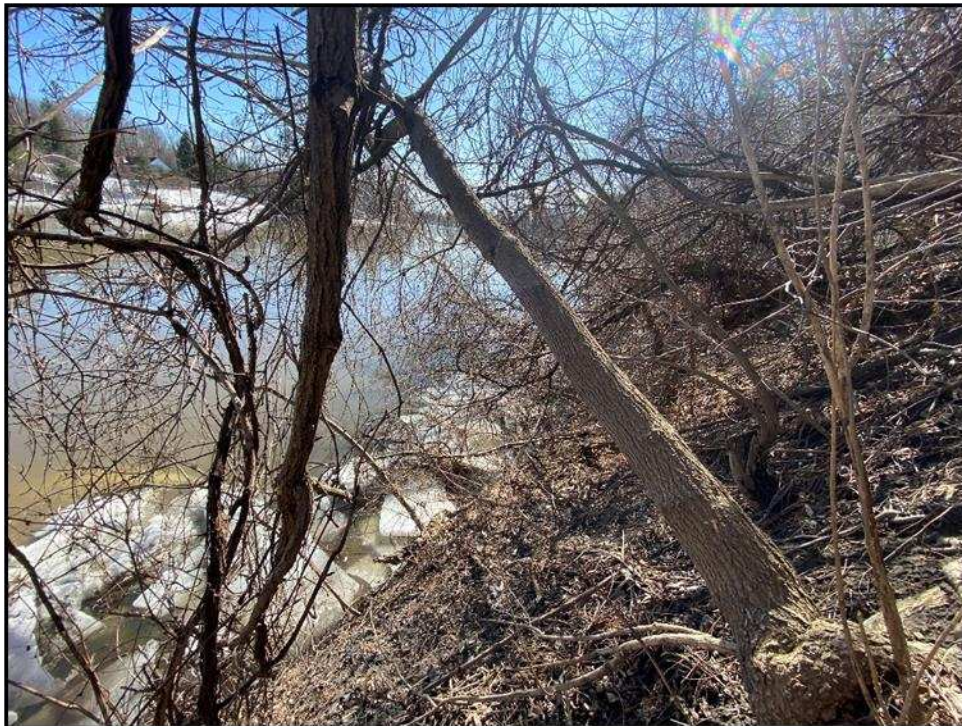
Photo 4: Photograph taken in a southwest direction illustrating some evidence of active erosion along the west bank of the Rideau River.

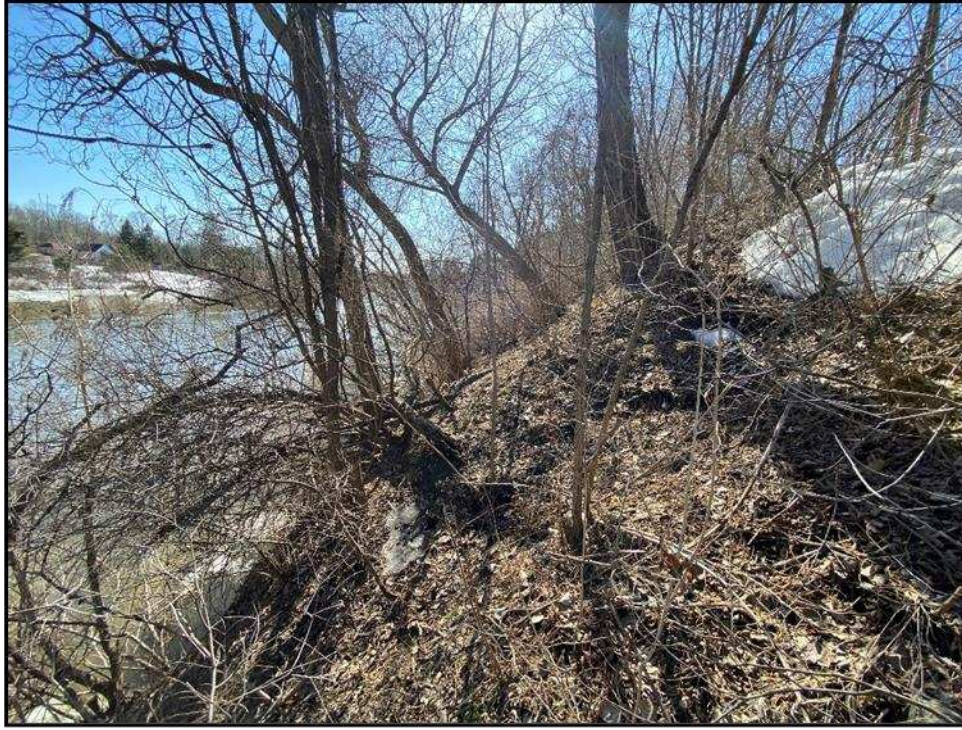
Photo 5: Photograph taken in a southwest direction illustrating some evidence of active erosion along the west bank of the Rideau River.

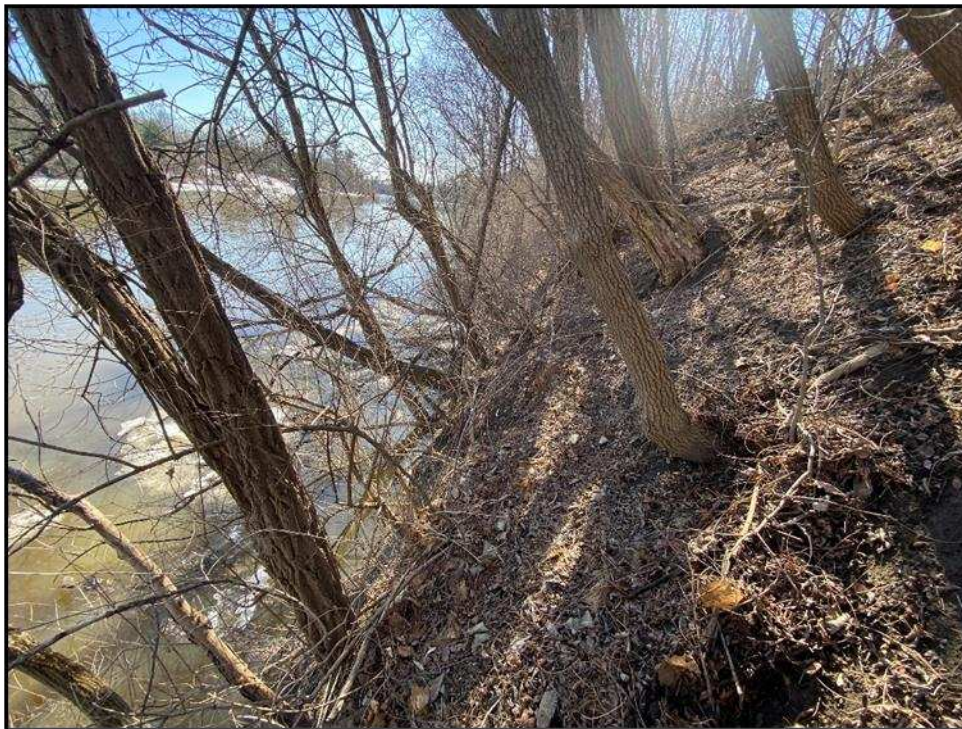
Photo 6: Photograph taken in a southwest direction illustrating some evidence of toe erosion along the west bank of the Rideau River.

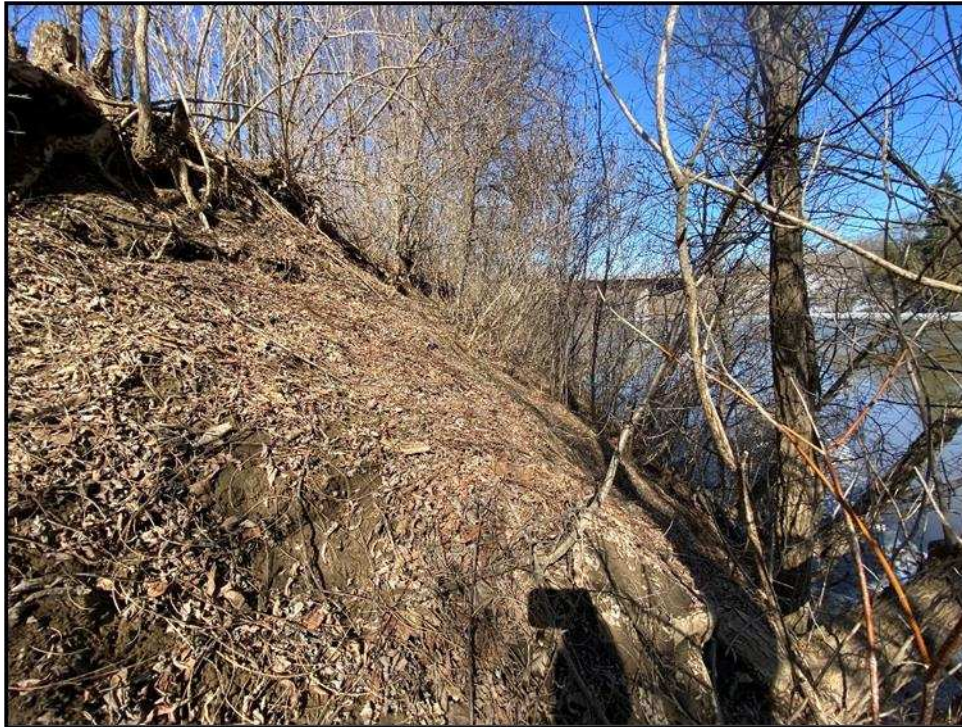
Photo 7: Photograph taken in a northeast direction illustrating some evidence of active erosion along the west bank of the Rideau River.

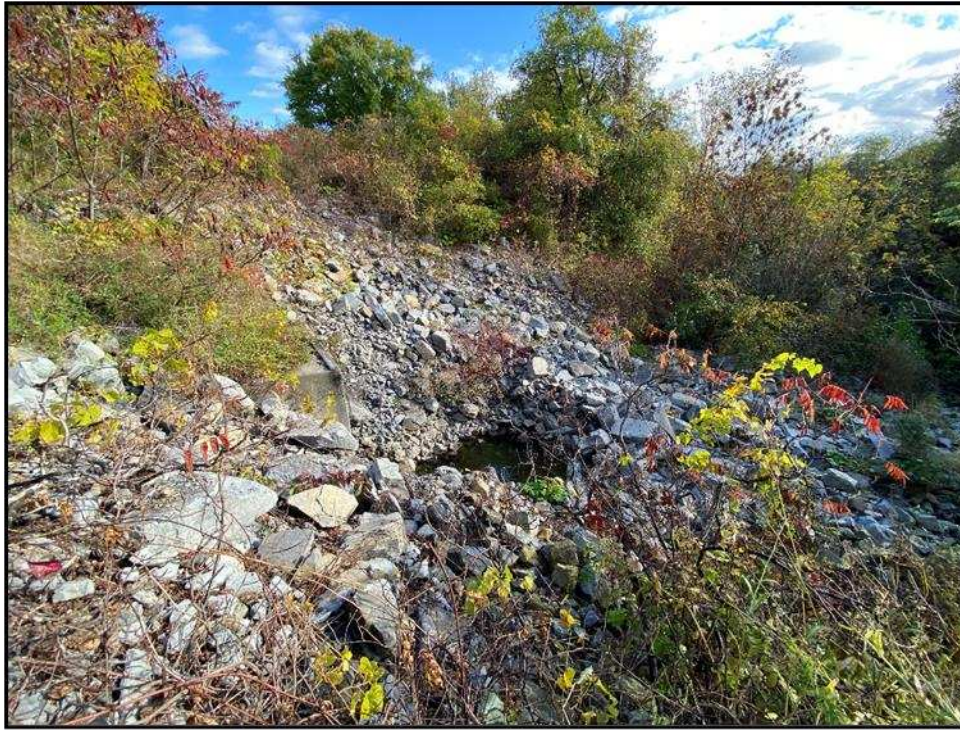
Photo 8: Photograph taken in a northeast direction illustrating the placement of riprap stone around the culvert outlet that discharges into the tributary to the Rideau River.

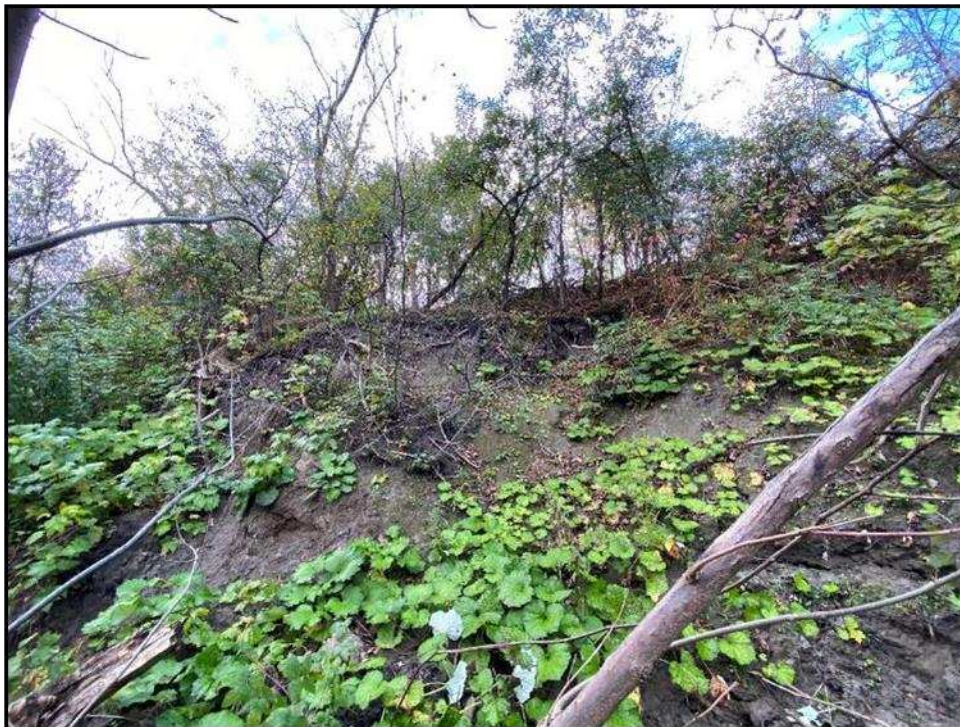
Photo 9: Photograph taken in a south direction along the tributary to the Rideau River illustrating some evidence of historical slip failures along the south banks of the valley corridor.

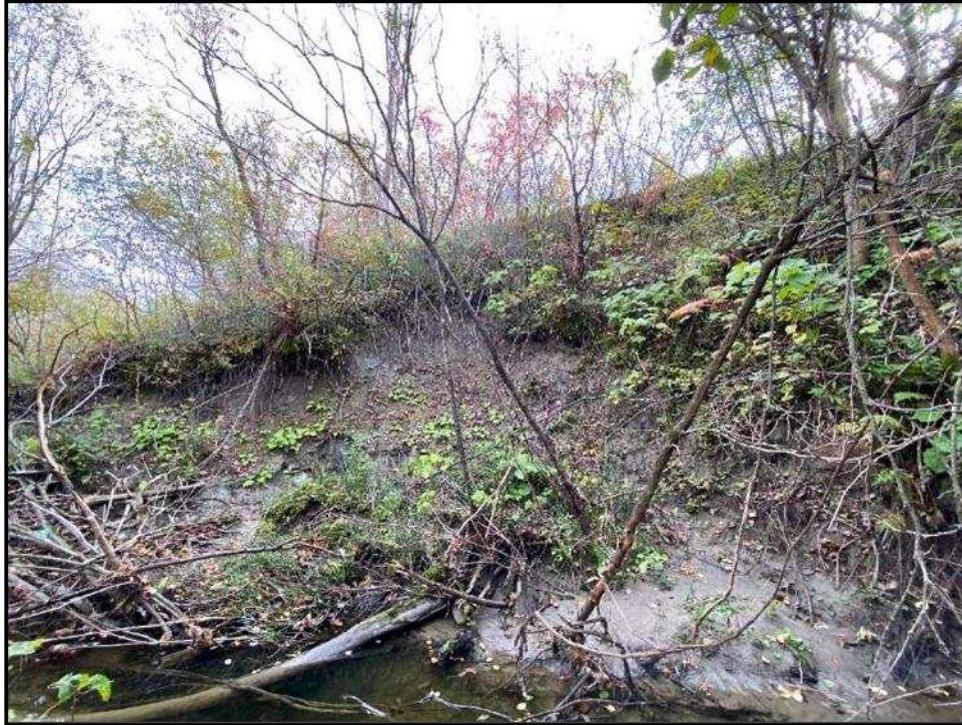
Photo 10: Photograph taken in a south direction along the tributary to the Rideau River illustrating some toe erosion along the base of the valley corridor where the watercourse meets the wall of the valley corridor.

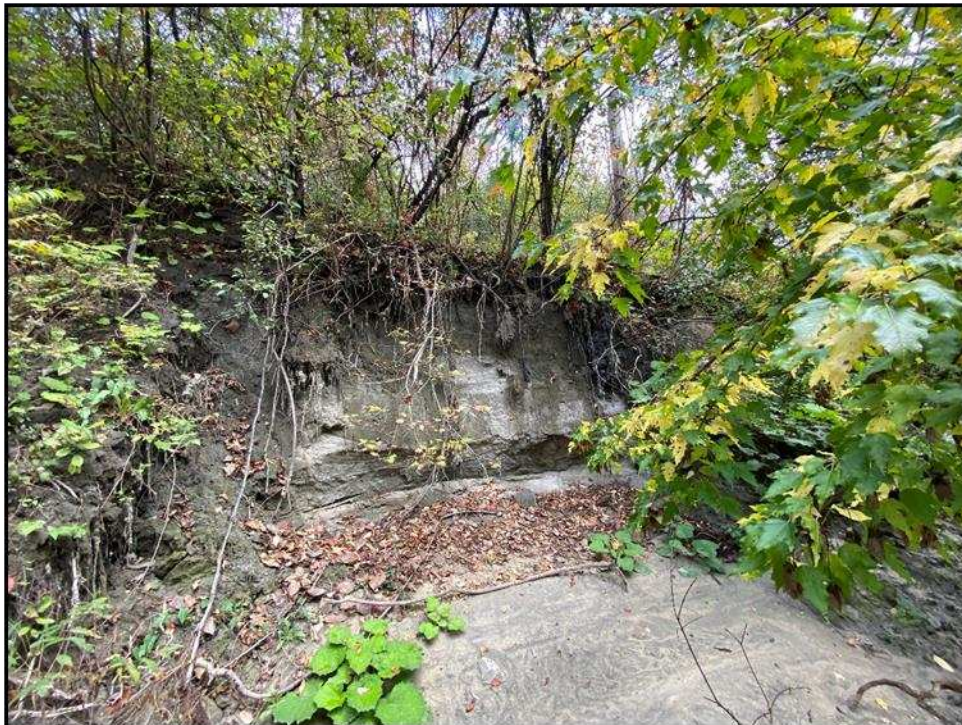
Photo 11: Photograph taken in a north direction along the tributary to the Rideau River illustrating evidence of active erosion along the north bank of the valley corridor.

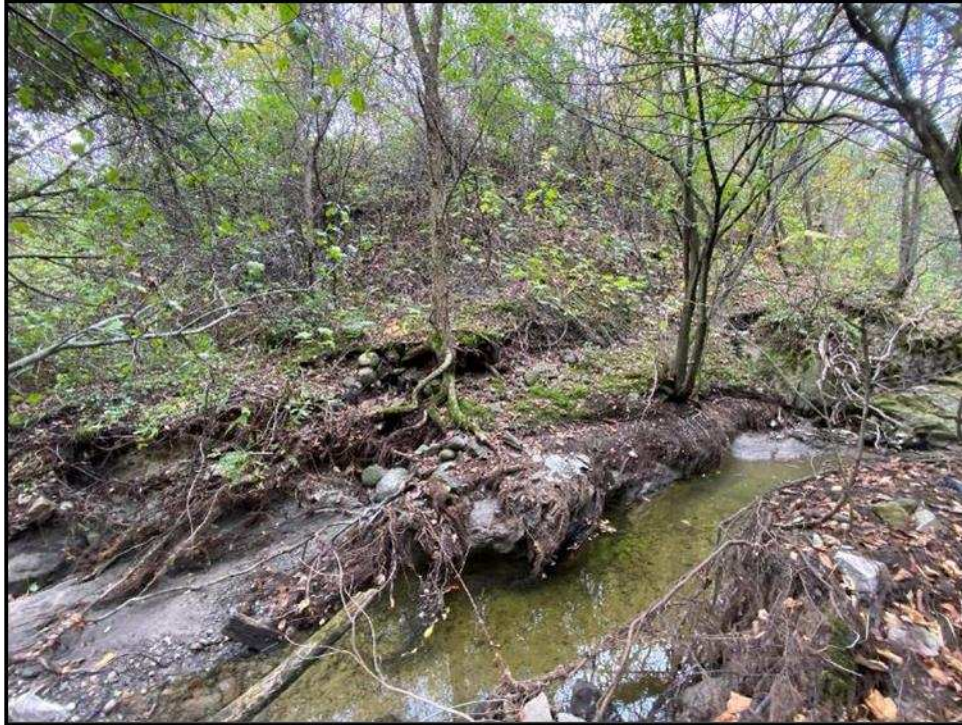
Photo 12: Photograph taken in a south direction along the tributary to the Rideau River illustrating evidence of historical slip failures along the south bank of the valley corridor and evidence of active erosion where the watercourse meets the wall of the valley corridor.

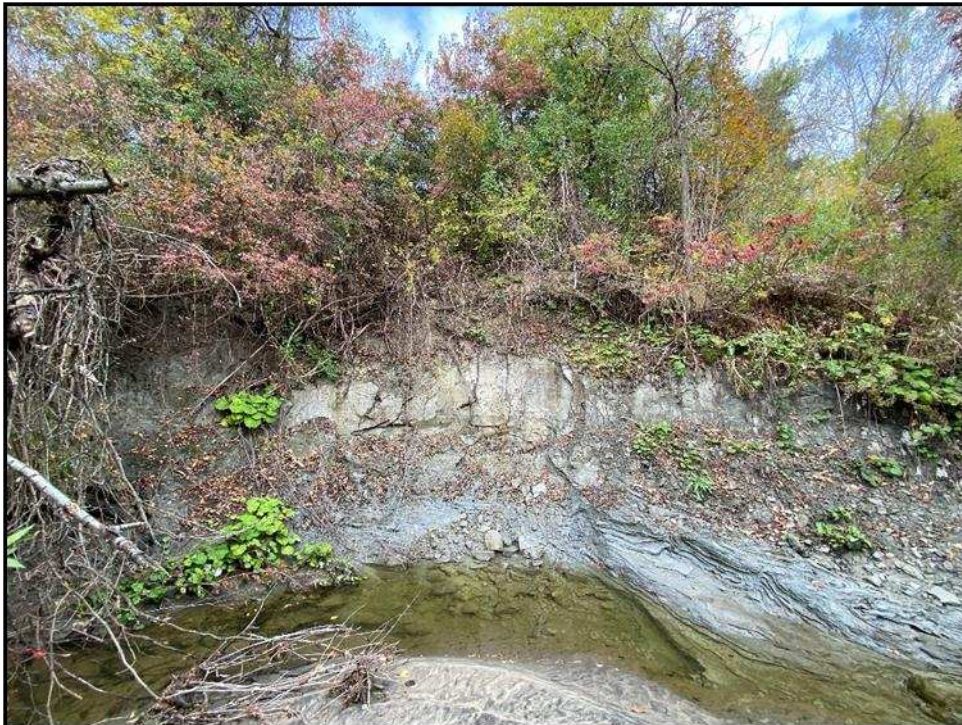
Photo 13: Photograph taken in a north direction along the tributary to the Rideau River illustrating evidence of active erosion.

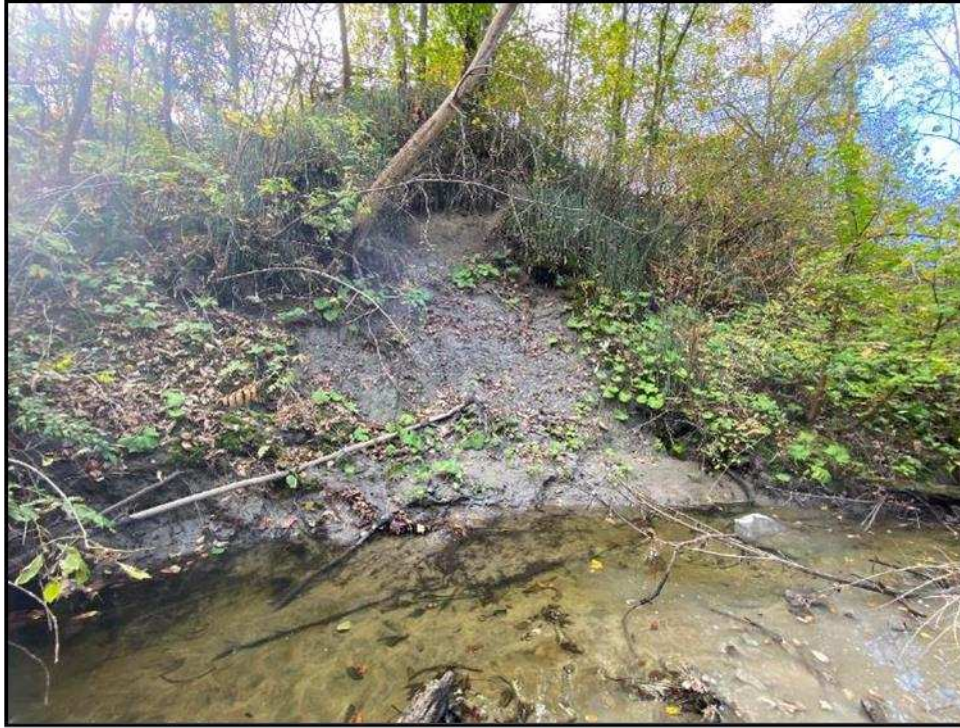
Photo 14: Photograph taken in a south direction along the tributary to the Rideau River illustrating evidence of historical slip failures along the south bank of the valley corridor and evidence of active erosion where the watercourse meets the wall of the valley corridor.

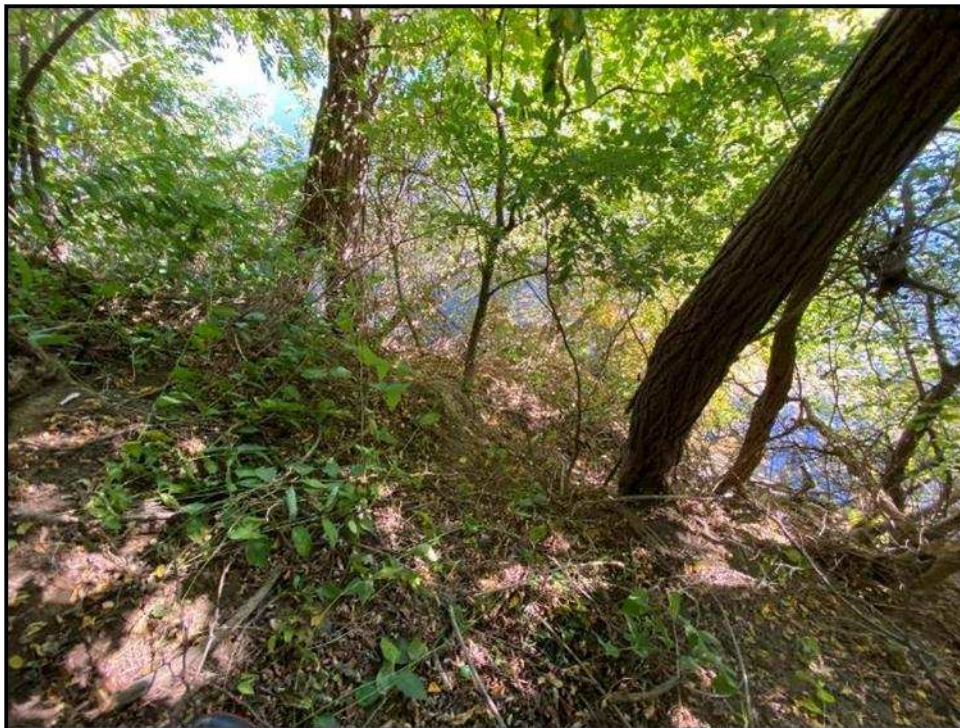
Photo 15: Photograph taken in an east direction over the west bank of the Rideau River showing some active erosion.

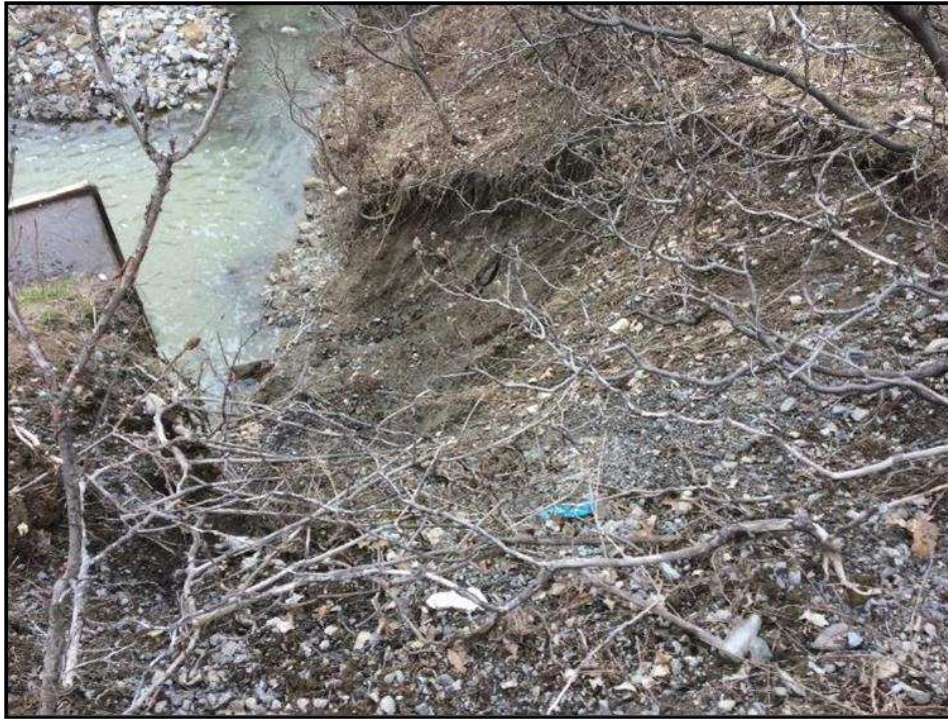
Photo 16: Photograph taken in an east direction illustrating the active erosion and subsequent slip failures adjacent to the concrete box culvert.

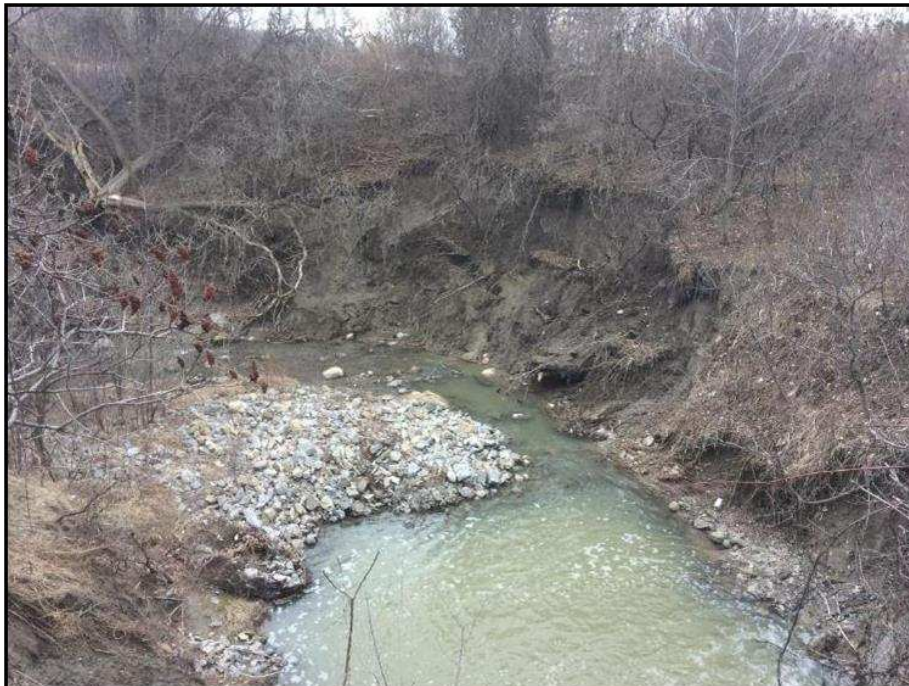
Photo 17: Photograph taken in an east direction from the top of the concrete box culvert illustrating the active erosion and subsequent slip failures along the south bank of the tributary to the Rideau River.

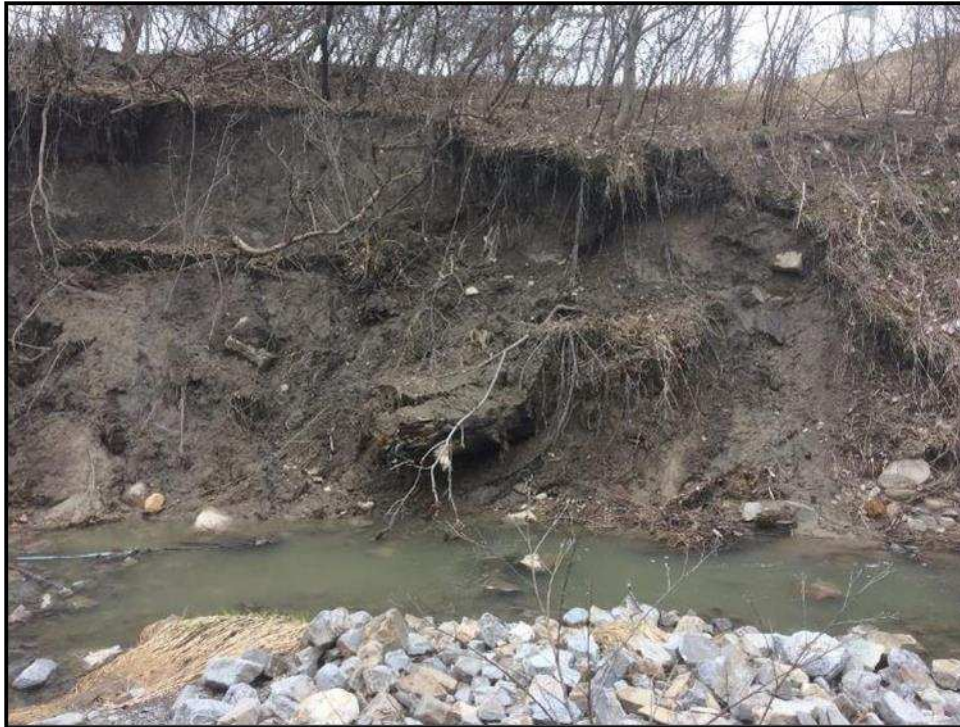
Photo 18: Photograph taken in a west direction to further capture the active erosion and subsequently slip failure presented in the previous photograph.

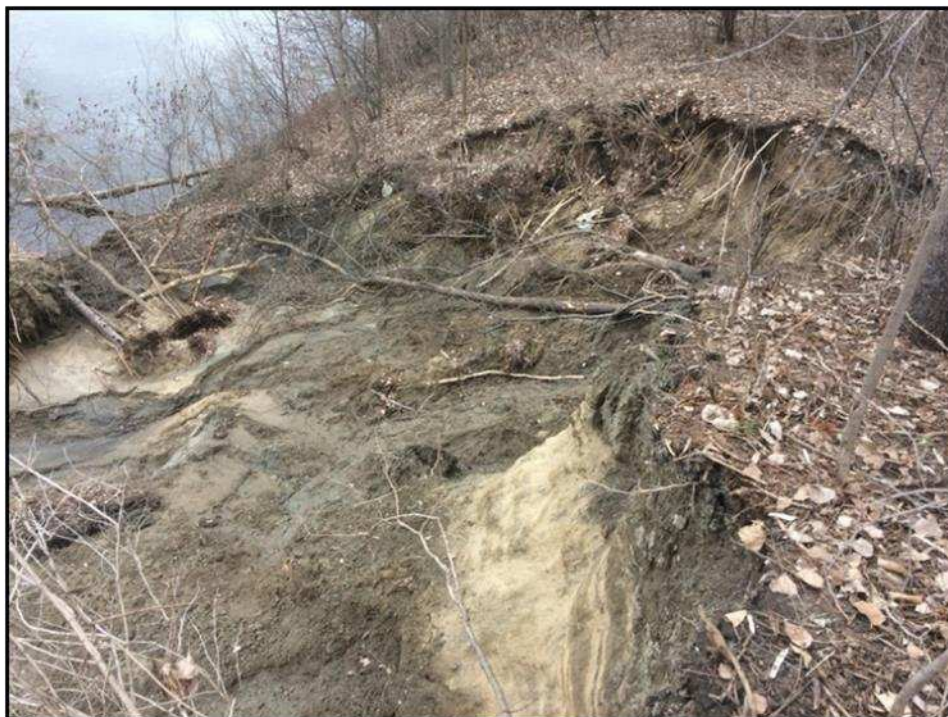
Photo 19: Photograph taken in a south direction illustrating a relatively recent slope failure along the west bank of the Rideau River.

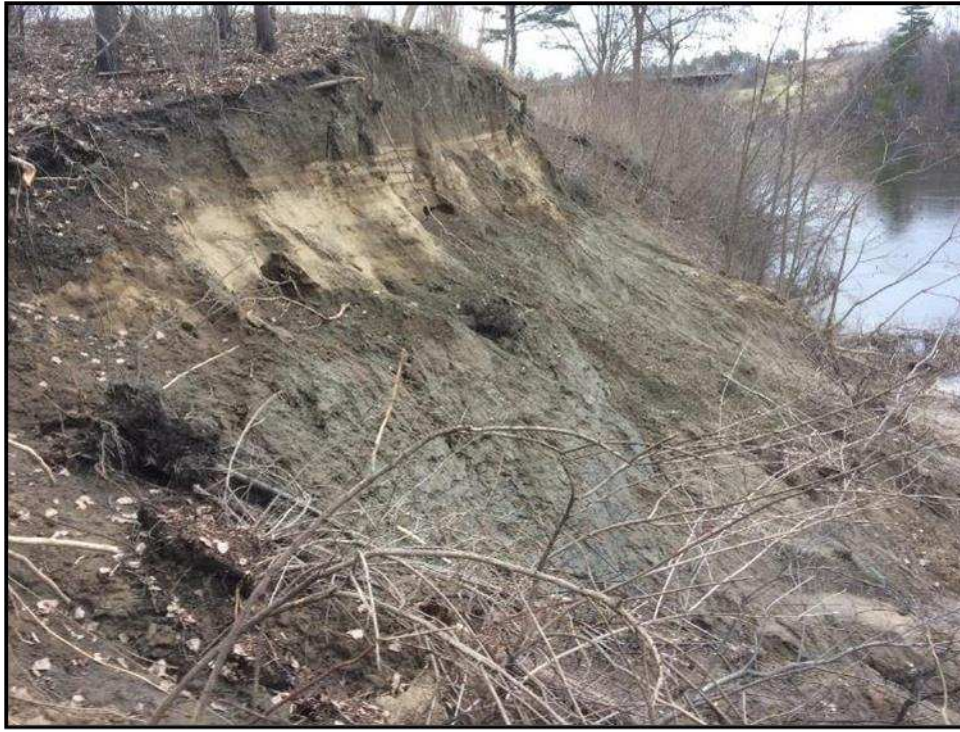
Photo 20: Similar to the previous photograph but taken in a north direction further illustrating the relatively recent slip failure along the west bank of the Rideau River.

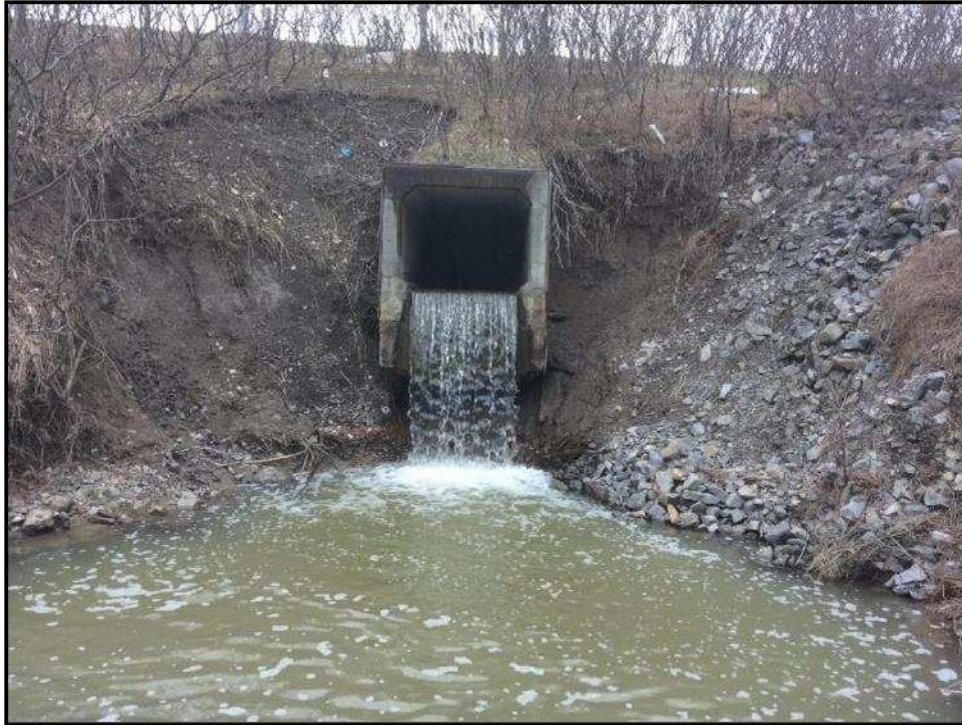
Photo 21: Photograph taken in a west direction on April 17, 2017, illustrating the active erosion and subsequent slip failures adjacent to the concrete box culvert.

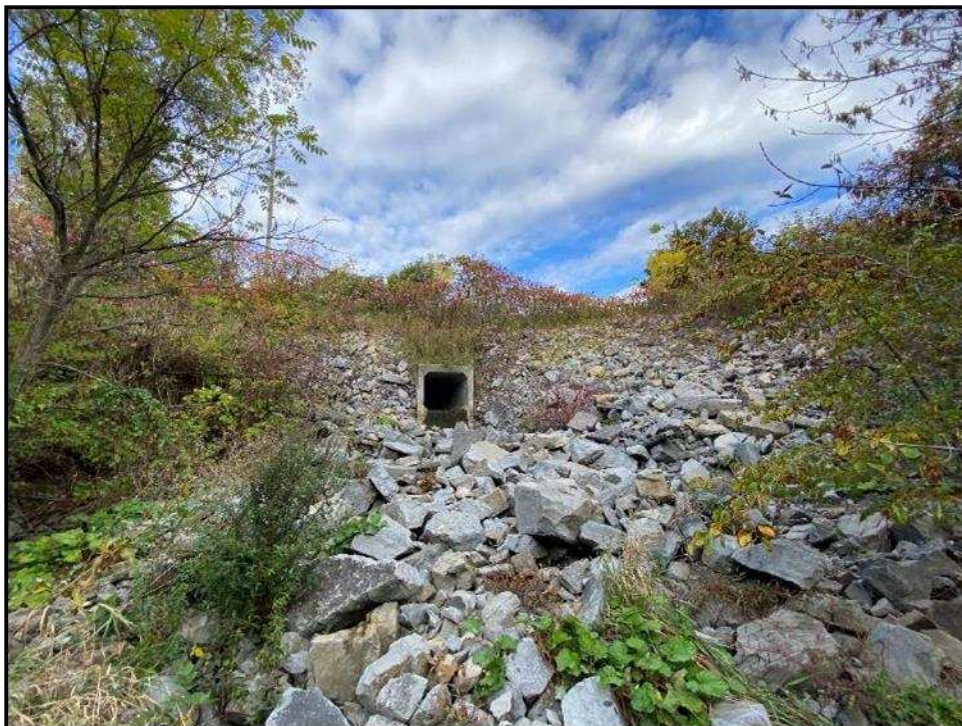
Photo 22: Photograph taken in a west direction on October 8, 2024, illustrating the placement of blast rock fill to mitigate the active erosion near the outlet of the concrete box culvert.

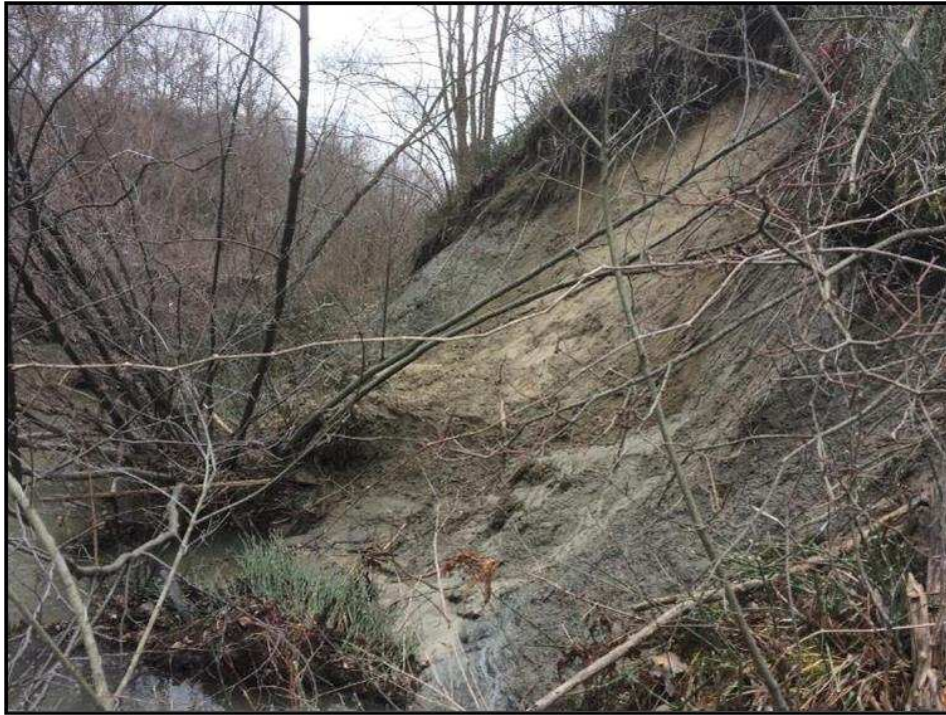
Photo 23: Photograph taken in an east direction on April 17, 2017, illustrating the active erosion and subsequent slip failure along the south bank of the Tributary to the Rideau River.

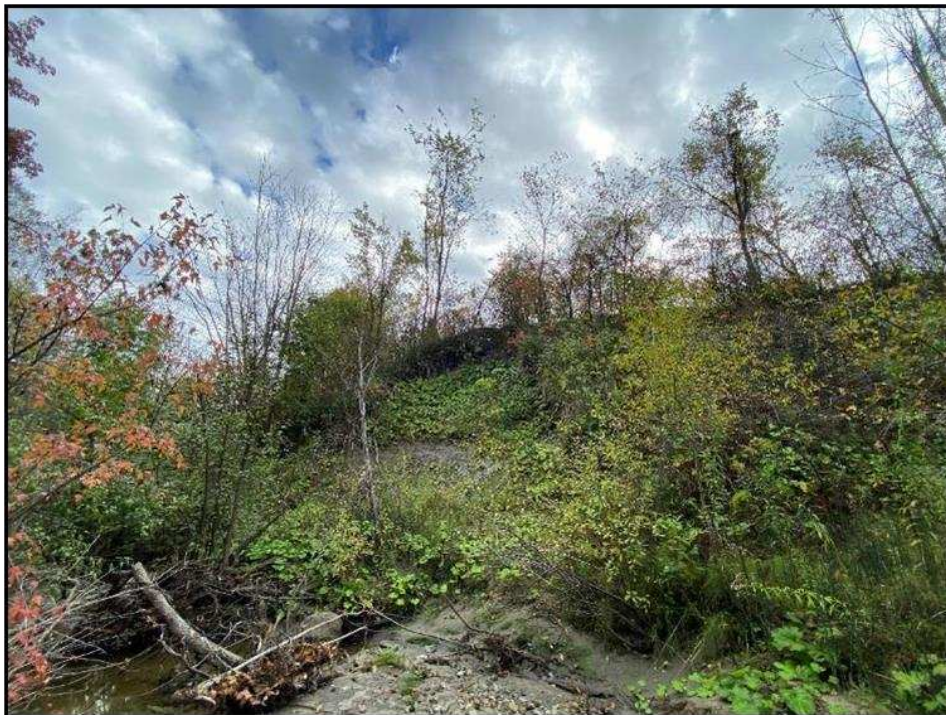
Photo 24: Photograph taken in southeast direction on October 8, 2024, illustrating the active erosion at the toe of the slope and the development of vegetation along the previously identified slip failure.

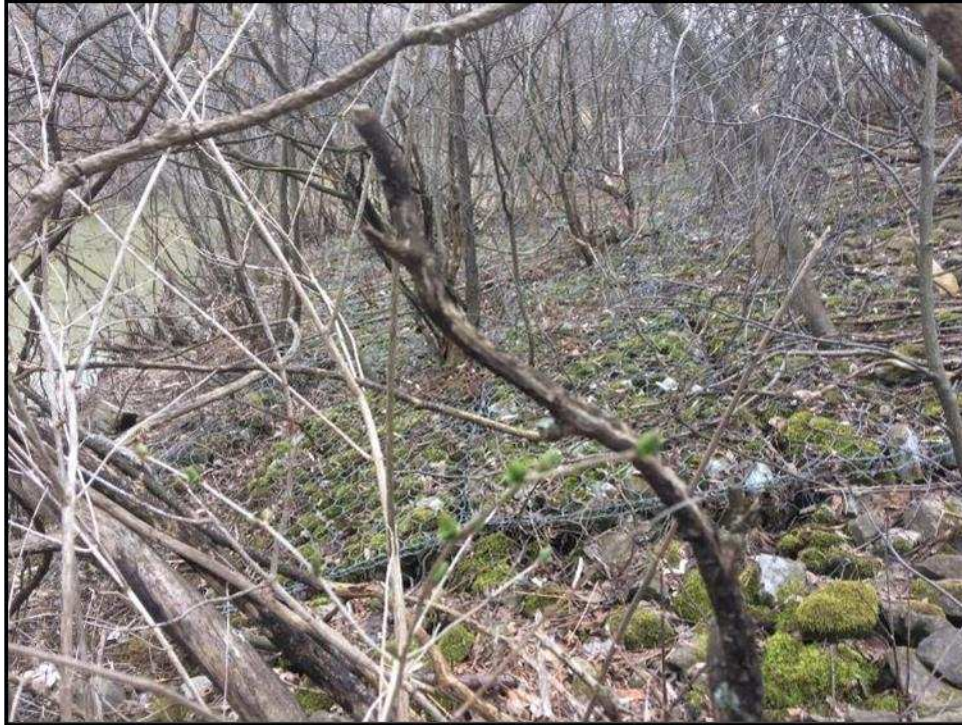
Photo 25: Photograph taken in an east direction on April 17, 2017, illustrating some gabion baskets used to mitigate the active erosion along the south bank of the tributary to the Rideau River.

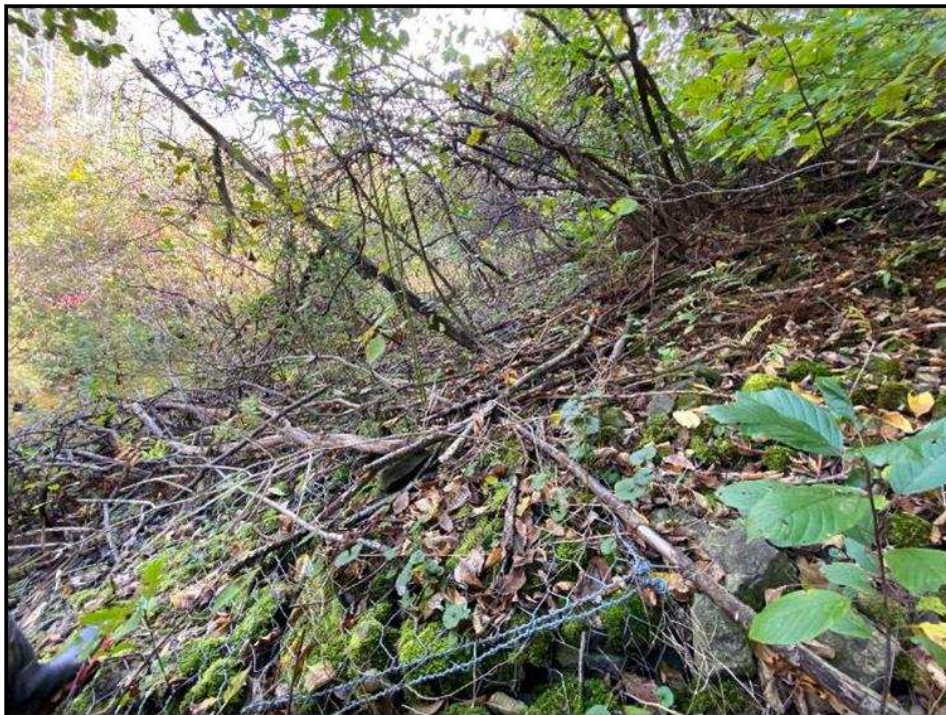
Photo 26: Photograph taken in an east direction on October 8, 2024, validating that the gabion baskets that are continuing to perform as designed.

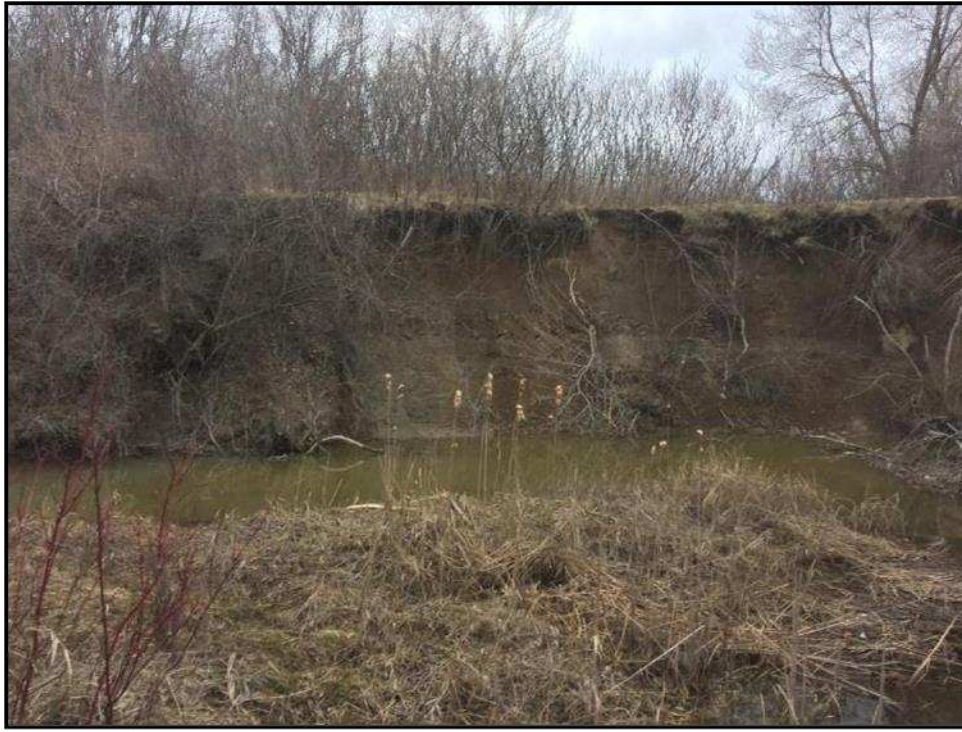
Photo 27: Photograph taken on April 17, 2027, in a northeast direction illustrating the active erosion and subsequent slip failures along the north bank of the tributary to the Rideau River.

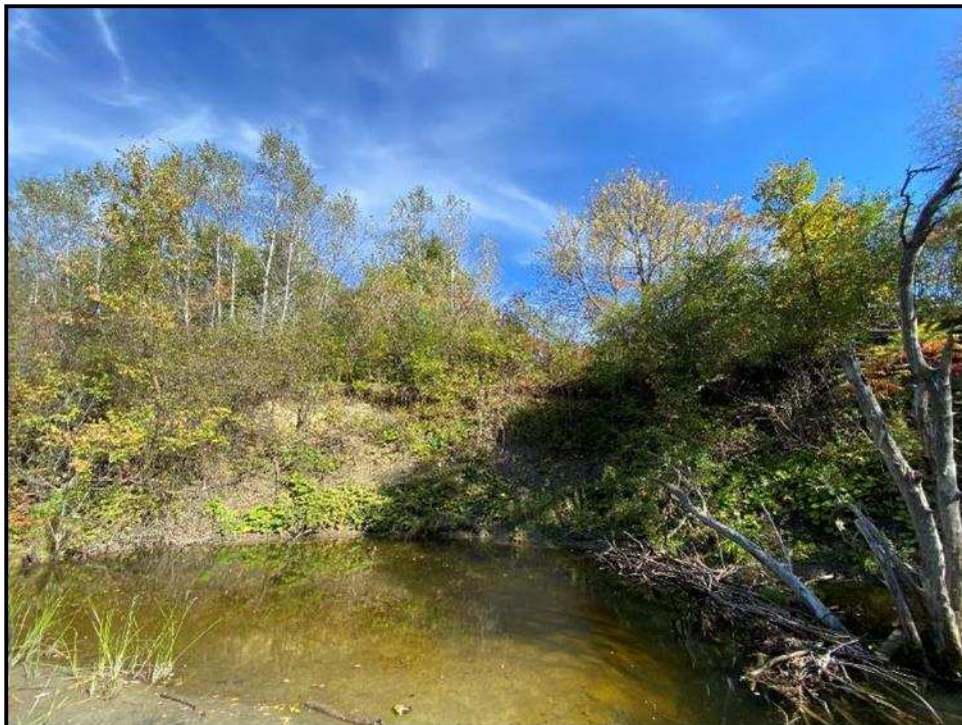
Photo 28: Photograph taken on October 8, 2024, in a northeast direction further documenting the active erosion and historic slope failure that occurred along the north bank of the tributary to the Rideau River.
