**PATERSON
GROUP**

February 20, 2026
PG6557-LET.01 Revision 2

Subject: **Preliminary Geotechnical Investigation
Proposed Commercial Development
2175 Prince of Wales Drive – Ottawa, Ontario**

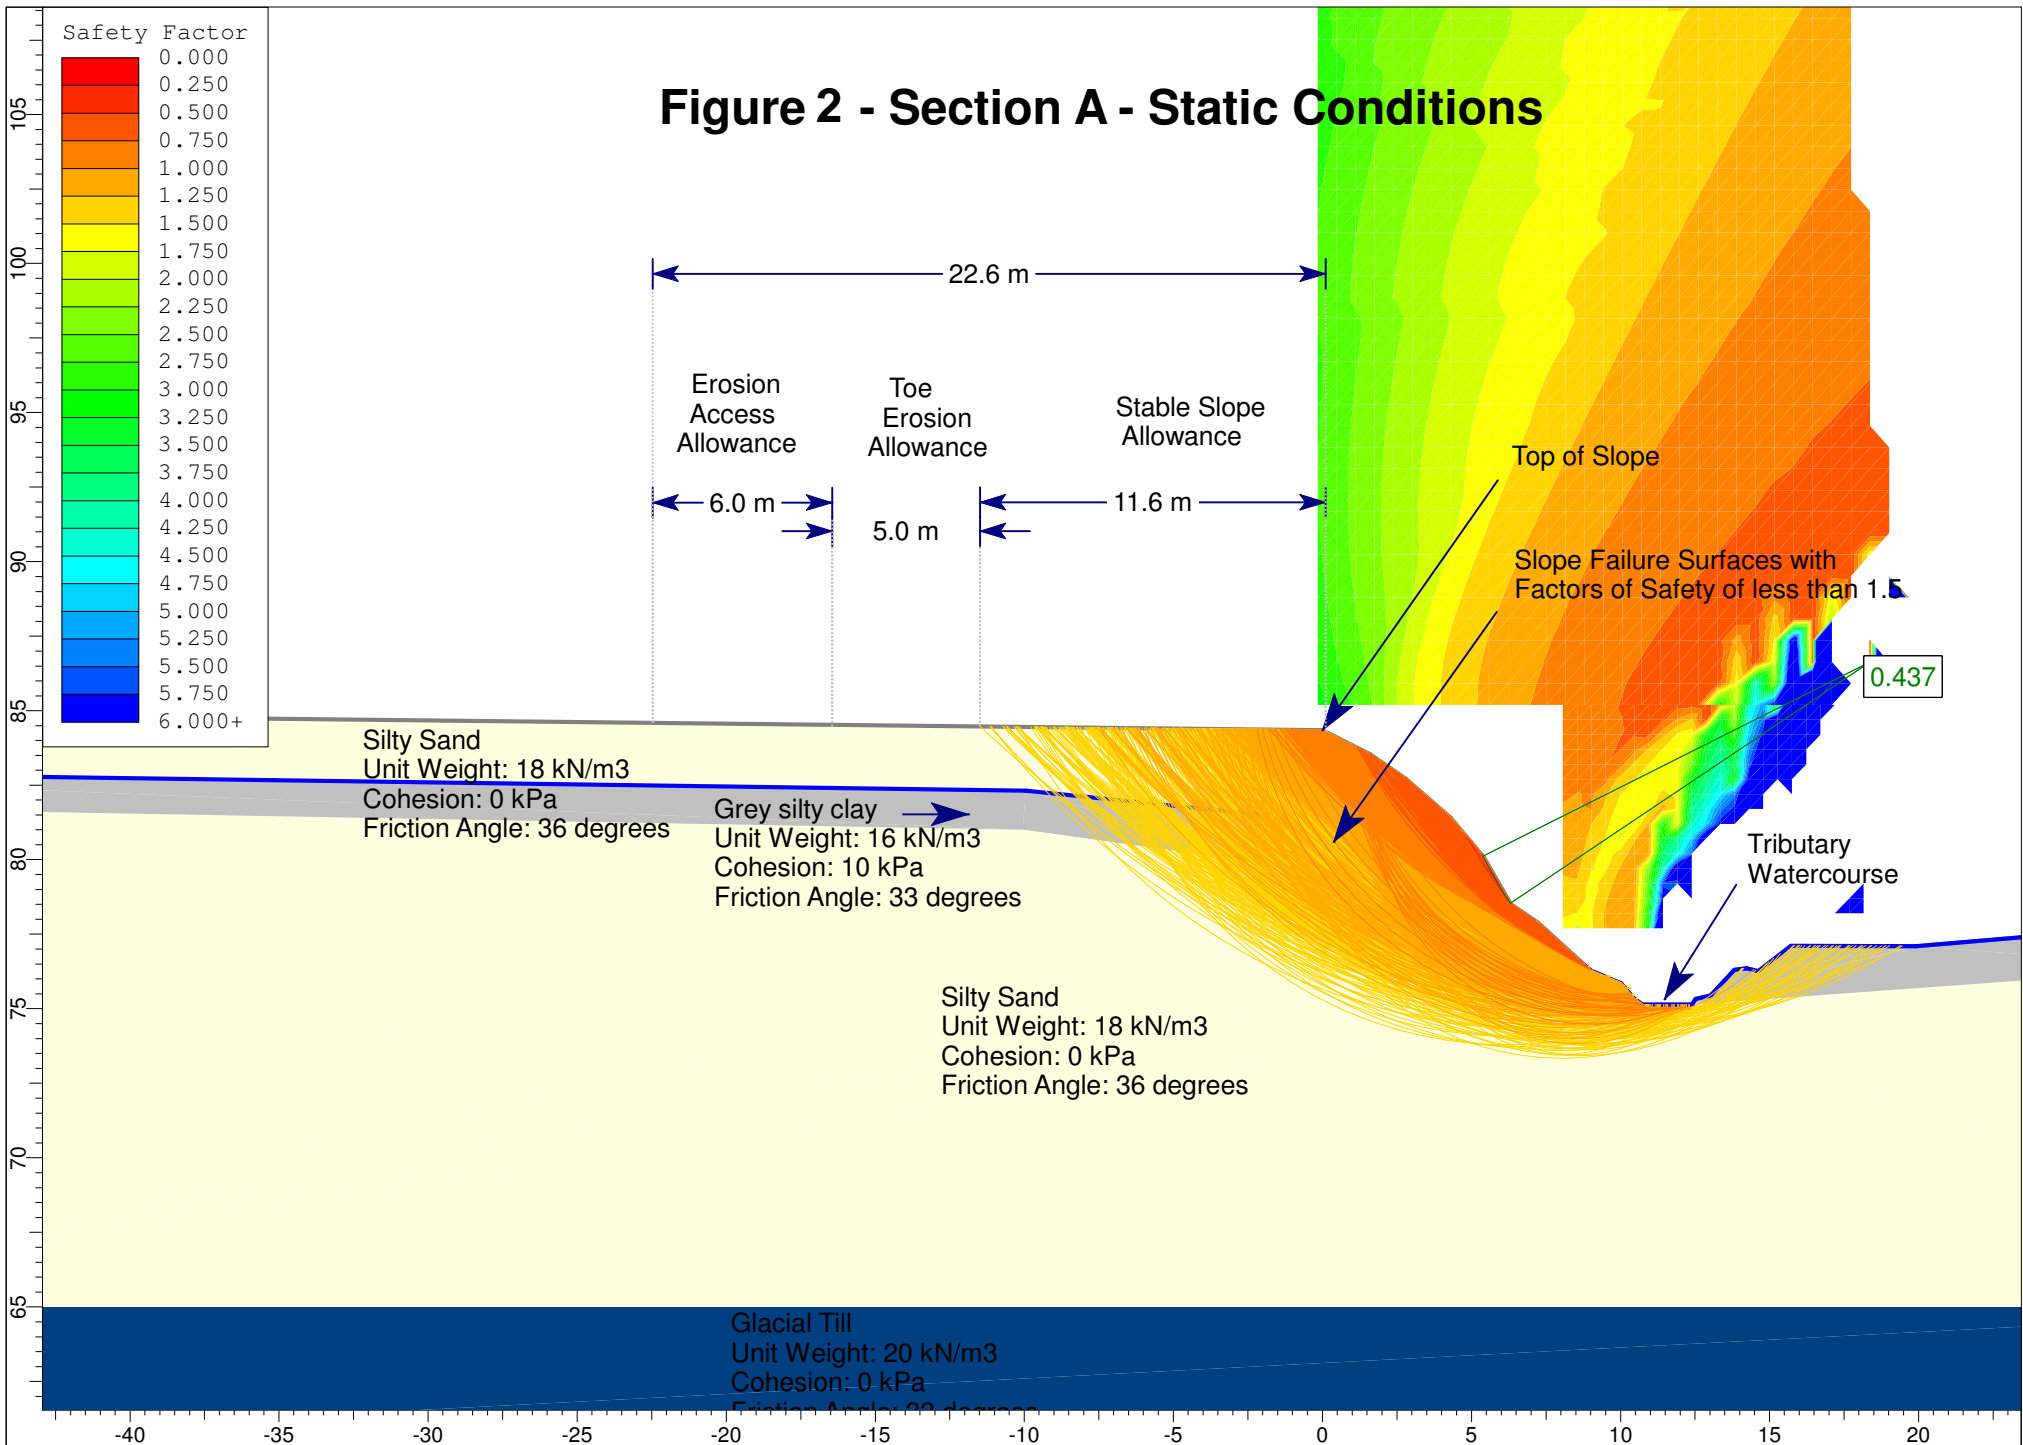
Figure 2 - Section A - Static Conditions

The results of the existing slope conditions under static loading at Section A, Section B, and Section C are shown in Figures 2, 4, and 6, respectively, attached to the present report. The overall slope stability factors of safety for the subject sections were found to be less than 1.5, except for Section C. The stable slope allowance from the top of slope required for slope with a minimum factor of safety of 1.5 is identified for each profile in the attached figures.
