re: Environmental Remedial Action Plan
Proposed Site Redevelopment
178 – 200 Isabella Street - Ottawa
to: Minto Communities – Mr. Kevin Harper – kharper@minto.com
date: August 4, 2023
file: PE4710-RAP.01

MINTO COMMUNITIES INC.
REMEDIAL ACTION PLAN
 178, 180, 182 & 200 ISABELLA STREET

Title: **ANALYTICAL TESTING PLAN - SOIL**

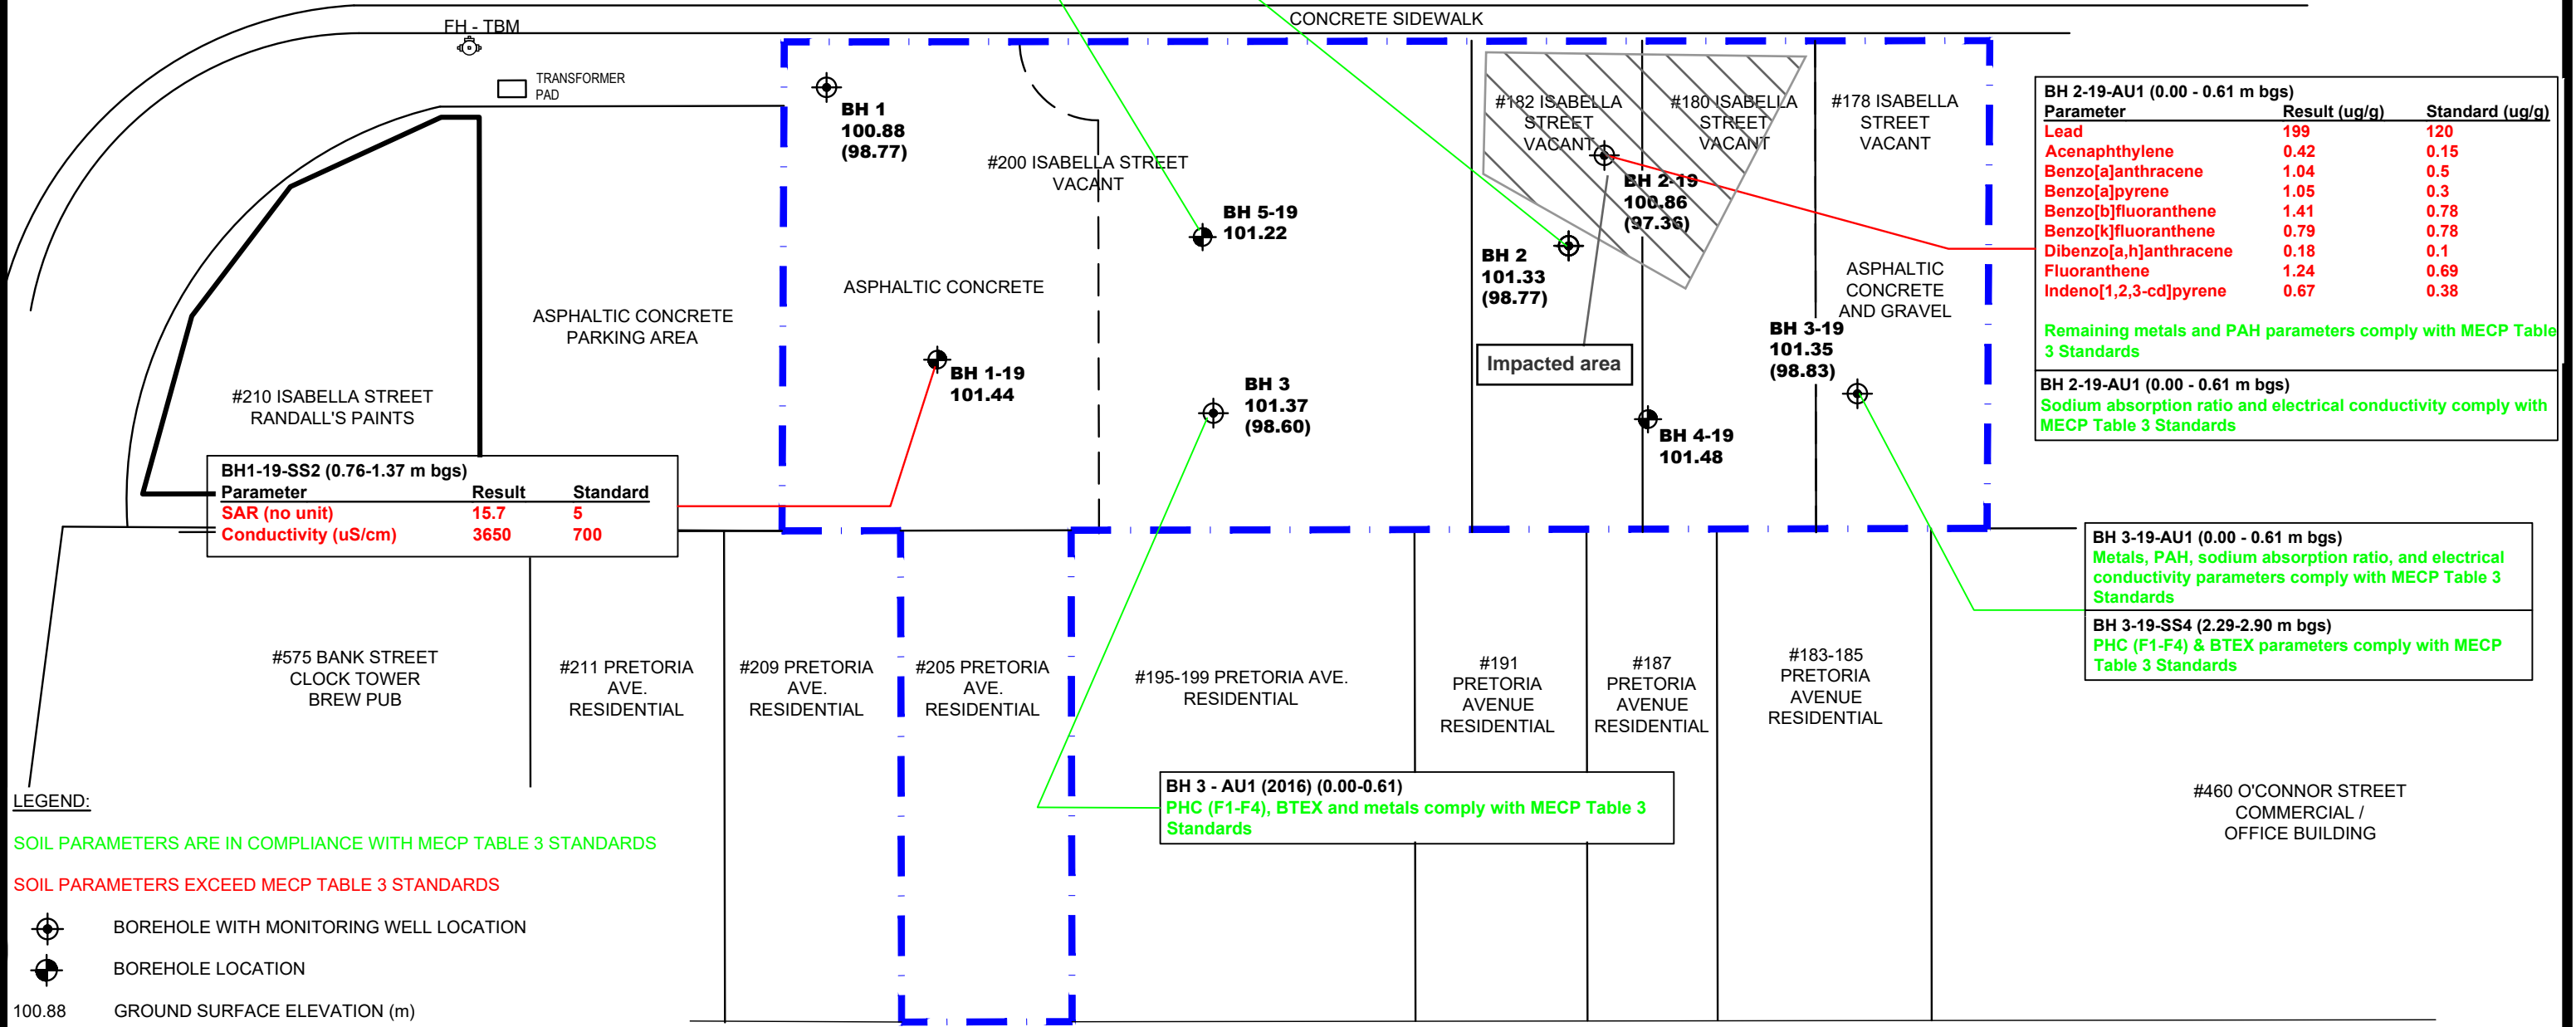
Scale:	1:400	Date:	08/2023
Drawn by:	MPG	Report No.:	PE4710-RAP.01
Checked by:	MW	Dwg. No.:	PE4710-9
Approved by:	MSD	Revision No.:	0

Based on the findings of the Phase II ESAs, fill material in the area of BH2-19 is contaminated with metals (lead) and several PAHs in excess of the selected MECP Table 3 Residential Standards. The impact is considered to be confined in the upper layer of fill at a depth of approximately 0 to 0.63mbgs.

Parameter	Result (ug/g)	Standard (ug/g)
Lead	199	120
Acenaphthylene	0.42	0.15
Benzo[a]anthracene	1.04	0.5
Benzo[a]pyrene	1.05	0.3
Benzo[b]fluoranthene	1.41	0.78
Benzo[k]fluoranthene	0.79	0.78
Dibenzo[a,h]anthracene	0.18	0.1
Fluoranthene	1.24	0.69
Indeno[1,2,3-cd]pyrene	0.67	0.38

Remaining metals and PAH parameters comply with MECP Table 3 Standards

- A soil remediation program to separate impacted fill from the underlying clean soil will be conducted. Additional testing will be completed to segregate impacted material from clean material (fill/soil). This approach will be used in conjunction with the site development.

- All overburden soils in the impacted areas will be stripped, segregated from clean soil and disposed off site at an approved waste disposal facility. A TCLP analysis will be carried out on a representative sample.
