TREE CONSERVATION REPORT

1058-1066 Silver Street
and 1291-1305 Summerville Avenue

Dendron Forestry Services

December 23, 2024

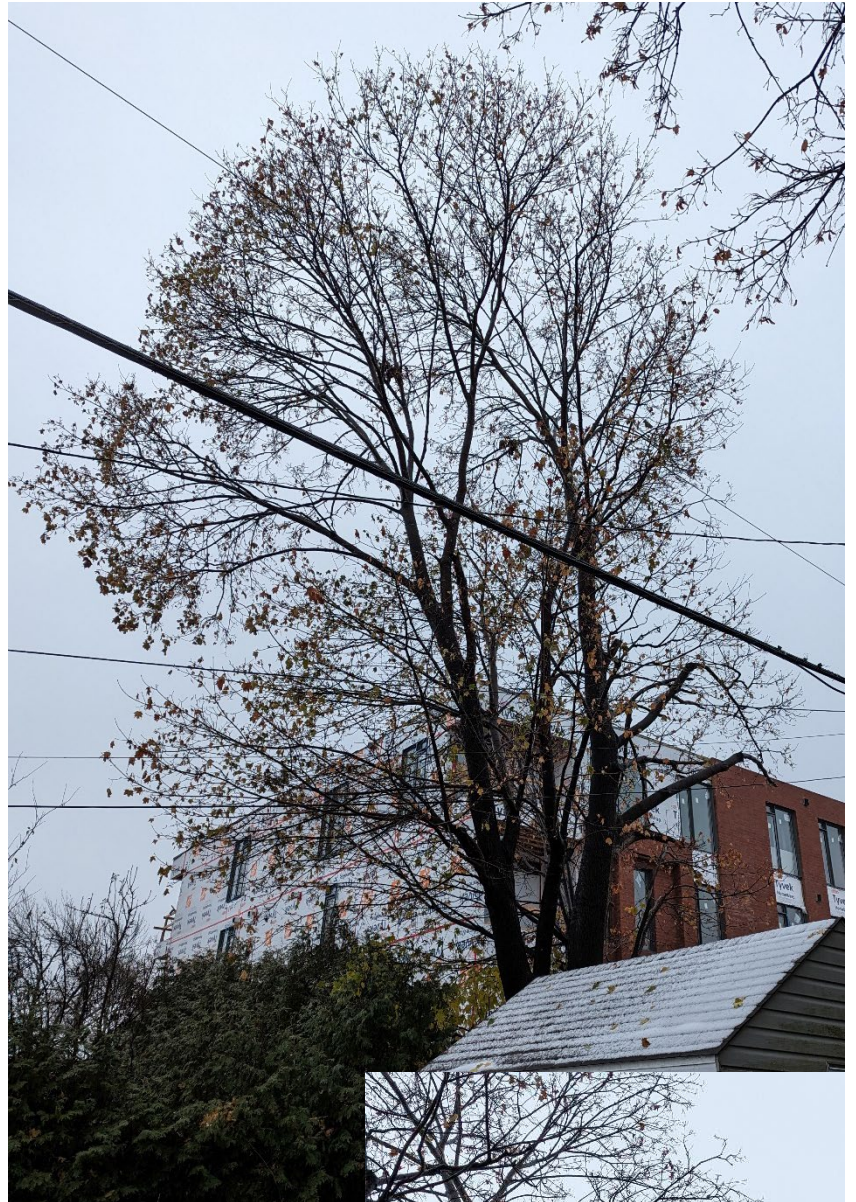
Above right: Canopies of Trees 3-5 - private maples to be removed.

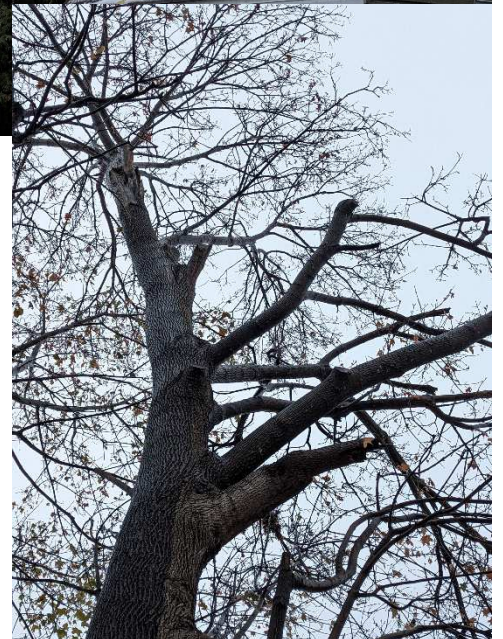
Below right: trunk and pruned branches of Tree 4

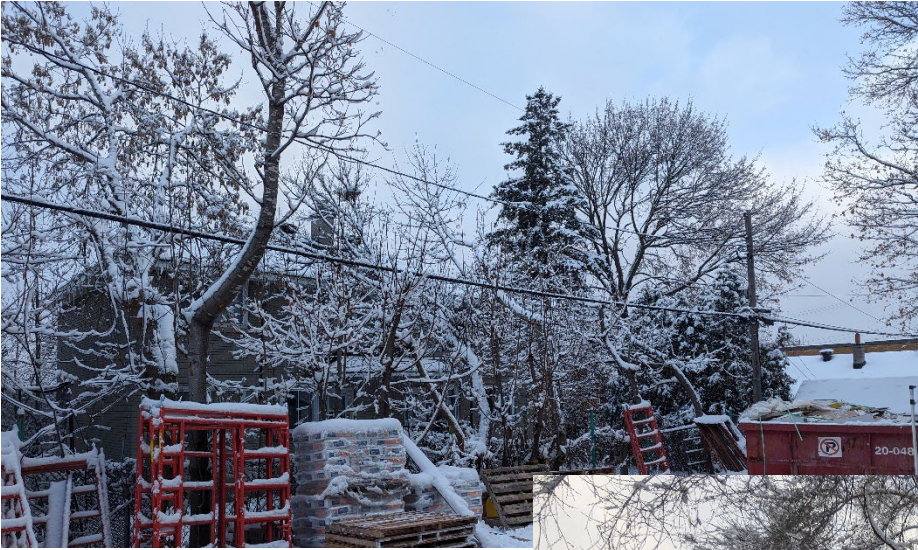
Clockwise from upper left: Tree group 21 – heavily pruned Manitoba maples to be removed (crowns of Tree 1 and 2 in background).

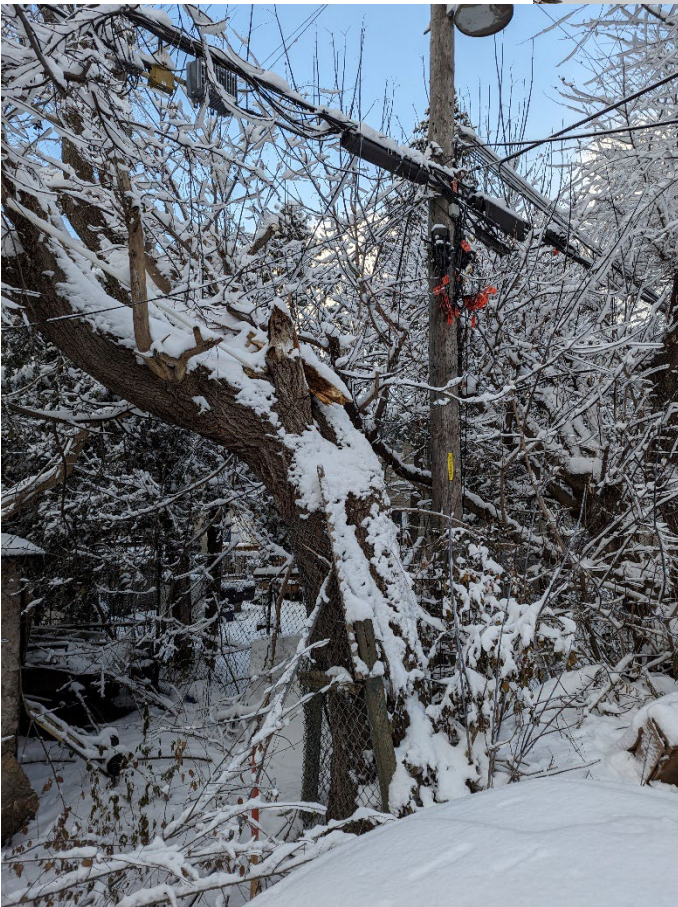
Tree 25 – Boundary Siberian elm to be removed.

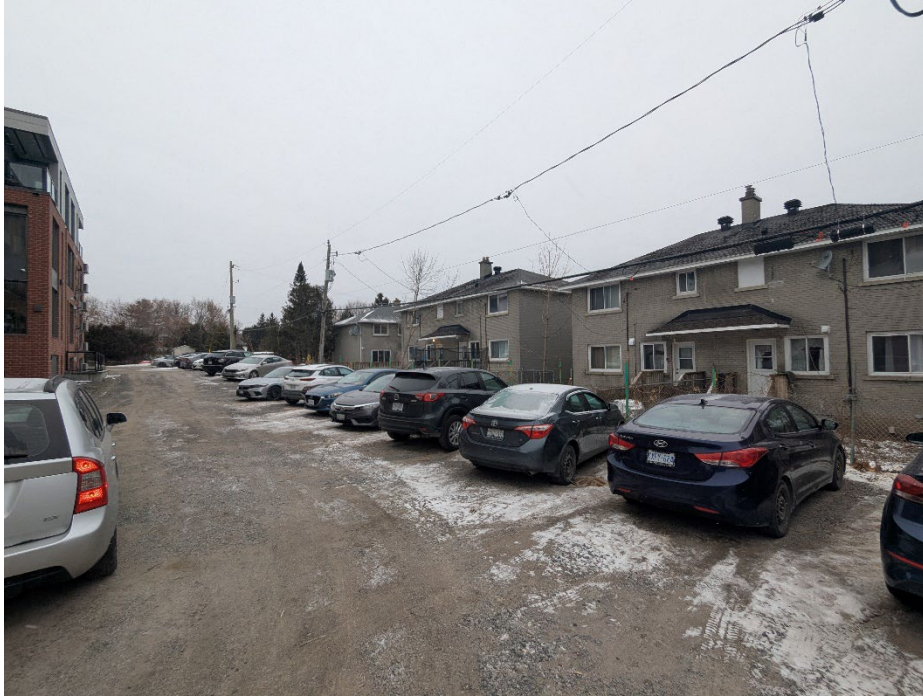
Above: Rear parking area behind the Summerville properties – all trees removed (photo December 23, 2024).

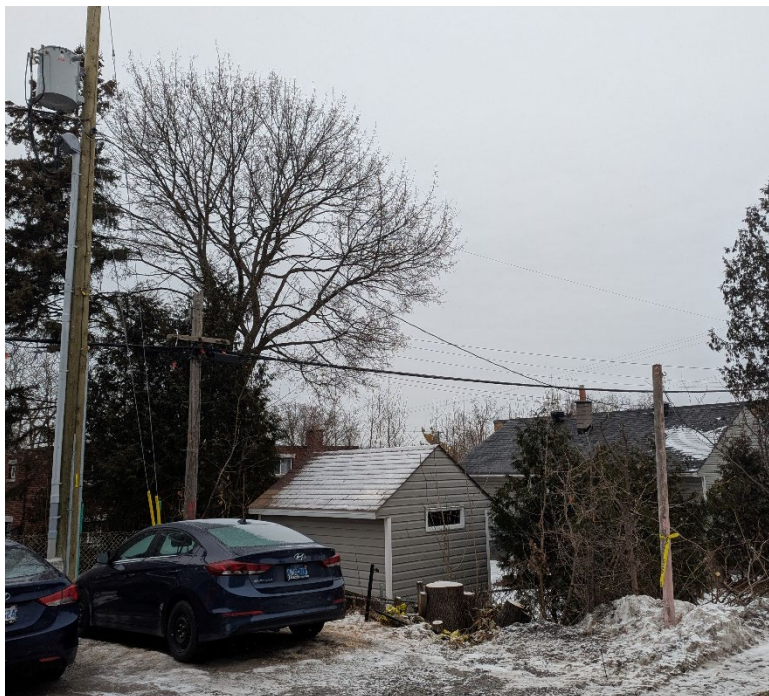
Below: stumps of Trees 3-5 (photo December 23, 2024)
