TREE CONSERVATION REPORT  
ADDENDUM 2.1  
71 Russell Ave

Tree Conservation Report Addendum submitted as  
Partial Requirements for a Site Plan Control  
Application, May 29, 2026

## **Tree Conservation Report Addendum**

**Address:** 71 Russell Ave  
**Date of Report:** May 29, 2026  
**Date of Site Visit:** April 9, 2026  
**Prepared by:** Astrid Nielsen, RPF, ISA Certified Arborist ®  
101- 45 Spencer Ave, K1Y 2P5  
[Astrid.nielsen@dendronforestry.ca](mailto:Astrid.nielsen@dendronforestry.ca)  
**Client:** Colin Miller, [Colin@pinehillbuilders.ca](mailto:Colin@pinehillbuilders.ca)

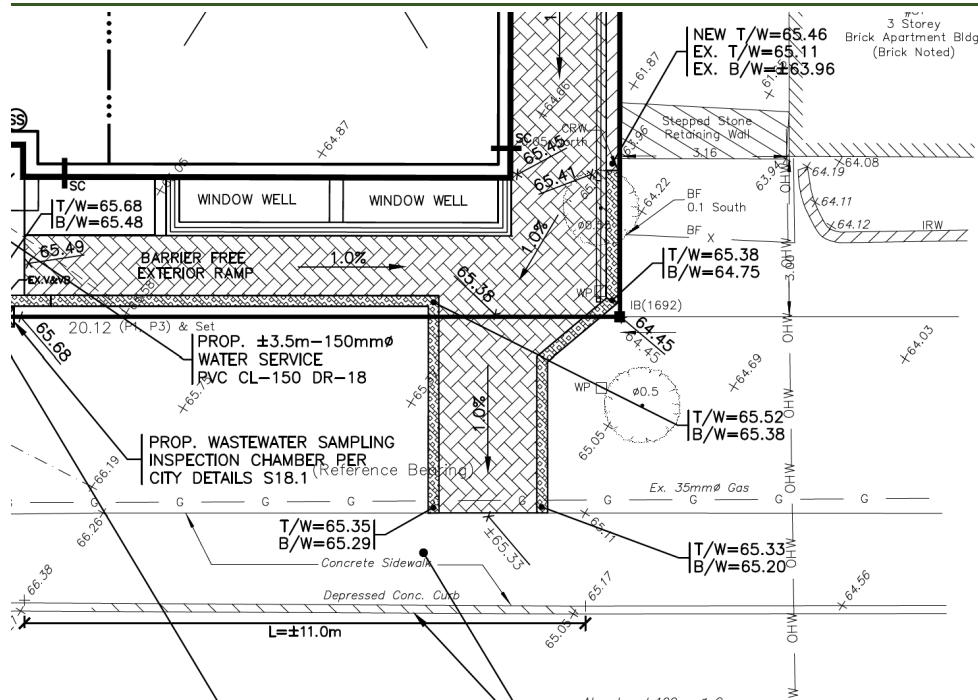
**Tree 1:** This updated report reflects changes that were made to the grading plan for the walkway to curve around the tree. The new walkway and retaining wall will be approximately 1.5 m from the edge of the tree trunk which should avoid impacting the structural integrity of the tree. The tree roots are to be pruned in advance of any excavation for the walkway and retaining wall and be completed by a certified arborist and/or city forestry staff. The same applies to the removal of any branches for the clearance of equipment on site.

**Note:** Historical Google Street View imagery reveals a survey post embedded within the center of this tree's trunk. This hazard should be flagged in the city's internal system to prevent injury during future removal operations.

Figure 1: Image clip from updated grading plan prepared by TL Mak dated May 27, 2026 showing the walkway curving around tree 1, city owned Norway maple. The distance from the edge of the tree trunk to the edge of the retaining wall is approximately 1.5 m.

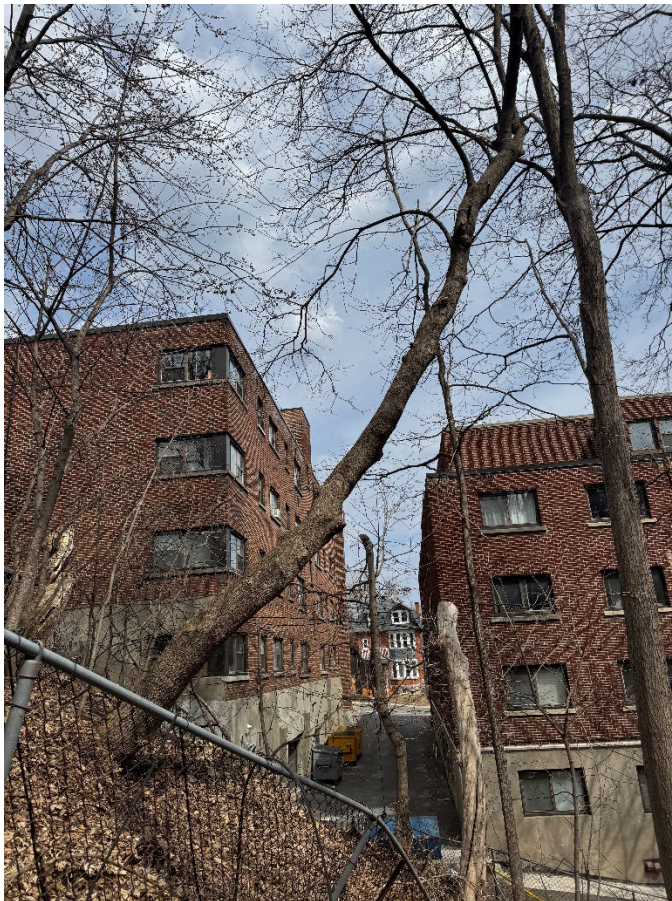
**Tree 27:** This tree is situated on an adjacent property on a steep slope experiencing active soil creep. Evidence of this movement is visible in the accumulation of soil and organic debris against the boundary fence, which has mostly collapsed under the pressure near the base of the slope. The physical weight of the tree is actively exacerbating this slope instability.

The tree currently exhibits a significant lean toward the subject property, presenting an existing safety hazard. While a full assessment was limited by property access, visual inspection from the property line suggests potential girdling roots on the upslope side of the root flare. Furthermore, the proposed building footprint presents a direct conflict with the tree's crown.

It is critical to note that the risk of whole-tree failure will increase once the trees on the subject site are removed, as Tree 27 will suddenly be subjected to increased wind exposure. Concurrently, the subject site will become an active construction zone, increasing the number of targets (workers, equipment, and structures) within the fall zone.

**Photo 3: Tree 27, Manitoba maple on adjacent property that should be removed due to the potential for failure on subject property**

Because of these compounding structural and site factors, there are no effective or practical mitigation measures available to reduce this risk to an acceptable level. Given the lack of viable alternatives, removing the tree is the only recommended option to ensure site safety. Furthermore, the massive above-ground weight of the tree is likely contributing to the downward soil creep. Removing the tree while leaving the stump and entire root network intact may actually reduce ongoing erosion and improve the overall stability of the slope. Immediate planting with small trees and shrubs is recommended for further slope stability.

If the adjacent property owner does not support removal of this tree, an option would be to remove the portion of the tree extending over the subject property line to reduce the weight and reassess. Although this may not be an accepted arboricultural practice, it may reduce the risk to an acceptable level which is a higher priority. It is recommended that a risk assessment be completed after the pruning has been completed.
