January 2016

Limited Pre-Demolition Designated Substances and Hazardous Materials Survey for the Property Located at 151 Metcalfe Street, Ottawa, Ontario

Report Number: 1547068 (2000)

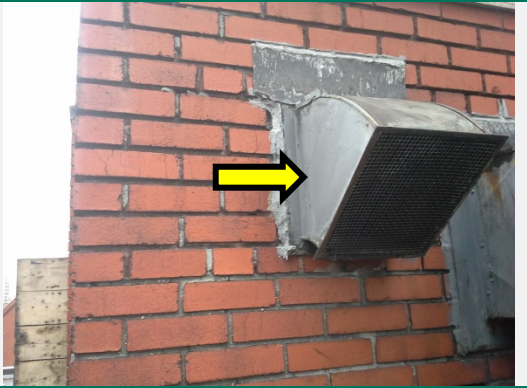
Material Description	Material Location	Observed Estimated Quantity	Condition	Friable (Yes / No)	Accessibility	Sample #	Asbestos Concentration (%) and Type	Photograph
Gloss black tar	On grey shingles on the roof	N/A ⁽¹⁾	N/A	N/A	N/A	01A – 01C	None detected	N/A
Flat black tar	On gravel on the roof	N/A	N/A	N/A	N/A	02A – 02C	None detected	N/A
Flexible light brown caulking	On exterior walls of the elevator shaft room on the roof	N/A	N/A	N/A	N/A	03A – 03C	None detected	N/A
Black (appears grey) caulking	On metal duct and siding on the exterior walls of the elevator shaft room on the roof	15 Linear meters	Good	No	High	04A – 04C	15% Chrysotile

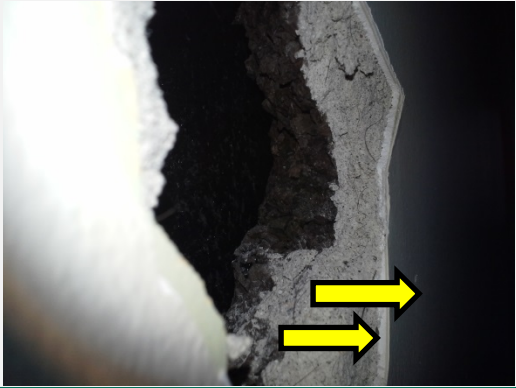
Material Description	Material Location	Observed Estimated Quantity	Condition	Friable (Yes / No)	Accessibility	Sample #	Asbestos Concentration (%) and Type	Photograph
Skim / white plaster over rough / grey plaster with horse hair (composite sample)	Over brick walls and/or metal lath on interior walls and ceilings throughout the stairwell, hallways and apartments	Throughout the Building	Good	No	High	06A – 06G	2% Chrysotile (composite sample)

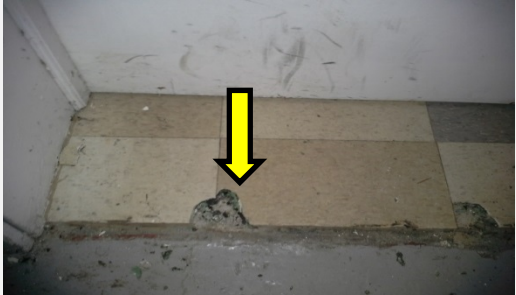
Material Description	Material Location	Observed Estimated Quantity	Condition	Friable (Yes / No)	Accessibility	Sample #	Asbestos Concentration (%) and Type	Photograph
Green vinyl sheet flooring	Under 30 cm by 30 cm cream vinyl floor tile with tan flecks in the apartment in the basement and suspected throughout Building	Not quantified (The interior of the apartment was not accessible during the DSS/HMS) It may also be present throughout other units of Building	Good	No	High	09A – 09C	3% - 5% Chrysotile

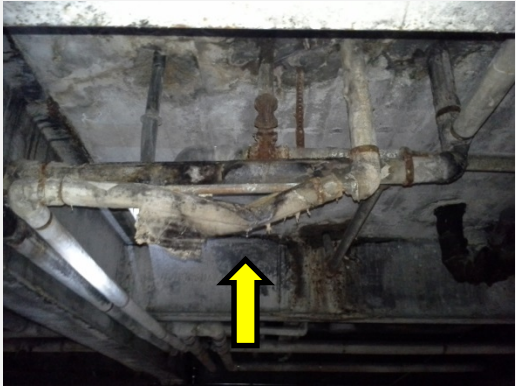
Air-Cell pipe insulation	On cast iron and copper pipes throughout basement storage rooms, laundry room, furnace room and parking garage (Also observed under a layer of parging on a boiler in the furnace room and is	650 Linear meters	Fair to Poor	Yes	Moderate	10A – 10C	50% - 60% Chrysotile

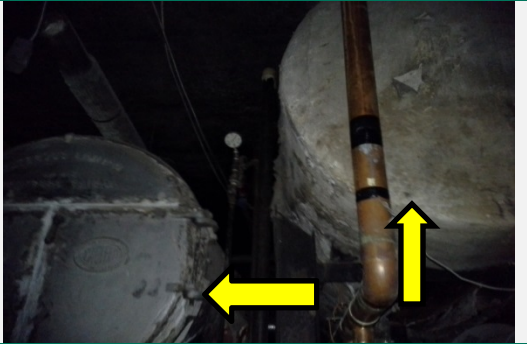
Material Description	Material Location	Observed Estimated Quantity	Condition	Friable (Yes / No)	Accessibility	Sample #	Asbestos Concentration (%) and Type	Photograph
Parging cement	Over Air-Cell insulation on the boilers located in the furnace room in the basement	80 Square meters	Poor	Yes	Moderate	13A – 13C	20% - 30% Chrysotile

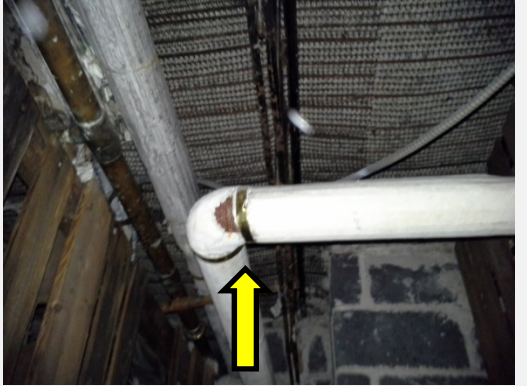
Parging cement	On 2" to 6" cast iron and copper pipe elbows throughout the basement storage rooms, laundry room, furnace room and parking garage (Also suspected to be present within additional concealed areas throughout the Building)	300 Elbows	Fair to Poor	Yes	Moderate	14A – 14C	30% Chrysotile

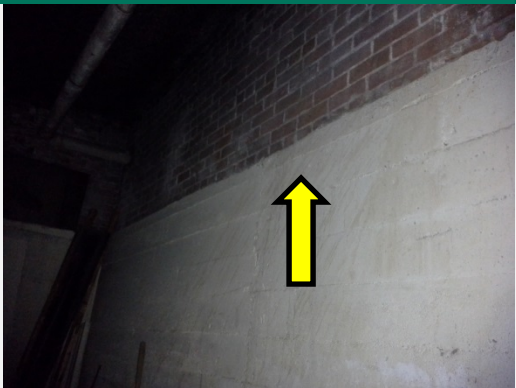
Material Description	Material Location	Observed Estimated Quantity	Condition	Friable (Yes / No)	Accessibility	Sample #	Asbestos Concentration (%) and Type	Photograph
Cementitious parging / compound	Over brick on perimeter walls in the basement laundry room, furnace room and parking garage	275 Square meters	Good	No	High	15A – 15C	2% Chrysotile

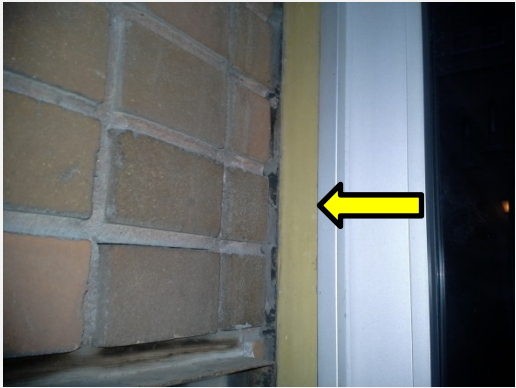
Material Description	Material Location	Observed Estimated Quantity	Condition	Friable (Yes / No)	Accessibility	Sample #	Asbestos Concentration (%) and Type	Photograph
Brittle black caulking	Around exterior front entrance door and window frames	20 Linear meters	Fair	No	Moderate	18A – 18C	5% Chrysotile

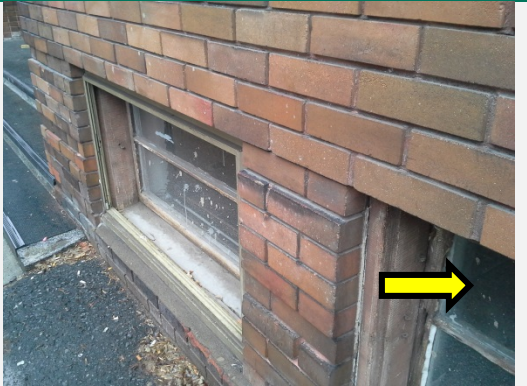
Material Description	Material Location	Observed Estimated Quantity	Condition	Friable (Yes / No)	Accessibility	Sample #	Asbestos Concentration (%) and Type	Photograph
30 cm by 30 cm cream vinyl floor tile and associated yellow mastic	Under 30 cm by 30 cm white vinyl floor tile with white flecks in the kitchen in apartment #303	N/A	N/A	N/A	N/A	20A – 20C	None detected (tile) Not detected (mastic)	N/A
Brittle white caulking	Around exterior window frames	265 Linear meters	Fair	No	Moderate	21A – 21C	2% Chrysotile

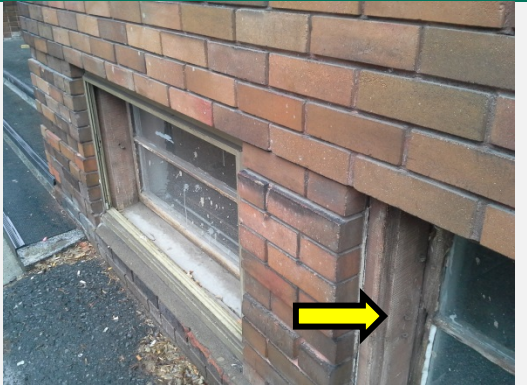
Flexible white caulking	Around exterior window frames	265 Linear meters	Fair	No	Moderate	22A – 22C	10% Chrysotile

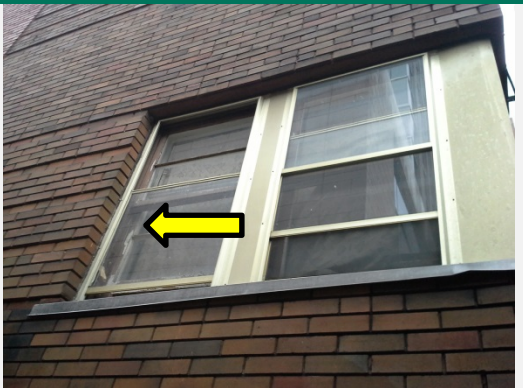
Material Description	Material Location	Observed Estimated Quantity	Condition	Friable (Yes / No)	Accessibility	Sample #	Asbestos Concentration (%) and Type	Photograph
Flexible white (appears black) caulking	Around exterior window frames	265 Linear meters	Fair	No	Moderate	23A – 23C	6% - 7% Chrysotile

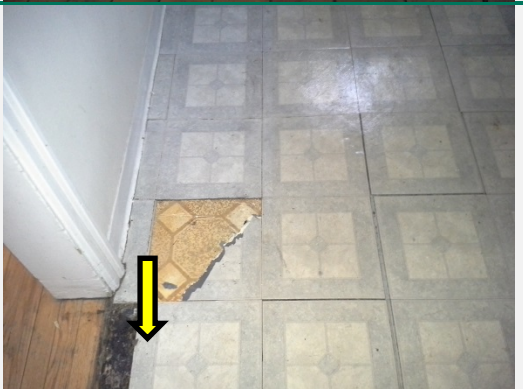
Black mastic	On 30 cm by 30 cm black vinyl floor tile under 30 cm by 30 cm beige/brown patterned vinyl floor tile in the kitchen in apartment #204	8 Square meters (may also be present throughout other units of Building)	Good	No	High	24A – 24C	None detected (black vinyl floor tile) 2% Chrysotile (black mastic)

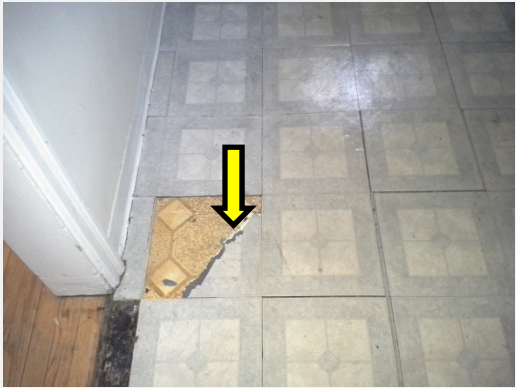
Material Description	Material Location	Observed Estimated Quantity	Condition	Friable (Yes / No)	Accessibility	Sample #	Asbestos Concentration (%) and Type	Photograph
30 cm by 30 cm beige/brown patterned vinyl floor tile and associated yellow mastic	Under 30 cm by 30 cm non-asbestos-containing grey with square pattern vinyl floor tile in the kitchen in apartment #204	8 Square meters (may also be present throughout other units of Building)	Good	No	High	25A – 25C	2% Chrysotile (beige/brown patterned vinyl floor tile) None detected (yellow mastic)

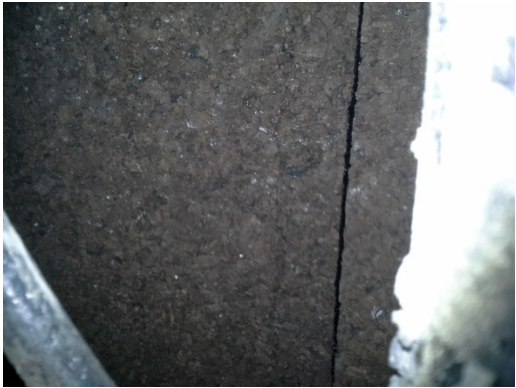
Black tar	On corkboard on perimeter, interior walls (observed in the wall cavity adjacent to plaster on wire lath ceiling in apartment #204)	Not Accessible	Good	No	Low	Not sampled	Sample not Collected (Not accessible)

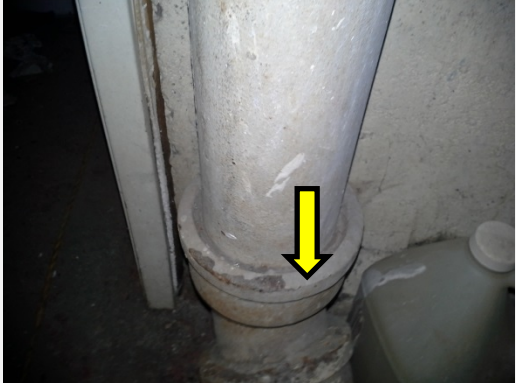
Material Description	Material Location	Observed Estimated Quantity	Condition	Friable (Yes / No)	Accessibility	Sample #	Asbestos Concentration (%) and Type	Photograph
Bell and Spigot Joints	Observed on cast iron pipes located throughout the Building (Also suspected to be present within additional concealed areas throughout the Building)	Throughout the Building	Good	Yes	Low	Not sampled (sampling would have affected the integrity of the pipe system)	The packing material contained inside the bell and spigot joints is considered to be asbestos-containing until tested and proven otherwise

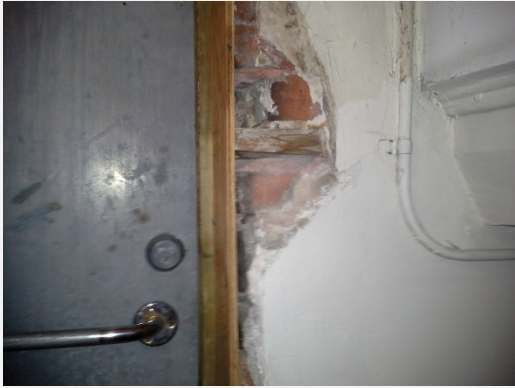
Sample Number	Description / Location of Material	Condition	Lead Concentration (ppm)	Lead Containing Paint?	Photograph
LP01	Cream paint on plaster walls in the stairwell	Good to Fair	2,100	Yes

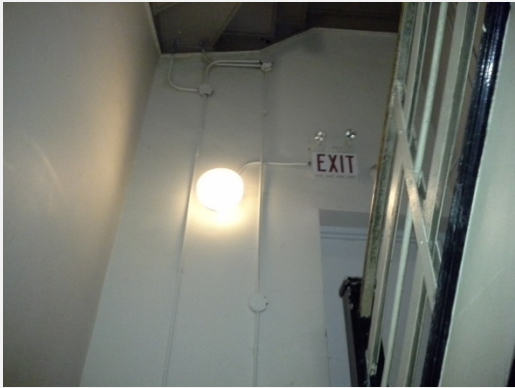
LP02	Black paint over red paint on metal railings in the basement stairwell	Good	3,800	Yes

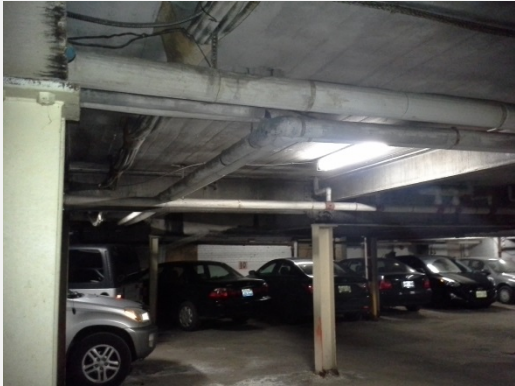
Sample Number	Description / Location of Material	Condition	Lead Concentration (ppm)	Lead Containing Paint?	Photograph
LP03	Dark cream paint on structural steel beams in the parking garage	Good	1,400	Yes

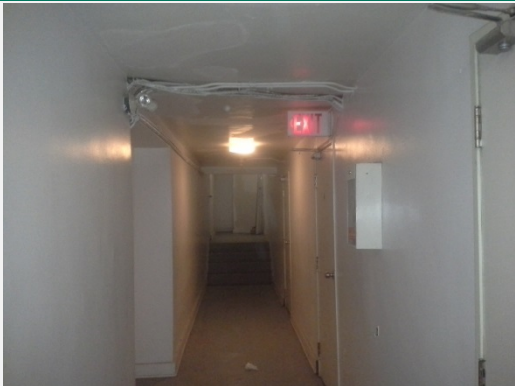
LP04	White paint on plaster walls in the hallway in the basement	Good	1,800	Yes

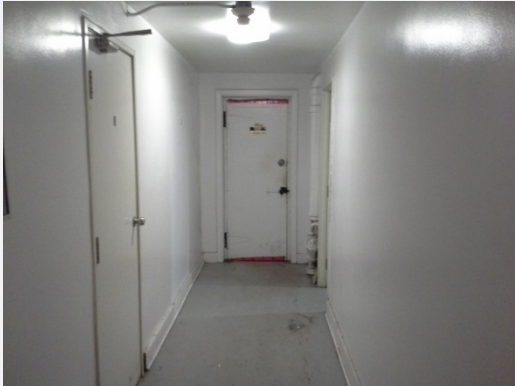
Sample Number	Description / Location of Material	Condition	Lead Concentration (ppm)	Lead Containing Paint?	Photograph
LP05	Grey paint over red paint on the concrete floor in the basement	Good to Poor	1,700	Yes

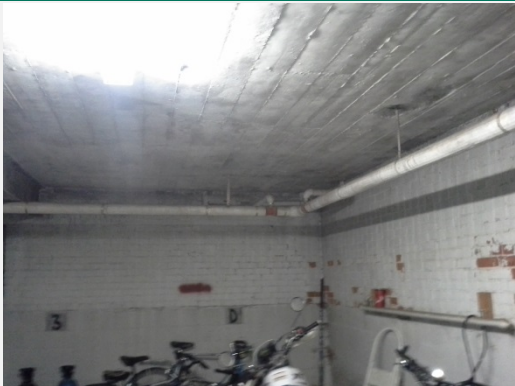
LP06	Grey-white paint on brick walls in the parking garage	Good to Poor	110	Yes

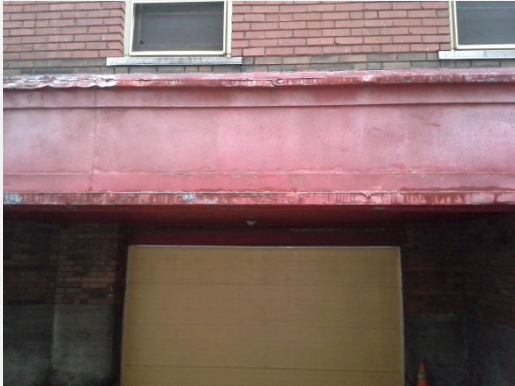
Sample Number	Description / Location of Material	Condition	Lead Concentration (ppm)	Lead Containing Paint?	Photograph
LP07	Dark red paint on the metal exterior parking garage bulkhead	Fair	110,000	Yes

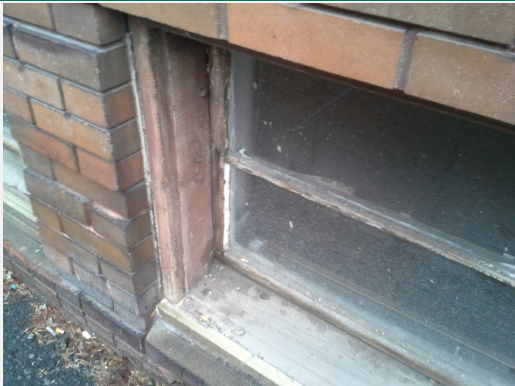
LP08	Dark brown paint on exterior wood window frames	Fair to Poor	150,000	Yes

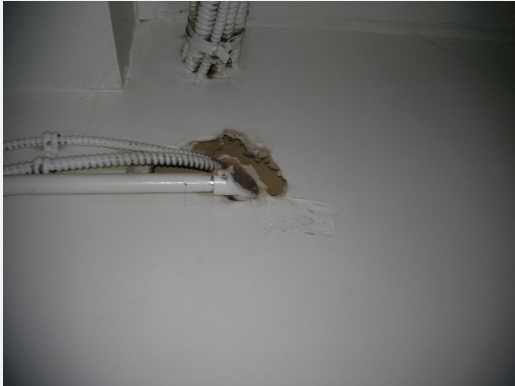
Sample Number	Description / Location of Material	Condition	Lead Concentration (ppm)	Lead Containing Paint?	Photograph
LP09	Olive green paint on plaster walls in the hallway in the basement	Good	1,000	Yes

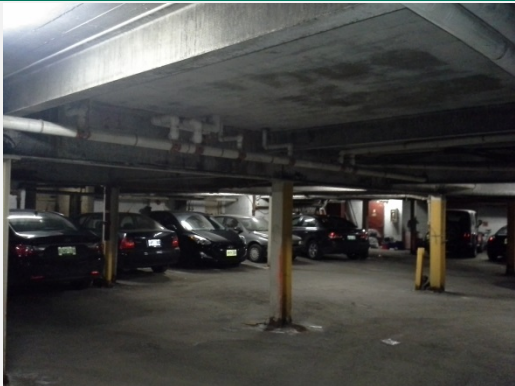
LP10	Yellow paint on structural steel beams in the parking garage	Good	23,000	Yes

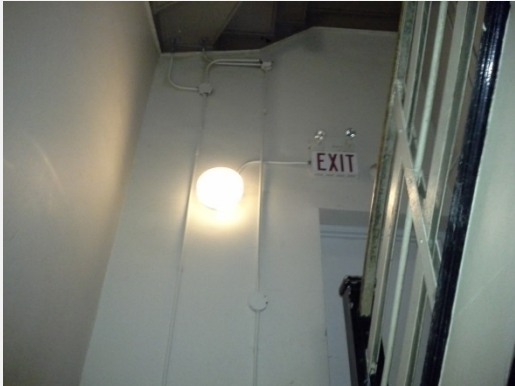
Sample Number	Description / Location of Material	Condition	Lead Concentration (ppm)	Lead Containing Paint?	Photograph
LP11	Medium brown paint over red paint on metal in the stairwell	Good to Fair	3,600	Yes

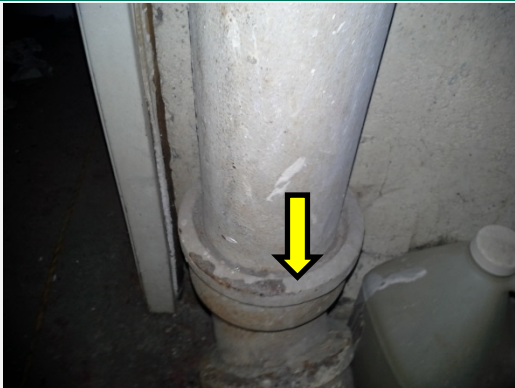
Not sampled as sampling would have affected the integrity of the pipe system	Observed on cast iron pipes located throughout the Building (Also suspected to be present within additional concealed areas throughout the Building)	Good	N/A	The packing material seal is considered to be lead-containing until proven otherwise
