STAGE II CULTURAL HERITAGE IMPACT STATEMENT & CONSERVATION PLAN

145 Loretta Avenue & 951 Gladstone Avenue,
Ottawa, Ontario

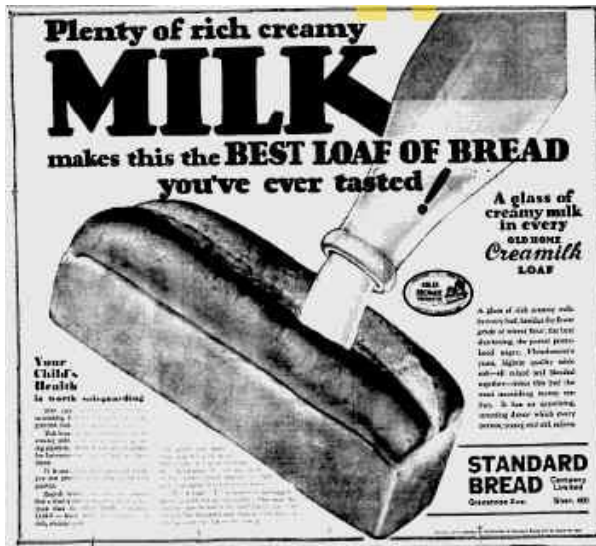
Figure 5: A typical ad marketing Standard Bread products. Advertisements such as this along with open houses were used to assure buyers that the highest quality materials were used in making the bread.

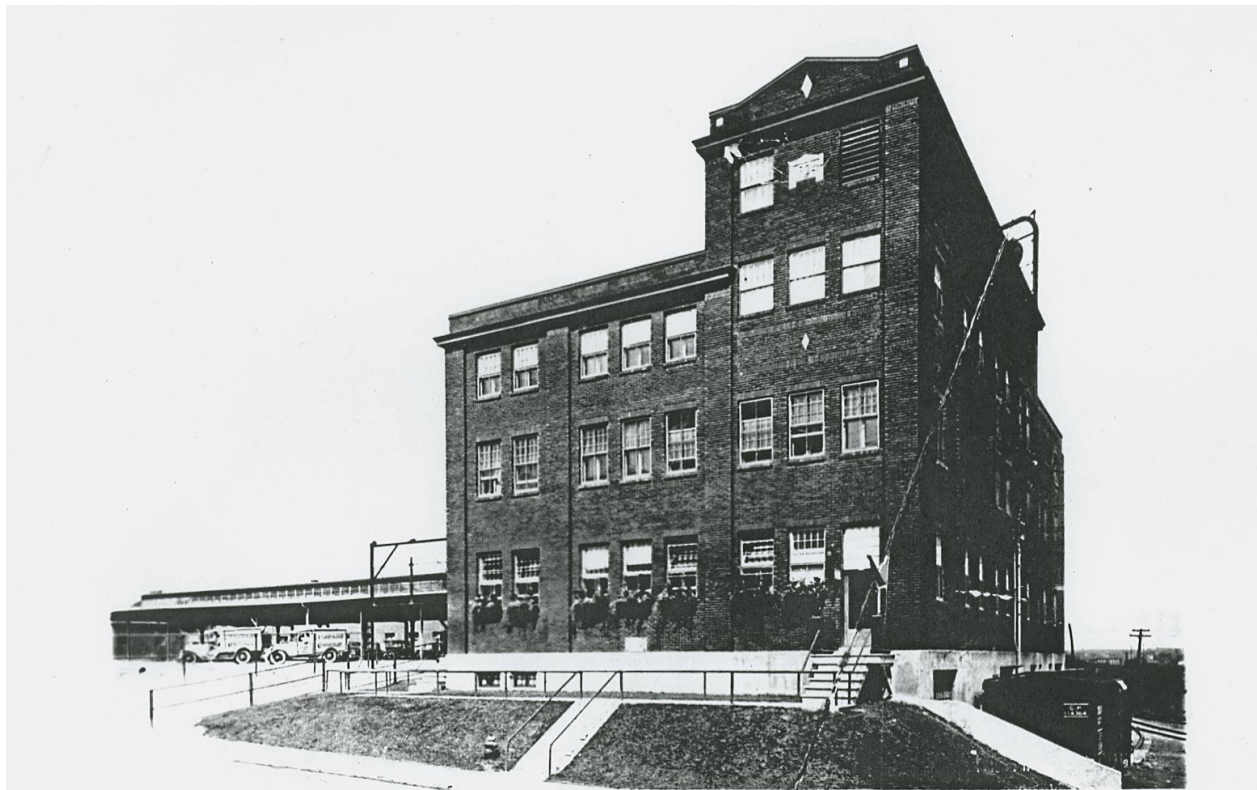
Figure 6: A photograph circa 1930 of the Standard Bread Building. Note the railway boxcar on a siding to the right of the photo. Source: City of Ottawa Archives

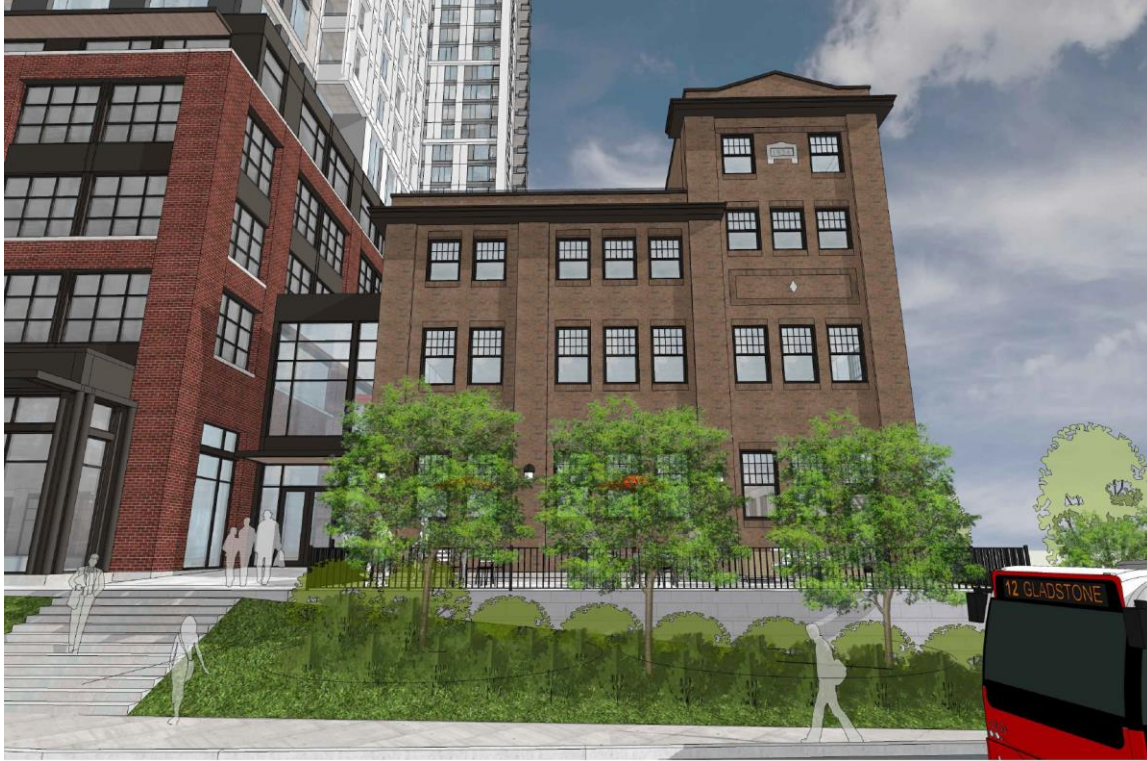
Figure 17: A Perspective view of the south elevation of the Standard Bread Building illustrating the double height two-storey glazed link and featuring the stairway accessing upper floors and the roof terrace in the Standard Bread building. Source: Hobin Architecture 2021.

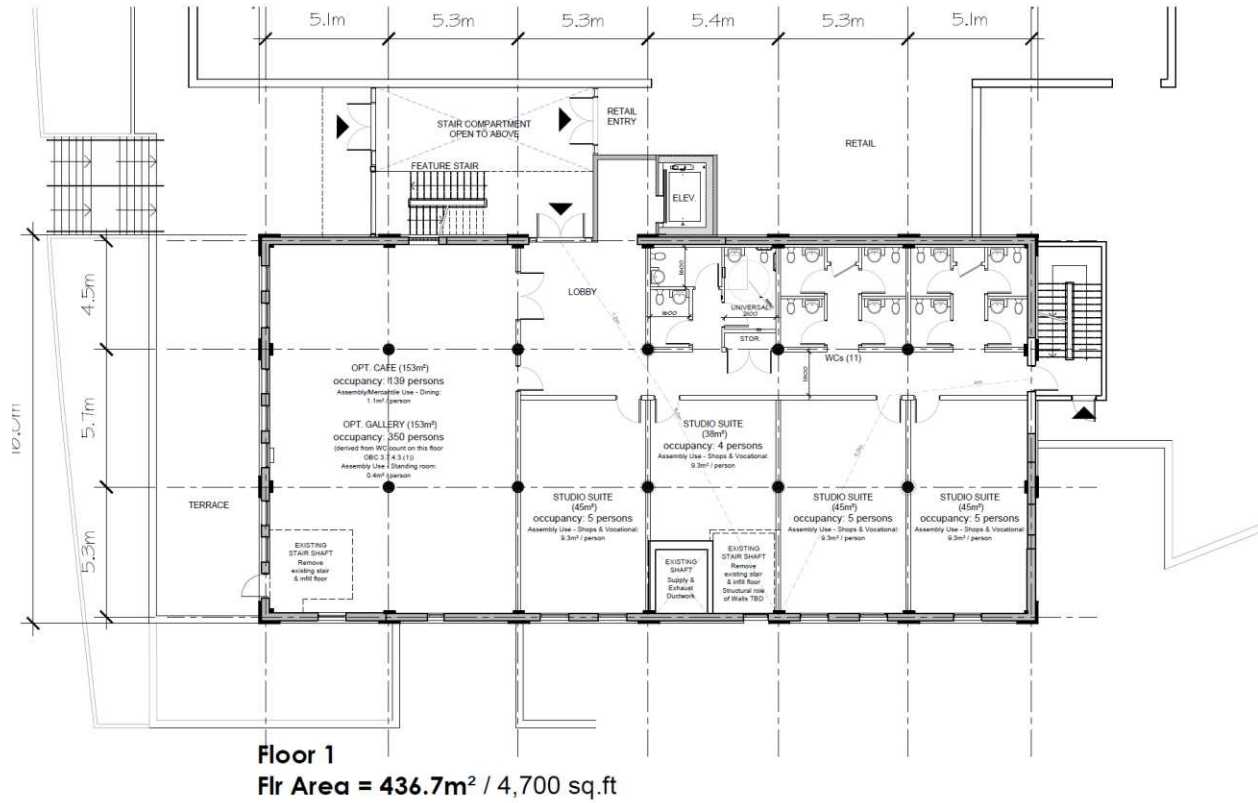
Figure 18: Standard Bread Building Ground Floor Plan illustrating the layout of the link with the mushroom columns establishing the floor grid. Source: Hobin Architecture 2022.

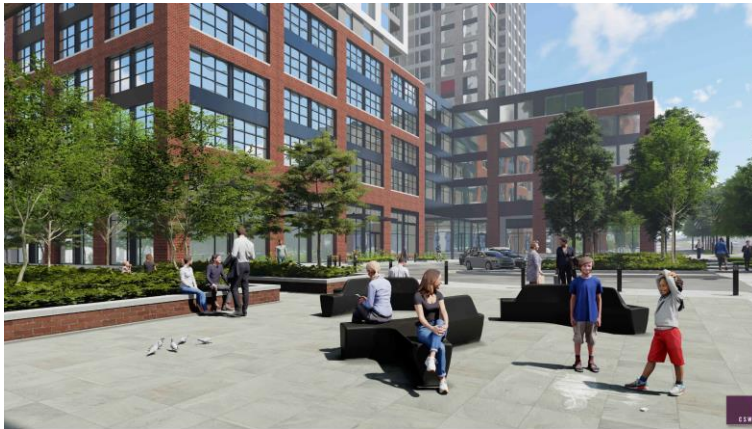
Figure 20: A view into the central plaza off of Loretta Avenue. Source CSW Landscape Architects 2022.

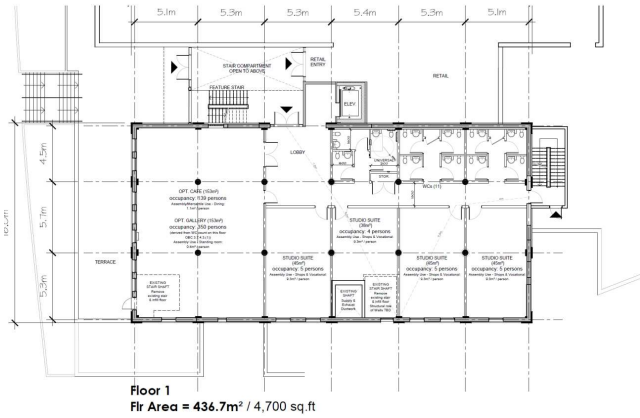
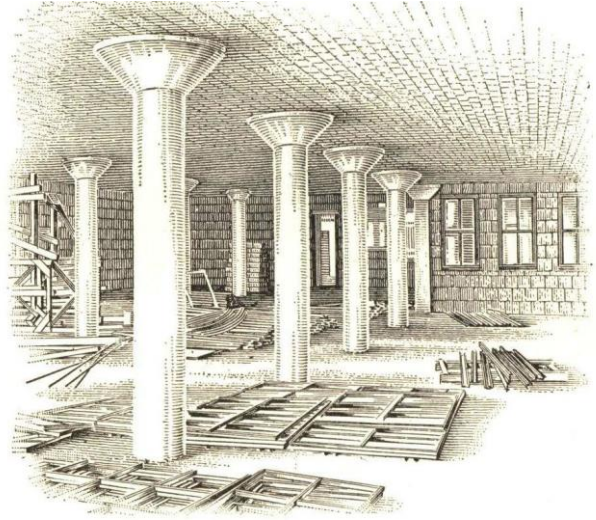
Discussion: The Standard Bread Building is being retained in-situ except for the one- storey wing on the north side of the building where the ovens were located. The existing reinforced concrete frame, including columns, beams, floor, and roof structures on the 3 and 4 storey portions of the building will be retained; the interior columns are one of the building's character- defining features as well as the exterior wall assemblies, including terra cotta back-up walls and the brick veneer all of which are being conserved.

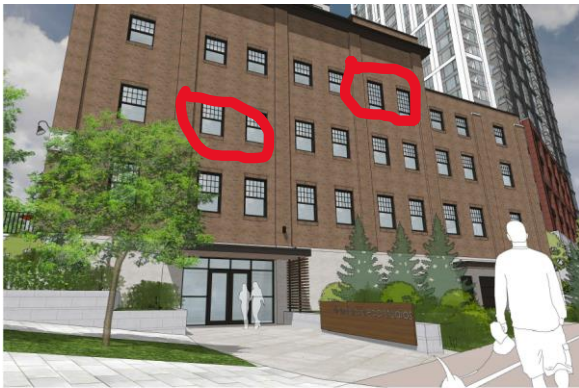
Figure 24 and 25: The fenestration along the east facade follows the profile of the original building as the as-found drawing below illustrates. Highlighted in red are proposed windows replacing doors and the introduction of new windows that were not originally part of the façade.

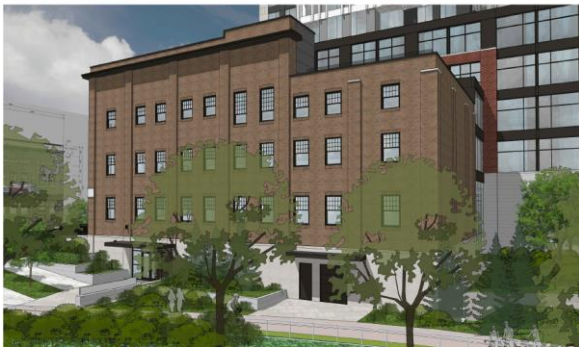
An addition on the north end of the building that at one time housed the ovens is slated for demolition.

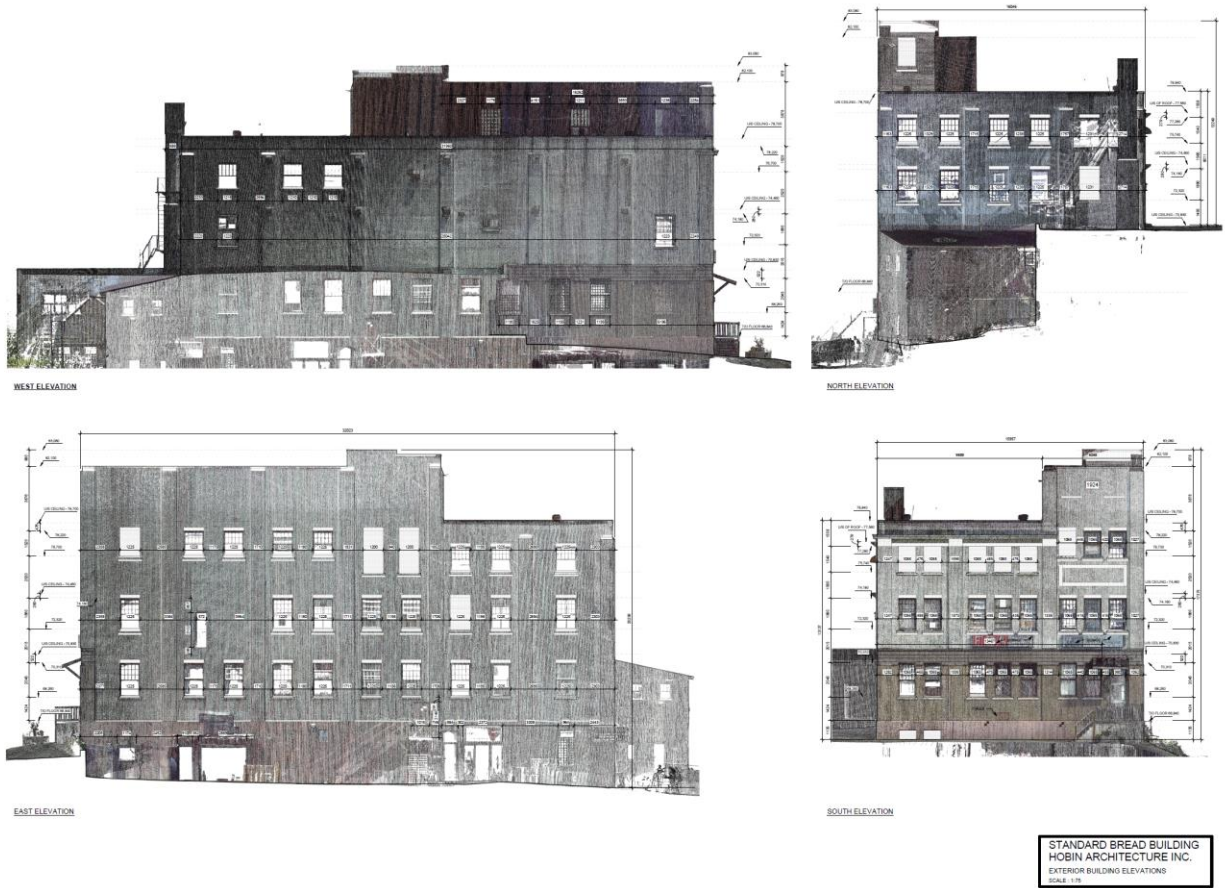
Figure 27: Photogrammetric recording of the Standard Bread Building. Source Hobin Architects

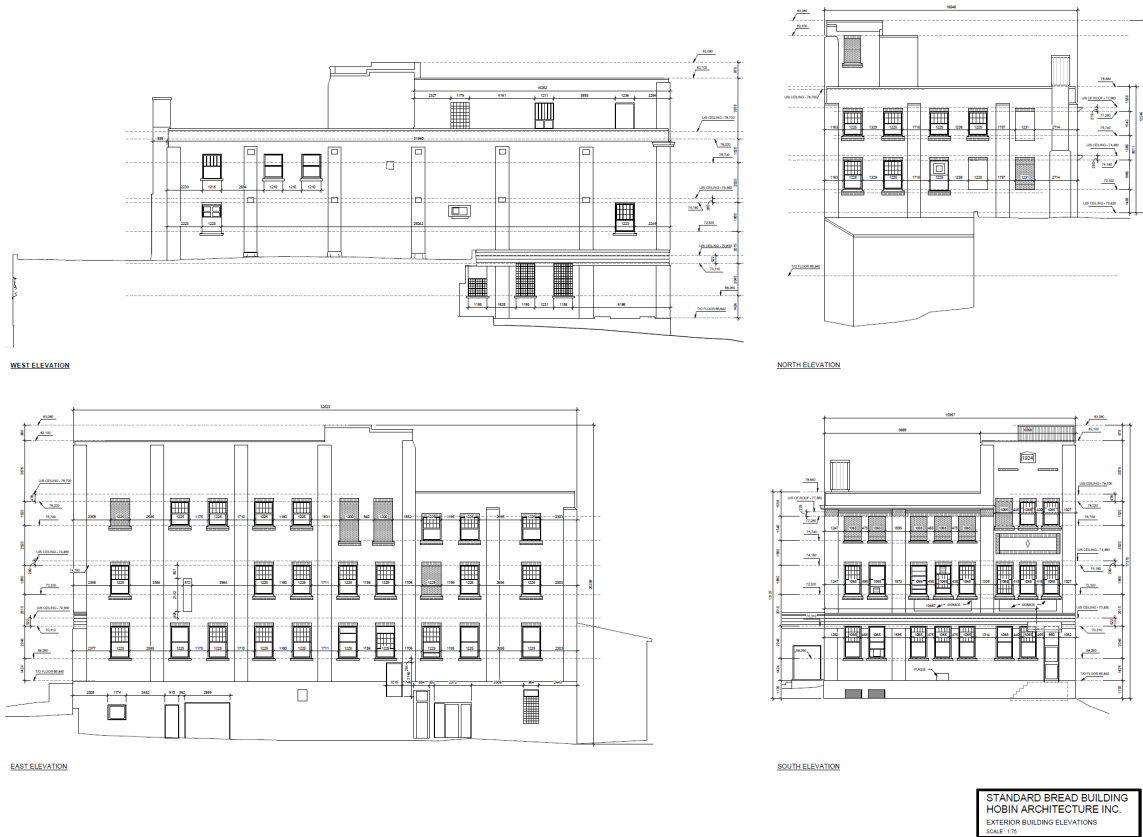
Figure 28: Dimensioned as-found record of elevation and floor plans of the Standard Bread Building. Source Hobin Architecture Inc.

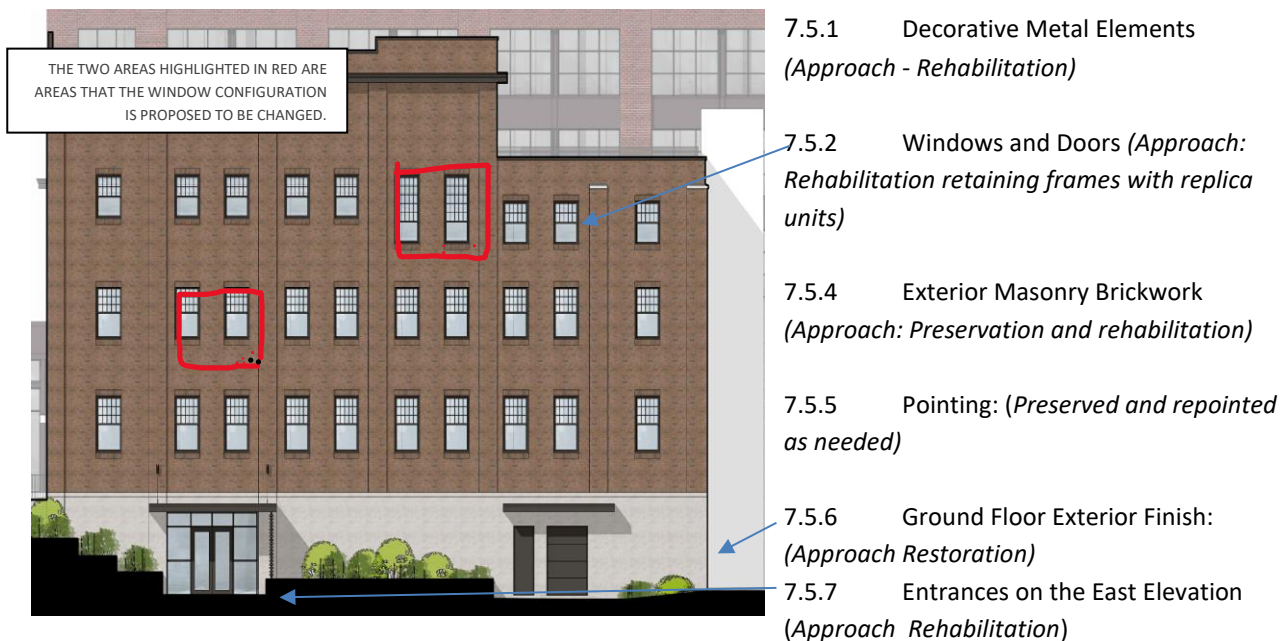
Commonwealth undertook an inspection of the exterior masonry in December 2020 to document the condition of the exterior walls including the windows, decorative metal elements, brickwork, concrete, pointing, and to determine the materials applied to the ground floor of the main façade. The information supplements the condition report prepared by John Cooke (see Appendix A). The inspection was limited to the ground floor and second floor walls on the north and west facades of the building which were accessed from a fire exit to the roof of the single storey wing. Specific attributes are referenced on the East and South Elevations and described below.

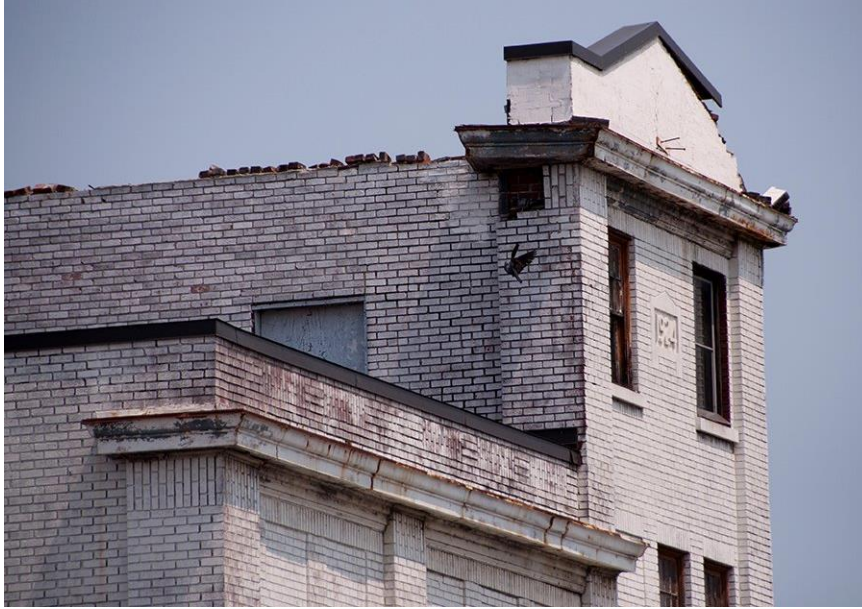
Figure 30: The gabled brick and metal parapets will be re-instated to their original form and design. The height of the parapet can be determined from period photos. The original colour of the brick is evident in areas where the paint has worn off. Bricked-in windows will be opened and reglazed retaining the glazing pattern.

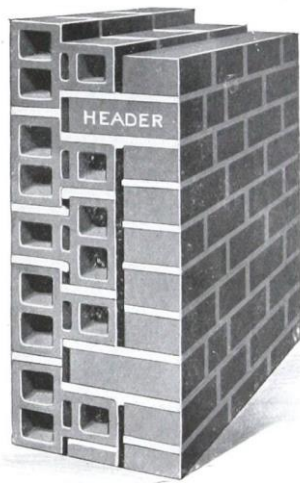
The bricks are a pressed brick with ground shale as the primary raw material, common for the period as clay deposits were being exhausted. The bricks are wire cut and have a textured surface that is painted. The removal of the paint from the interstices in the brick surfaces will be difficult if not impossible as the oil-based paint is well adhered to the surfaces. The brickwork is generally in good condition with localized spalled bricks. The brickwork in the areas that were inspected appeared to be well adhered to the terra-cotta backup walls when sounded with a hammer.

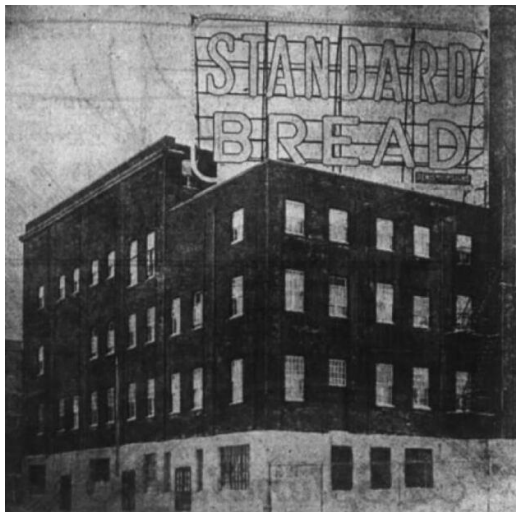
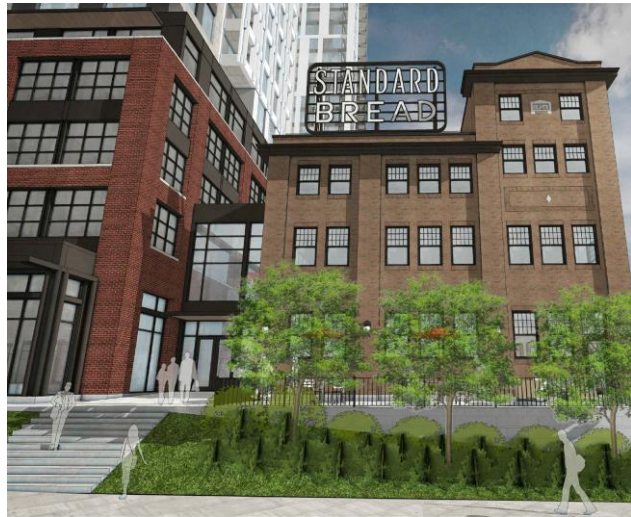
Figure 35: A historic photo illustrates the original sign with a rendering of the signage treatment being considered. Source: Hobin Architecture. 2022.

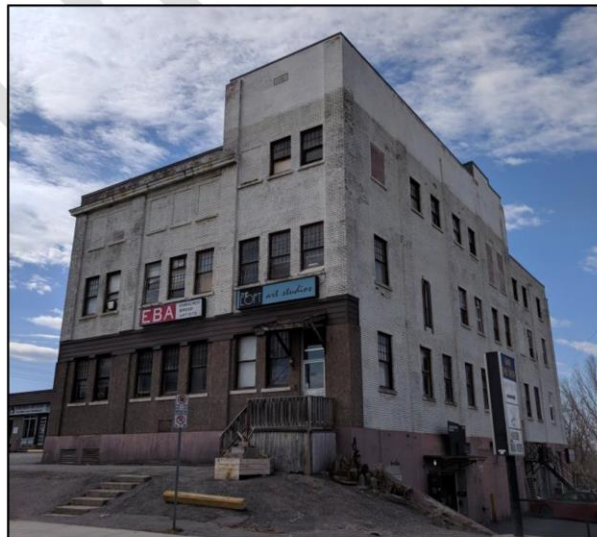
Photo 1: 951 Gladstone Avenue, south and east elevations [JCAL 2018].

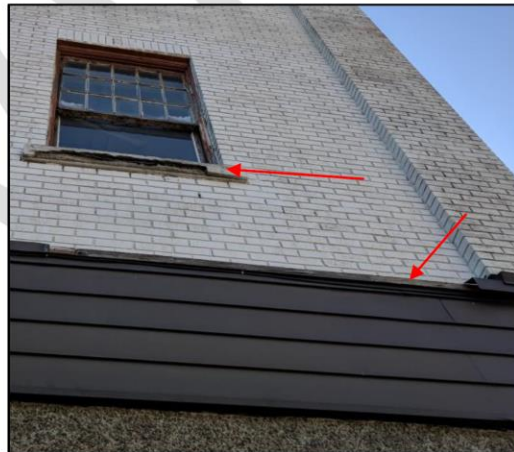
Photo 8: Deteriorated concrete window sill and damaged flashing on west elevation [JCAL 2018].
