RE: TREE PROTECTION PLAN FOR 2040 ARROWSMITH DRIVE, OTTAWA

This tree protection plan was prepared by IFS Associates Inc. (IFS Inc.) in support of a building permit for 2040 Arrowsmith Drive in Ottawa. The need for this report is related to trees protected under the City of Ottawa's Tree Protection By-law (By-law No. 2020-340). The work proposed includes demolishing existing buildings and construction of a six-storey mixed-use building (see plan on page 7 of this report). A driveway with retaining wall and curb is proposed for the rear of the building and is adjacent to a stand of trees on the neighbouring property at 2000 Jasmine Crescent. This plan details efforts to ensure the successful retention of these trees.

The inventory in this report details the assessment of nineteen trees - five located fully on the subject property and the remainder on the neighbouring property. No trees were found on nearby City of Ottawa lands. Field work for this report was completed in February 2026.

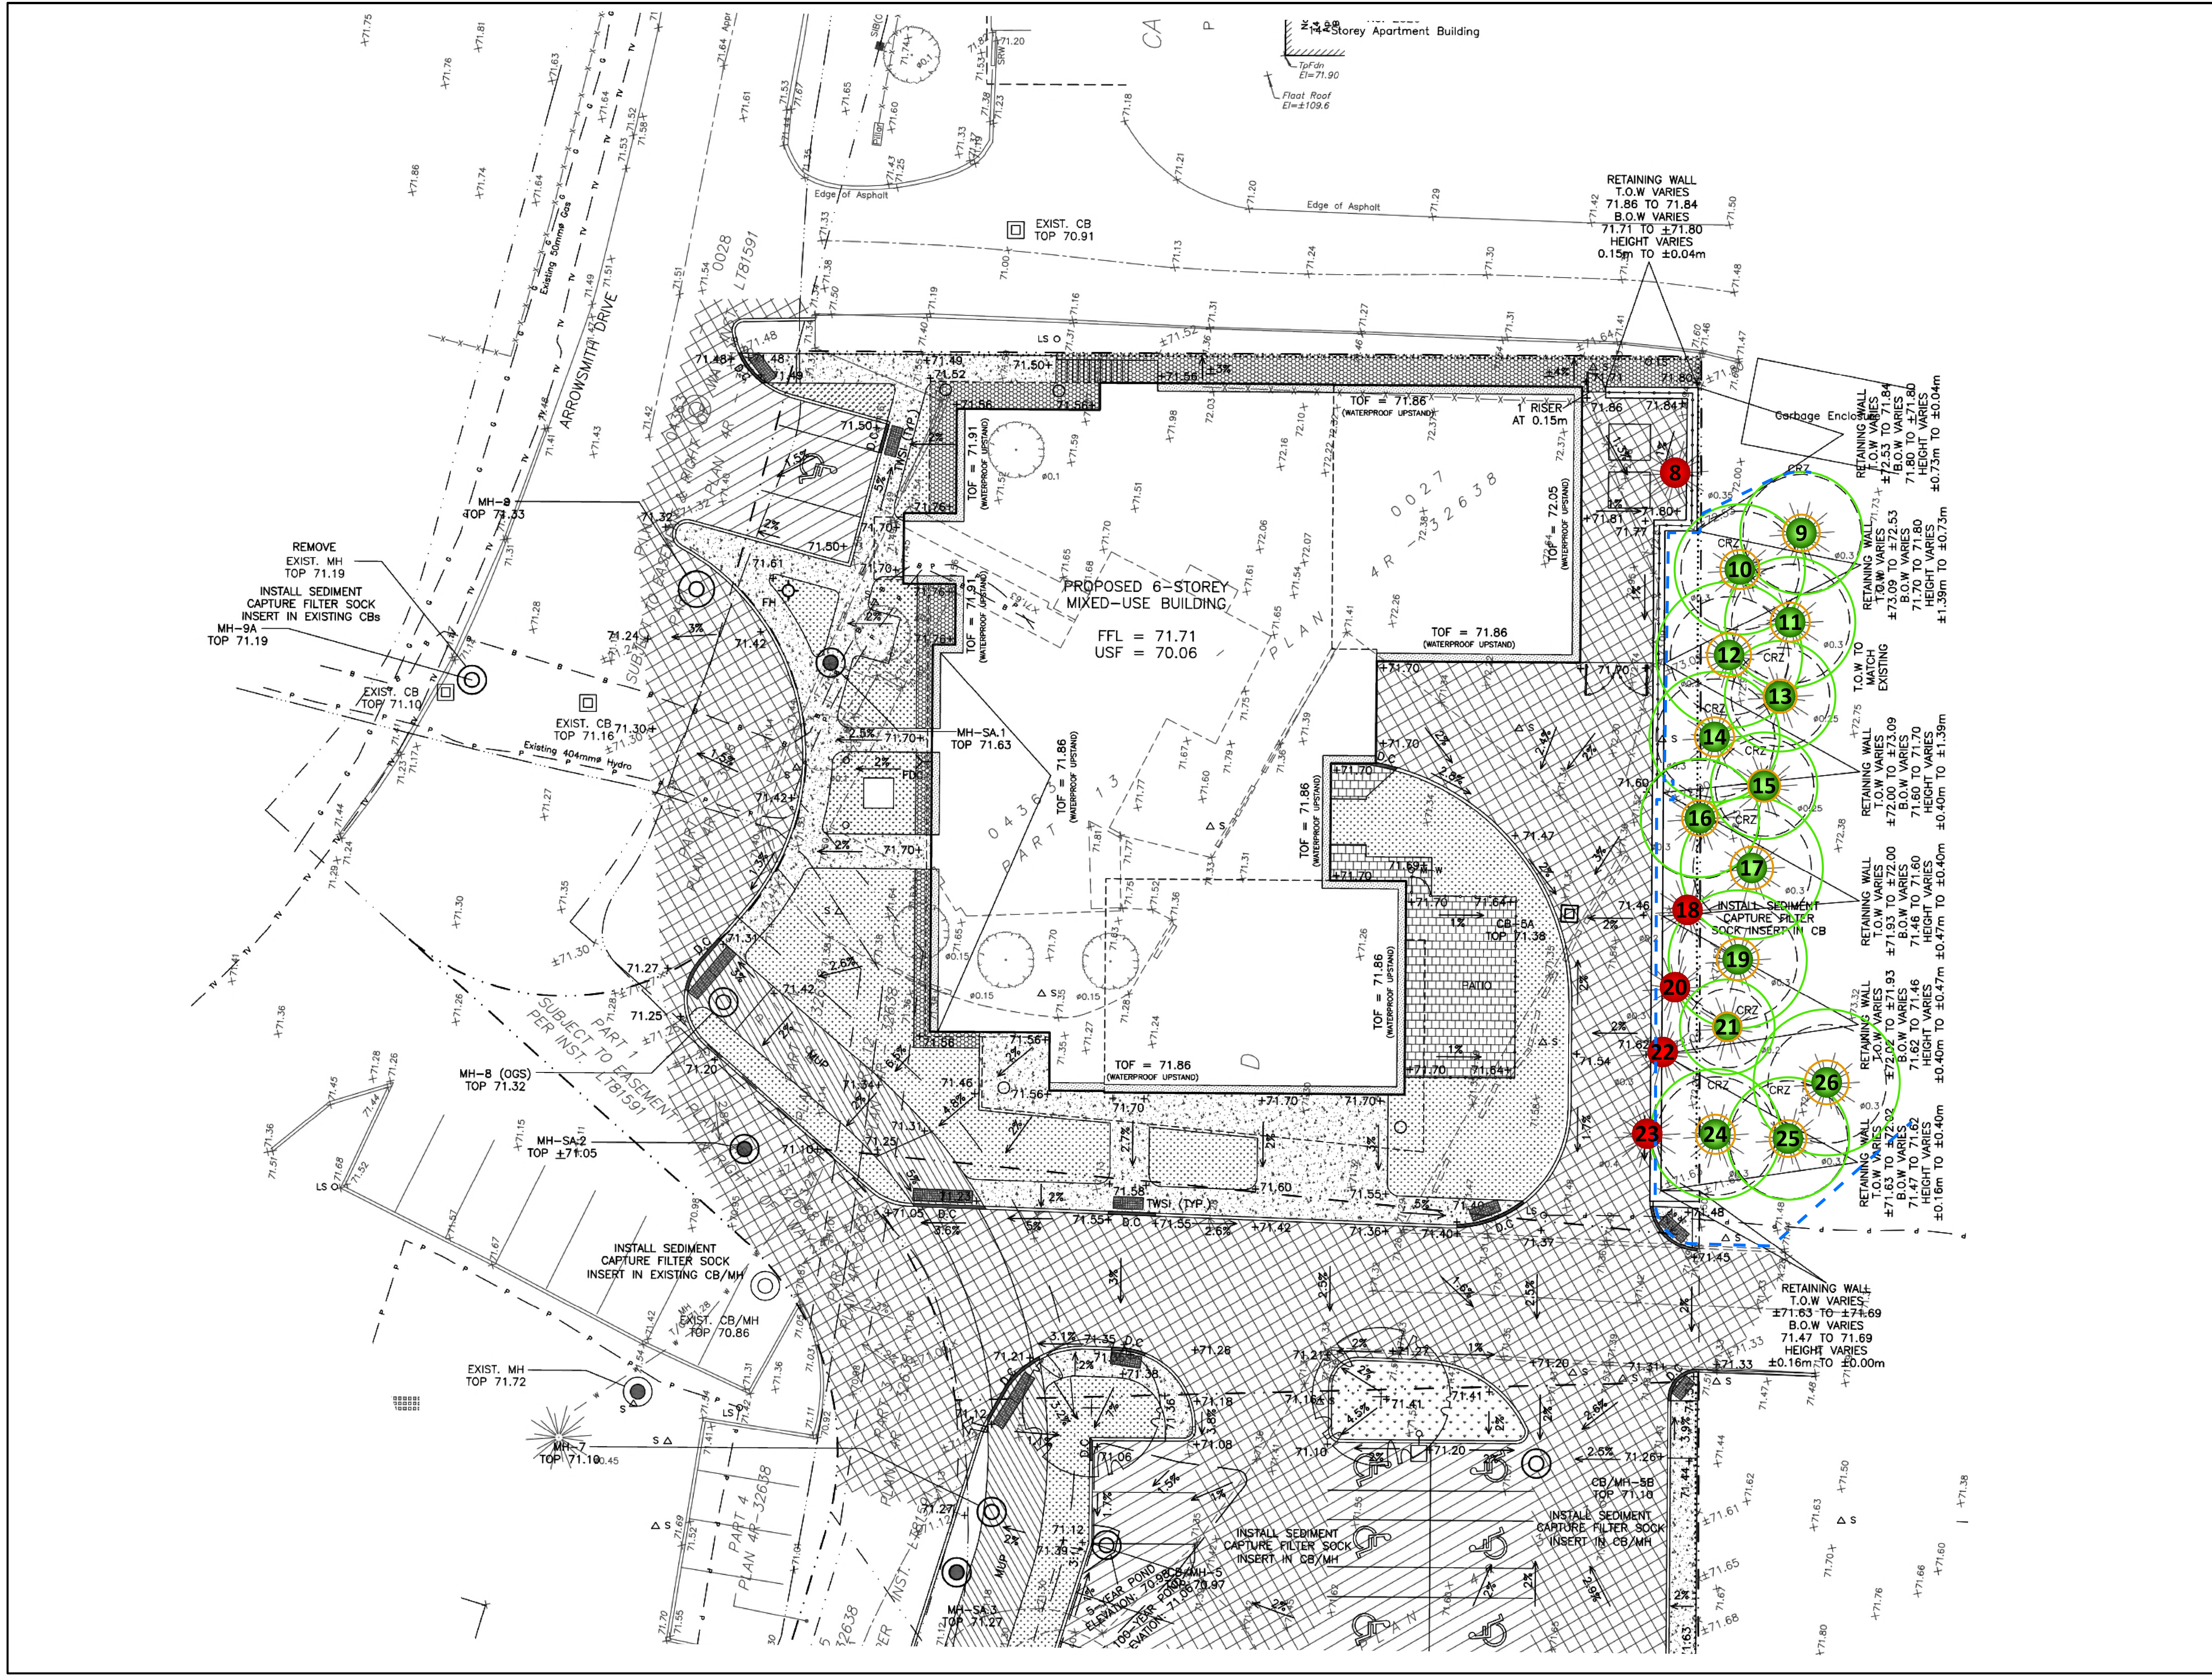
DRAWING: Tree Protection Plan

At most, 30% of one tree’s CRZ (tree #16) will be impacted by grading. This equals the maximum recommended in ISA best management practices. As shown in the plan on page 7, no static root zones will be impacted.

The consulting engineer and forester have discussed the implications of the work proposed along the eastern edge of the site. Grading behind the proposed retaining wall remains as existing. Approximately 30% of the CRZ of tree #16 will be impacted while lesser amounts of the CRZs of trees #10, 12, 14 and 24 will be impacted.

1. Erect a fence as close as possible to the critical root zone (CRZ) of trees (City of Ottawa tree protection barrier detail included on page 11). Portions of this fence will be moved as necessary (and temporarily) for access purposes when constructing the retaining wall and when completing grading.
2. Do not place any material or equipment within the CRZ of the tree.
3. Do not attach any signs, notices or posters to any tree.
4. Do not raise or lower the existing grade within the CRZ without approval.
5. Tunnel or bore when digging within the CRZ of a tree.
6. Do not damage the root system, trunk or branches of any tree.
7. Ensure that exhaust fumes from all equipment are NOT directed towards any tree's crown.

As excavation for the proposed retaining wall is proposed within the CRZs of trees #10, 12, 14, 16 and 24, the following measures will be taken:

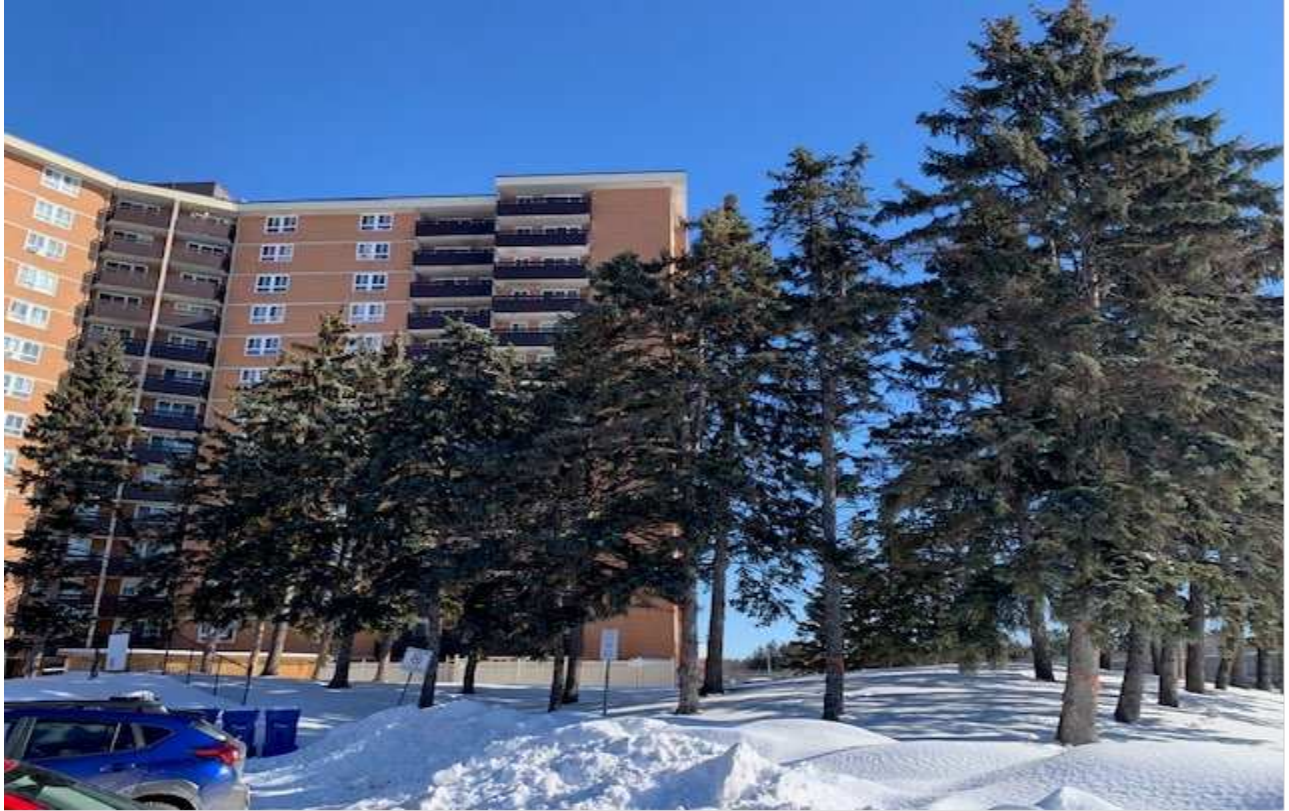
Picture 1. Trees #8 to 23 (left to right) – Colorado spruce trees on and adjacent to 2040 Arrowsmith Drive

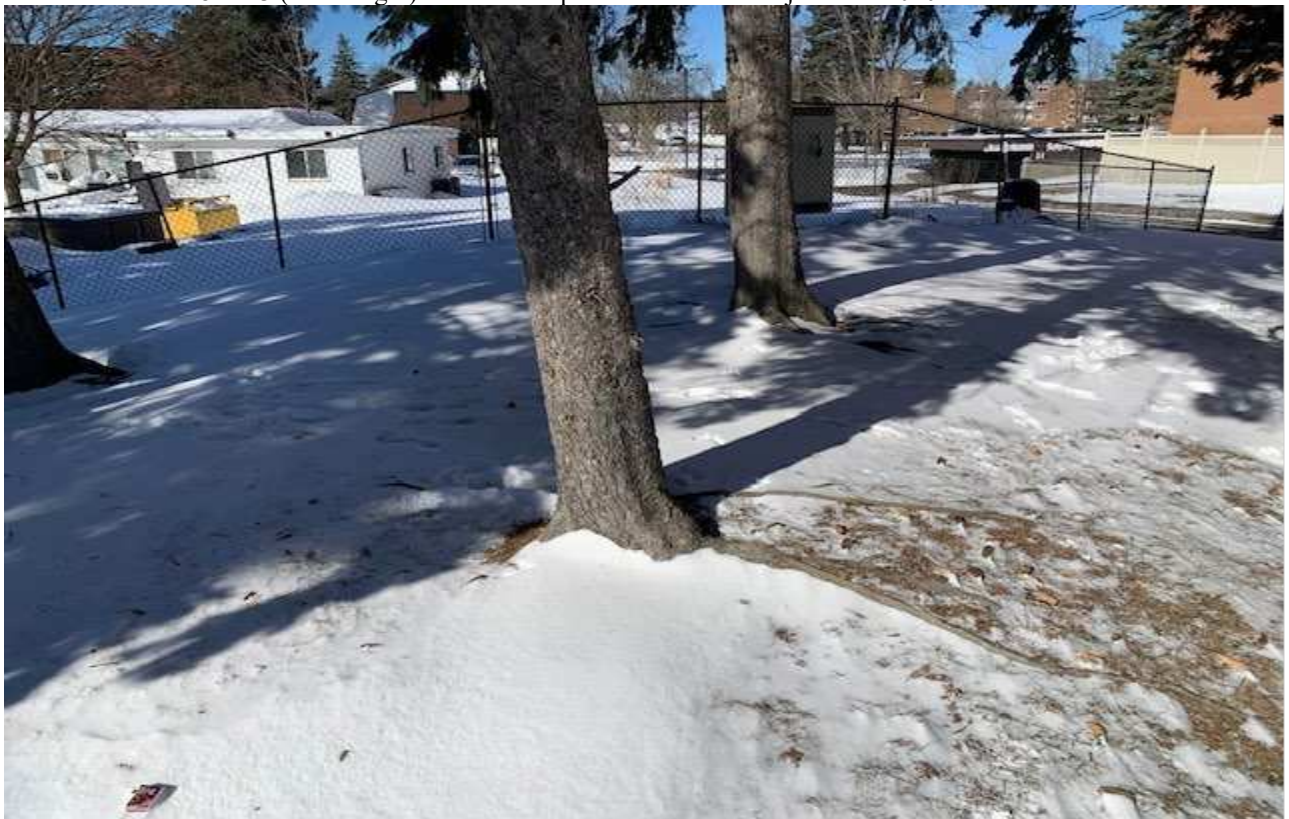
Picture 2. Rooting conditions below Colorado spruce trees on and adjacent to 2040 Arrowsmith Drive (note exposed surface roots)

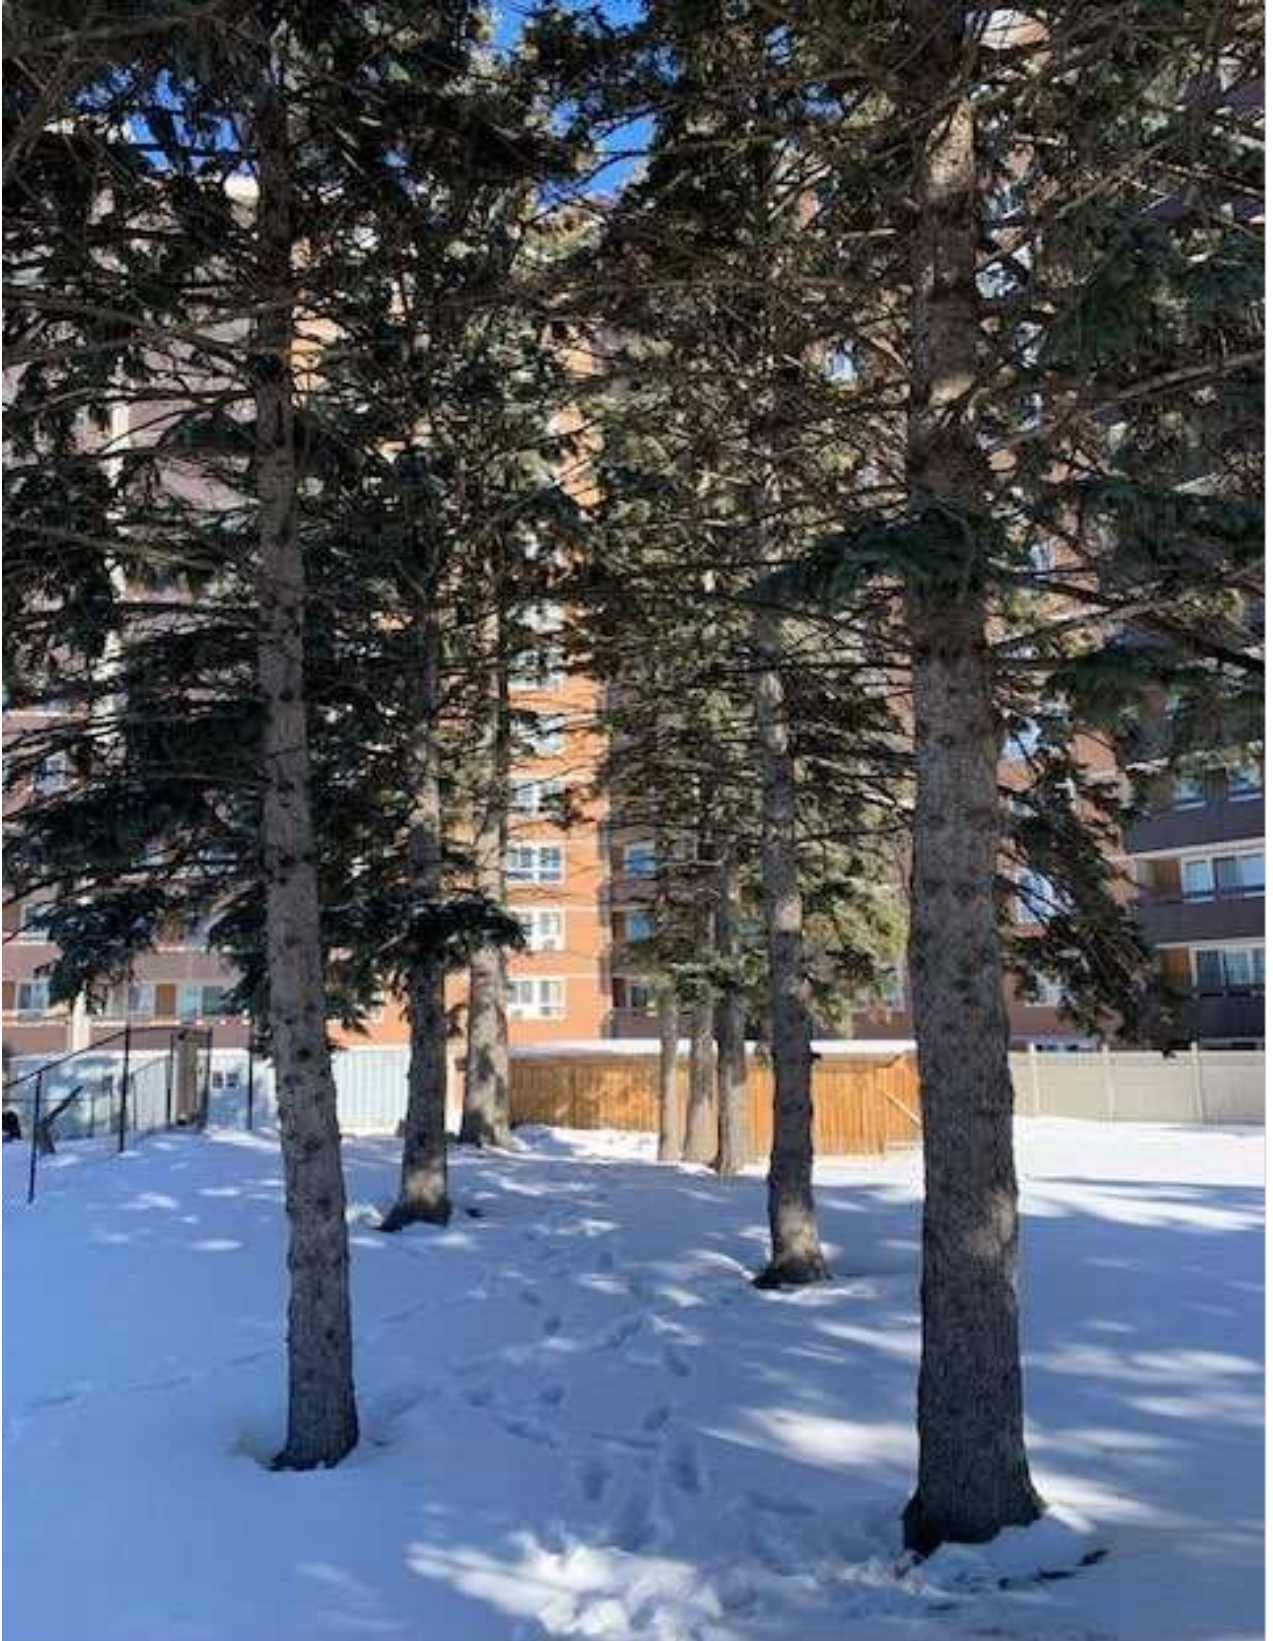
Picture 3. Lines of Colorado spruce trees adjacent to 2040 Arrowsmith Drive

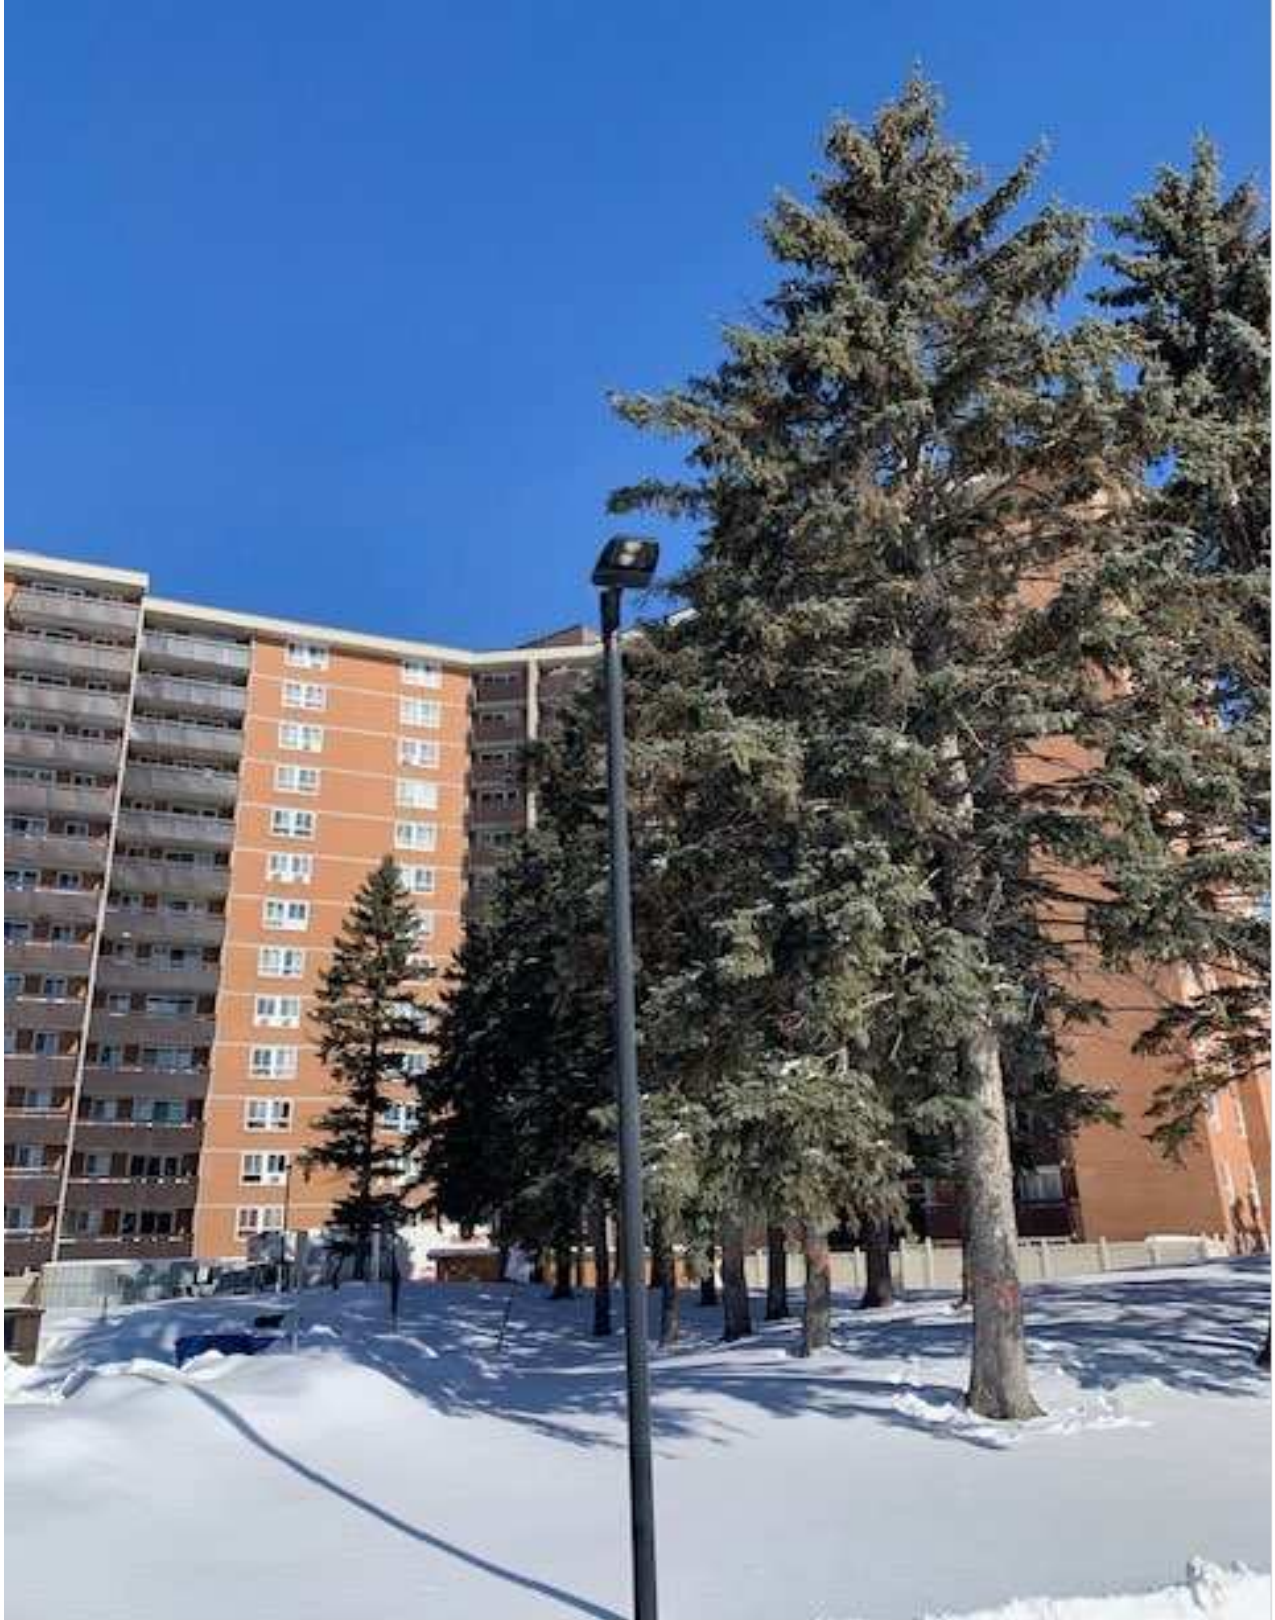
Picture 4. Colorado spruce trees on and adjacent to 2040 Arrowsmith Drive (note trees marked for removal with flagging tape)
