VIDEO CAMERA INSPECTION REPORTS

**116 – 118 CARRUTHERS AVENUE
LYNDALE - STONEHURST
OTTAWA**

PRE CONSTRUCTION

**SANITARY
APRIL 6, 2026
AQ-4841A**

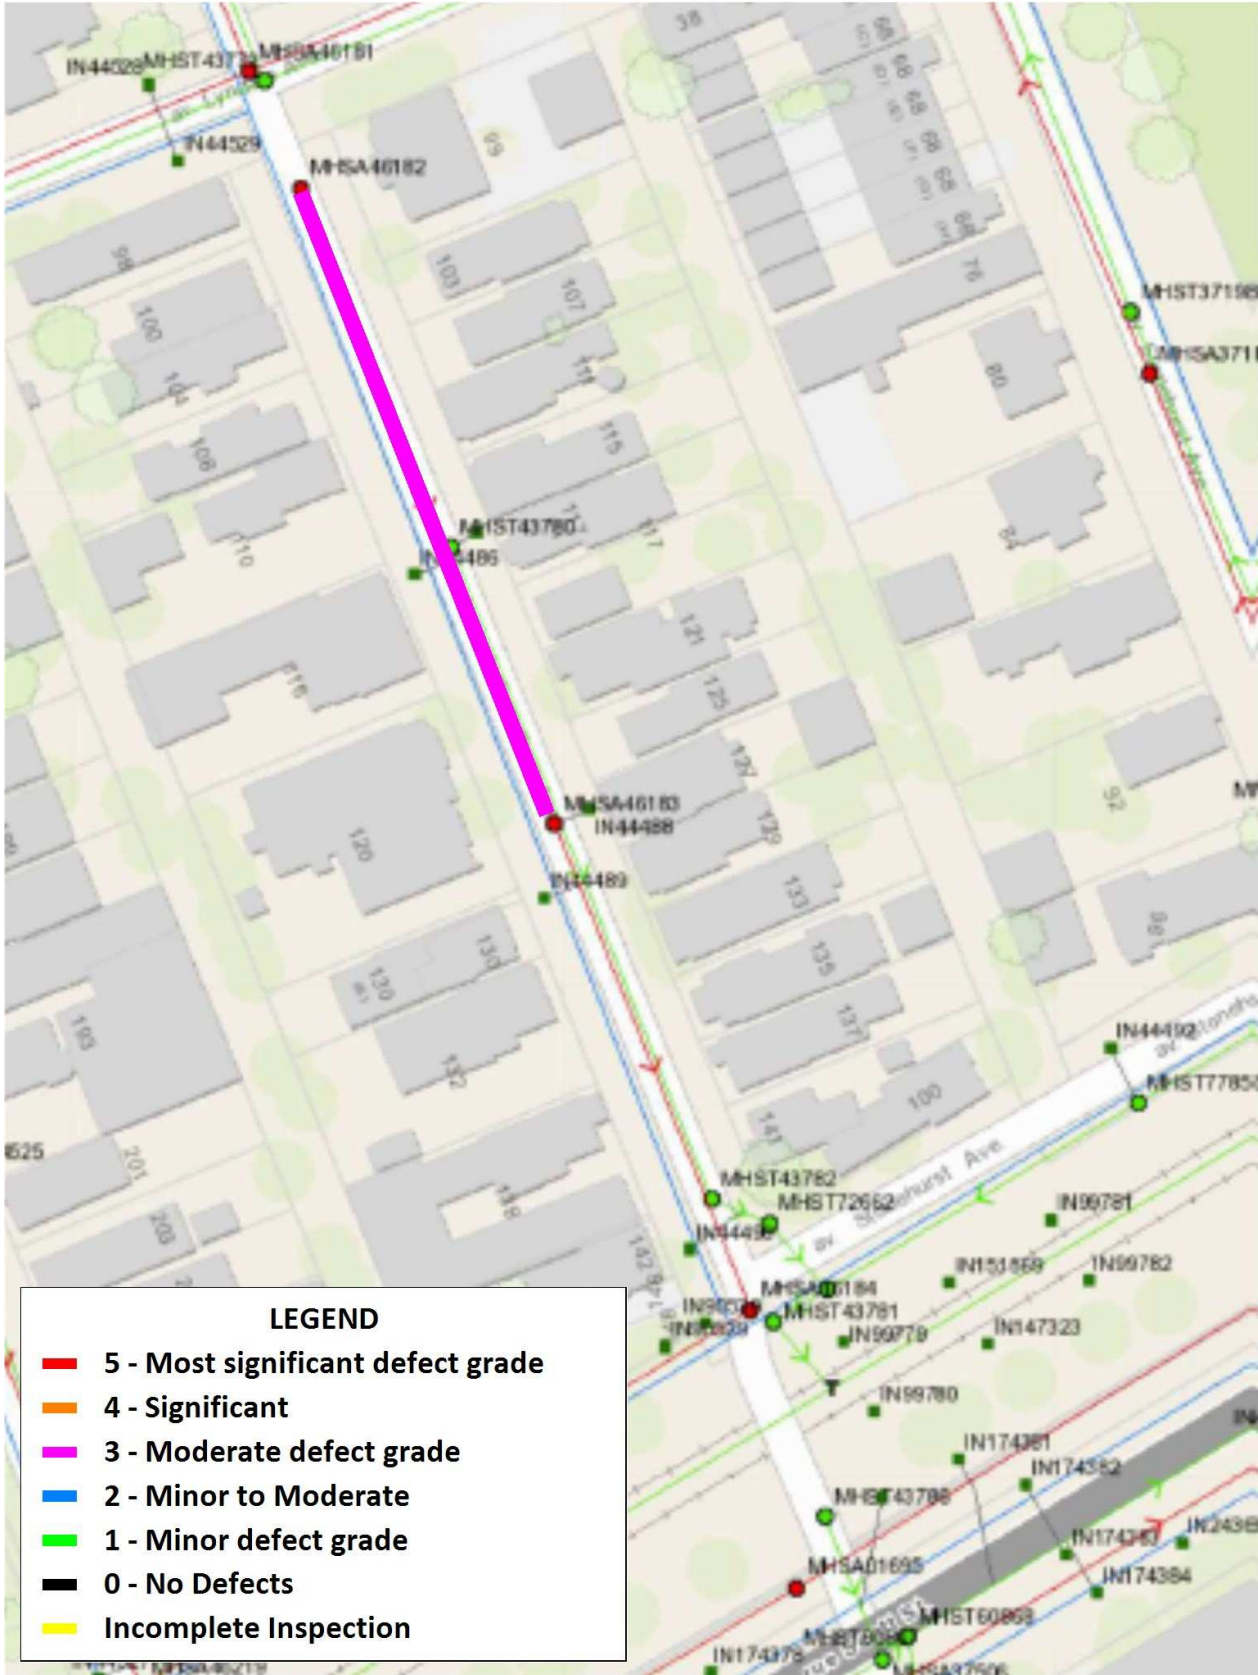
Structural rating map

3 - Moderate defect grade (1 of 1 items)

| Score | Quick | Index | Pipe | Upstream | Downstream | Street | Page |
|---|---|---|---|---|---|---|---|
| 3 | 3100 | 3 | SAN45072 | MHSA46182 | MHSA46183 | CARRUTHERS AVE | 9 |

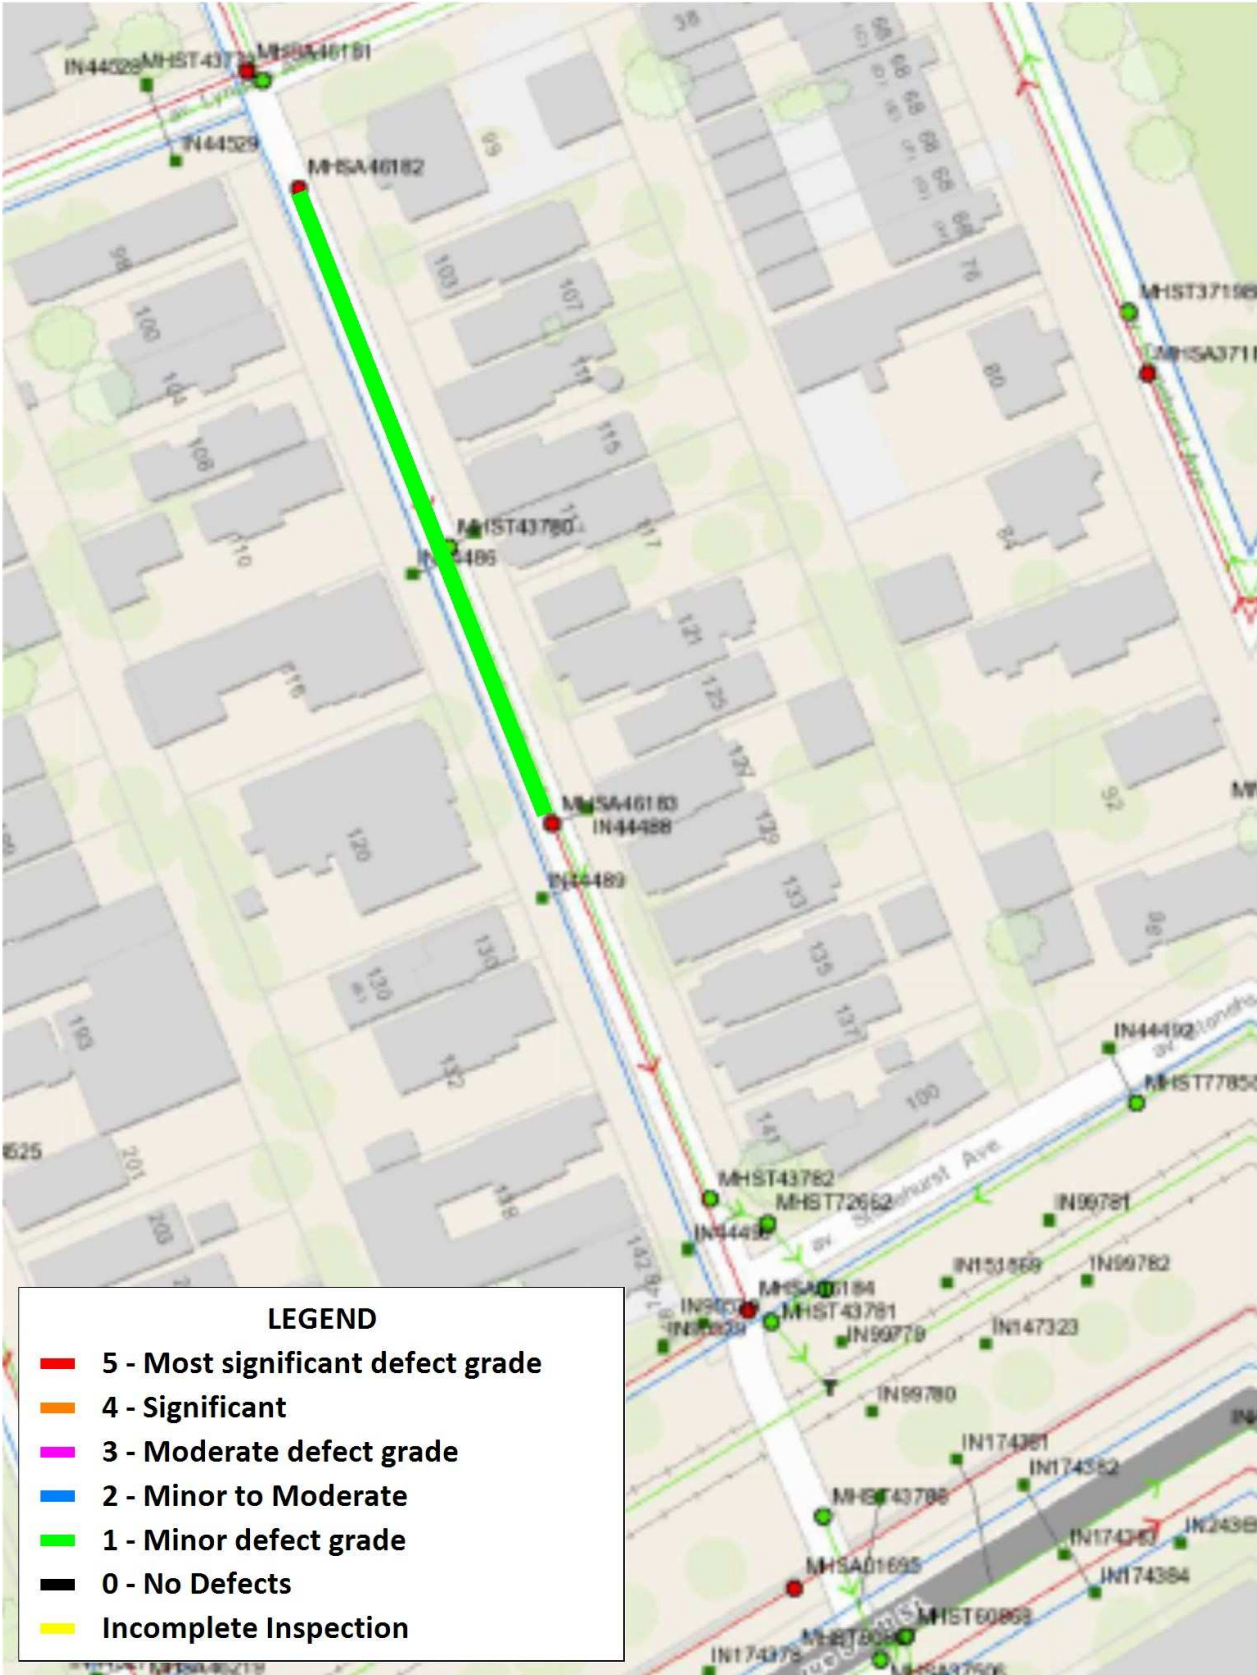
O&M rating map

1 - Minor defect grade (1 of 1 items)

| Score | Quick | Index | Structural | Pipe | Upstream | Downstream | Street | Page |
|---|---|---|---|---|---|---|---|---|
| 1 | 1100 | 1 | 3 | SAN45072 | MHSA46182 | MHSA46183 | CARRUTHERS AVE | 9 |

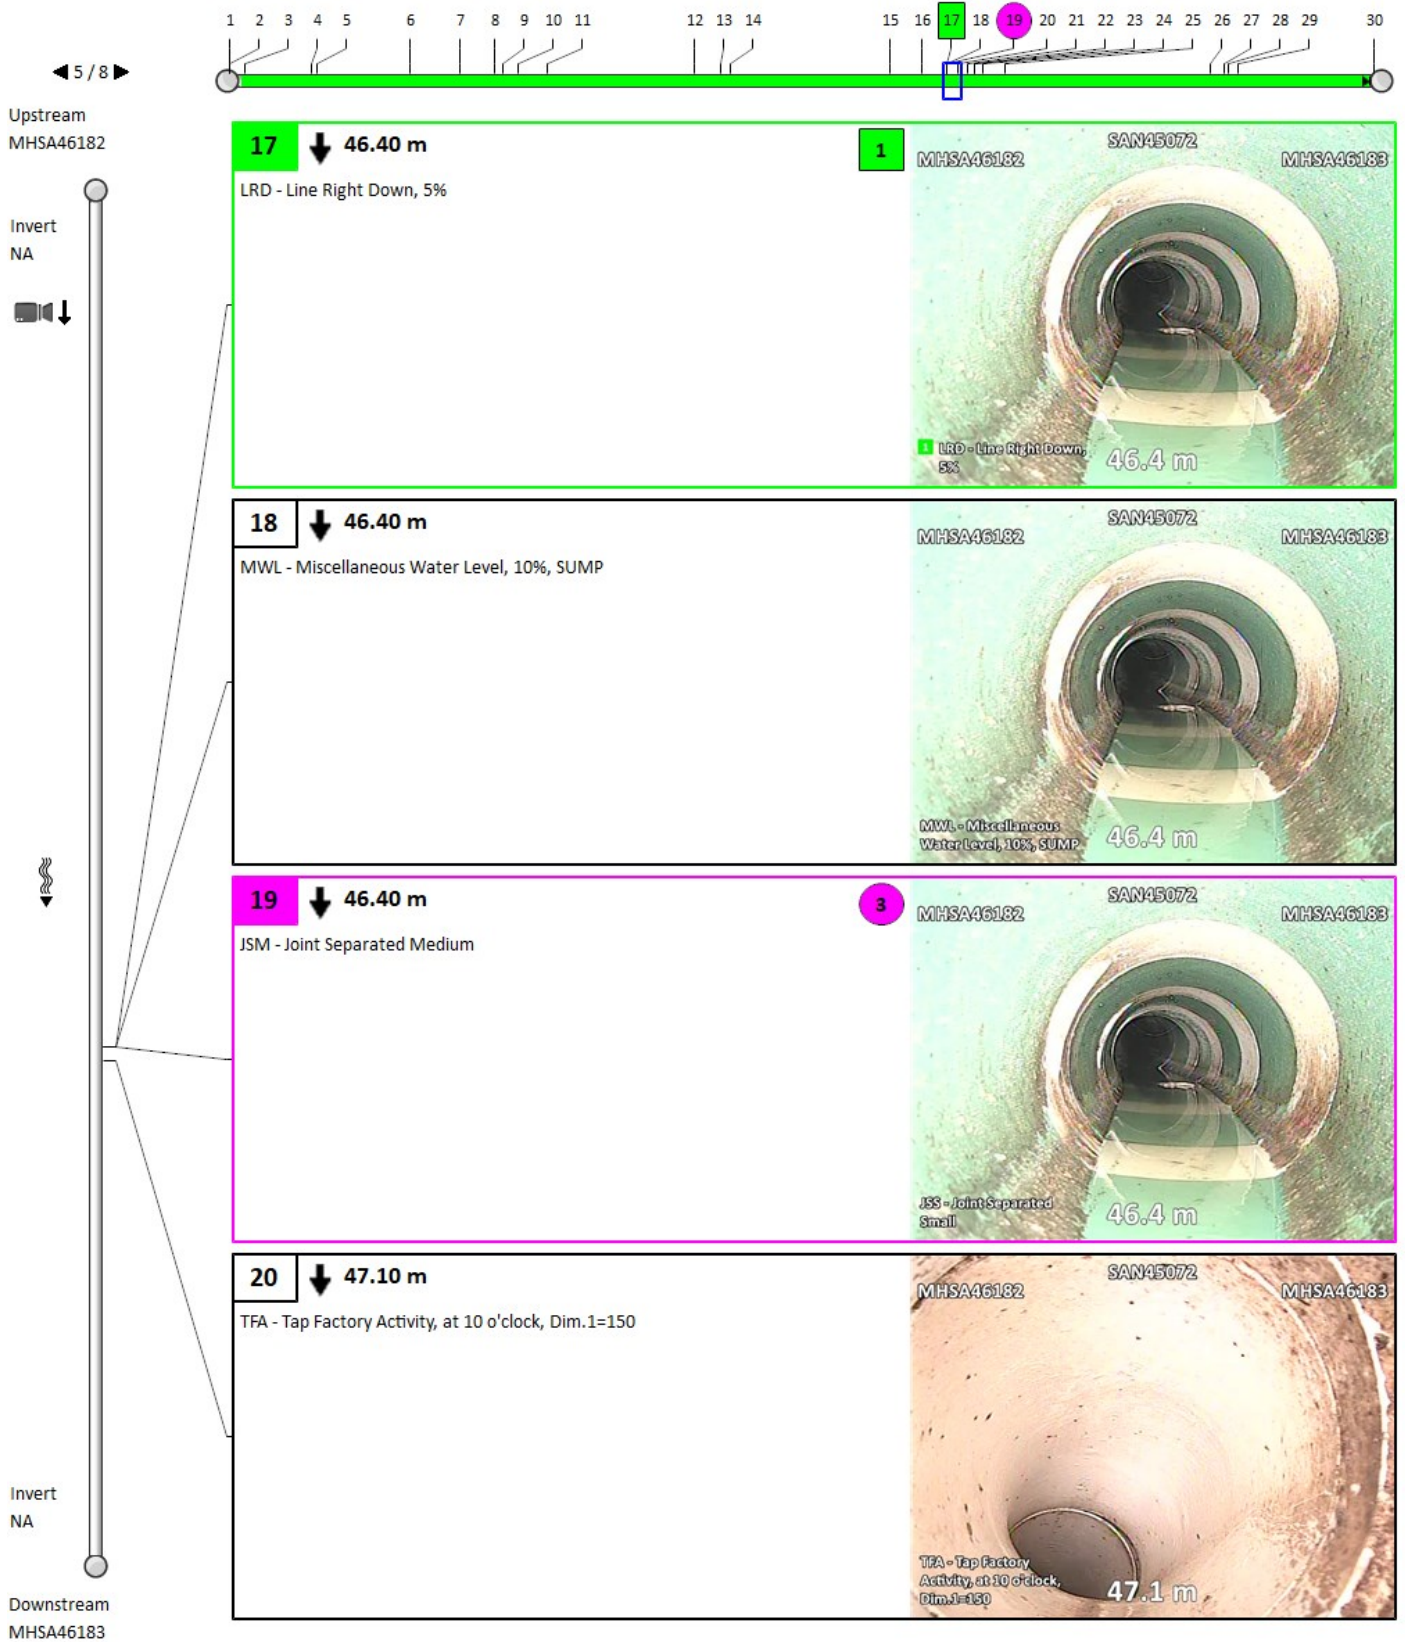
17 ↓ 46.40 m

LRD - Line Right Down, 5%

18 ↓ 46.40 m

MWL - Miscellaneous Water Level, 10%, SUMP

19 ↓ 46.40 m

JSM - Joint Separated Medium

20 ↓ 47.10 m

TFA - Tap Factory Activity, at 10 o'clock, Dim.1=150
