240798

April 22, 2025

**RE: SLOPE STABILITY ASSESSMENT
PROPOSED LONG TERM CARE FACILITY ADDITION
1541 ST. JOSEPH BOULEVARD
CITY OF OTTAWA, ONTARIO**

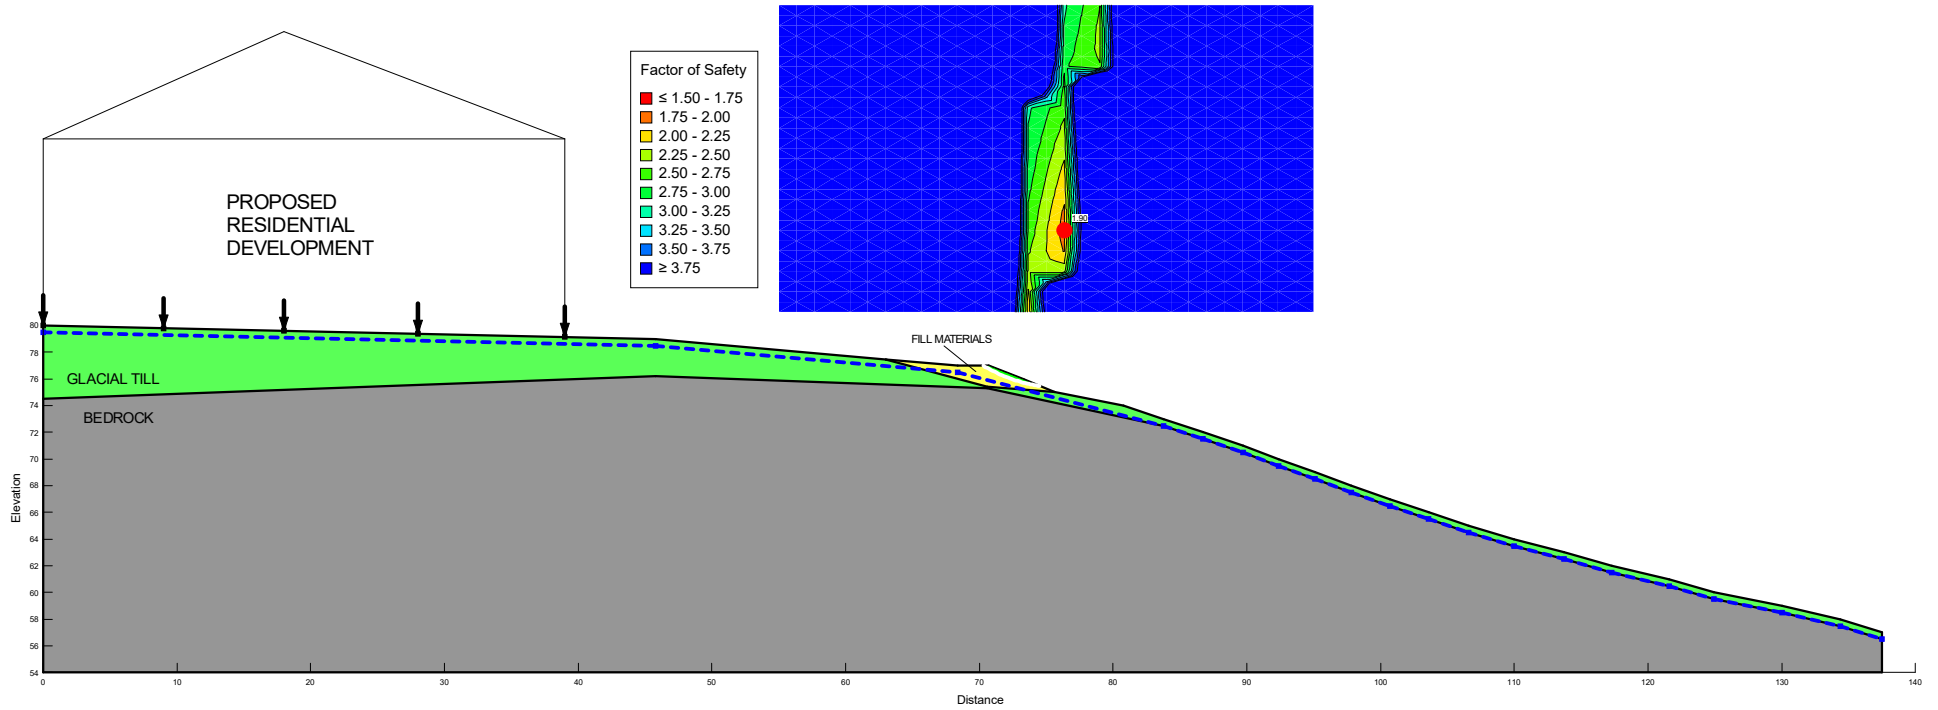
SLOPE SECTION 1 - POST DEVELOPMENT (STATIC CONDITIONS)

Section	Minimum Factor of Safety		Minimum Setback for Origin of Slip Surface with $FS \geq 1.5$ ¹
	Static	Seismic	
Section 1 – Predevelopment	1.90	1.35	none encountered ²
Section 1 – Post development	1.90	1.50	none encountered ²
Section 2	1.39	1.05	3.3 metres
Section 3	2.11	1.46	none encountered ²

The slope stability analysis completed on the critical sections indicated that the slope is stable, having factors of safety greater than 1.5 under static conditions and 1.1 under seismic conditions, except for section 2. There are no conditions at which the defined slope on the property in the area of the proposed development are less than stable. As such, there is no requirement for a stable slope setback and the construction of a multi-unit residential building in the proposed location will have no effect on the stability of the slope.

For slope section 2 – Erosion Hazard Limit = 0 + 3.3 + 6 = 9.3 metres from the top of the stable slope.

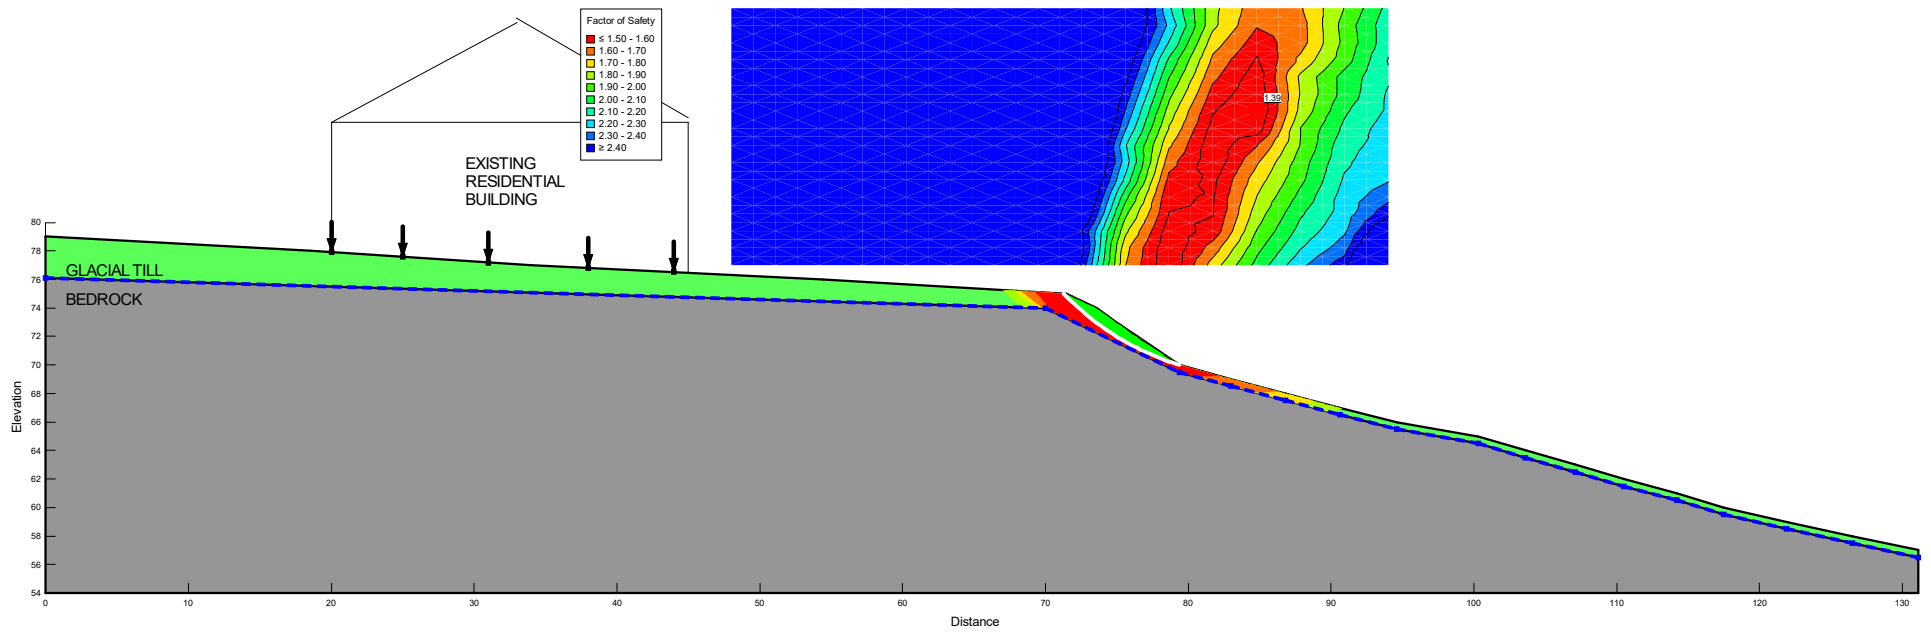
SLOPE SECTION 2 - STATIC CONDITIONS

Category	Criteria	Rating
1. Slope Inclination	18 - 26 (19.5 degrees)	6
2. Soil Stratigraphy	Glacial Till/Clay, silt (Stiff)	12
3. Seepage from Slope Face	None or near bottom only	0
4. Slope Height	More than 10 m (18m)	8
5. Vegetation	Well vegetated; heavy shrubs or forested with mature trees	0
6. Table Land Drainage	Minor drainage over slope, no active erosion	2
7. Proximity to Watercourse	More than 15 metres from slope toe	0
8. Previous Landslide Activity	No	0
Total		28
*No seepage was noted during the visit by Kollaard Associates Inc.		
25-36 – Slight potential = Site Inspection only, and surveying, preliminary study, detailed report

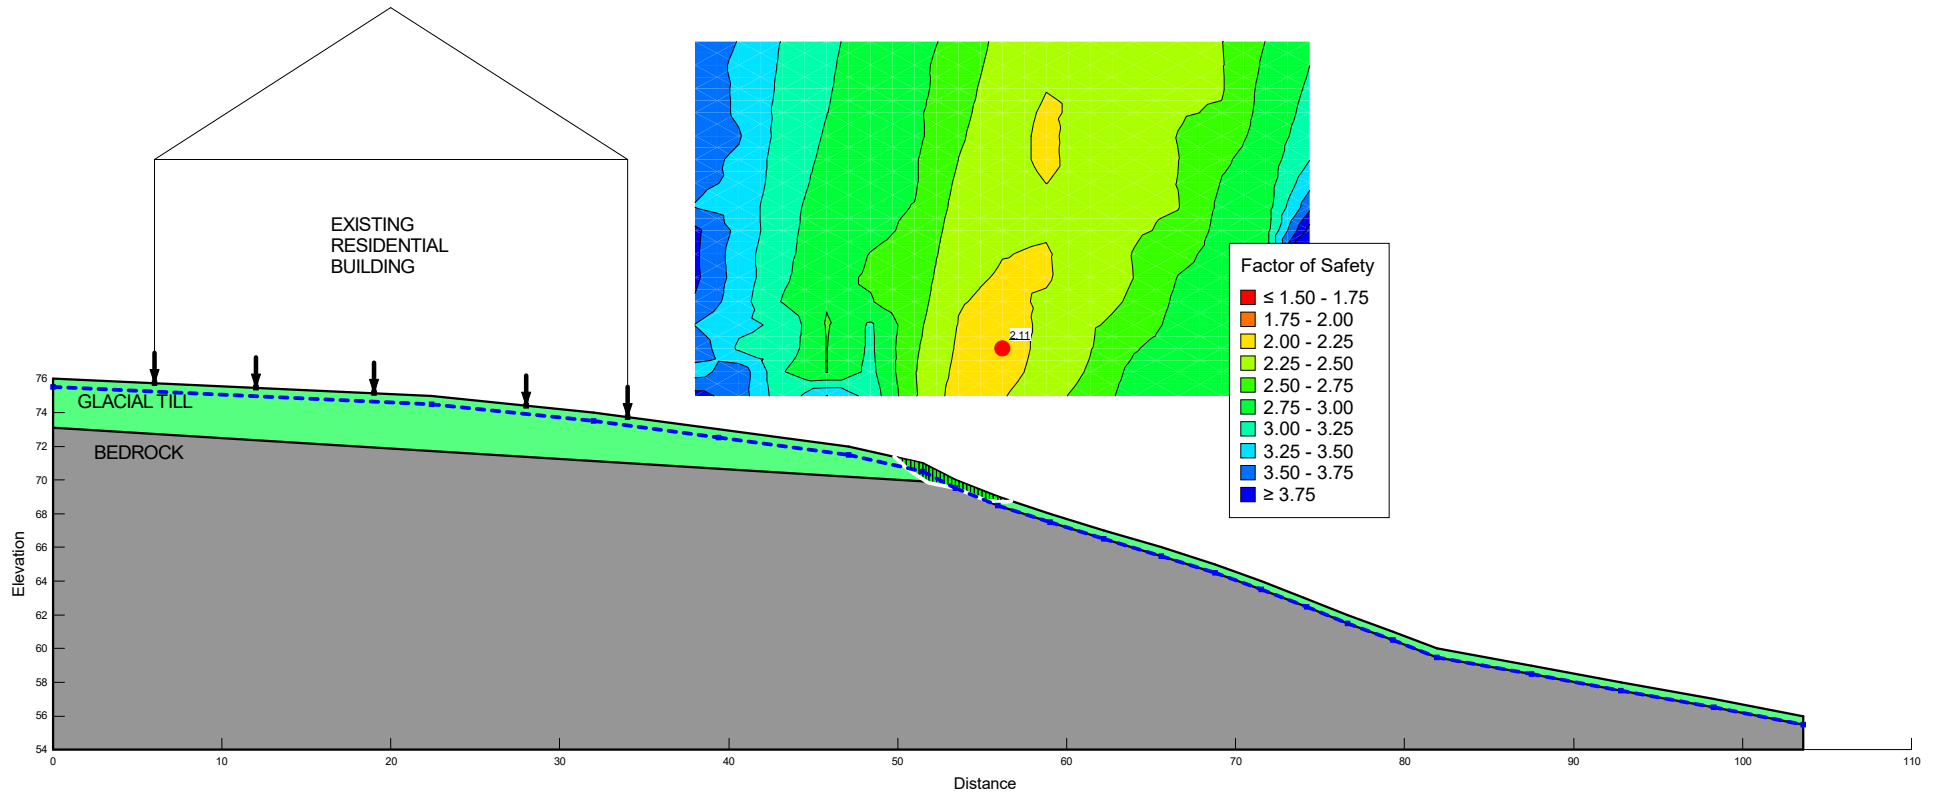
SLOPE SECTION 3 - STATIC CONDITIONS

Category	Criteria	Rating
1. Slope Inclination	18 or less (17.4 degrees)	0
2. Soil Stratigraphy	Glacial Till/Clay, silt (Stiff)	12
3. Seepage from Slope Face	None or near bottom only	0
4. Slope Height	More than 10 m (16m)	8
5. Vegetation	Well vegetated; heavy shrubs or forested with mature trees	0
6. Table Land Drainage	Minor drainage over slope, no active erosion	2
7. Proximity to Watercourse	More than 15 metres from slope toe	0
8. Previous Landslide Activity	No	0
Total		22
*No seepage was noted during the visit by Kollaard Associates Inc.		
<24 – Slight potential = Site Inspection only, confirmation, report letter

For slope section 3 – Erosion Hazard Limit = 0 + 0 + 6 = 6 metres from the top of the stable slope.
