January 20, 2026

Department of Planning, Development and Building Services (PDBS)
 City of Ottawa
 110 Laurier Avenue West
 Ottawa, ON K1P 1J1

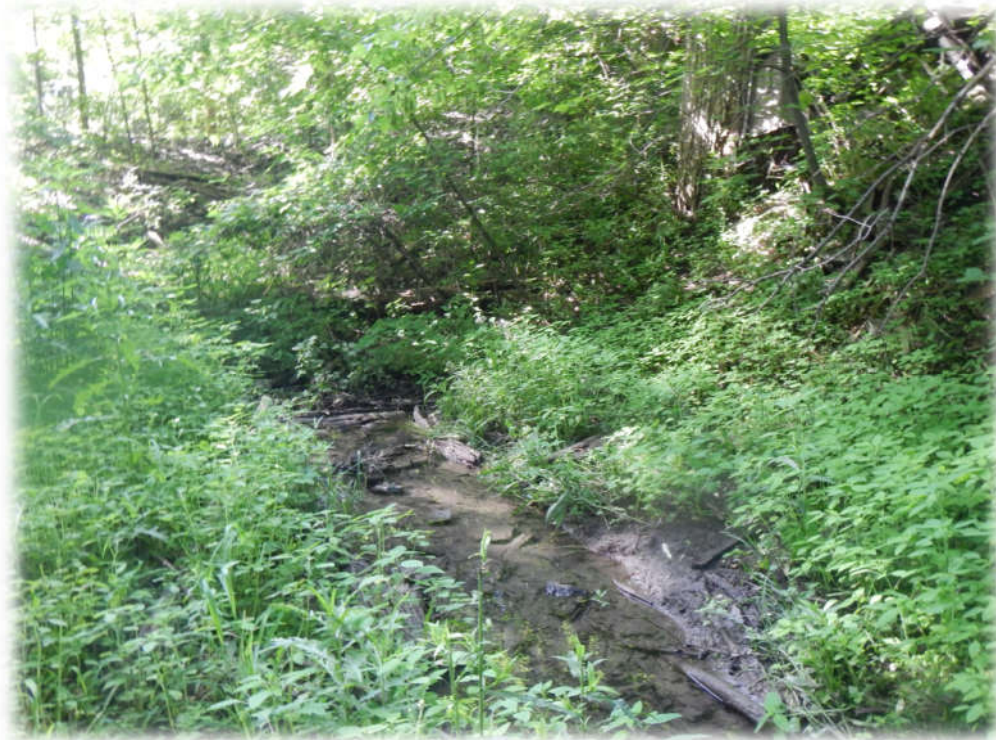
Prepared for:
Inverness Homes
69 Moore Street
Richmond ON K0A 2Z0

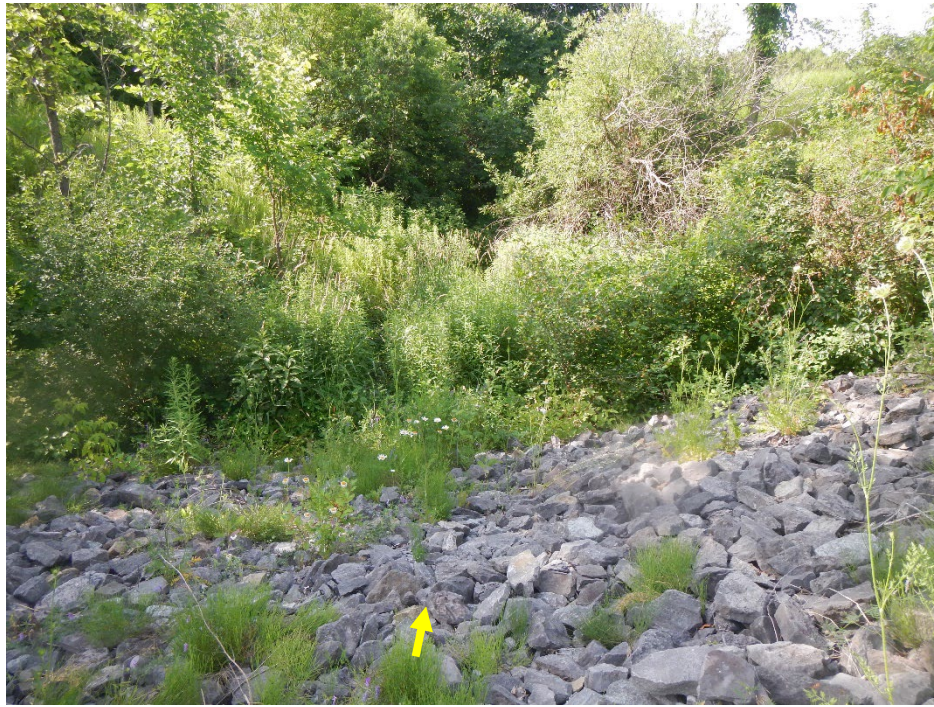
Riprap stabilization on top of a concrete culvert in the upper third of the reach. Note the channel remained extensively encroached with vegetation and flowed through a confined valley. No erosion was observed in vicinity of the crossing.

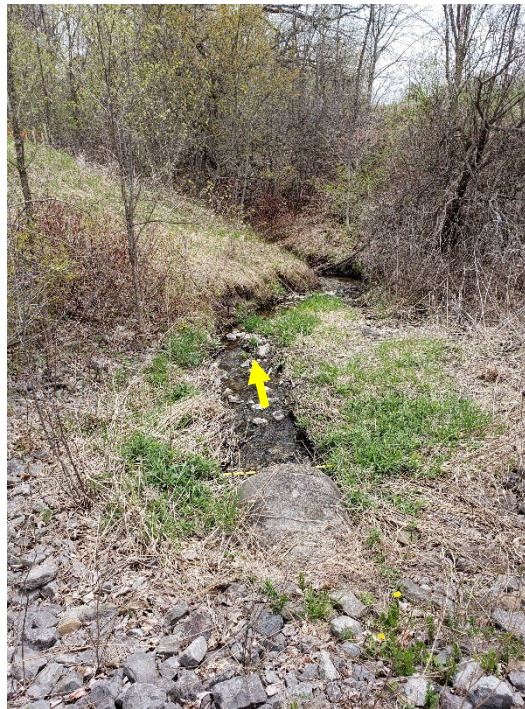
View of the channel downstream of the concrete culvert, where relatively minor channel adjustment along the toe of slope was observed.

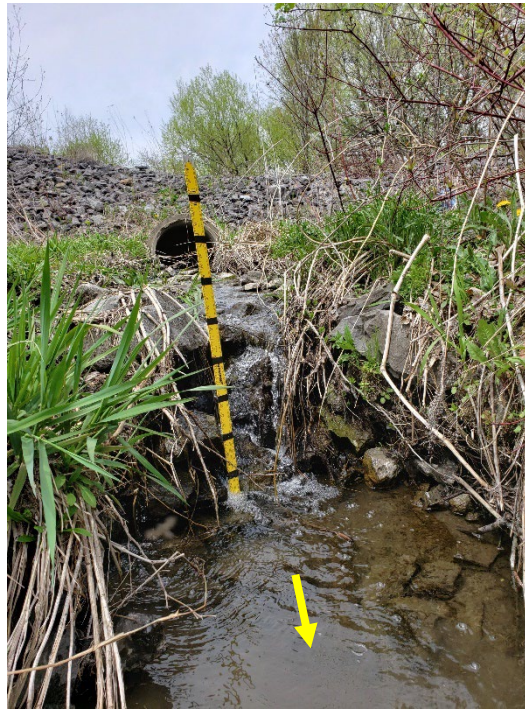
View of artificial knickpoint caused by rip rap installed at concrete culvert crossing.

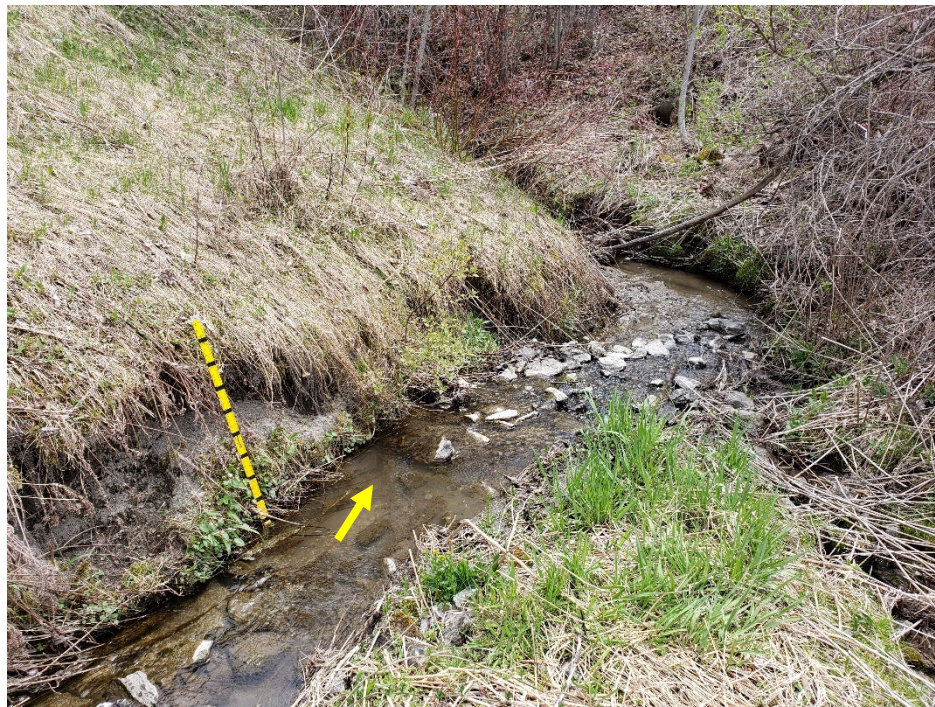
View of relatively minor channel adjustment along the toe of slope downstream of the concrete culvert. The valley slope was well-vegetated.

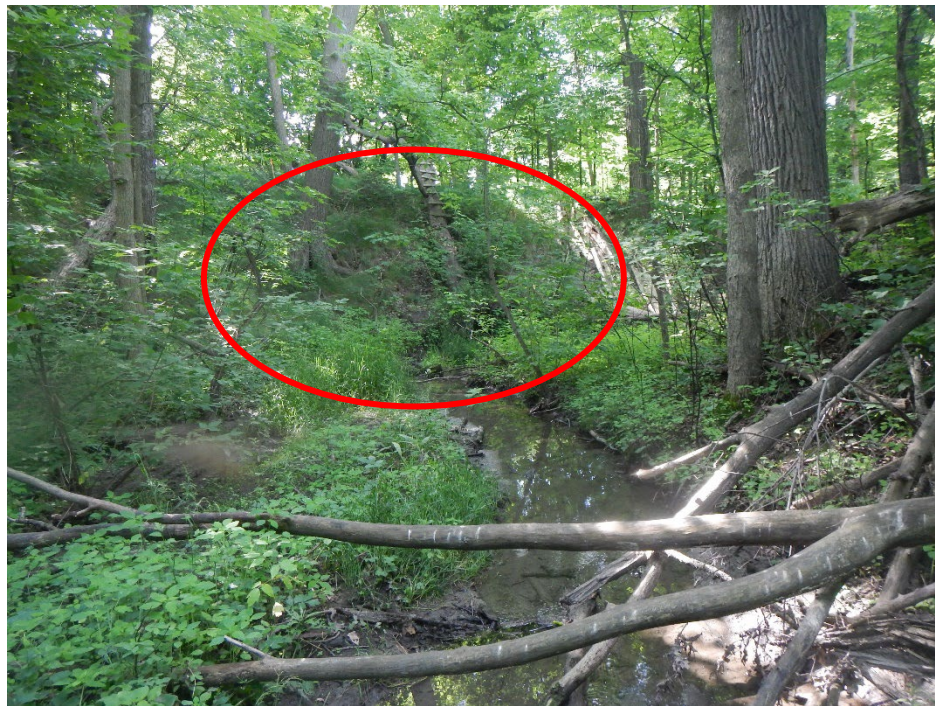
Woody debris within the forested section of the channel (valley wall contact circled in red). Photo 25 (below) provides a view of conditions in the spring.

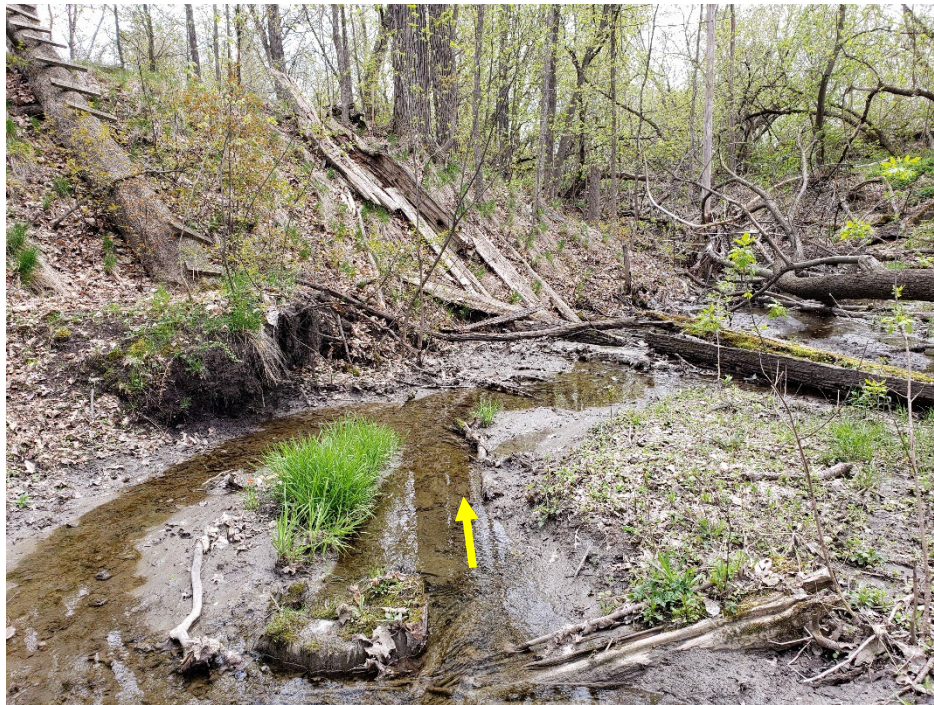
Note the tree has fallen away from the channel rather than towards, indicating limited channel adjustment at the valley wall contact. There was no evidence suggesting that trees had fallen due to channel adjustment.

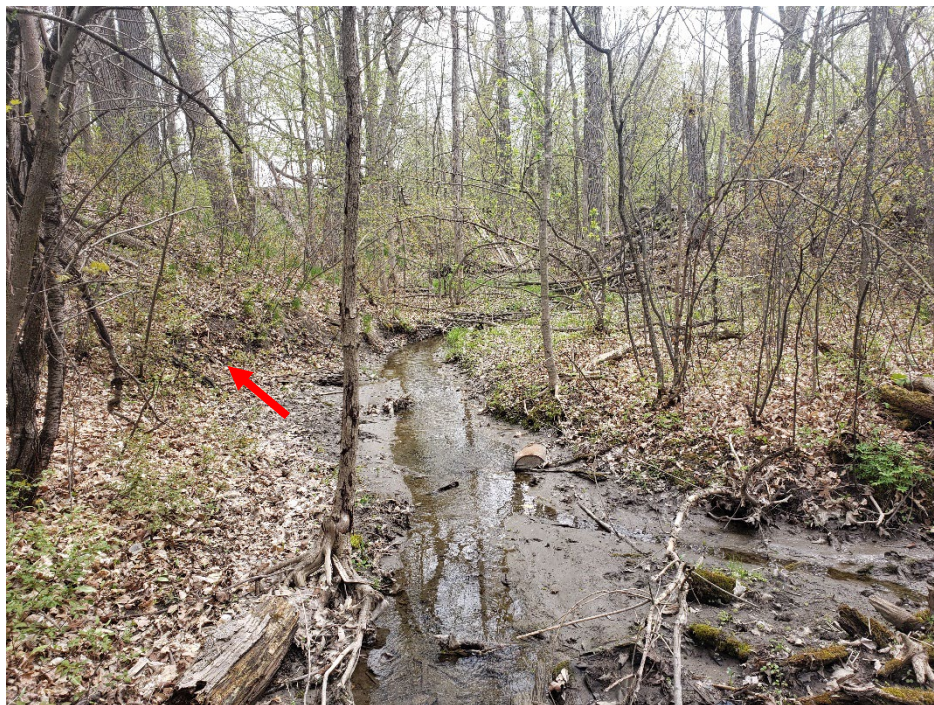
Example of where the channel has migrated away from the valley wall (historic valley wall contact noted with red arrow).

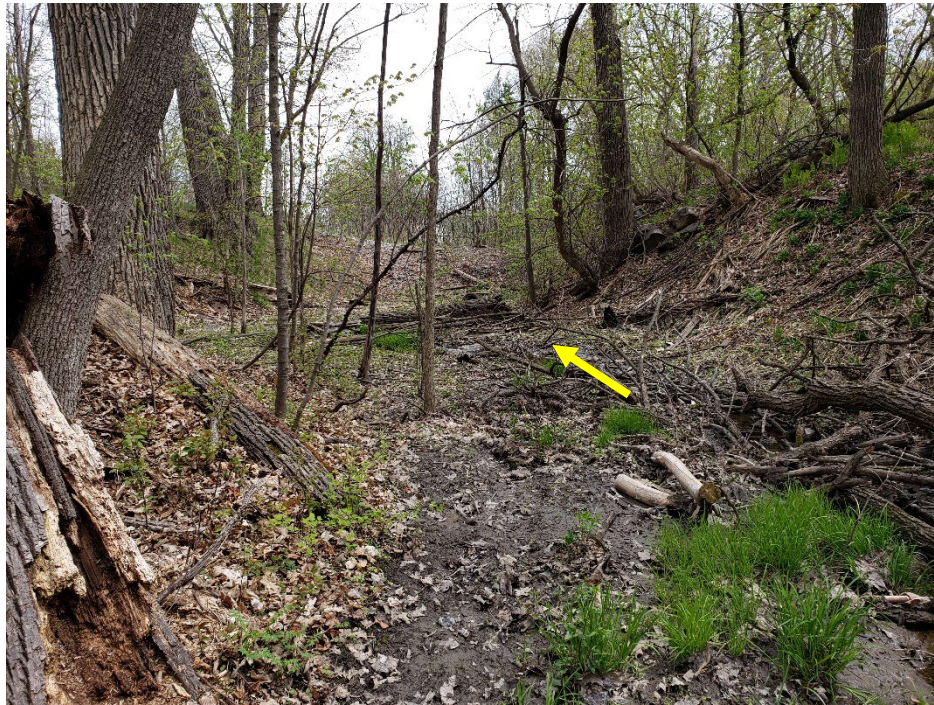
Channel temporarily loses definition before flowing through the second concrete culvert near the downstream extent of the reach.

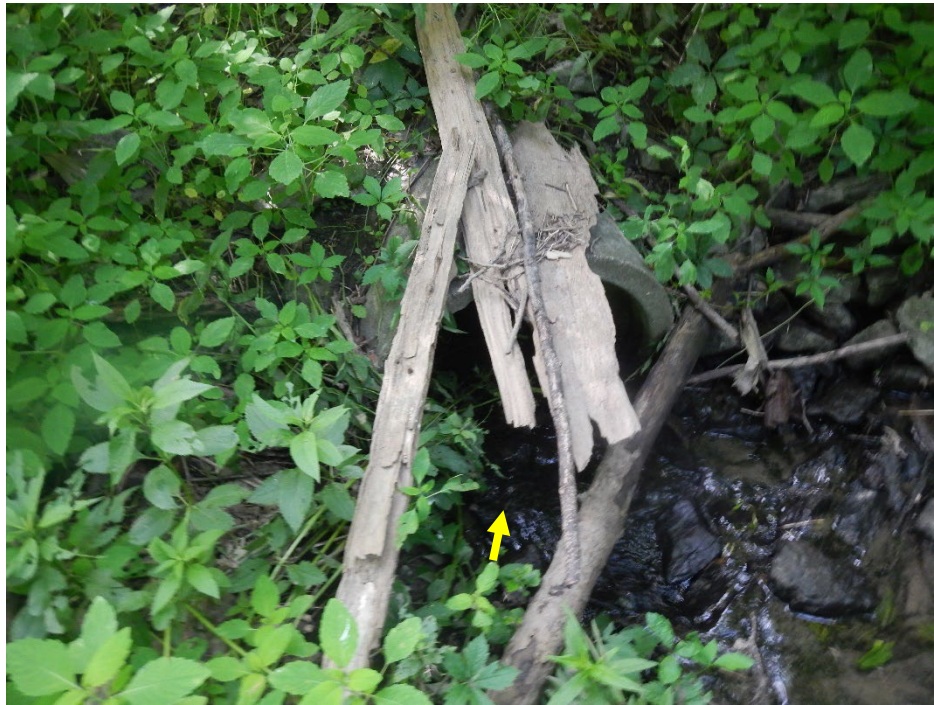
Concrete culvert located in the lower third of the reach. Rip rap stabilization was observed on top of the culvert. No channel adjustment was observed in vicinity of the crossing.

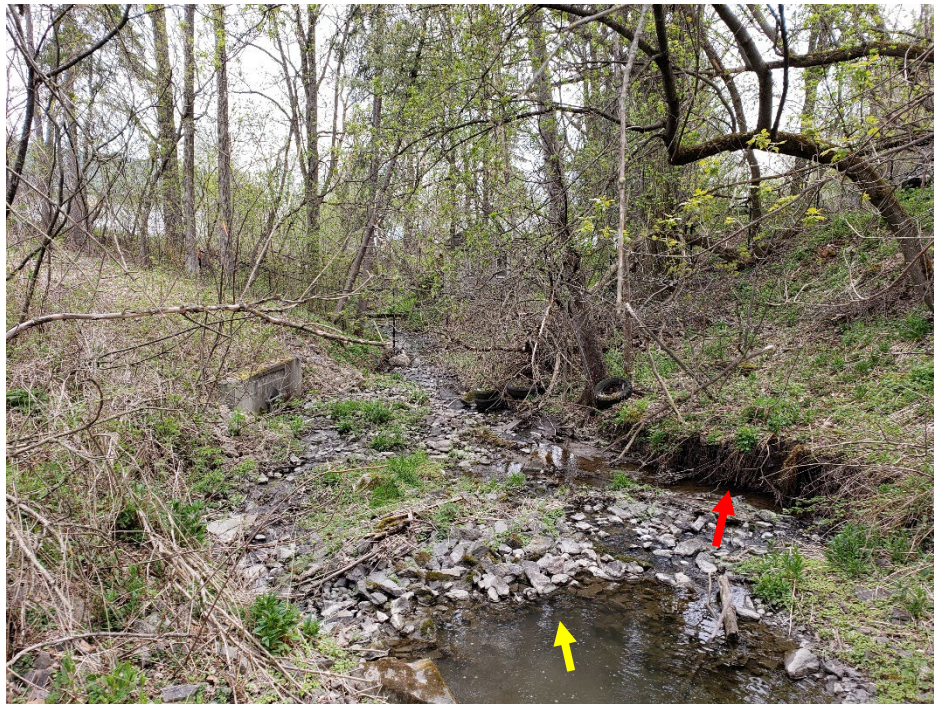
View of the channel downstream of the second concrete culvert. Relatively minor channel adjustment was observed along the toe of slope (red arrow).

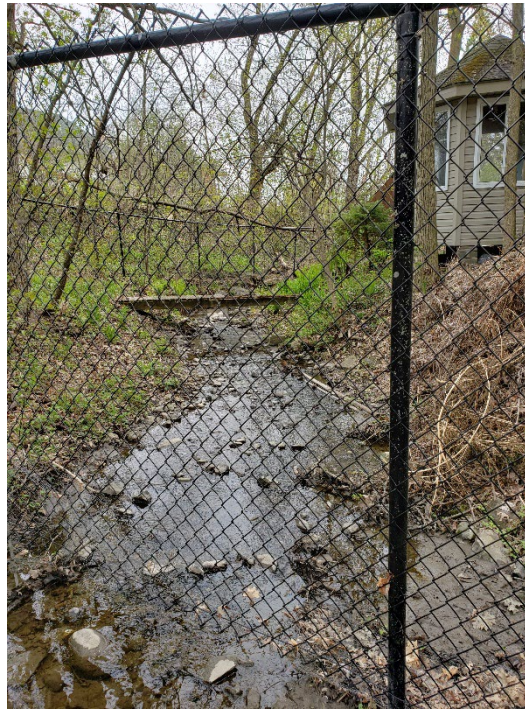
View of the channel downstream, where it flowed through private property.

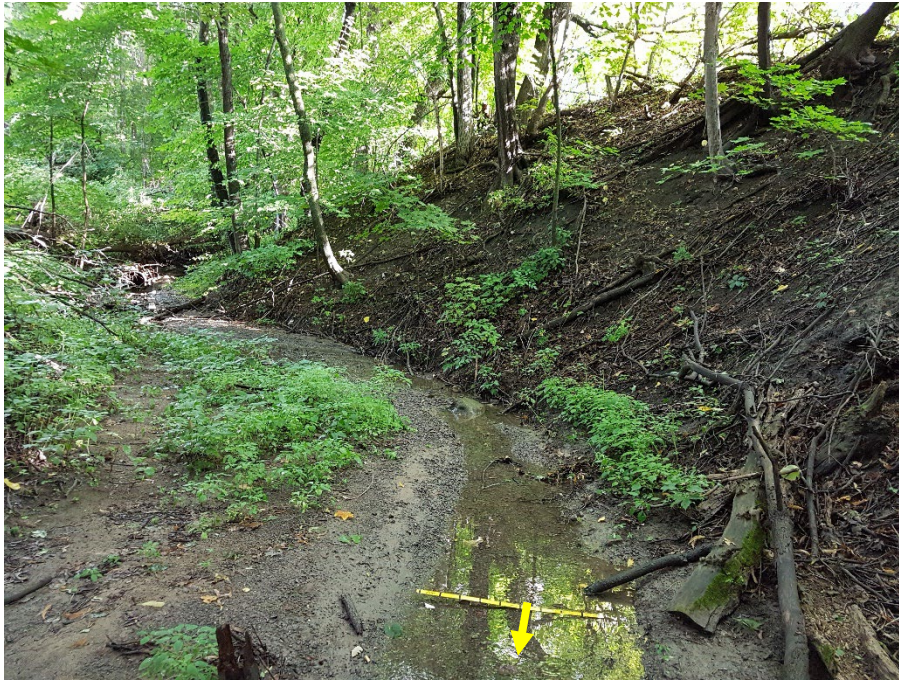
Channel flowed along the toe of slope. Minor channel adjustment and fallen trees were observed. There was no evidence that fallen trees were associated with channel adjustment.

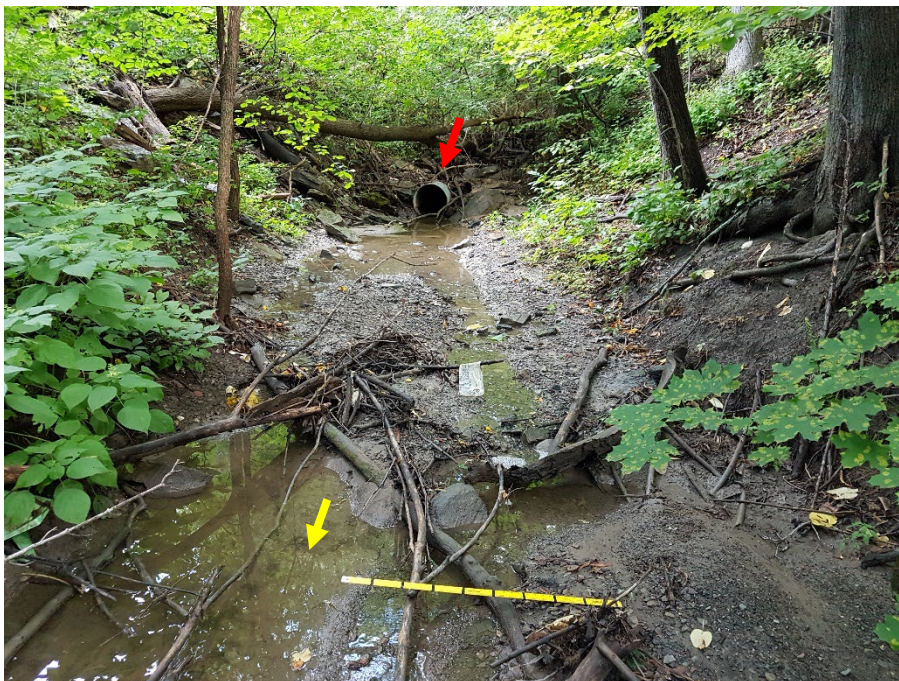
Flows conveyed through a compromised corrugated steel pipe that appeared overtopped during larger flows; however, erosion was not an issue.

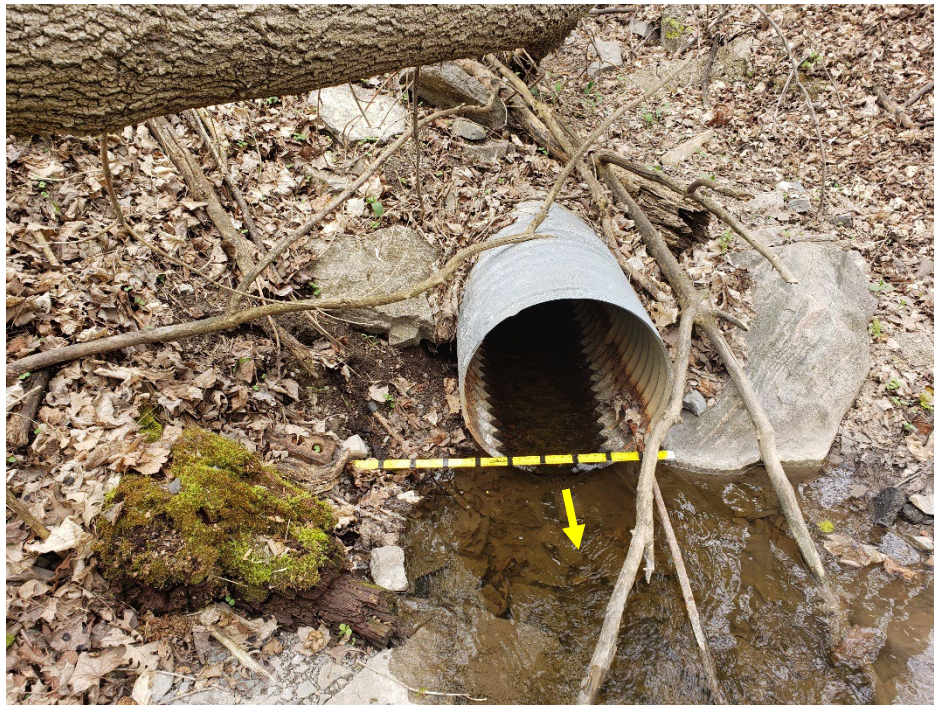
Downstream end of damaged corrugated steel pipe culvert (also pictured in Photo 36). Recent disturbance to the ravine was evident through the placement of fill near the top of slope to the west and debris on the slopes.

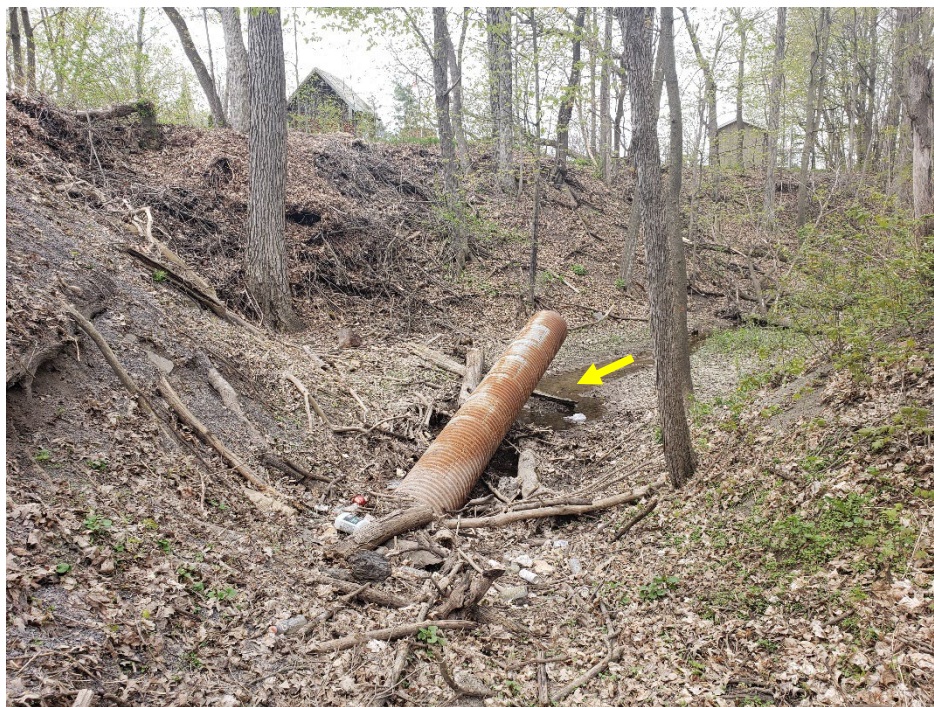
View of damaged CSP with the inlet suspended approximately 0.9 m above the channel. Flows appear to enter the culvert through hole(s) approximately midway in the structure.

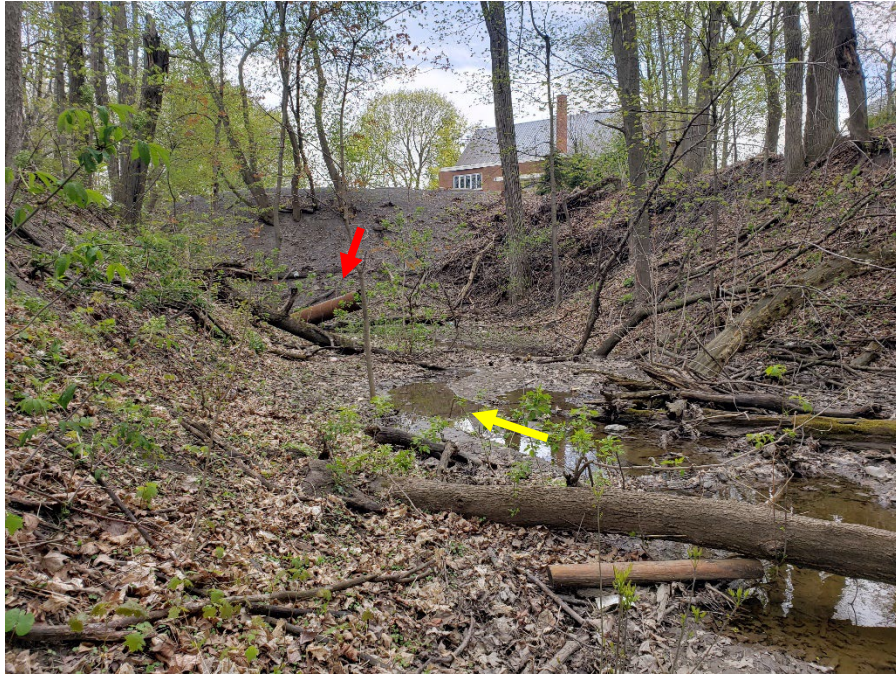
View of the ravine adjacent to the church where the channel was poorly defined and the majority of trees on the slope were upright. The location of the damaged CSP culvert is shown by the red arrow.

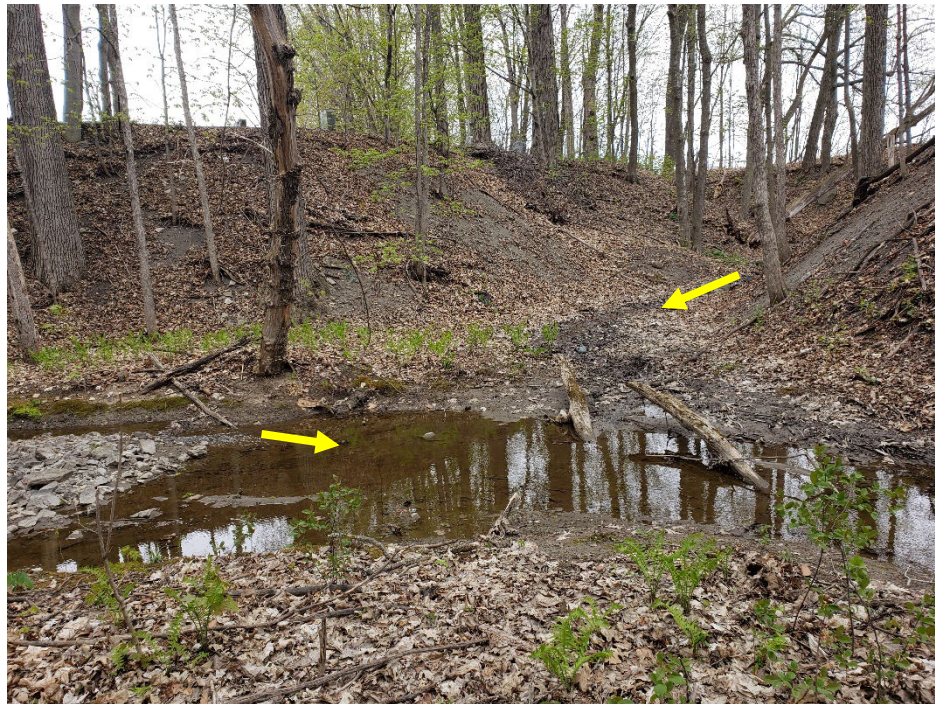
View of the confluence of CR-2 and CR-2a

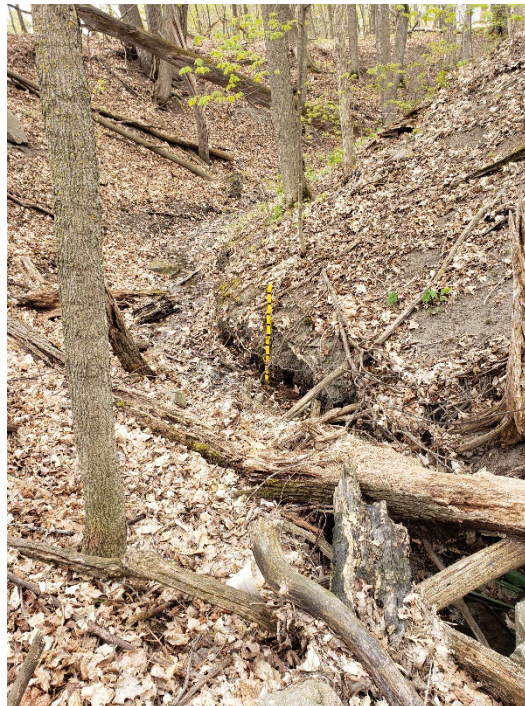
Evidence of relatively minor channel adjustment along the toe of the slope with undercuts measuring to approximately 0.1 m. This area was located on the bank opposite the proposed development and is therefore not considered to pose a hazard.

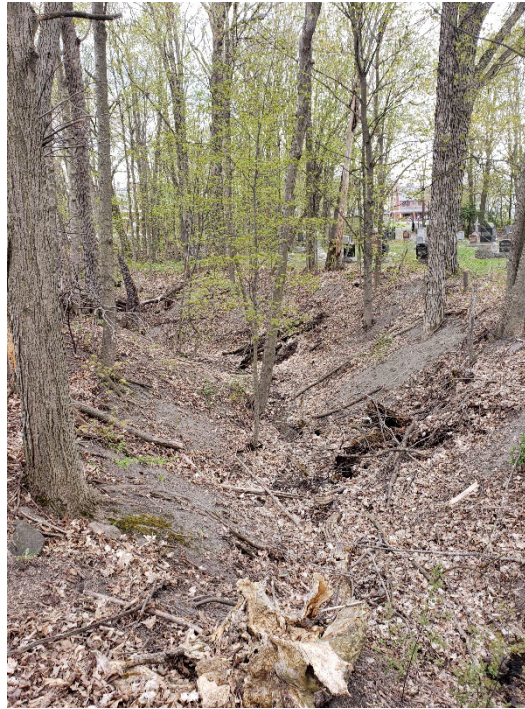
Downstream view of the upstream extent of the reach.

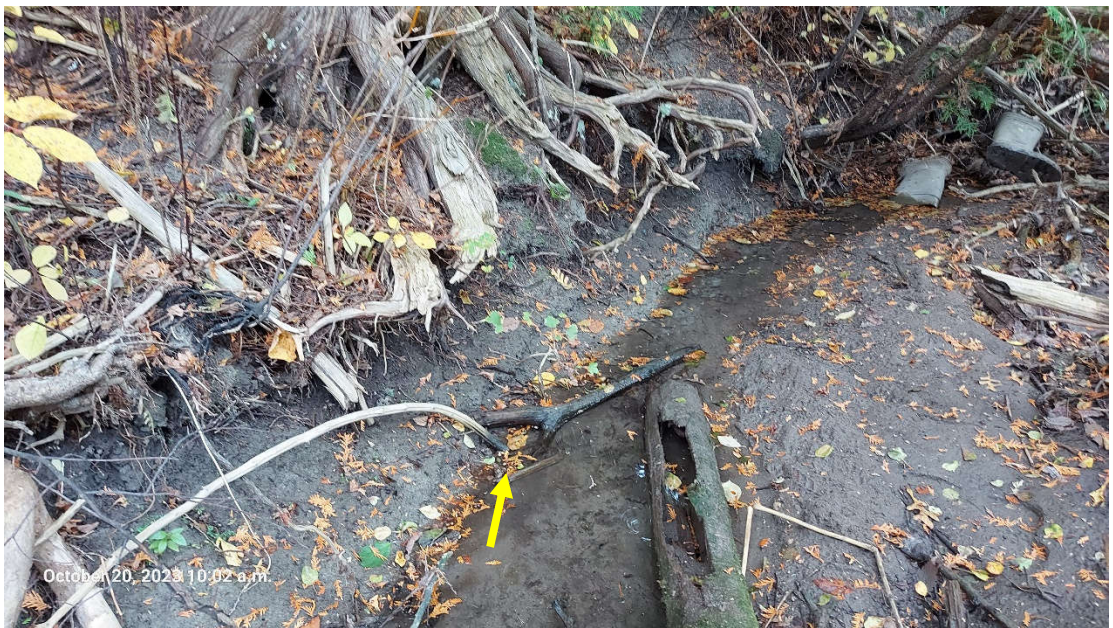
Photograph taken at **Site 9b** during Fall 2023 site visit. The channel bed and banks were composed of fine materials. Minor sediment deposition was observed along the right bank.

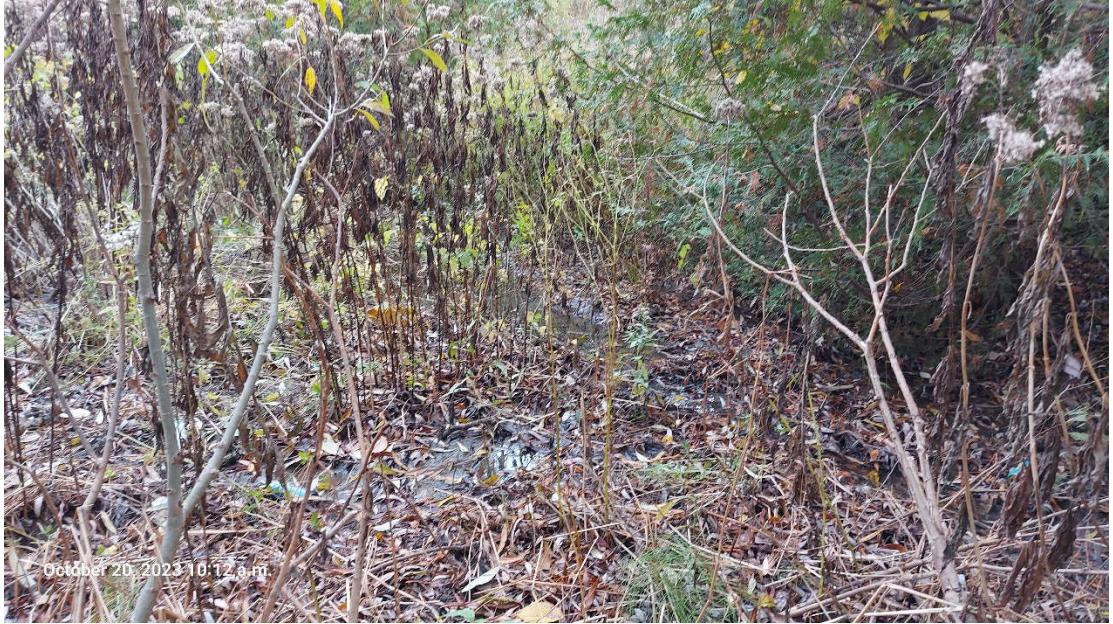
Photograph taken between **Sites 9b** and **8**. A large depositional zone was identified with measurements of up to 0.4 m of sediment accumulation. The channel lost definition and multiple flow paths were present downstream of the zone.

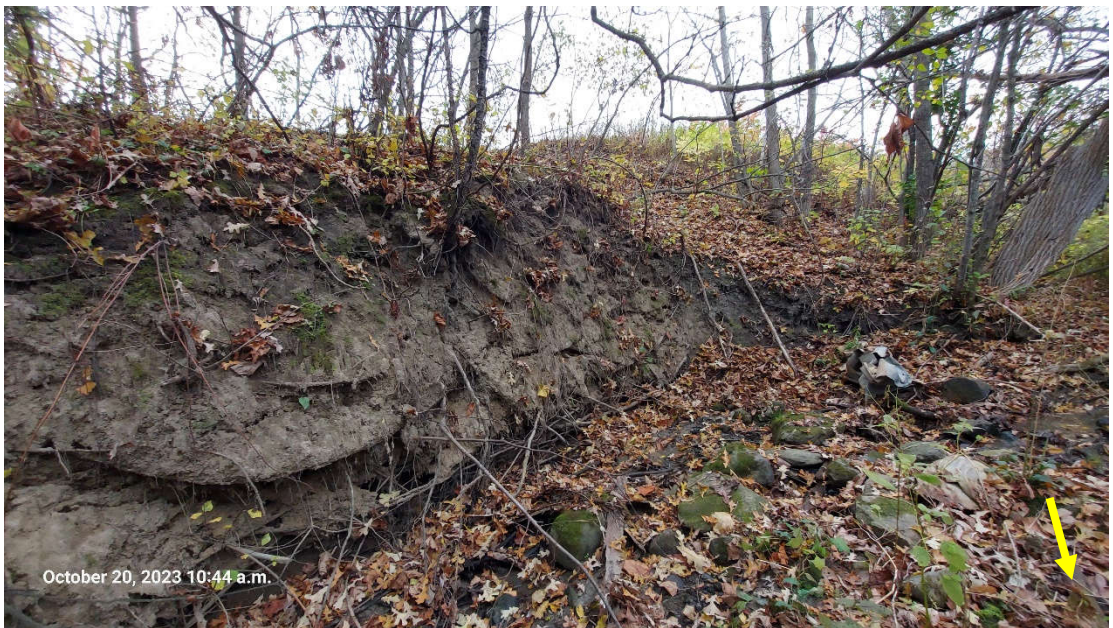
Photograph taken at **Site 5** during the Fall 2023 site visit. Channel bed was composed of fine materials up to large angular cobble. The channel bank was composed of fine materials. A few relatively small 'J' hooked trees were observed at the top of the cutbank.

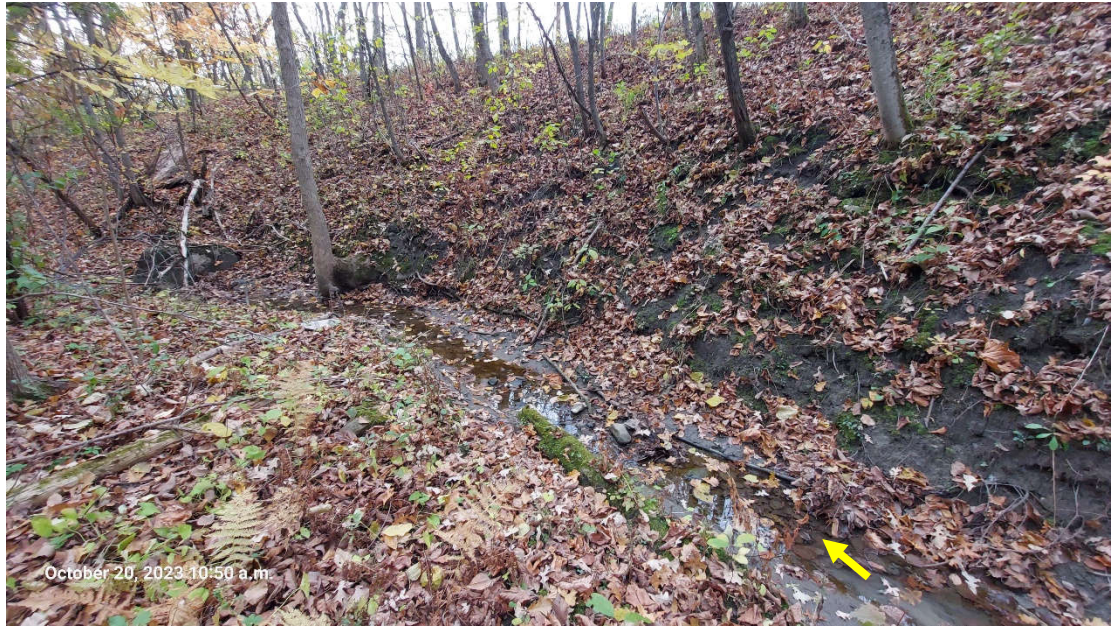
Photograph taken at **Site 4** during the Fall 2023 site visit. Channel bed and bank materials were composed of fine materials. Well established pool-riffle features were located up and downstream of the site.

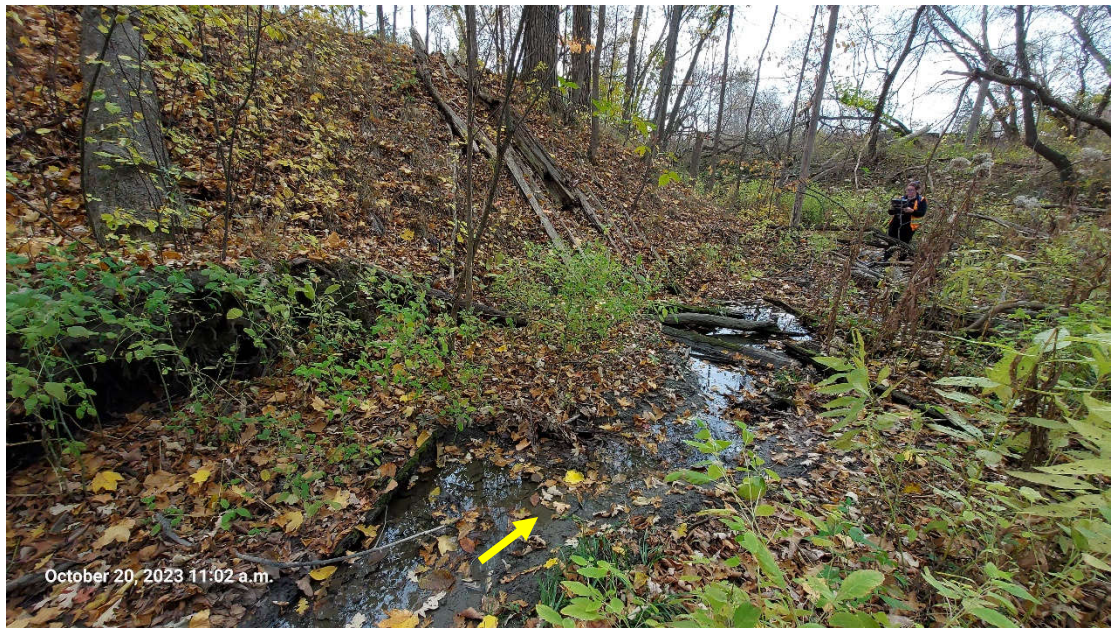
Photograph taken at **Sites 2 and 3** during the Fall 2023 site visit. Little bank erosion was observed; however, zones of deposition (up to 0.3 m) were present within the channel. Woody debris was common in this portion of the reach.

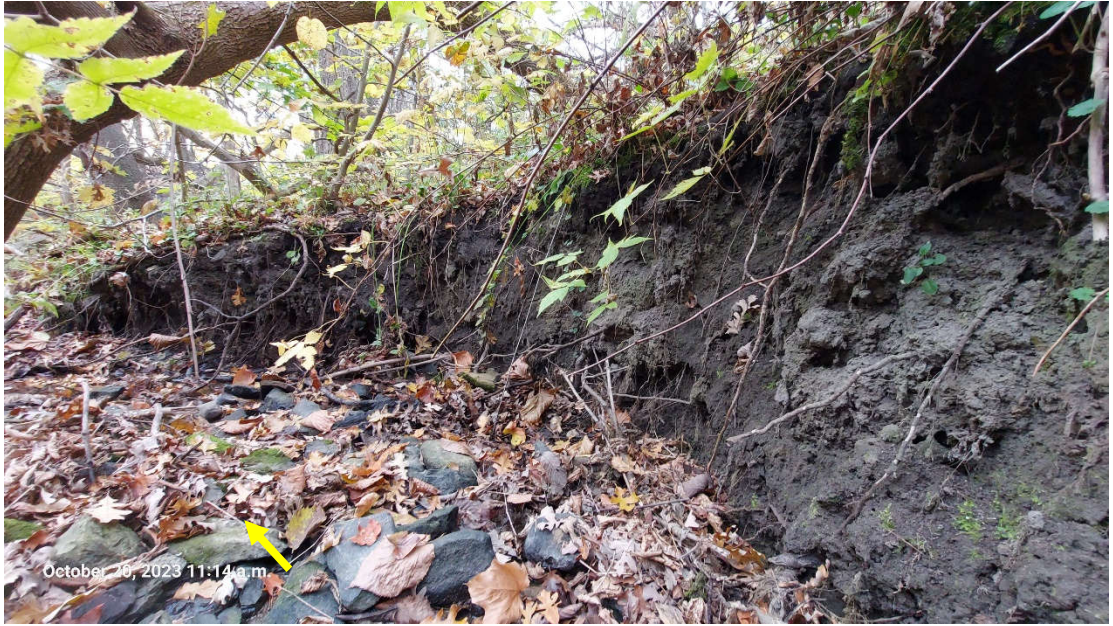
Photograph taken on the right bank of **Site 1** during the Fall 2023 site visit. The channel bed was composed of angular cobble, and the banks were composed of fine materials. An accumulation of riprap in the center of the channel had diverted flows, which were eroding the left and right bank at this site.

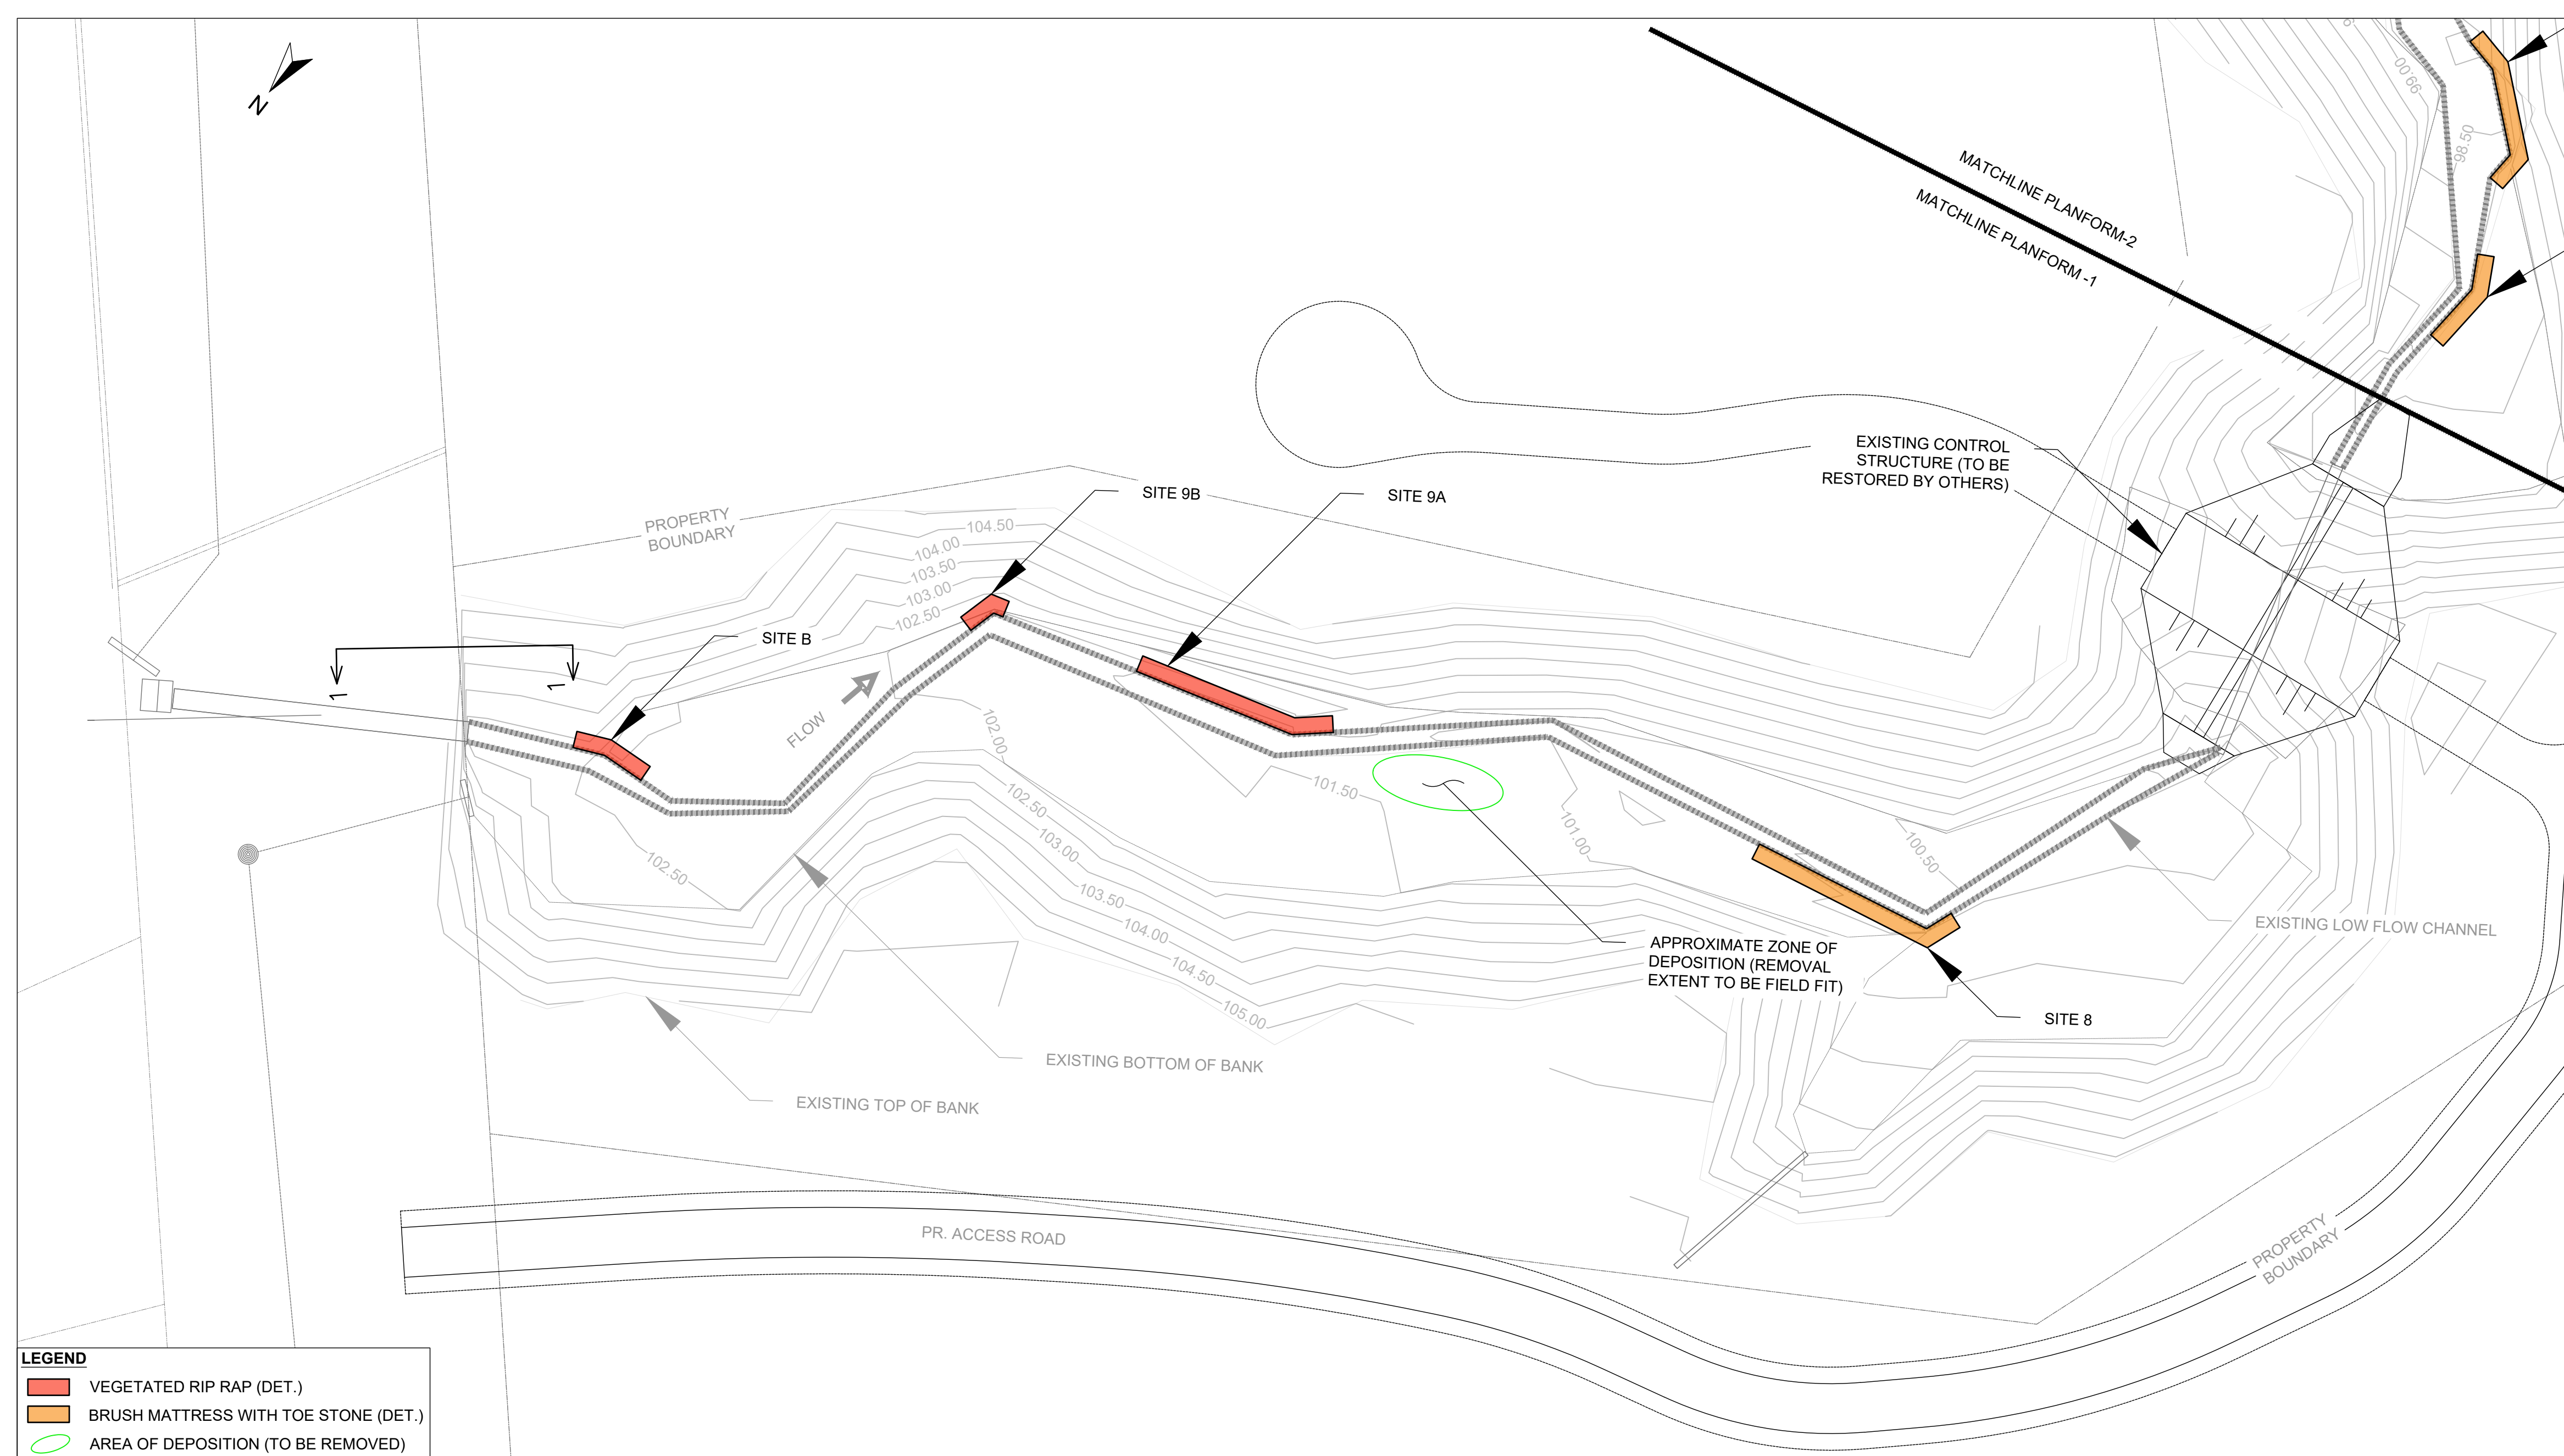
PROJECT No.: 23100 DRAWING No.: GEO-1
 SCALE: AS NOTED SHEET 1 OF 4
