January 20, 2026

Department of Planning, Development and Building Services (PDBS)
 City of Ottawa
 110 Laurier Avenue West
 Ottawa, ON K1P 1J1

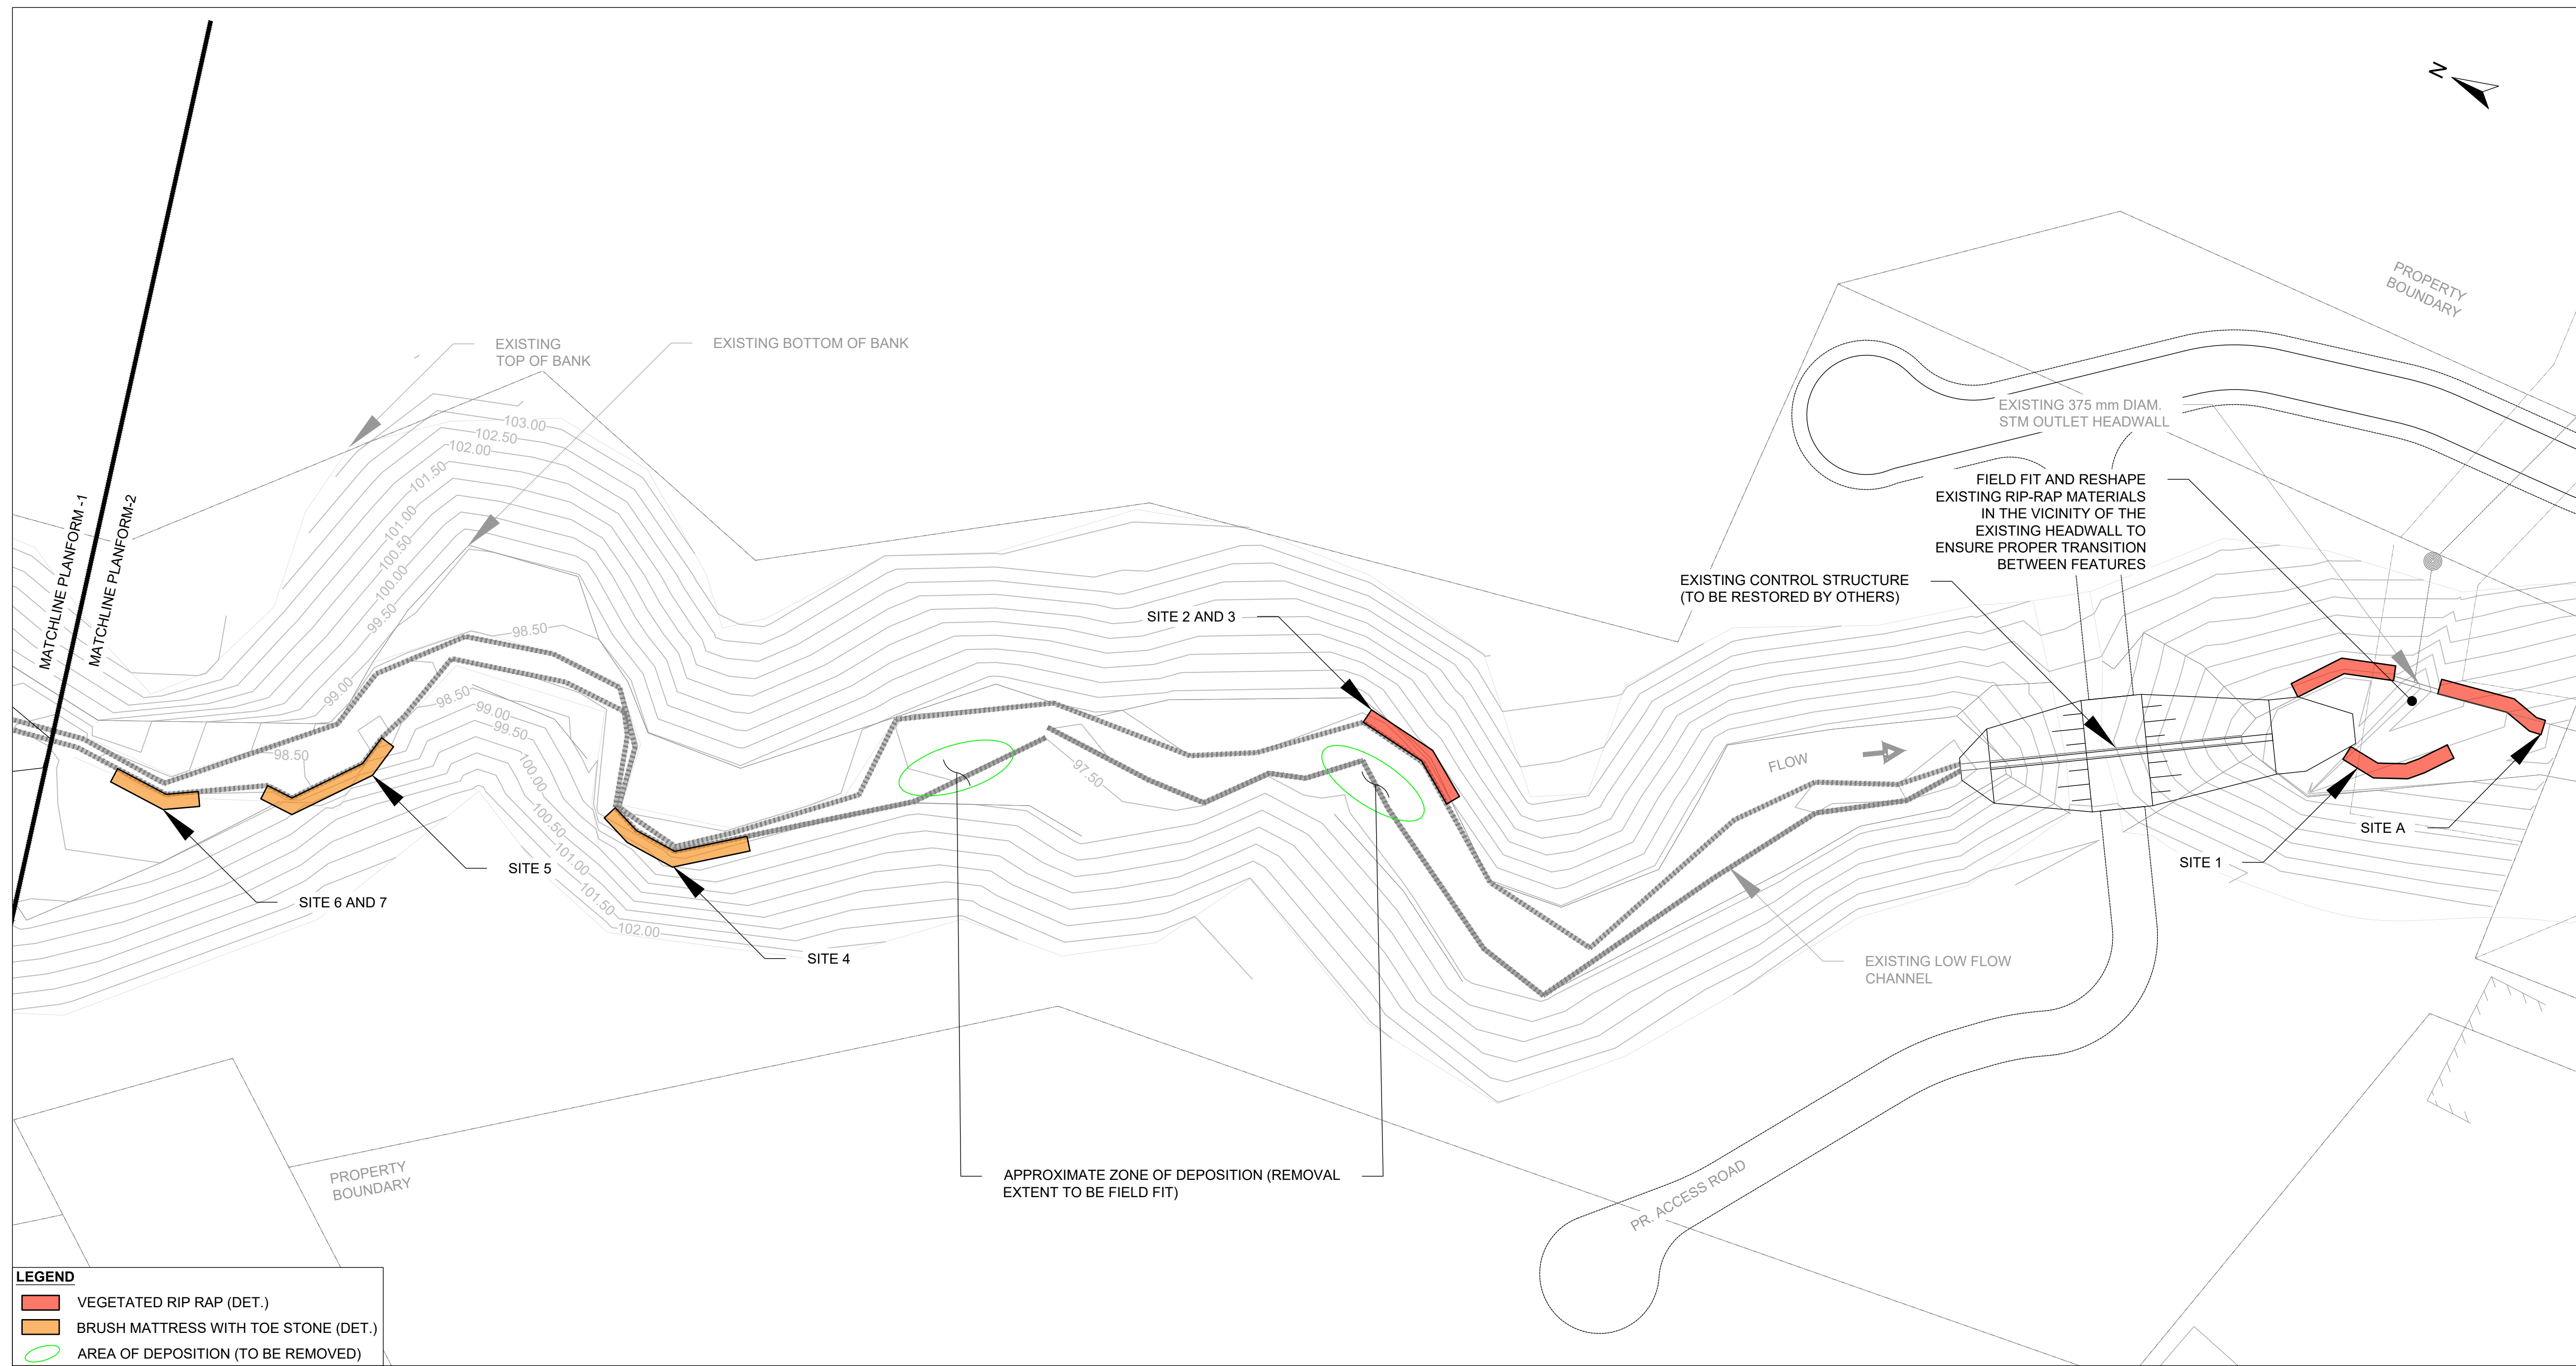
PROJECT No.: 23100 DRAWING No.: GEO-2
 SCALE: AS NOTED SHEET 2 OF 4

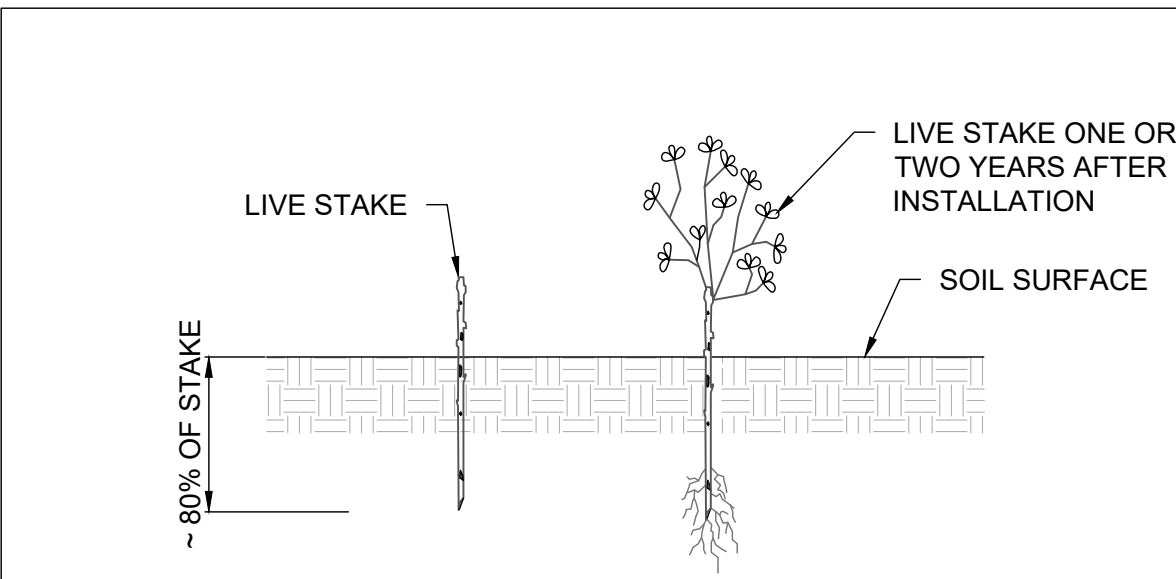
SPECIES AND QUANTITIES

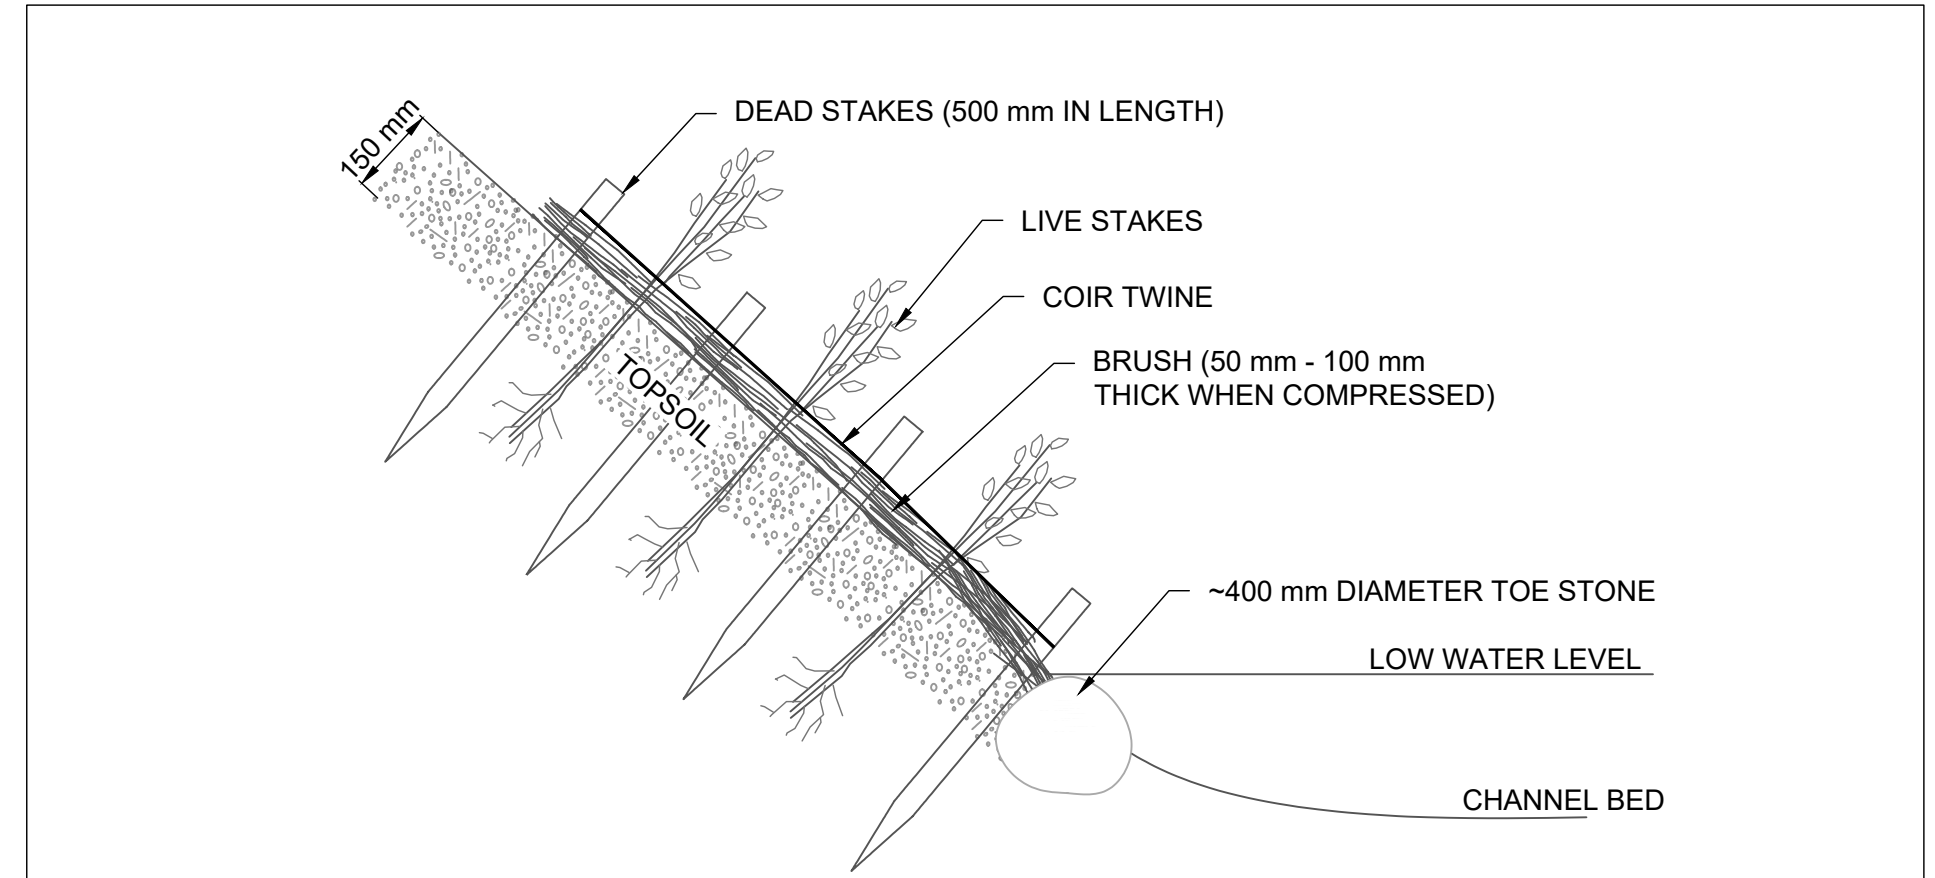
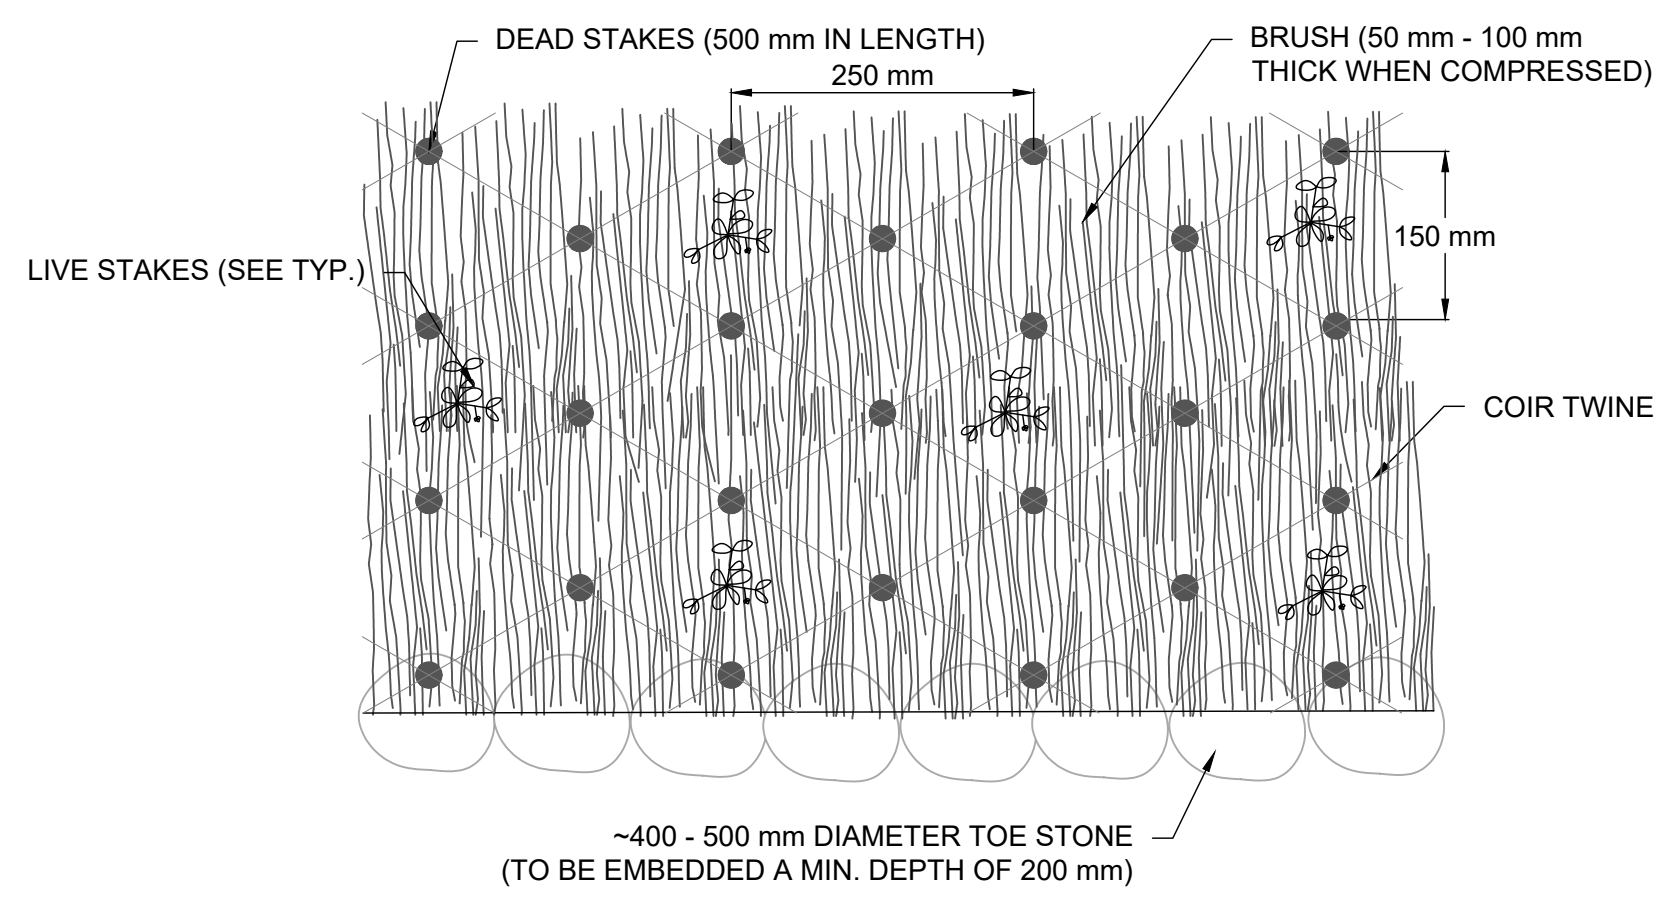
- NOTES**
- LIVE BRANCHES TO CONSIST OF WILLOW AND DOGWOOD SPECIES, APPROXIMATELY 1 m IN LENGTH AND 50 mm - 100 mm IN WIDTH.
 - BRANCHES TO BE KEPT IN MOIST AND COLD UNTIL INSTALLATION.
 - BRUSH MATTRESS TO BE INSTALLED WHILE BRANCHES ARE DORMANT.
 - BRANCHES TO BE PLACED ON SLOPE WITH BUTT END TOWARDS VALLEY FLOOR AND PUSHED INTO SOIL.
 - BRANCHES MUST BE FLEXIBLE ENOUGH TO CONFORM TO THE SLOPE SURFACE IRREGULARITIES.
 - POUND DEAD STAKES TO HALF THEIR LENGTH INTO SOIL BETWEEN BRANCHES. TIE COIR TWINE AROUND DEAD STAKES AND TIGHTLY OVER BRANCHES. USE A CLOVE HITCH TO SECURE STAKES. POUND STAKES INTO SLOPE TO COMPRESS BRANCHES AGAINST GROUND.
 - TAMP LIVE STAKES BETWEEN DEAD STAKES.
 - FILL VOIDS BETWEEN BRANCHES OF THE BRUSH MATTRESS WITH SOIL TO PROMOTE ROOTING.

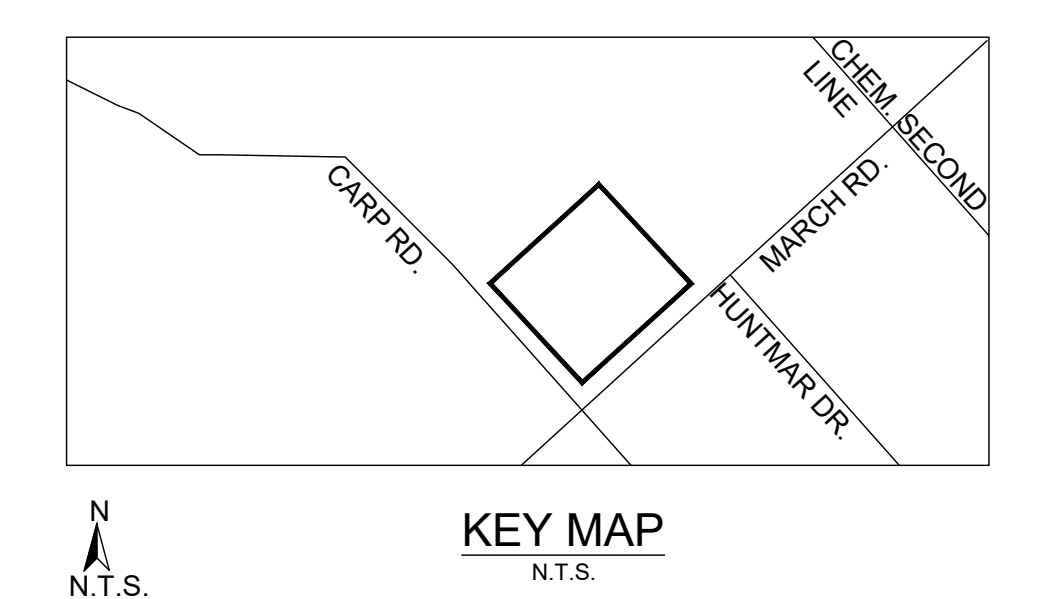
BRUSH MATTRESS
N.T.S.

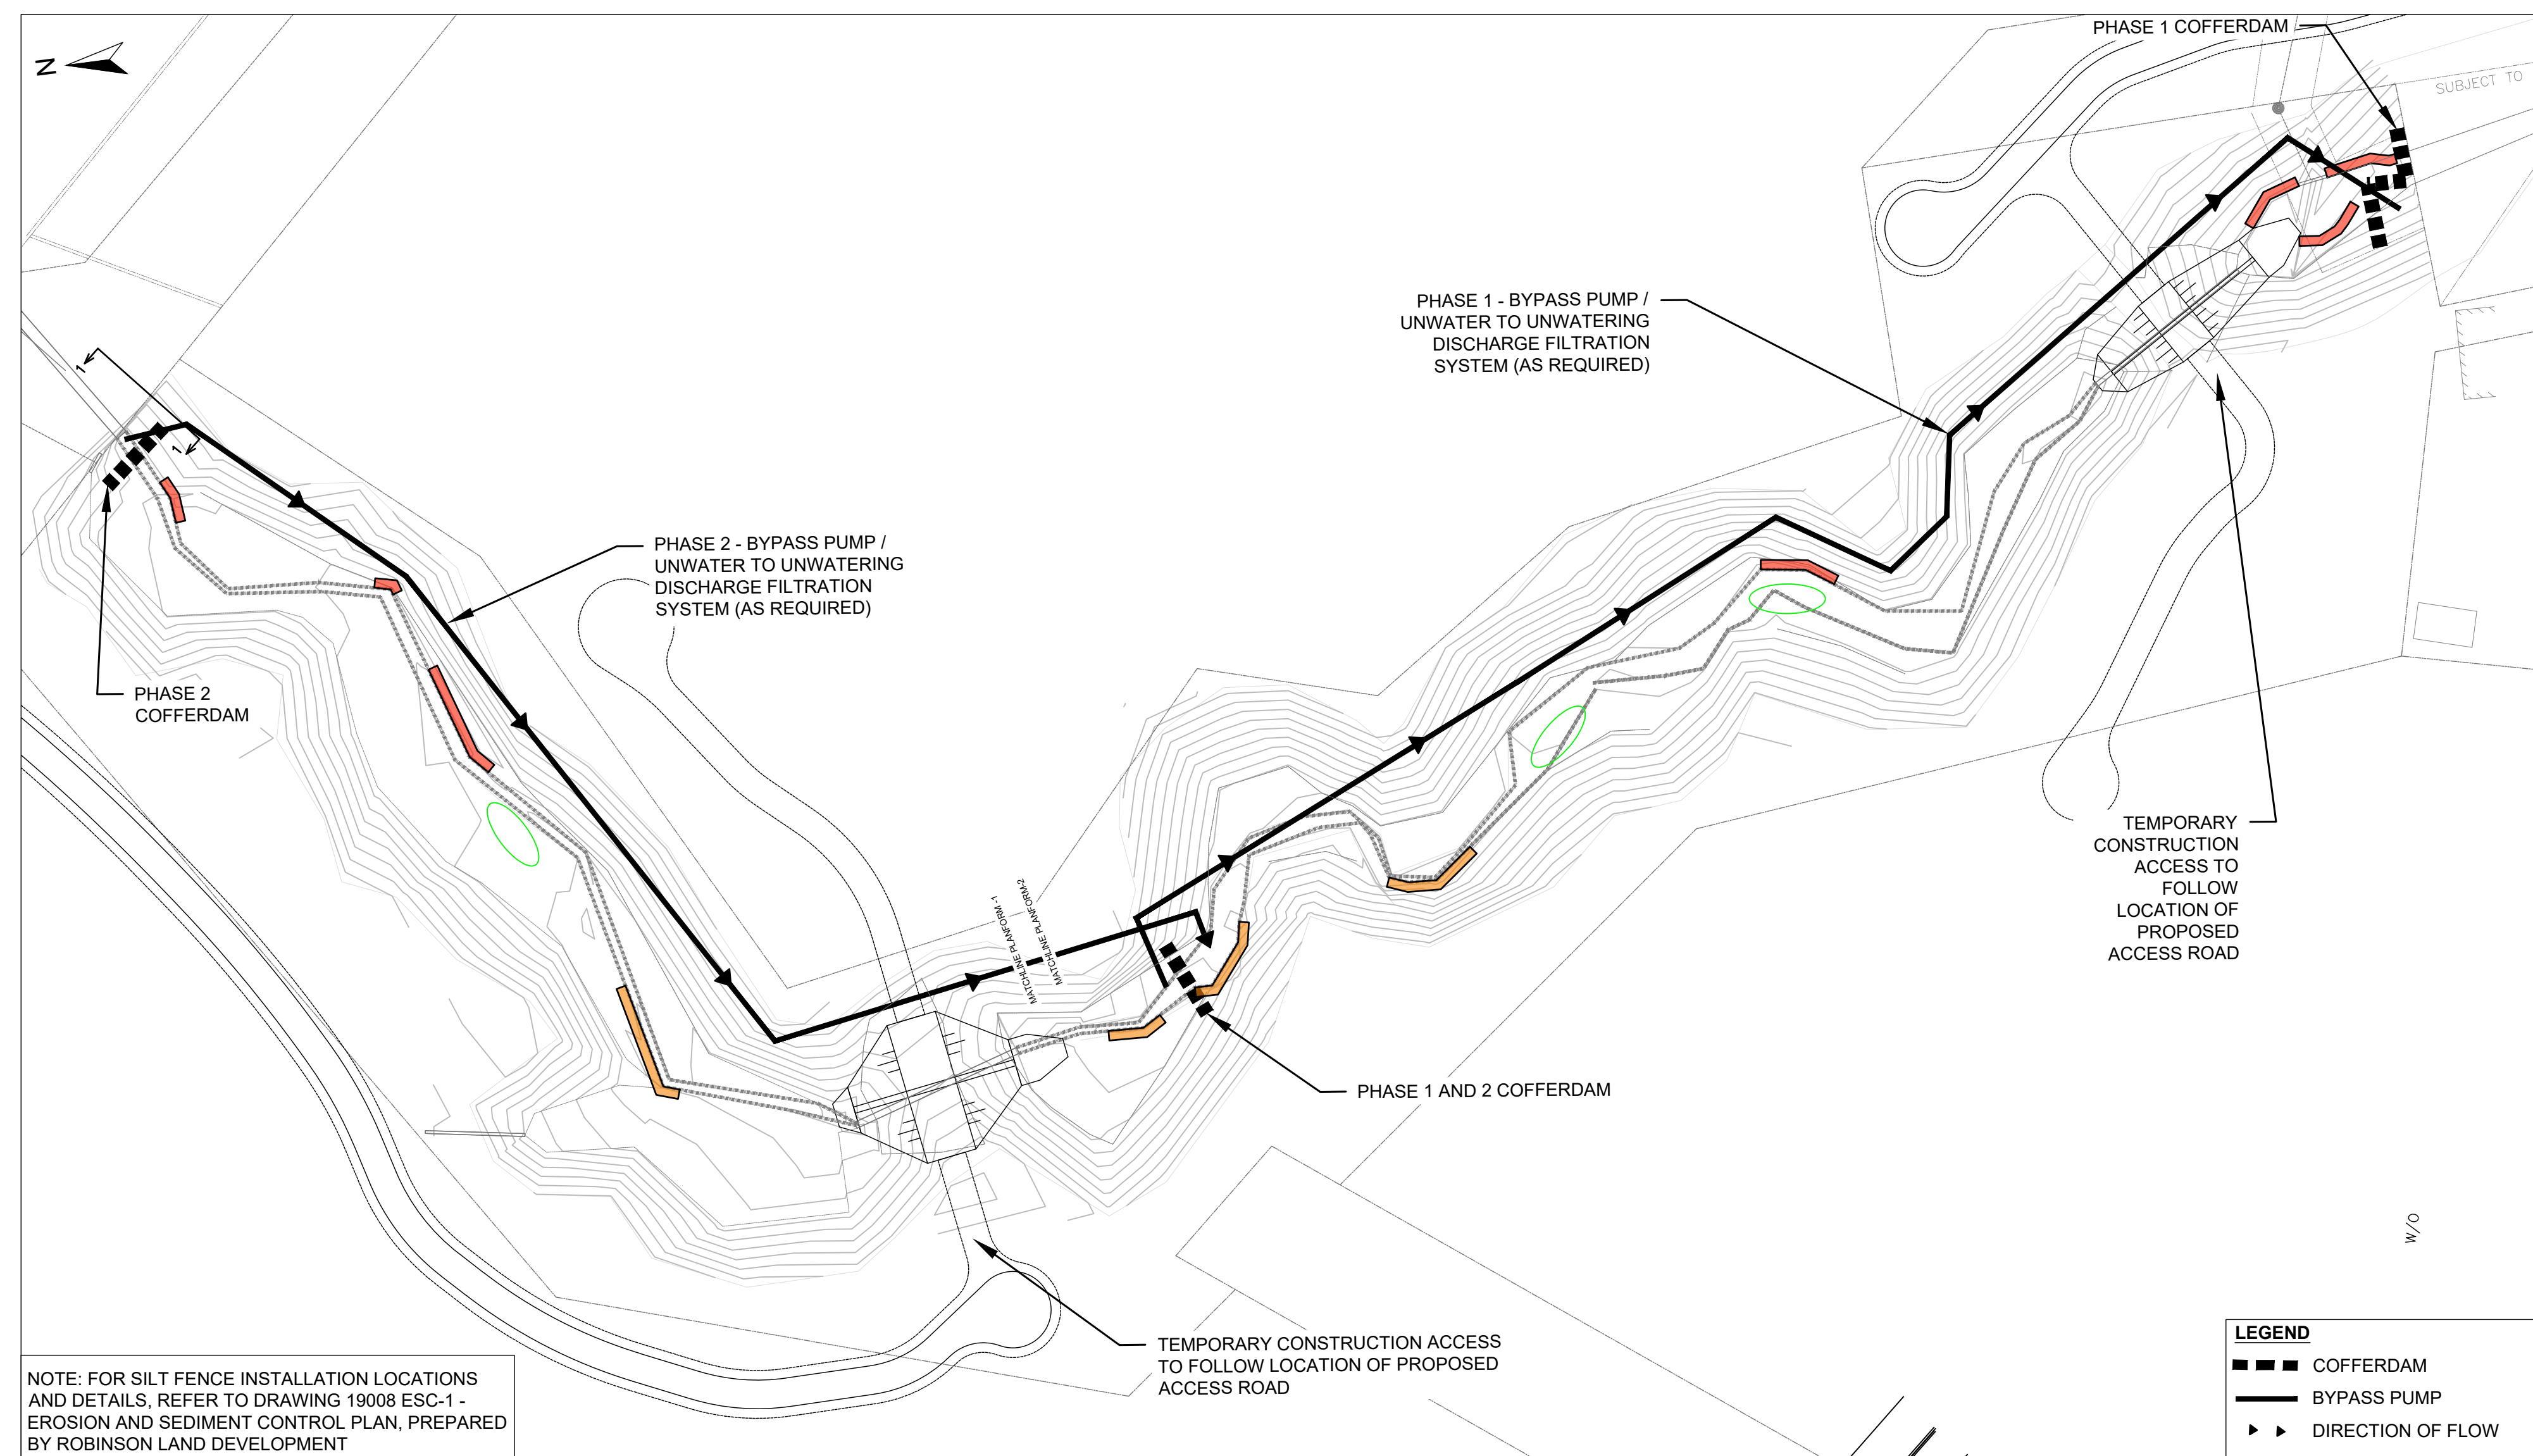
NOTE: FOR SILT FENCE INSTALLATION LOCATIONS AND DETAILS, REFER TO DRAWING 19008 ESC-1 EROSION AND SEDIMENT CONTROL PLAN, PREPARED BY ROBINSON LAND DEVELOPMENT

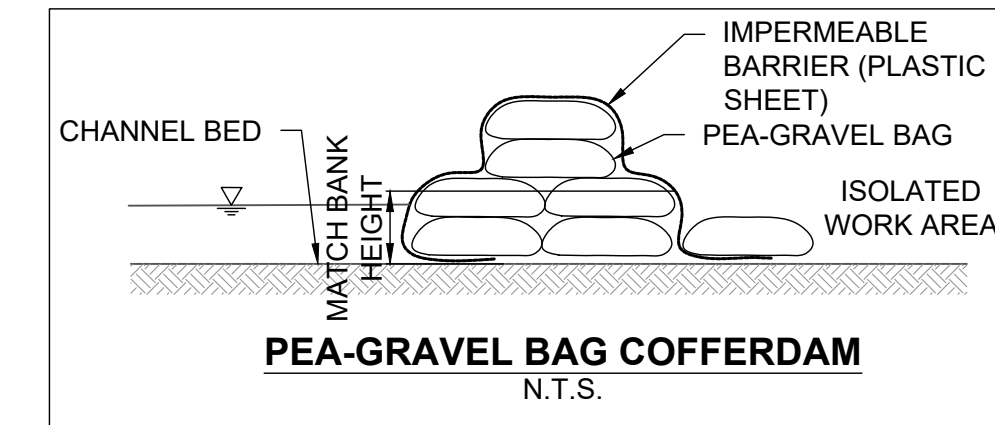
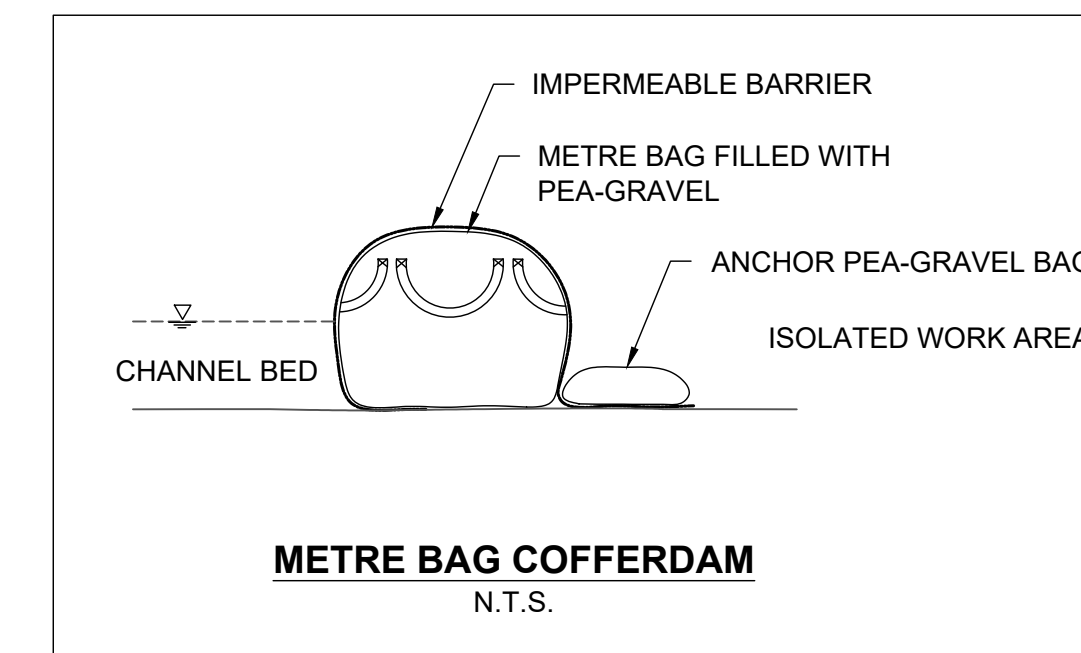
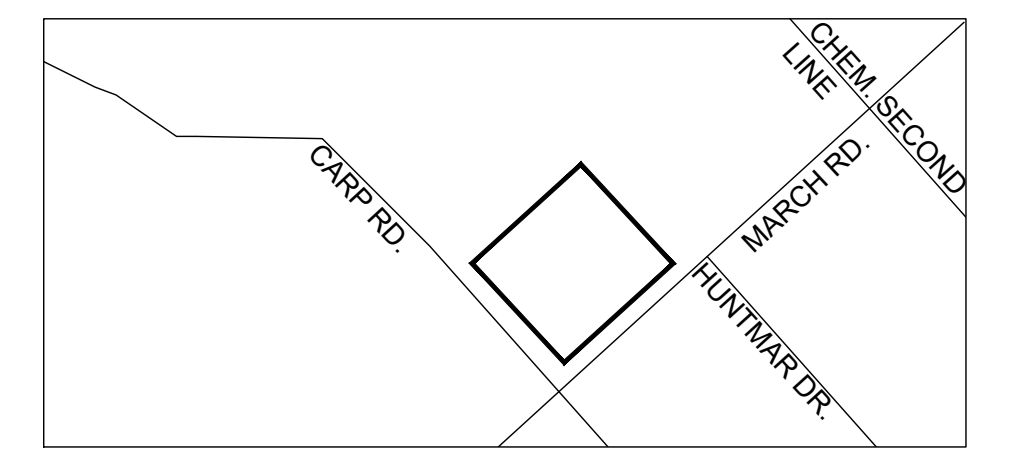
4. BIODEGRADABLE OR TAPERED WOODEN STAKES SHALL BE USED TO SECURE THE BLANKET. STAKES SHALL BE INSTALLED AT THE SPACING RECOMMENDED BY THE ECB MANUFACTURER TO PREVENT SURFACE RUNOFF FROM ERODING THE UNDERLYING SOIL.

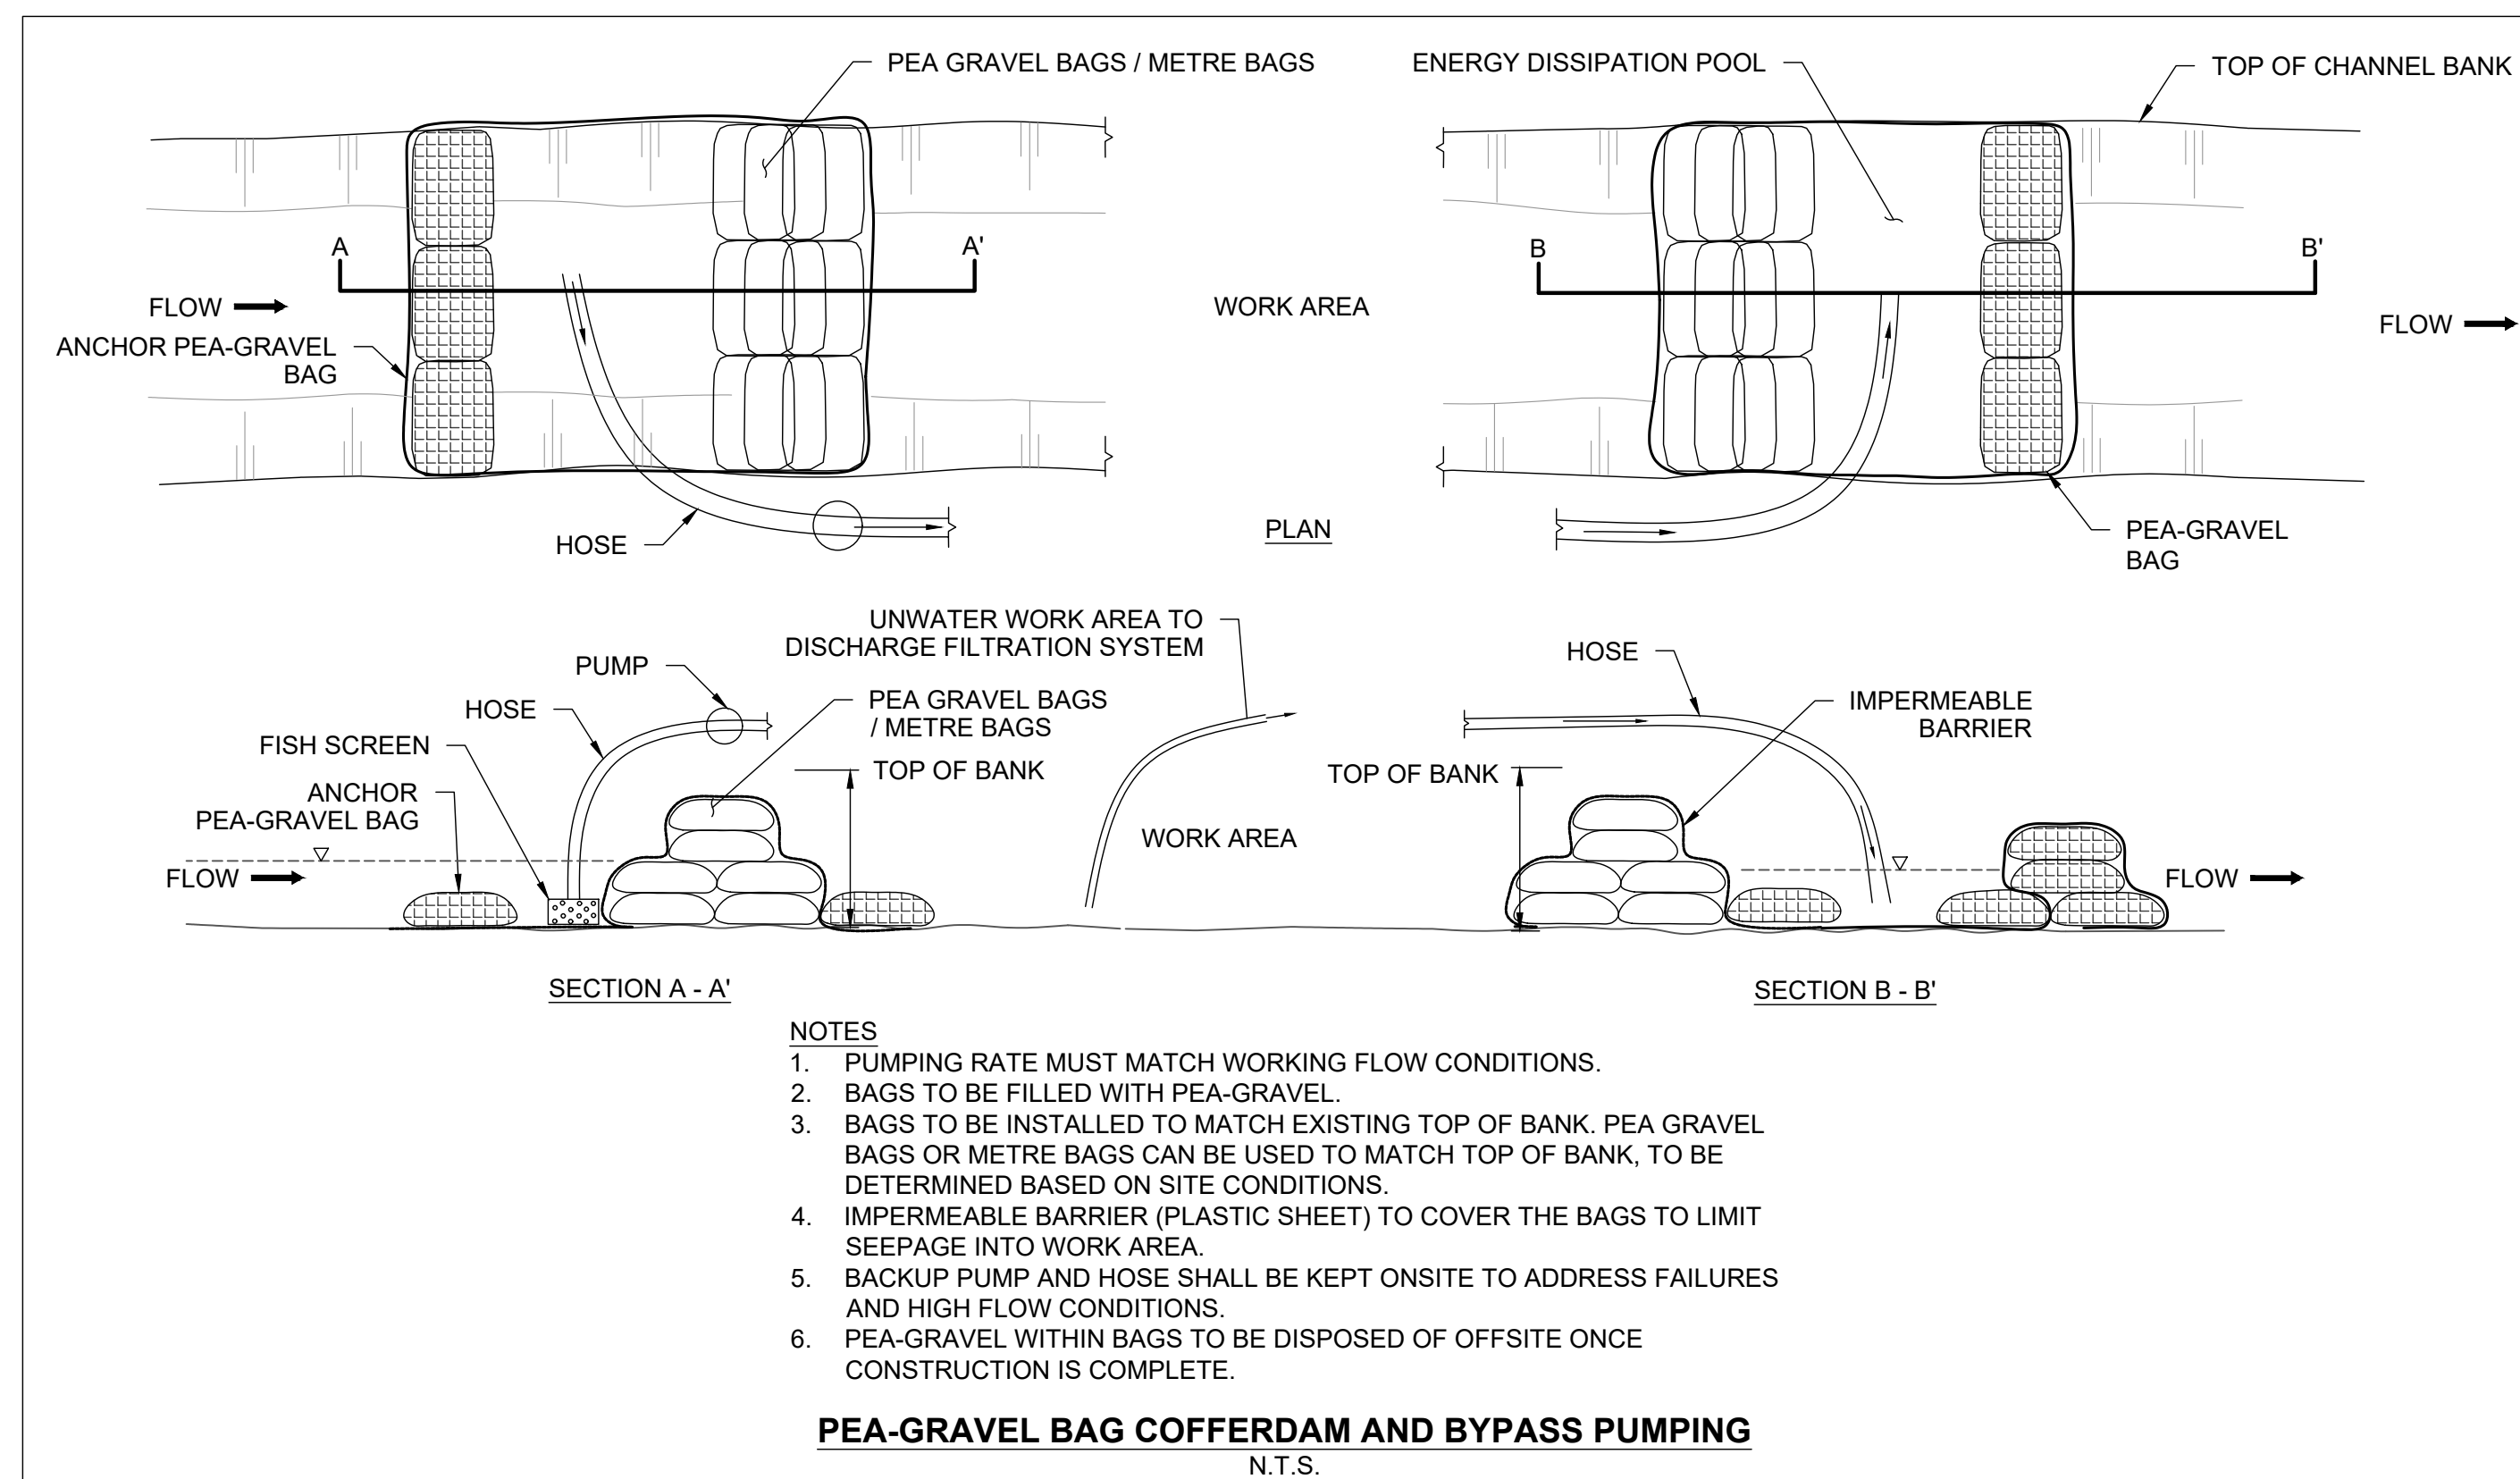
- NOTES**
1. PUMPING RATE MUST MATCH WORKING FLOW CONDITIONS.
 2. BAGS TO BE FILLED WITH PEA-GRAVEL.
 3. BAGS TO BE INSTALLED TO MATCH EXISTING TOP OF BANK. PEA GRAVEL BAGS OR METRE BAGS CAN BE USED TO MATCH TOP OF BANK, TO BE DETERMINED BASED ON SITE CONDITIONS.
 4. IMPERMEABLE BARRIER (PLASTIC SHEET) TO COVER THE BAGS TO LIMIT SEEPAGE INTO WORK AREA.
 5. BACKUP PUMP AND HOSE SHALL BE KEPT ONSITE TO ADDRESS FAILURES AND HIGH FLOW CONDITIONS.
 6. PEA-GRAVEL WITHIN BAGS TO BE DISPOSED OF OFFSITE ONCE CONSTRUCTION IS COMPLETE.
