Tree Conservation Report

Cisco Ottawa Campus – 2000 & 3000 Innovation Drive

December 8, 2025

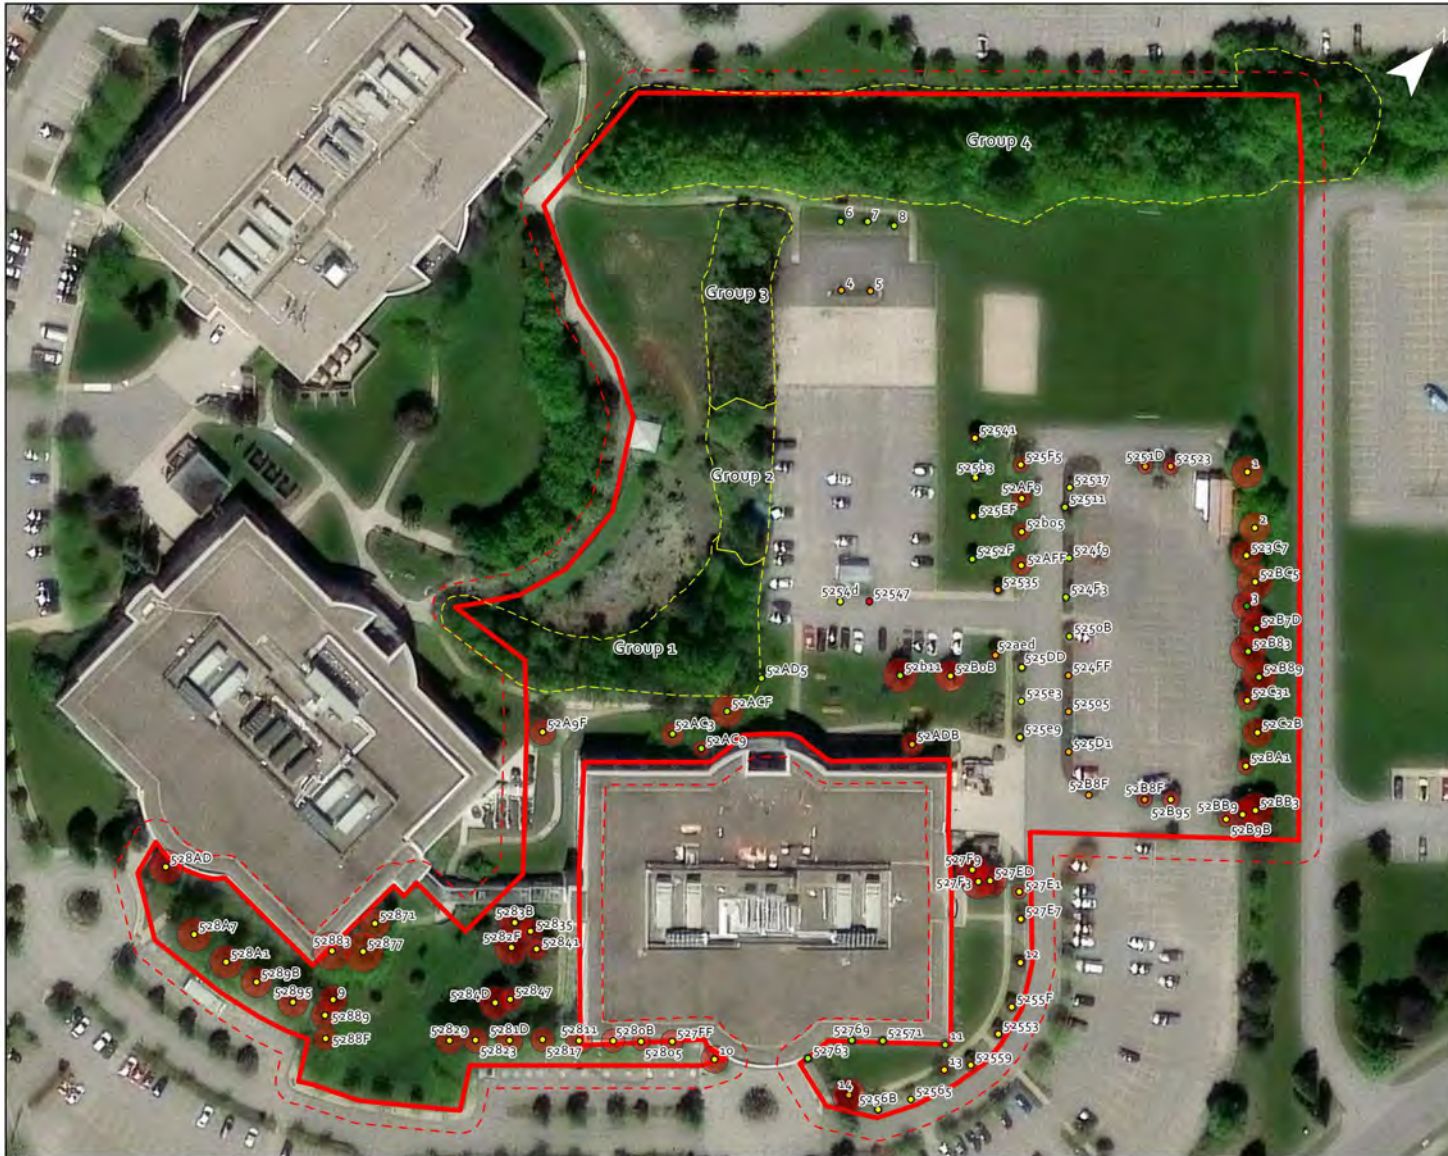
Project Name:	
Cisco OTT Campus: Tree Conservation Report	
Title:	
Current Vegetation (Map 1 as per City Guidelines)	
Prepared By:	
<small>Design & Consultancy for natural and built assets</small>	
Project: 30270525	Figure: 2
Date: 12/8/2025

A total of 101 individual trees and four groups were assessed as part of this inventory. The condition of the trees on Site ranged from Very Good to Poor, approximately 85% of which were in Very Good to Good condition. The most common species are Honey-Locust (46%), Norway maple (8%), Little Leaf Linden (8%), and White Spruce (7%).

There are 33 trees that meet the definition of a 'Distinctive Tree' as per Tree Protection By-law No. 2020-340 (any tree located on private property with a DBH of 30 cm or greater, within the inner urban area). Trees 52B0B and 52B11 are Distinctive trees that require removal based on the current design plans.

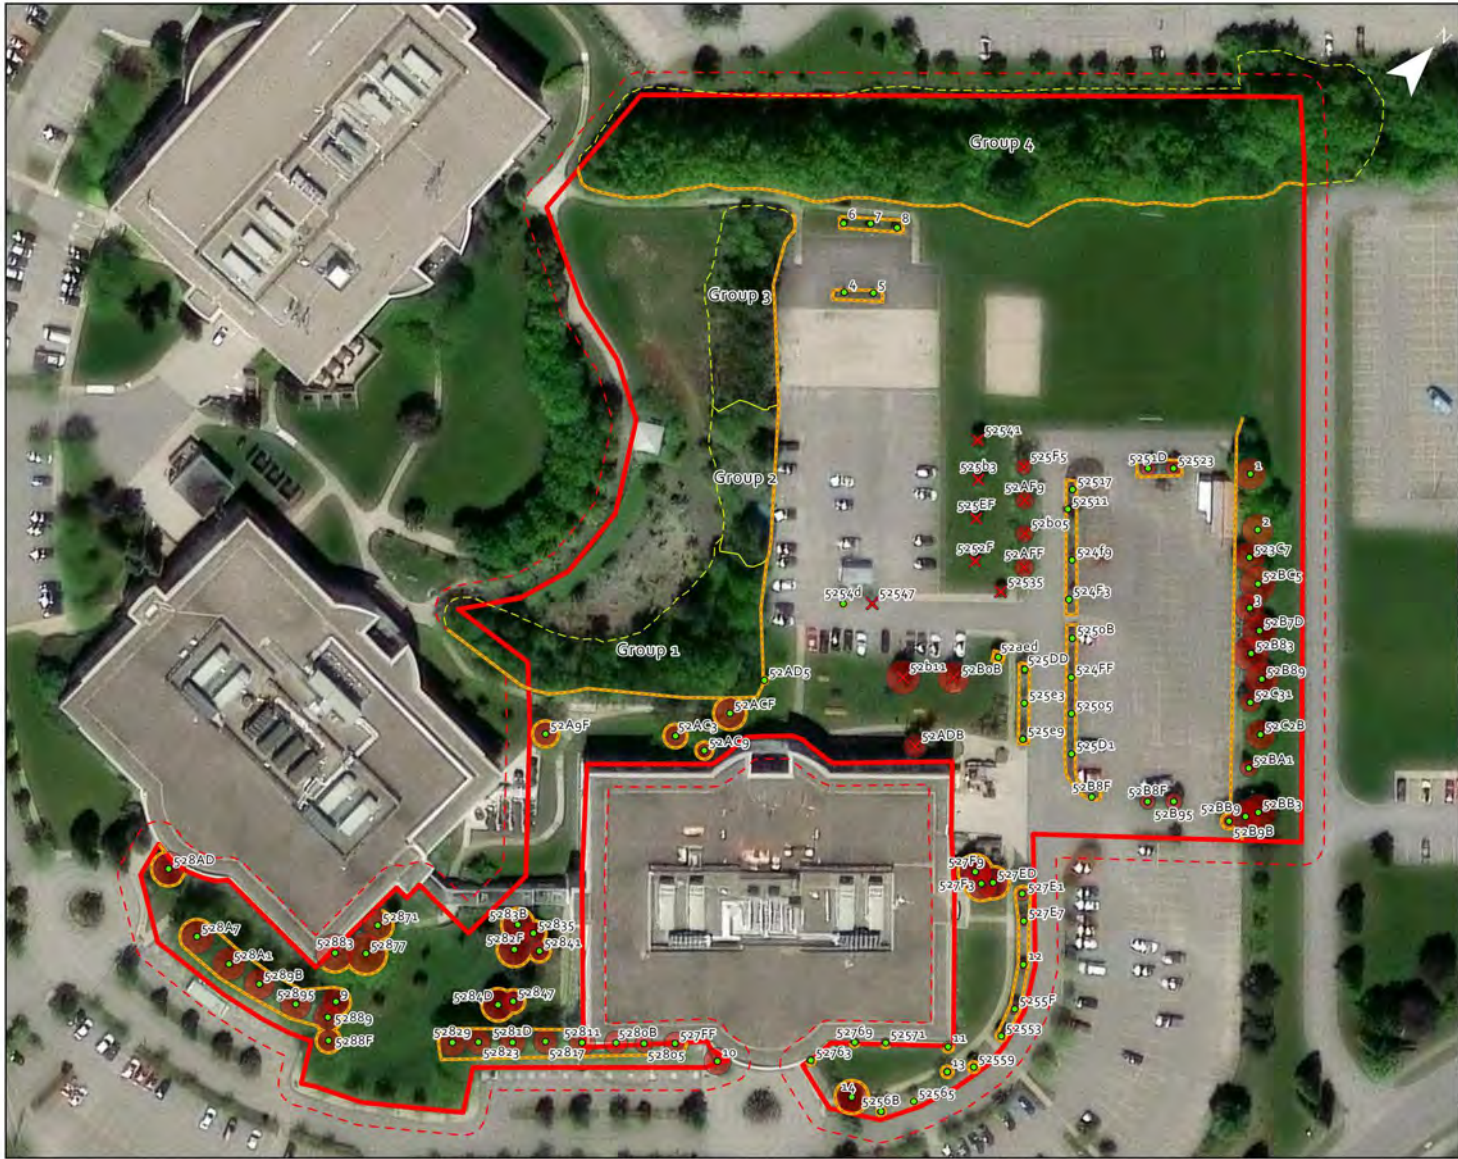
Project Name:	
Cisco OTT Campus: Tree Conservation Report	
Title:	
Recommended Actions (Map 2 as per City Guidelines)	
Prepared By:	
Design & Consultancy for natural and built assets	
Project: 30270525	Figure: 3
Date: 12/8/2025

Based on the conditions of the trees and extent of the proposed construction limits, **Table 2** summarizes the impact and recommended actions of the 101 trees and four (4) tree groups assessed within the Site. It is anticipated that 13 trees >10 cm diameter at breast height (DBH) will need to be removed. These details are depicted on Mandatory Map 2 below, as per the City of Ottawa, 2021, and outlined in the Tree Inventory and Assessment Table included in **Appendix A**.

Trees to be Removed	Trees to be Retained
13	88

Based on the proposed project design and existing conditions of the trees on site, 13 trees have been recommended for removal. The following recommendations are provided:

- Retain a Certified Arborist during site layout operations to confirm recommended tree removals, pruning, and tree protection fencing in proximity to the construction limits.
