Tree Conservation Report Addendum submitted as  
Partial Requirements for a Site Plan Control Application,  
August 25, 2026

Application: D02-02-26-0012 (Minor ZBLA) and D07-  
12-26-0014 (SPC)

TREE CONSERVATION REPORT ADDENDUM 4.0

71 Russell Ave

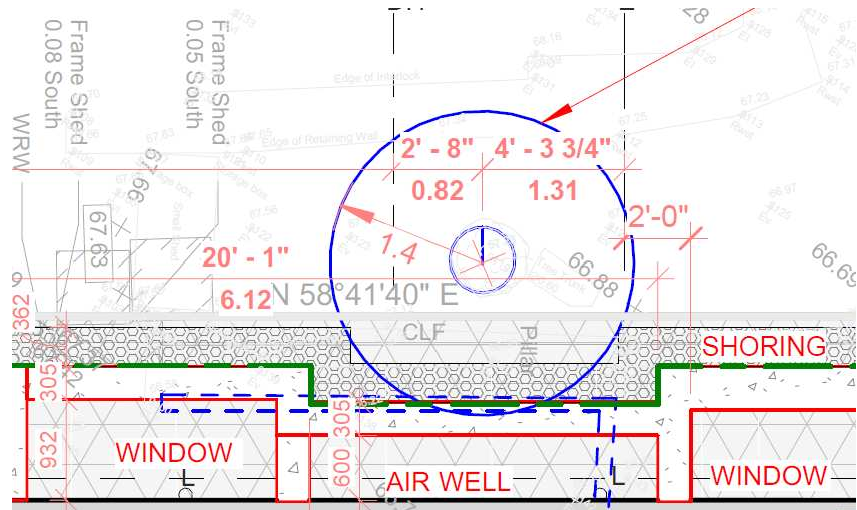
The project team has redesigned the wall to include a notch around the tree that relocated the shoring and proposed retaining wall to follow the path of the previous wooden wall, which followed the extent of the roots on the subject property immediately adjacent to the tree. The image below shows the updated site plan that includes the surveyed location of the tree and the location of the old wooden wall (extent of roots) as the dashed blue line. The green line represents the extent of excavation via shoring. This notching also demonstrates how the roots beyond the elbow of the old wall that will be severed as part of the shoring installation are outside of the static root zone, which is defined as three times the diameter of the tree. Although the diagram shows the measurement of the static root zone from the centre of the tree, the excavation is still outside of the static root zone if measured from the edge of the tree (an additional 23 cm).

Figure 1: Image of updated site plan with the surveyed location of tree 10 and proposed notch. The static root zone is shown in blue, the proposed excavation in green, and the old wooden wall in the hashed blue line

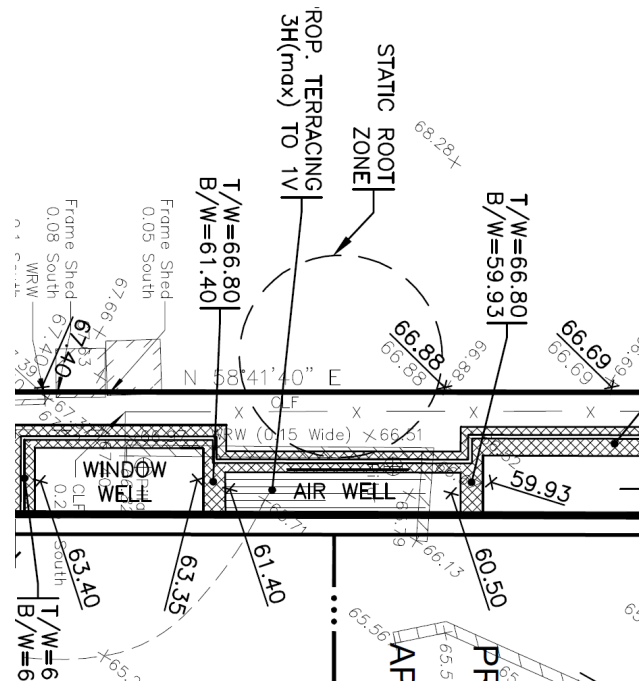
Figure 2: Updated grading plan to include the notch and surveyed location of tree#10
