TREE CONSERVATION REPORT  
ADDENDUM 2.1  
71 Russell Ave

Tree Conservation Report Addendum submitted as  
Partial Requirements for a Site Plan Control  
Application, May 29, 2026

Dendron Forestry Services

**Address:** 71 Russell Ave  
**Date of Report:** May 29, 2026  
**Date of Site Visit:** April 9, 2026  
**Prepared by:** Astrid Nielsen, RPF, ISA Certified Arborist®  
101- 45 Spencer Ave, K1Y 2P5  
[Astrid.nielsen@dendronforestry.ca](mailto:Astrid.nielsen@dendronforestry.ca)  
**Client:** Colin Miller, Colin@pinehillbuilders.ca

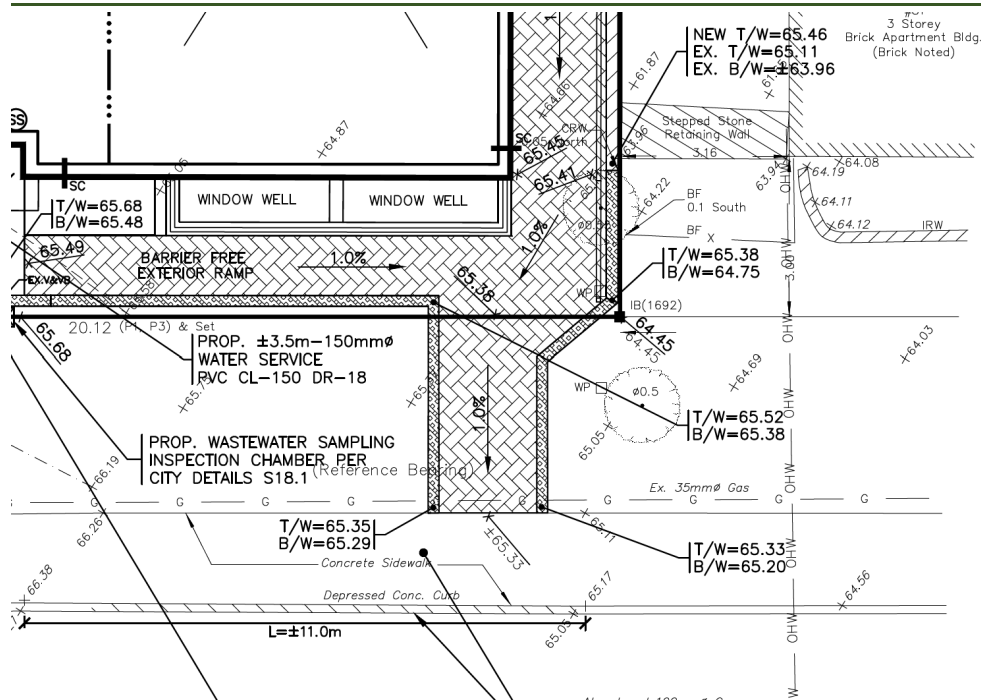
**Tree 1:** This updated report reflects changes that were made to the grading plan for the walkway to curve around the tree. The new walkway and retaining wall will be approximately 1.5 m from the edge of the tree trunk which should avoid impacting the structural integrity of the tree. The tree roots are to be pruned in advance of any excavation for the walkway and retaining wall and be completed by a certified arborist and/or city forestry staff. The same applies to the removal of any branches for the clearance of equipment on site.

**Note:** Historical Google Street View imagery reveals a survey post embedded within the center of this tree's trunk. This hazard should be flagged in the city's internal system to prevent injury during future removal operations.

Figure 1: Image clip from updated grading plan prepared by TL Mak dated May 27, 2026 showing the walkway curving around tree 1, city owned Norway maple. The distance from the edge of the tree trunk to the edge of the retaining wall is approximately 1.5 m.

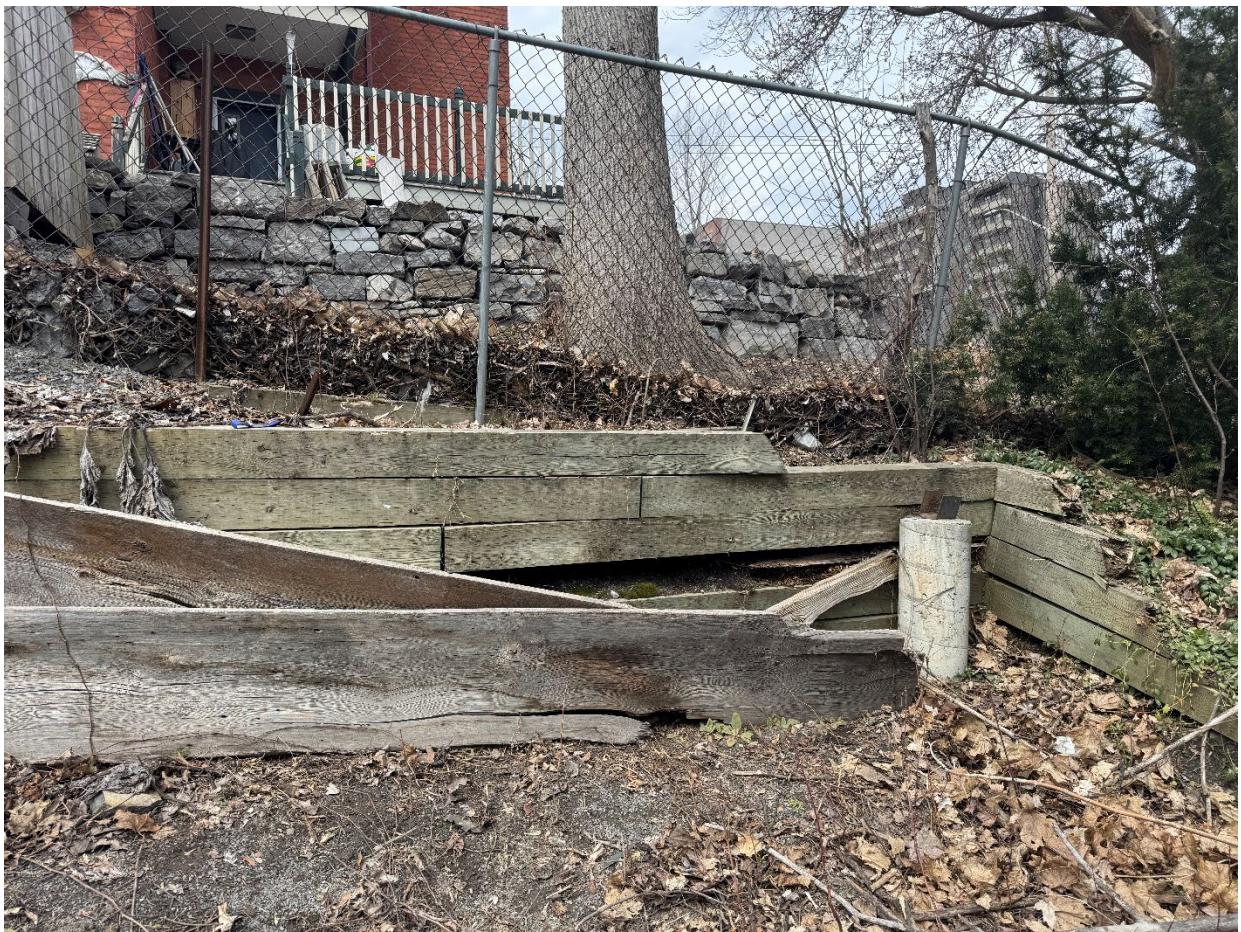
**Tree 10:** This tree is situated directly on the property line and will likely be impacted by the proposed development. While building excavation will utilize shoring, the construction of the new retaining wall requires a grade change exceeding 4 meters. Despite these impacts, the current project objective is to retain this tree during construction. The existing retaining wall will be replaced with shoring set approximately 20 cm closer to the tree. Soil in this critical area will be removed non-destructively via hydrovac exploration, concurrent with the retaining wall removal and shoring installation.

Photo 1: Existing retaining wall by Tree 10, American elm on adjacent property. The new retaining wall will be over 4 m in depth

Following this exploratory excavation, the tree must be re-assessed to determine if any critical stabilizing roots will become compromised and confirm whether retention is feasible. A full tree risk assessment is recommended. If the tree is identified as a high risk at that time and the property owners decide to keep it, they assume all liability and risk associated with that decision. Due to the deep excavation, the fall distance and severity of a potential branch or whole-tree failure are increased, and workers below will have limited to no overhead protection until the new building frame is erected. Dendron assumes no responsibility for personal injury, property damage, or project delays resulting from the retention of this tree.

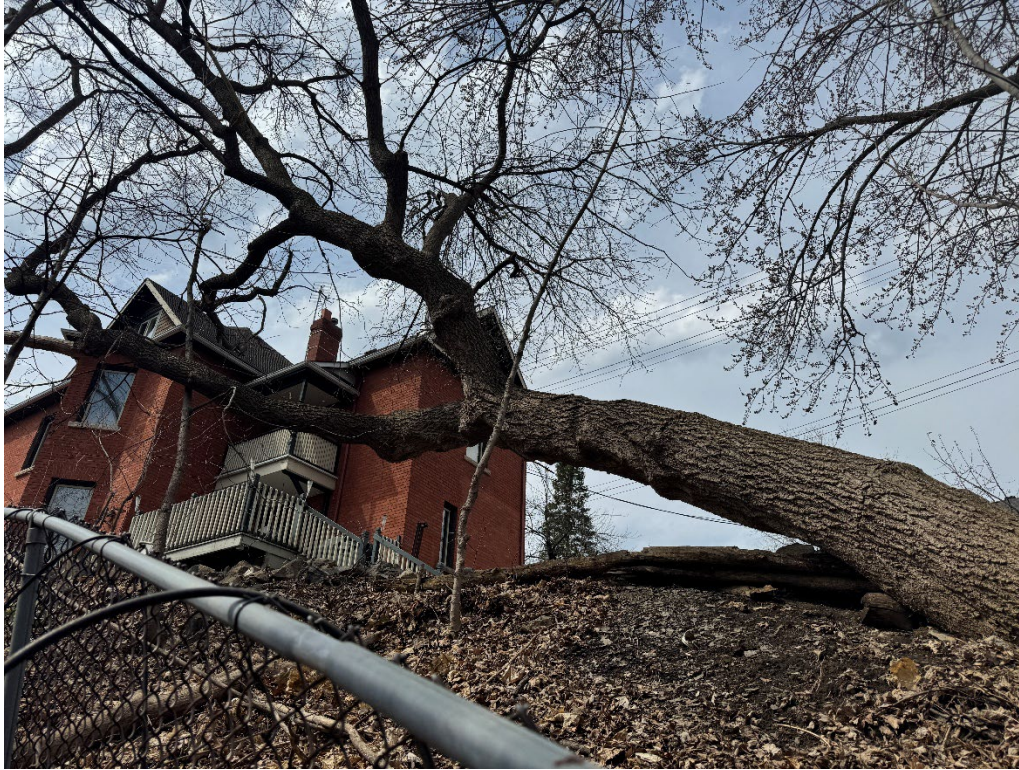
**Tree 11:** This tree is located on the adjacent property and exhibits a severe structural defect, growing at a nearly horizontal lean. Given its poor condition, the tree may be susceptible to failure triggered by construction-related vibrations. While its removal is not mandatory for the project, it is recommended that the applicant consult with the neighbor to explore this option. At a minimum, any large branches encroaching over the subject property that pose a risk of failure should be pruned.

**Photo 2:** Tree 11, Manitoba maple with very heavy lean on adjacent property

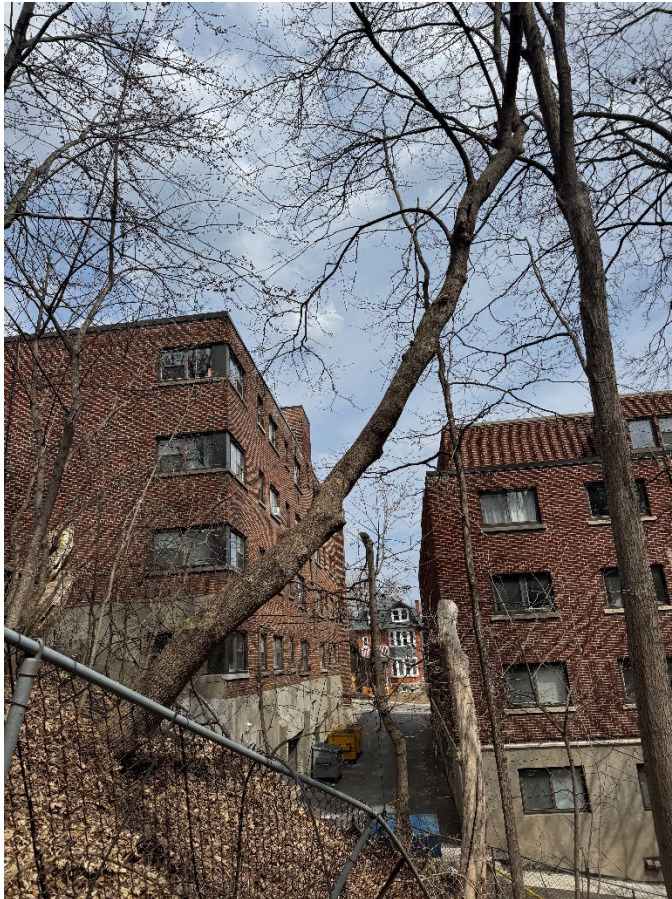
**Tree 27:** This tree is situated on an adjacent property on a steep slope experiencing active soil creep. Evidence of this movement is visible in the accumulation of soil and organic debris against the boundary fence, which has mostly collapsed under the pressure near the base of the slope. The physical weight of the tree is actively exacerbating this slope instability.

The tree currently exhibits a significant lean toward the subject property, presenting an existing safety hazard. While a full assessment was limited by property access, visual inspection from the property line suggests potential girdling roots on the upslope side of the root flare. Furthermore, the proposed building footprint presents a direct conflict with the tree's crown.

It is critical to note that the risk of whole-tree failure will increase once the trees on the subject site are removed, as Tree 27 will suddenly be subjected to increased wind exposure. Concurrently, the subject site will become an active construction zone, increasing the number of targets (workers, equipment, and structures) within the fall zone.

**Photo 3: Tree 27, Manitoba maple on adjacent property that should be removed due to the potential for failure on subject property**

Because of these compounding structural and site factors, there are no effective or practical mitigation measures available to reduce this risk to an acceptable level. Given the lack of viable alternatives, removing the tree is the only recommended option to ensure site safety. Furthermore, the massive above-ground weight of the tree is likely contributing to the downward soil creep. Removing the tree while leaving the stump and entire root network intact may actually reduce ongoing erosion and improve the overall stability of the slope. Immediate planting with small trees and shrubs is recommended for further slope stability.

If the adjacent property owner does not support removal of this tree, an option would be to remove the portion of the tree extending over the subject property line to reduce the weight and reassess. Although this may not be an accepted arboricultural practice, it may reduce the risk to an acceptable level which is a higher priority. It is recommended that a risk assessment be completed after the pruning has been completed.

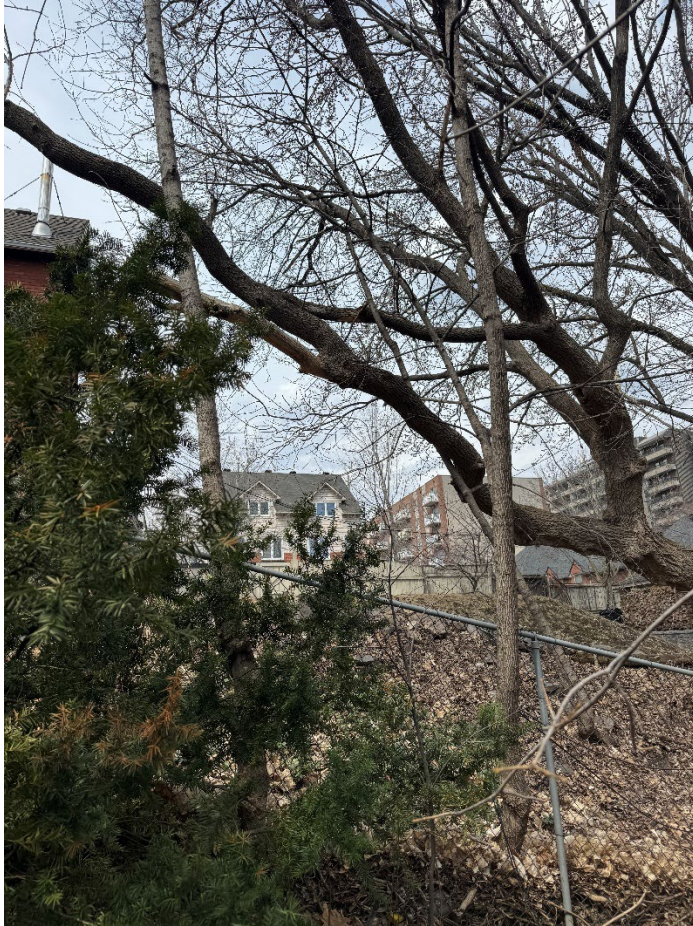
**Additional two small Manitoba maple along the fence line:** There are two small Manitoba maple along the fence line, intertwined with the existing metal fence, that will also require removal. These trees measure 11 cm in diameter and are in poor health due to their weak bases.

Photo 4: Small Manitoba maples along the fence line, intertwined with the fence
