TREE CONSERVATION REPORT  
ADDENDUM 3.0  
71 Russell Ave

Tree Conservation Report Addendum submitted as  
Partial Requirements for a Site Plan Control  
Application, July 12, 2026

## Tree Conservation Report Addendum 3.0

**Address:** 71 Russell Ave  
**Date of Report:** July 12, 2026  
**Date of Site Visit:** April 9, 2026 and July 2, 2026  
**Prepared by:** Astrid Nielsen, RPF, ISA Certified Arborist ®  
101- 45 Spencer Ave, K1Y 2P5  
[Astrid.nielsen@dendronforestry.ca](mailto:Astrid.nielsen@dendronforestry.ca)  
**Client:** Colin Miller, [Colin@pinehillbuilders.ca](mailto:Colin@pinehillbuilders.ca)

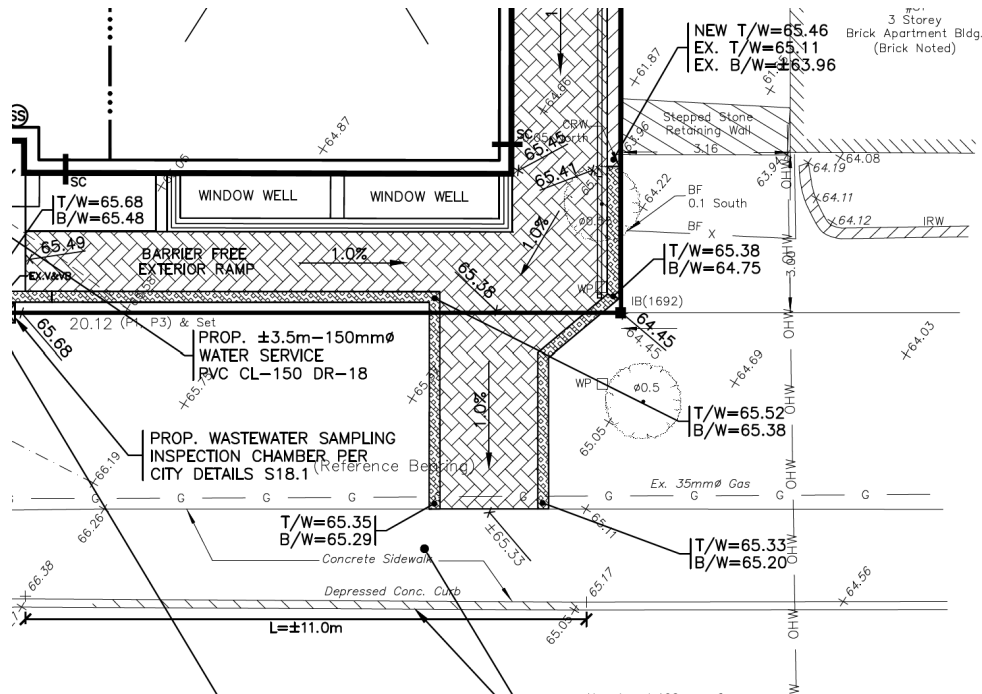
**Tree 1:** This updated report reflects changes that were made to the grading plan for the walkway to curve around the tree. The new walkway and retaining wall will be approximately 1.5 m from the edge

of the tree trunk which should avoid impacting the structural integrity of the tree. The tree roots are to be pruned in advance of any excavation for the walkway and retaining wall and be completed by a certified arborist and/or city forestry staff. The same applies to the removal of any branches for the clearance of equipment on site – clearance pruning will likely be required for site access.

Figure 1: Image clip from updated grading plan prepared by TL Mak dated May 27, 2026 showing the walkway curving around tree 1, city owned Norway maple. The distance from the edge of the tree trunk to the edge of the retaining wall is approximately 1.5 m.

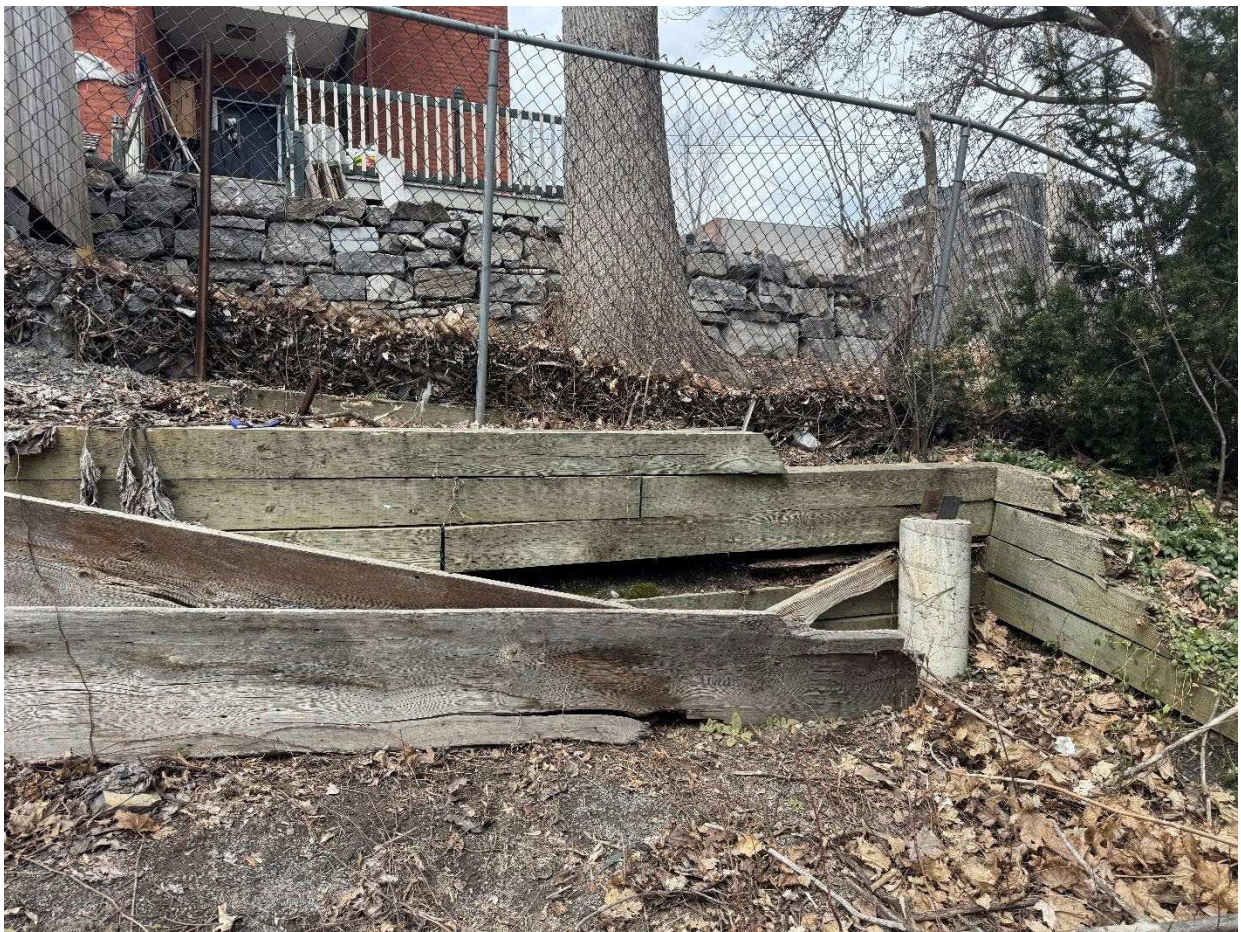
**Photo 1:** Existing wall by Tree 10, American elm on adjacent property. The new retaining wall will be over 4 m in depth and flush against the property line which is close to the existing fence

The existing wall is estimated to be 20 years old based on the condition of the wood. The team onsite noted that the wall was not functioning as a retaining wall and would likely have failed if it were supporting the soil. It was also noted that there was a French drain installed on the adjacent property which extends below the existing fence and onto the subject property.

The existing wall will be replaced with shoring set approximately 20 cm closer to the tree. Soil in this area will be removed, and pruned back by a certified Arborist, concurrent with the shoring installation. The required 20 cm of root pruning to accommodate the shoring system must be executed with clean cuts using sharp, sanitized arborist tools to minimize further stress and pathogen entry. Note that there is additional soil past the L bend of the wall that was not included in this assessment that will be excavated. It is anticipated this area will be beyond the area where structural roots will be located.

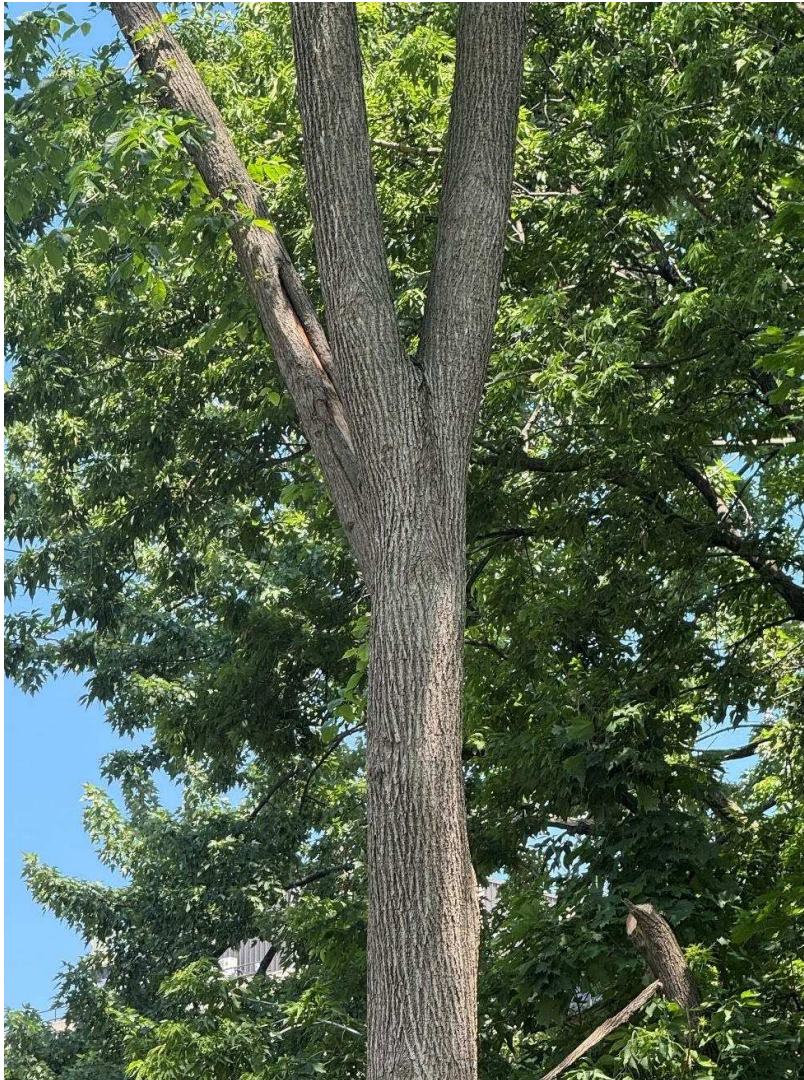
- Fair to declining canopy structure: canopy is slightly unbalanced, weighted mostly over the adjacent property
  - One major branch which extends over the adjacent property's roof has a large injury near its union with the trunk. Injury has limited wound wood growth.

Photo 2: Wound on the branch overhanging the adjacent property at 69 Russell. An aerial assessment is recommended.

Finally, we advise the neighbour to secure an independent Level 3 Advanced (aerial) Assessment from a TRAQ-certified arborist to fully evaluate the structural integrity of the potentially decayed root collar and the injured branch overhanging their roof structure.

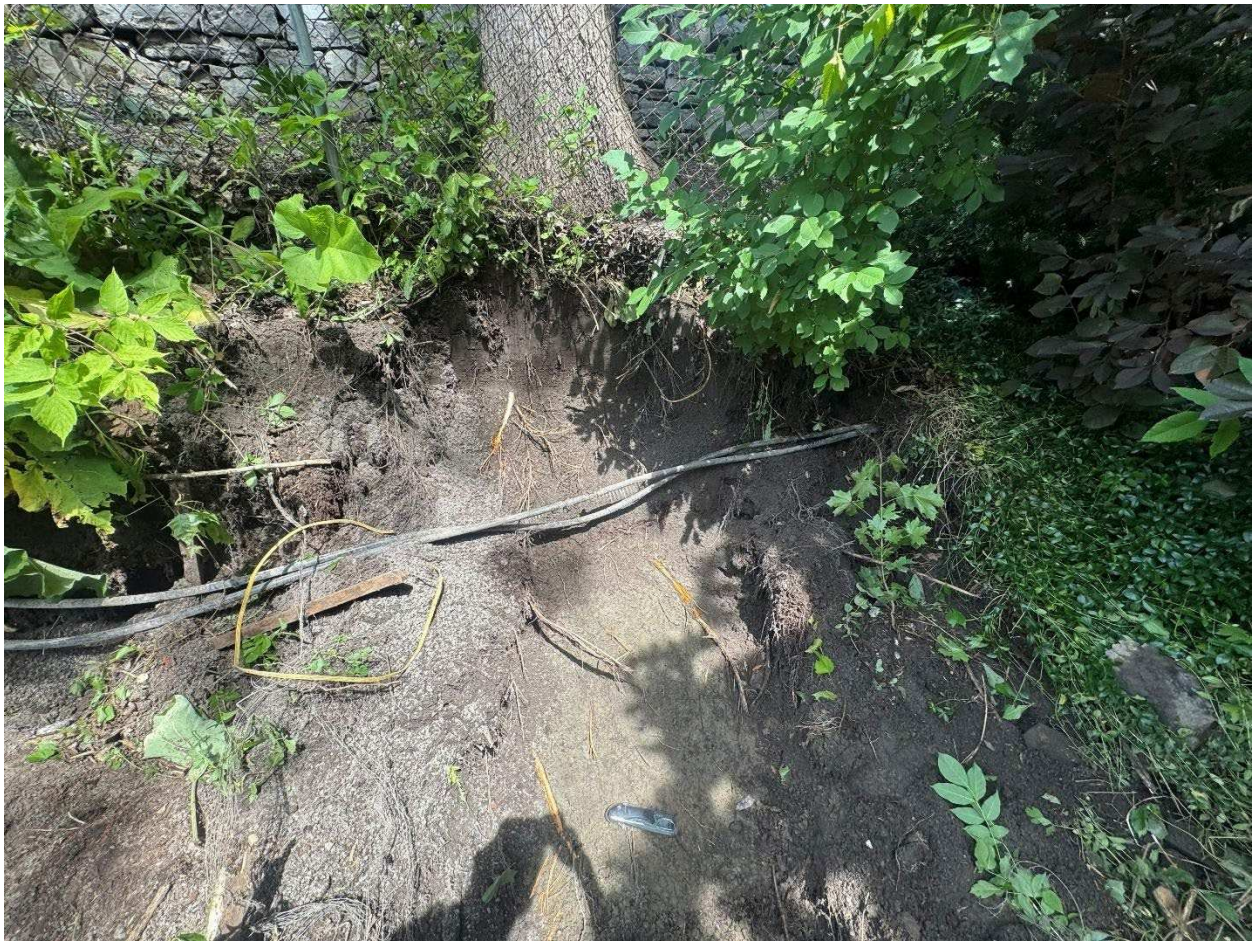
- Roots present in section of wall excavated:
  - 6 roots measuring 1.5 cm - 5 cm
    - 1 @ 5 cm
    - 1 @ 4.5 cm
    - 1 @ 3.5 cm
    - 1 @ 2 cm
    - 2 @ 1.5 cm
  - 9 roots measuring <1cm, >0.3cm
  - Fine roots
- There were two areas where some decayed wood was present that may have been roots at one point
- Roots extended the full depth of the wall, and are expected to continue deeper into the substrate on the subject property

Photo 3: Soil and roots visible after the removal of the wall

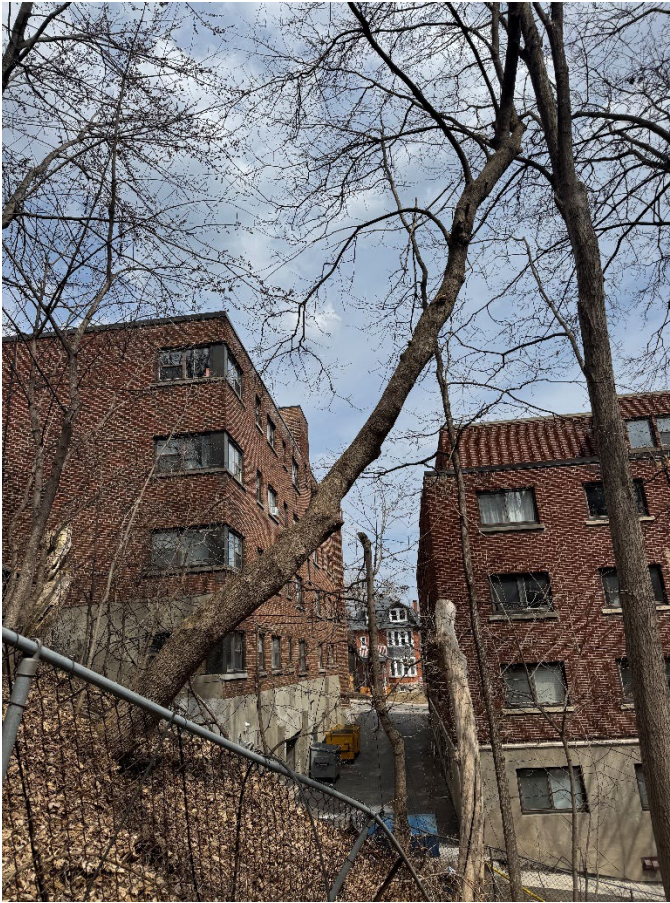
**Tree 27:** This tree is situated on an adjacent property on a steep slope experiencing active soil creep. Evidence of this movement is visible in the accumulation of soil and organic debris against the boundary fence, which has mostly collapsed under the pressure near the base of the slope.

The tree currently exhibits a significant lean toward the subject property, presenting an existing safety hazard. While a full assessment was limited by property access, visual inspection from the property line suggests potential girdling roots on the upslope side of the root flare. Furthermore, the proposed building presents a direct conflict with the tree's crown.

It is critical to note that the risk of whole-tree failure will increase once the trees on the subject site are removed, as Tree 27 will suddenly be subjected to increased wind exposure. Concurrently, the subject site will become an active construction zone, increasing the number of targets (workers, equipment, and structures) within the fall zone.

Manitoba maples are fast-growing, opportunistic trees characterized by weak wood and shallow, fibrous root systems that grow irregularly toward light, making them prone to storm failure. Furthermore, they tend to uproot more frequently than other maple species on similar sites (Ontario, 2024). From a failure potential perspective, the downhill lean increases the overturning moment on the shallow root plate. Should this tree fail, it is most likely to involve a full tree failure that includes the entire rooting mass. This root plate failure would remove a large volume of soil, exacerbating current erosion issues on the slope.

Photo 1: Tree 27, Manitoba maple on adjacent property that should be removed due to the potential for failure on subject property

Because of the degree of lean, there are no effective or practical mitigation measures available to reduce this risk to an acceptable level. Given the lack of viable alternatives, removing (most of) the tree is the only recommended option to ensure site safety. Furthermore, the massive above-ground weight of the tree is likely contributing to the downward soil creep. Removing the tree while leaving the stump and entire root network intact may actually reduce ongoing erosion and improve the overall stability of the slope.

To optimize slope stability while mitigating the overhead hazard, it is recommended that the crown and stem be removed, but the trunk and root system be left intact. Because Manitoba maple is a prolific stump sprouter, leaving the stump untreated will trigger the immediate production of epicormic shoots, ensuring the root system remains alive and continues functioning as it did prior to removal. To establish permanent structural anchoring, a succession planting strategy combining native trees, shrubs, and herbs is recommended. Shrubs will provide for immediate, shallow soil cohesion, whereas structural trees, such as oak, will establish deep taproots.

If the adjacent property owner does not support removal of this tree, an option would be to remove the portion of the tree extending over the subject property line to reduce the weight and reassess. Although this may not be an accepted arboricultural practice, it may reduce the risk to an acceptable level which is a higher priority. It is recommended that a risk assessment be completed after the pruning has been completed.
