**970 SILVER ST  
Ottawa, Ontario**

## **SEWER CCTV INSPECTION REPORT**

**Report Id**  
153924SA1

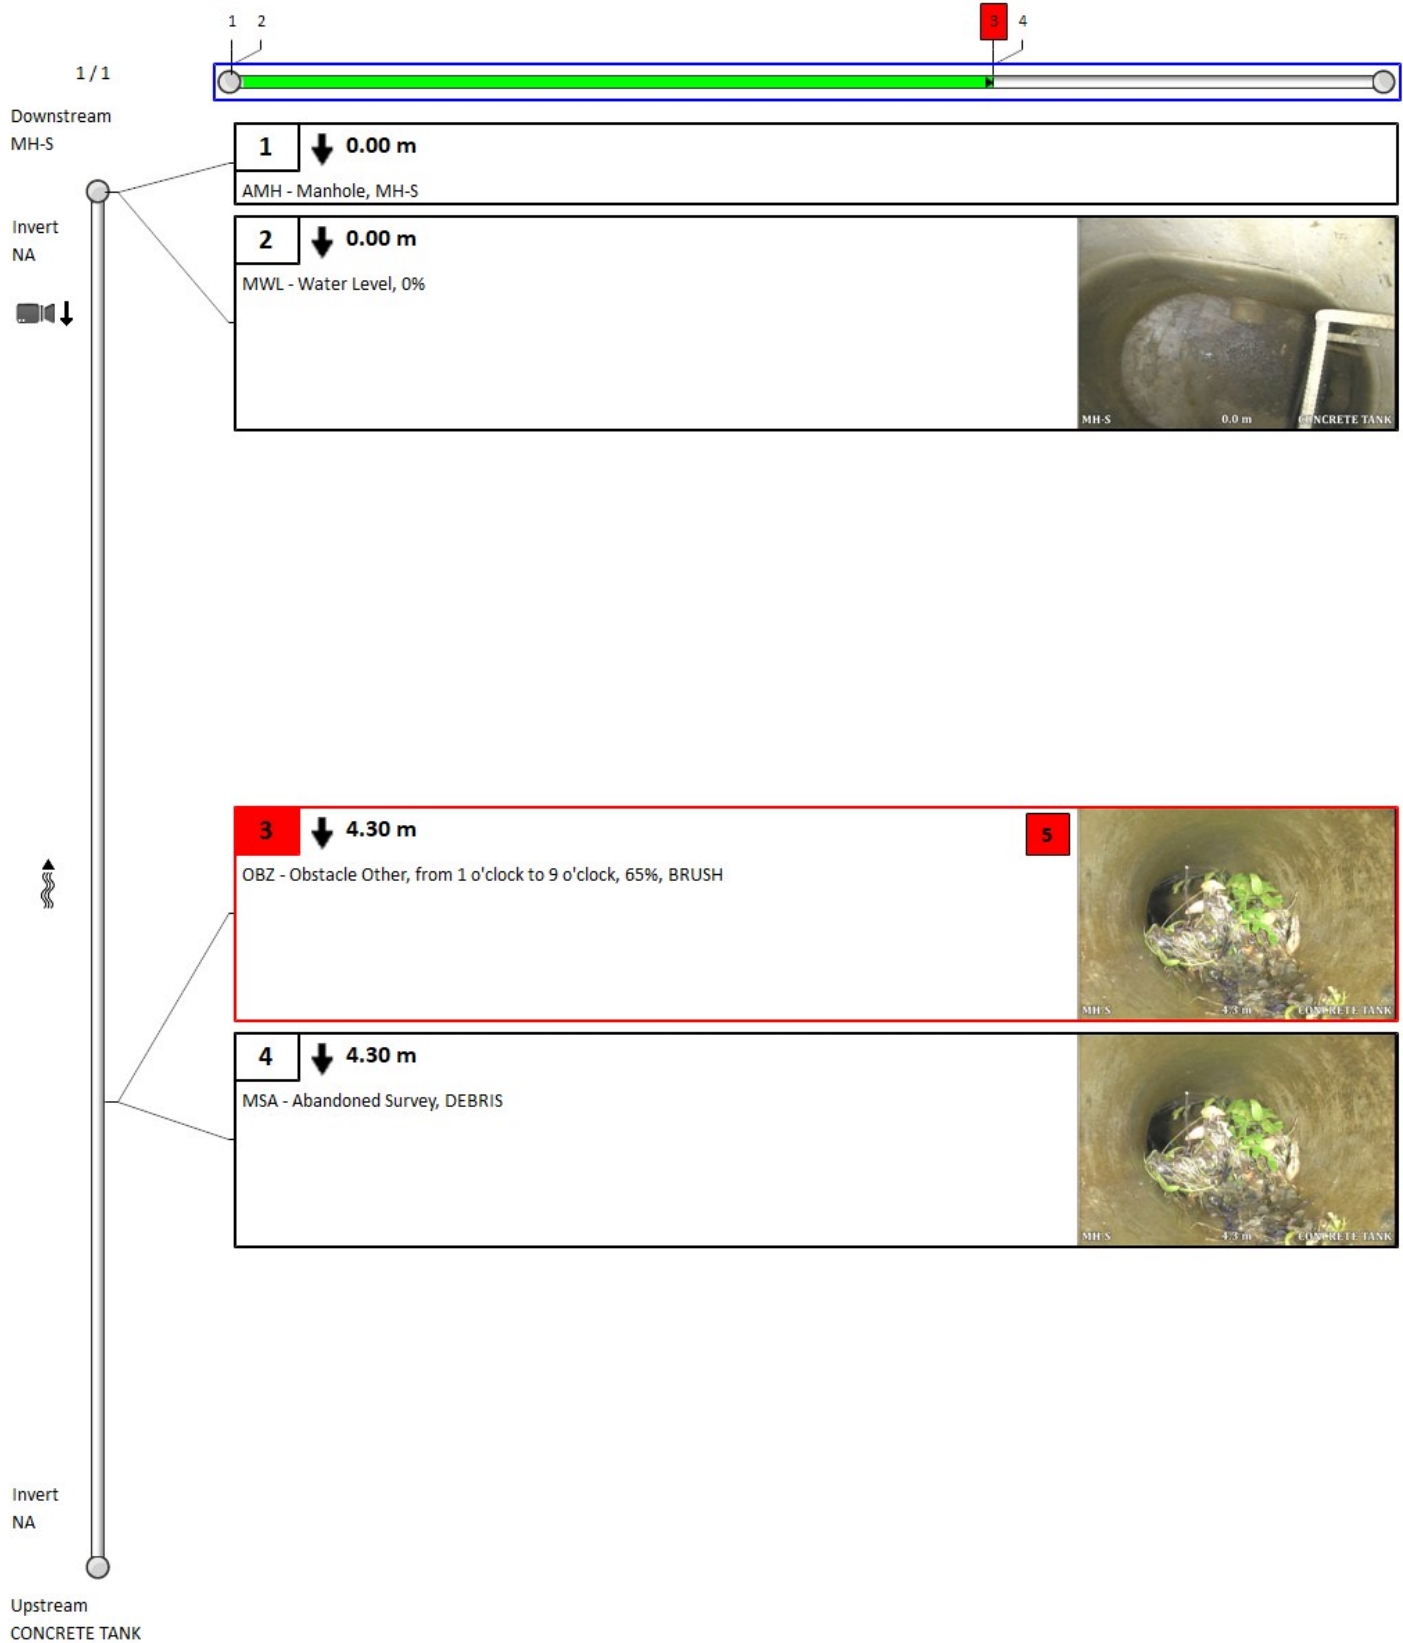
| Score | Quick | Index | Structural | Pipe | Start/End | Direction | Street | Page |
|---|---|---|---|---|---|---|---|---|
| 5 | 5100 | 5 | 0 | CONCRETE TANK MH-S | MH-S --> CONCRETE TANK | Against flow | 970 SILVER ST | 5 |

| Peak: | 0 | Peak: | 5 | Peak: | 5 |
