# SEWER CCTV INSPECTION REPORT

## City of Ottawa

### 960 Silver St Ottawa, ON

**Work Order:**  
152188

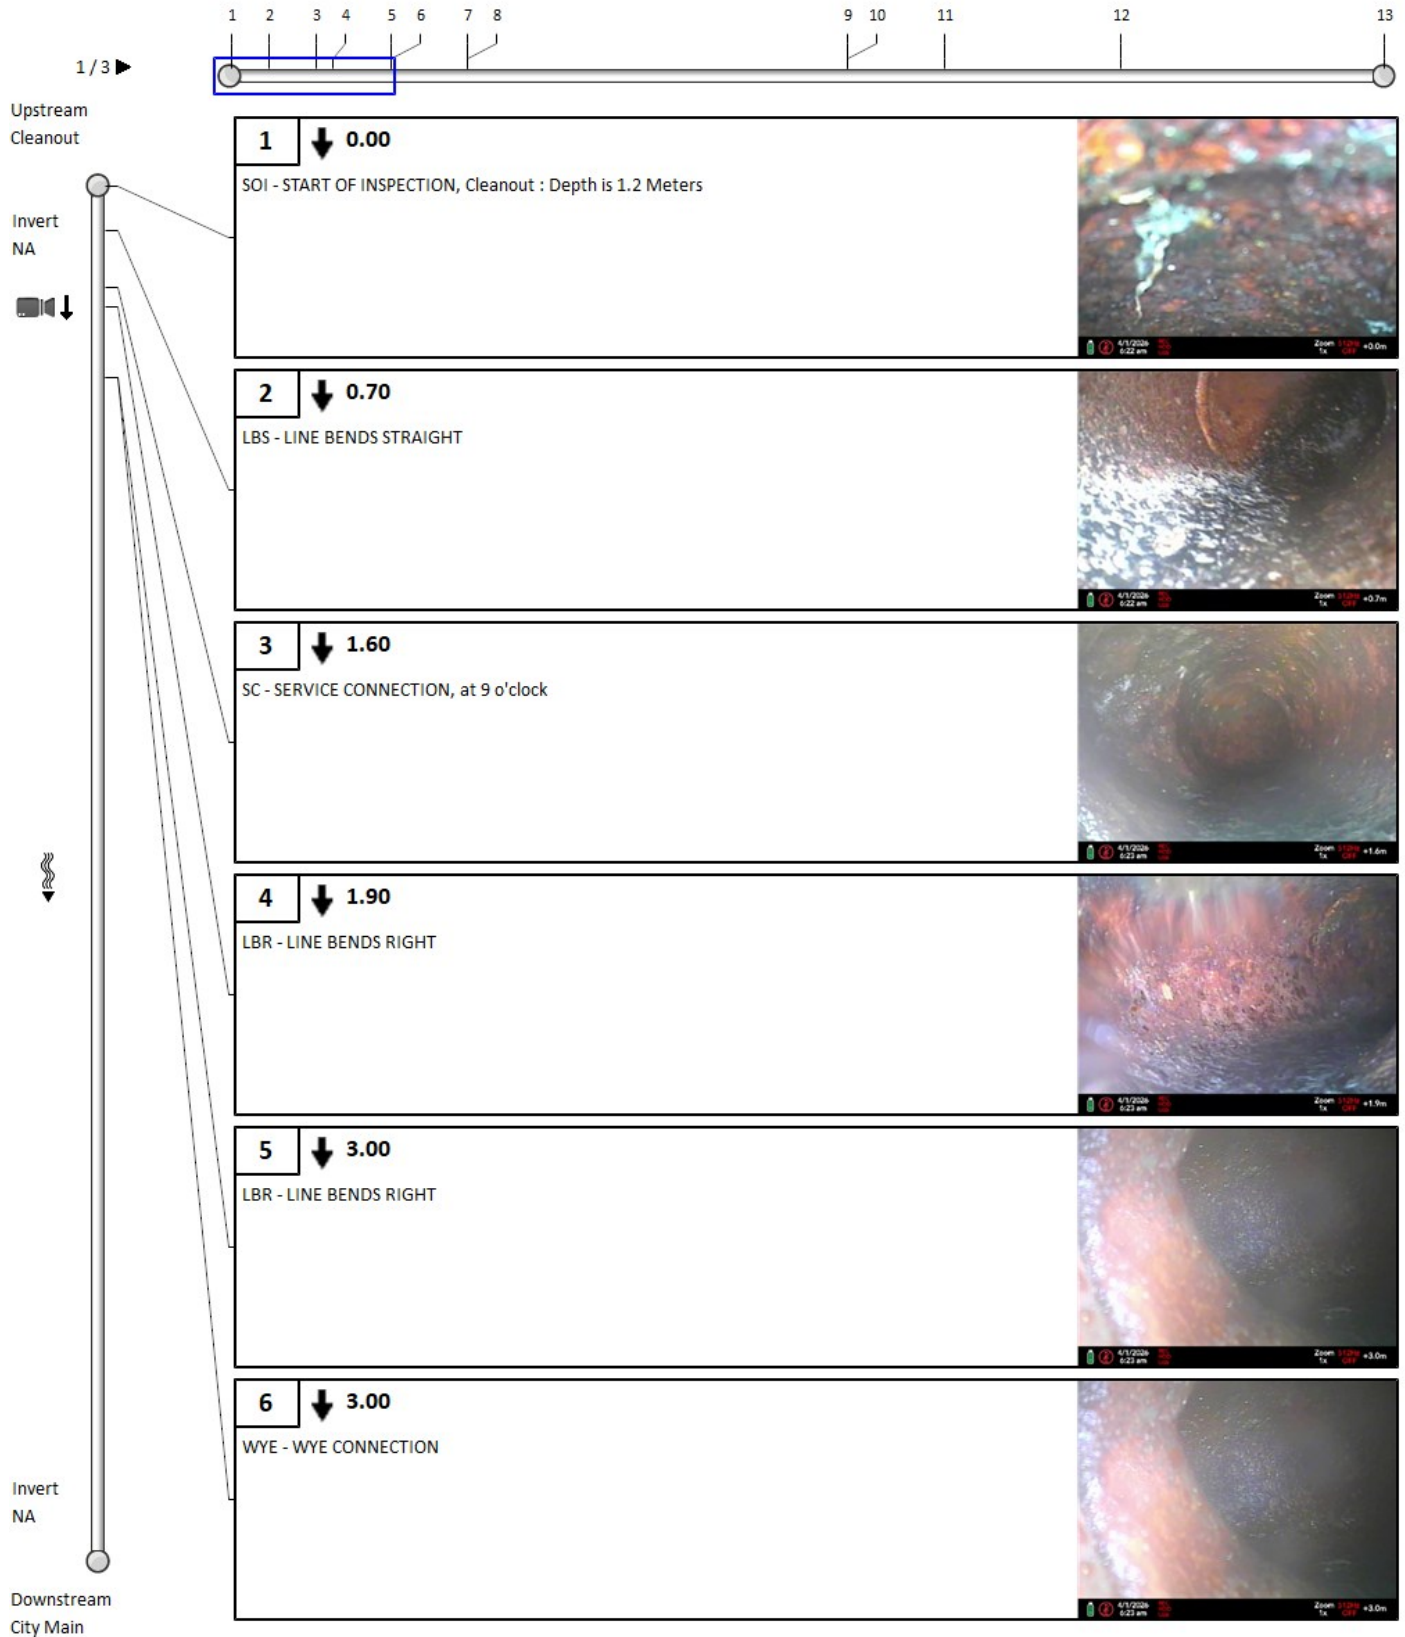
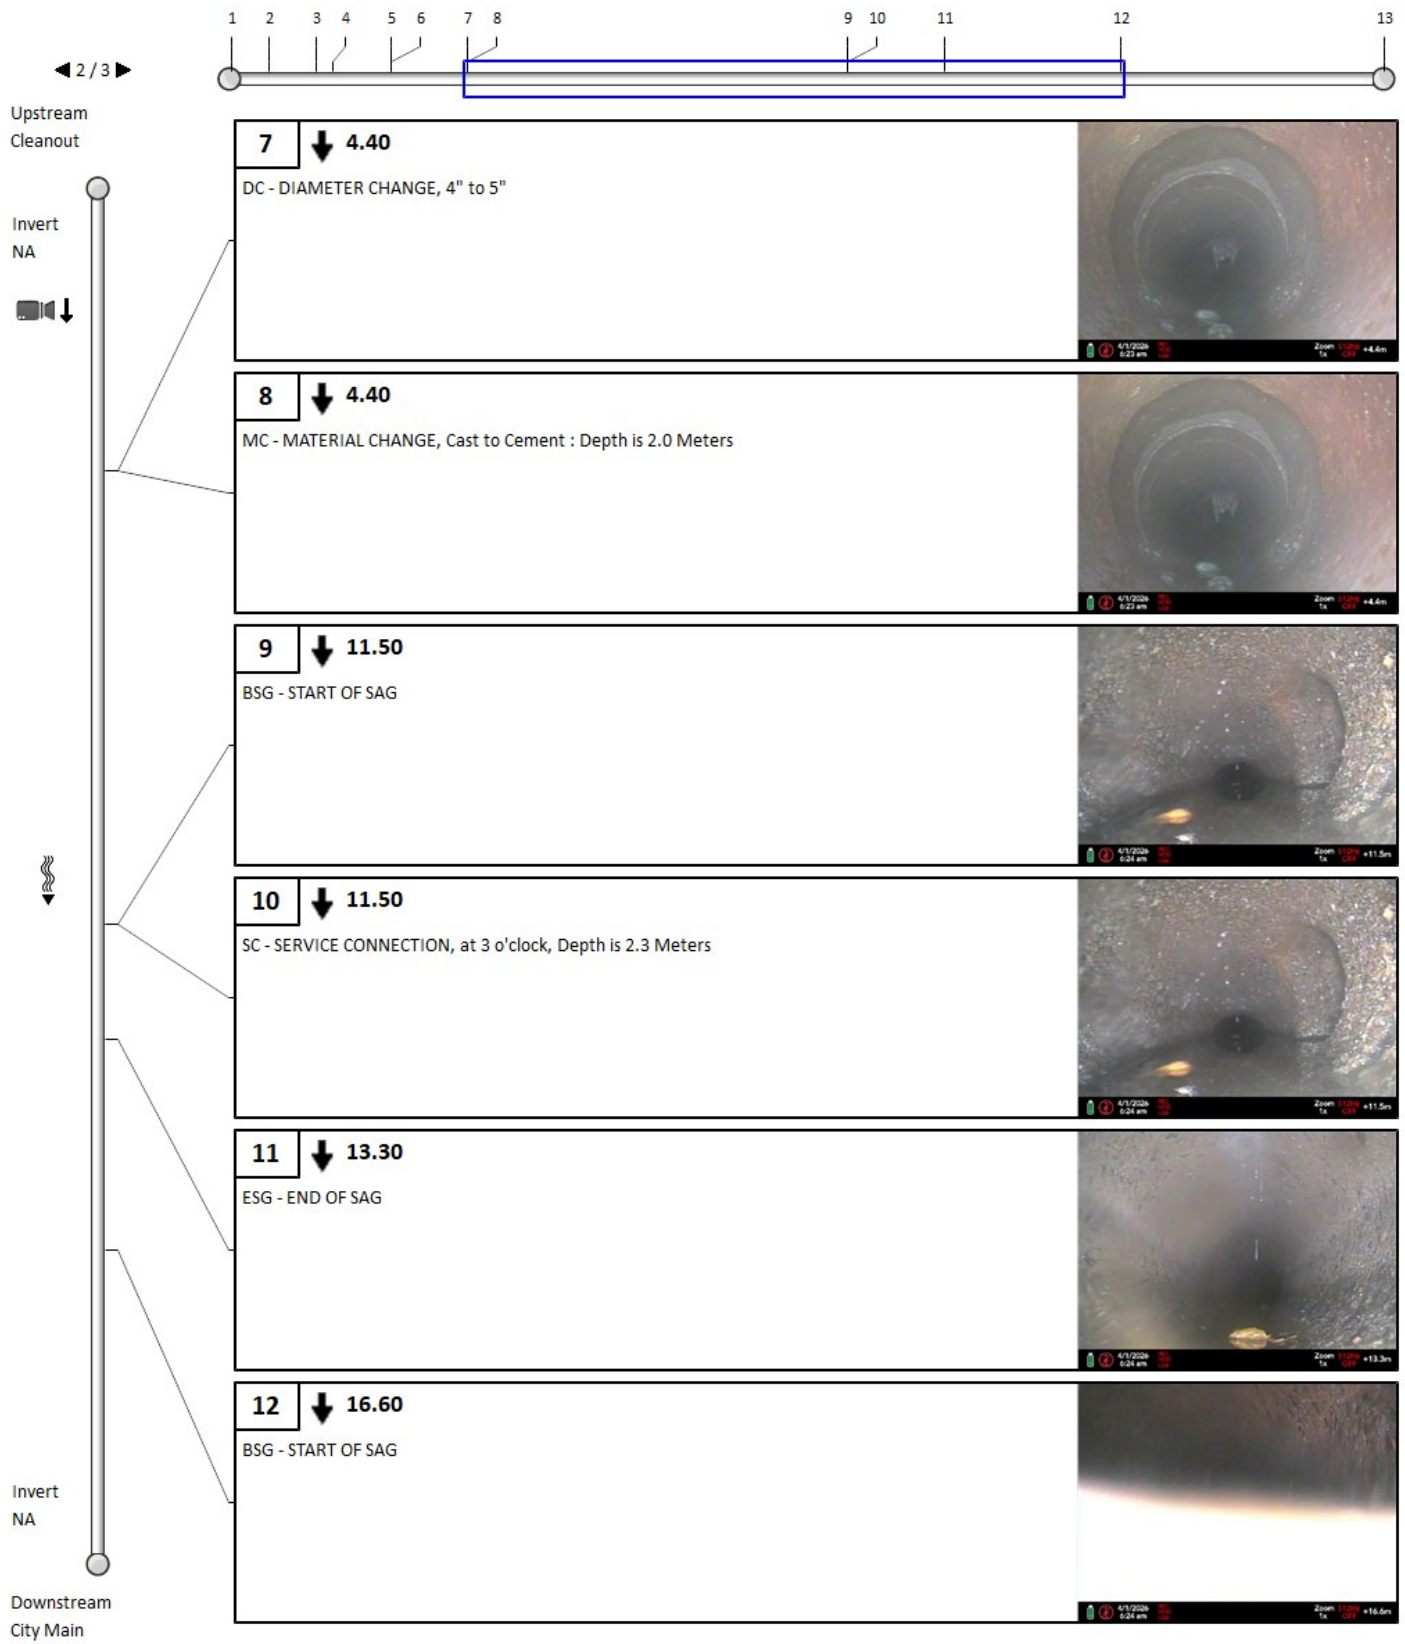
CCTV Inspection From Sanitary Cleanout to City Main
---

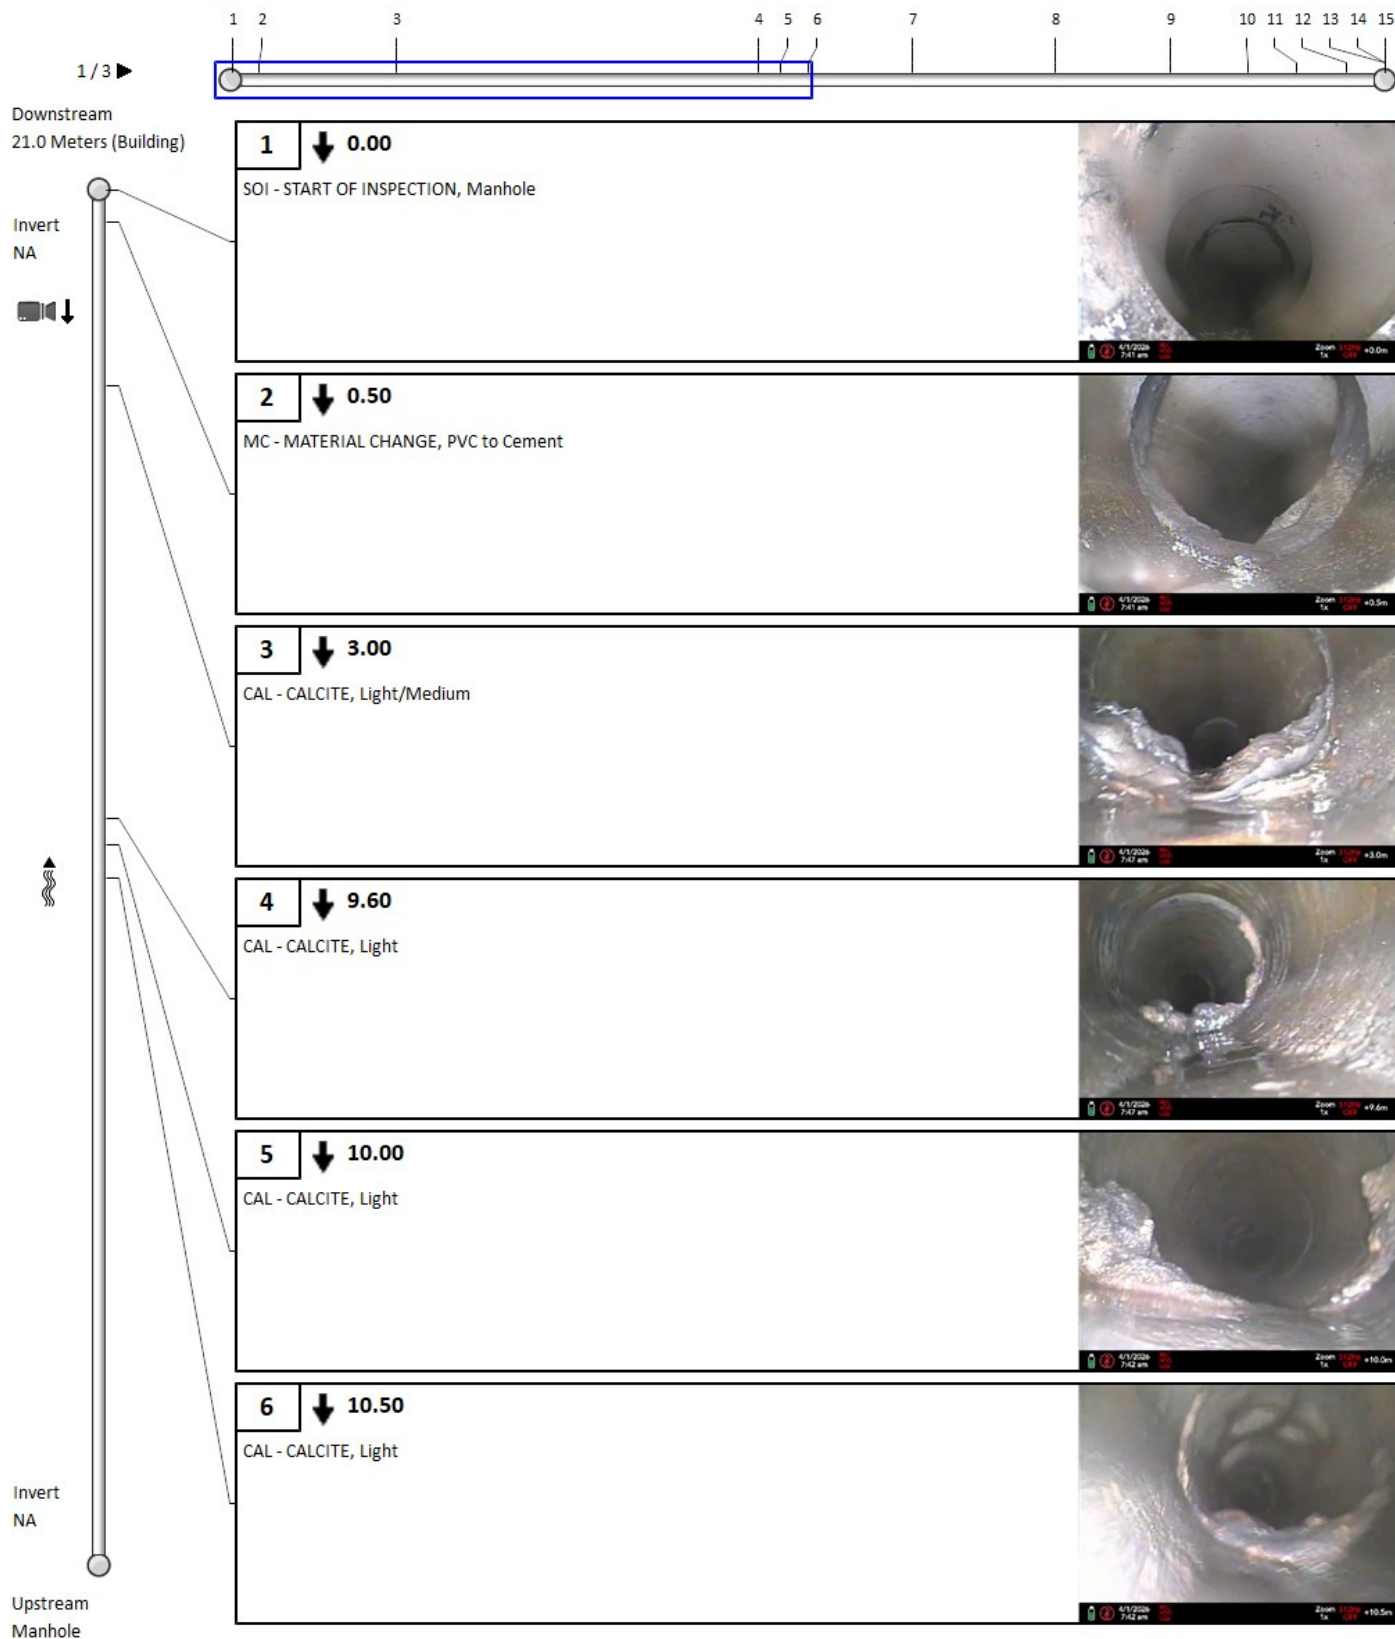
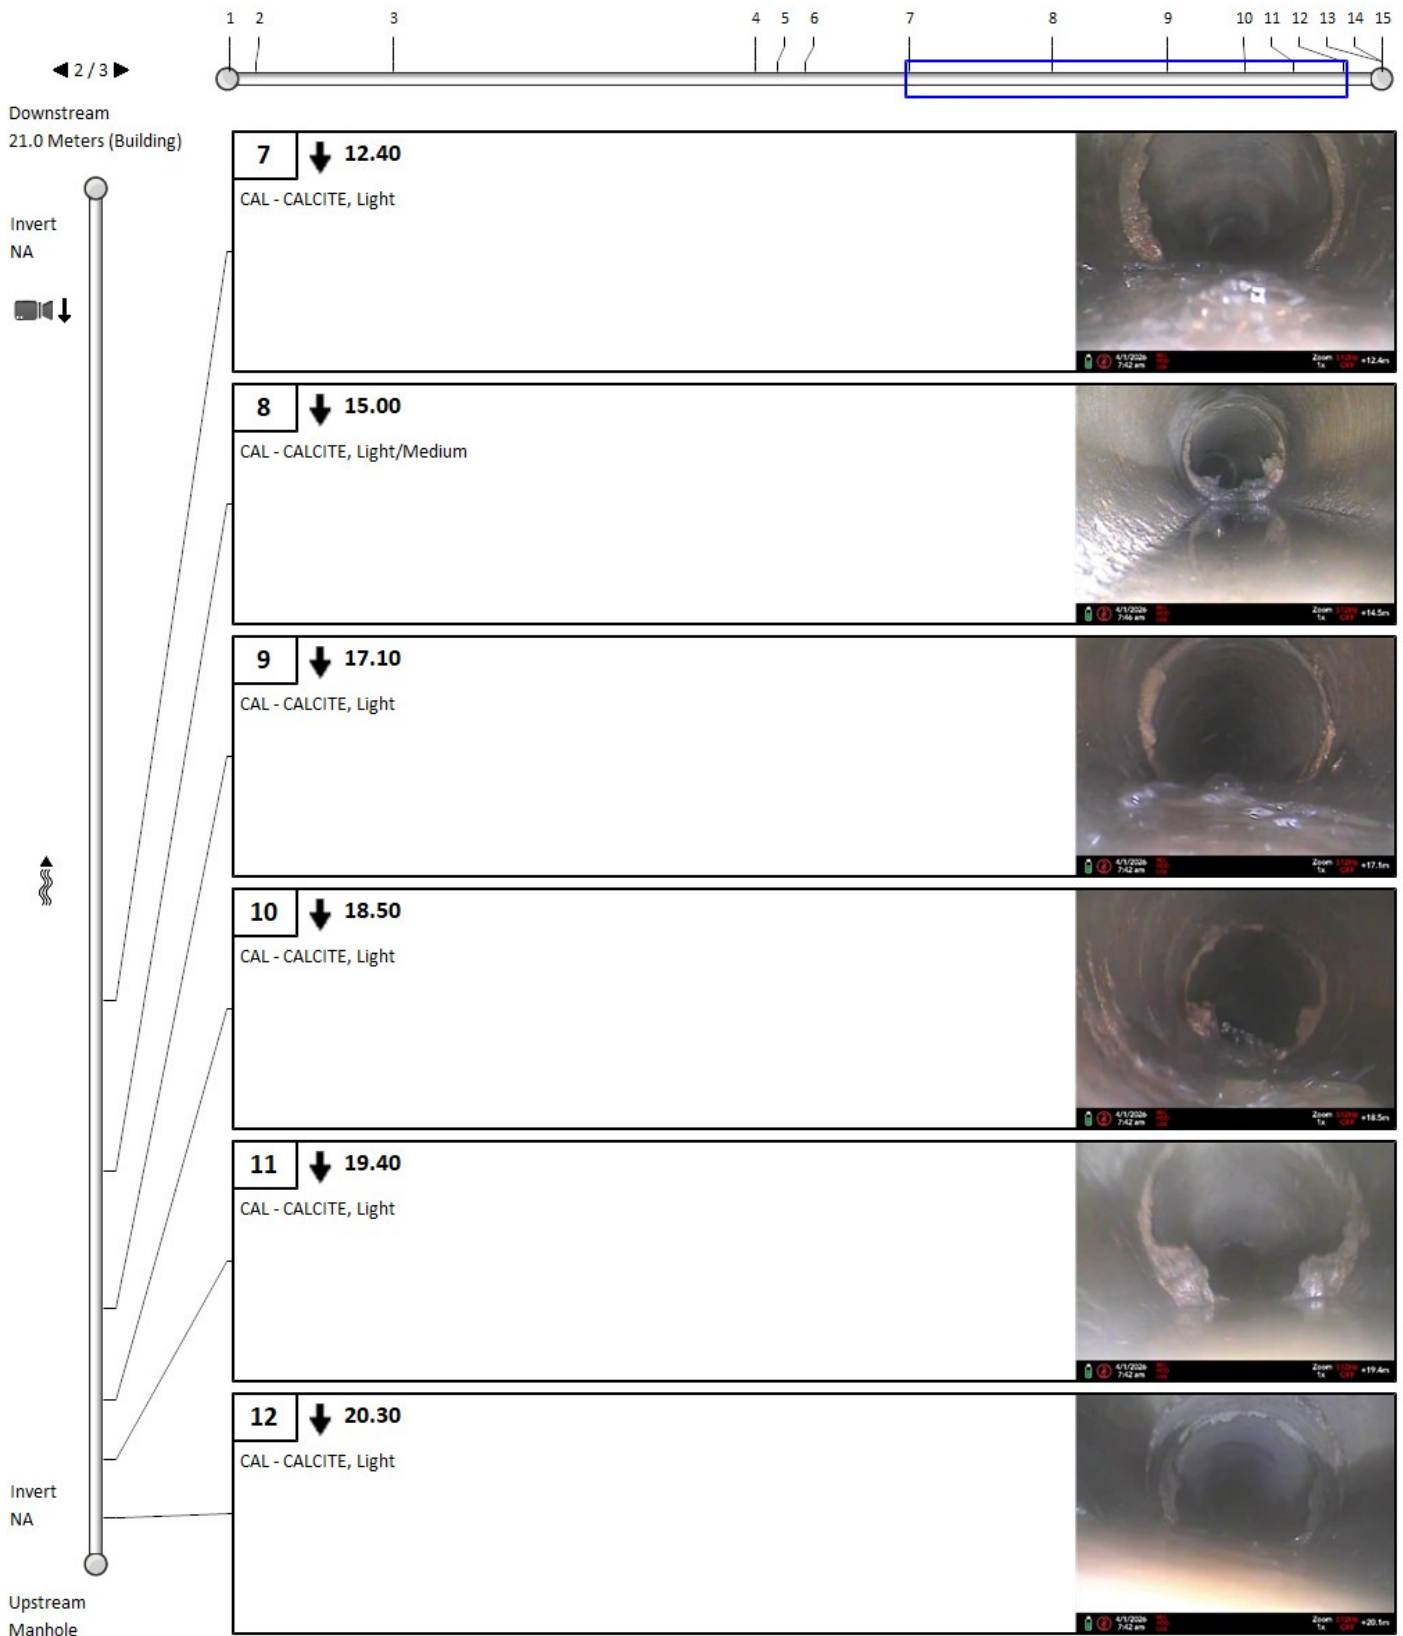
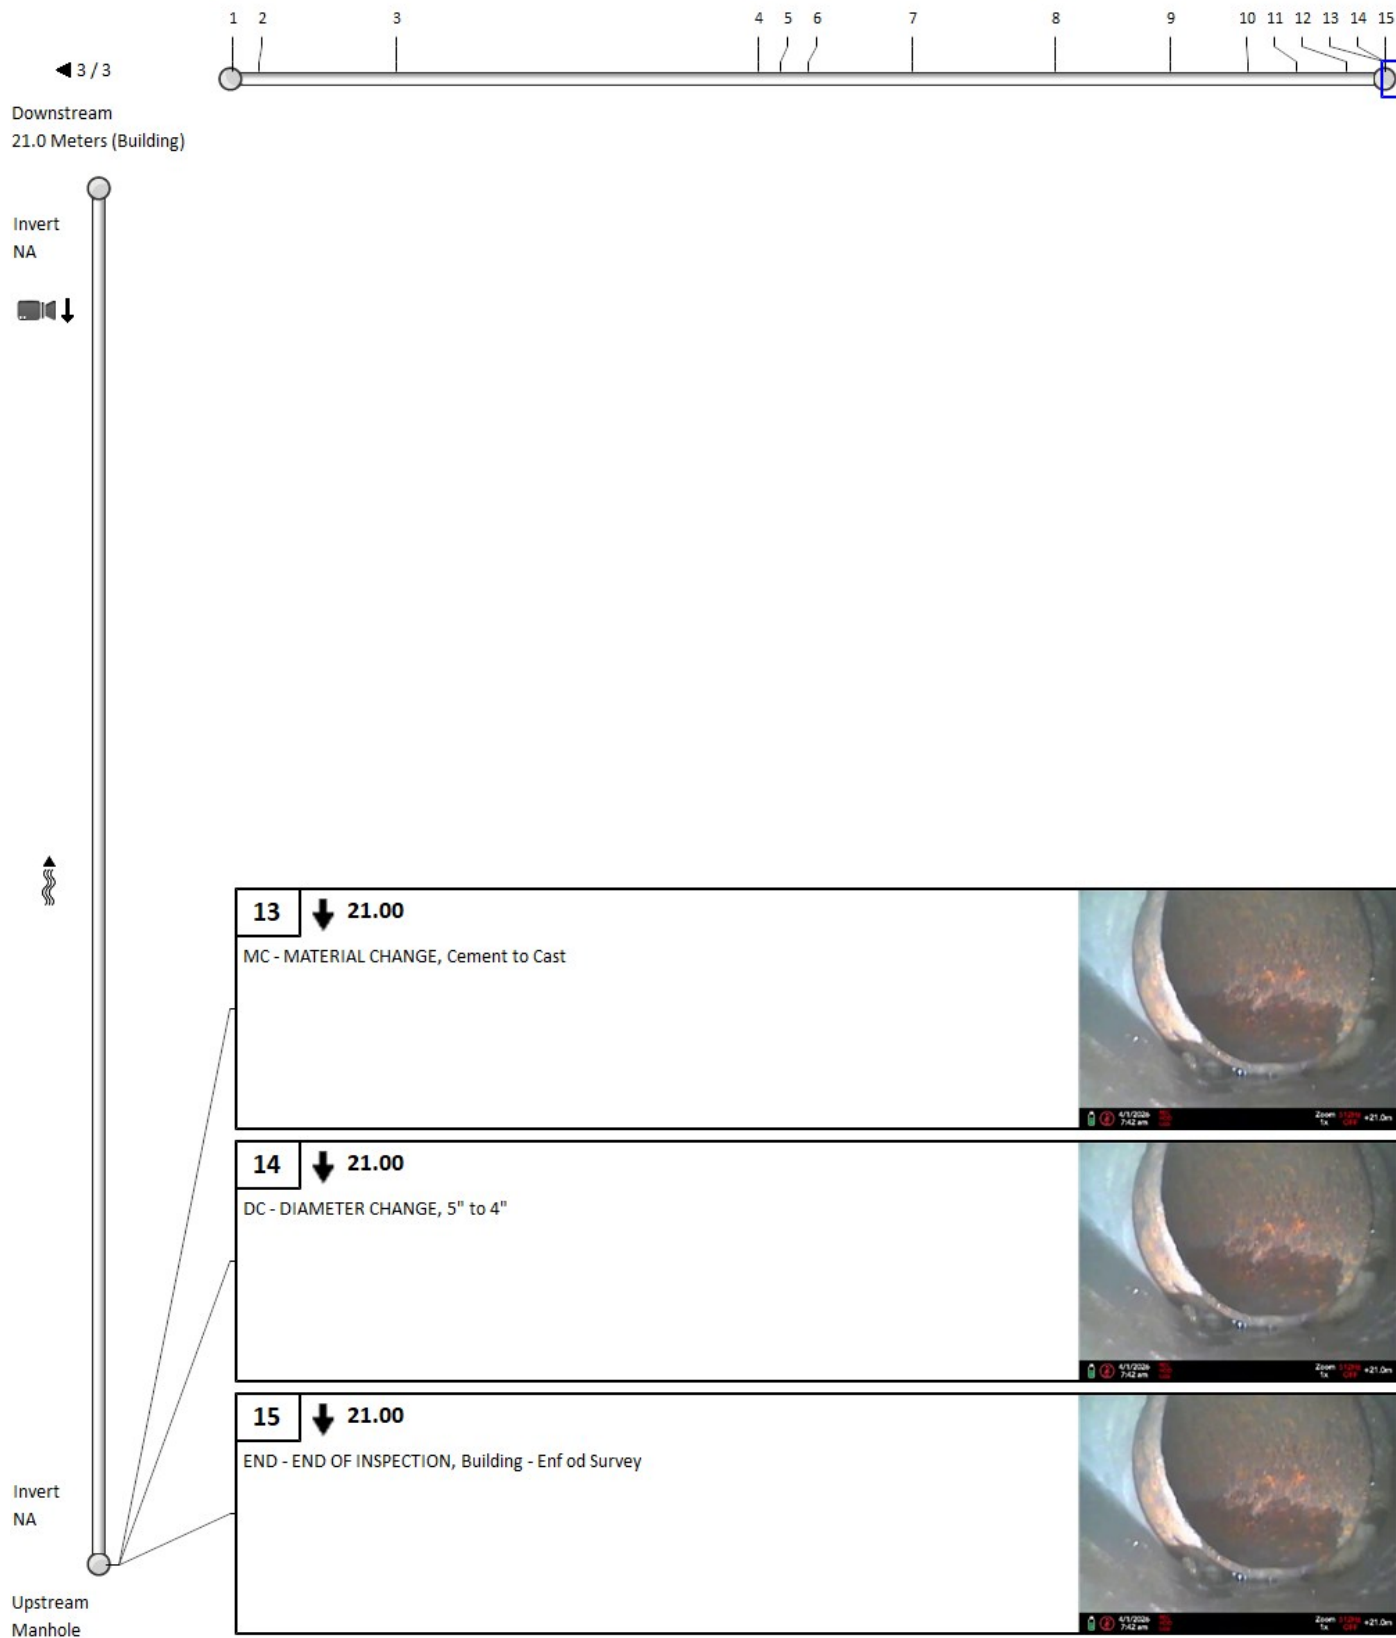
CCTV Inspection From Manhole to 21.0 Meters (Building) Light to Medium Calcite on Almost Every Joint
---

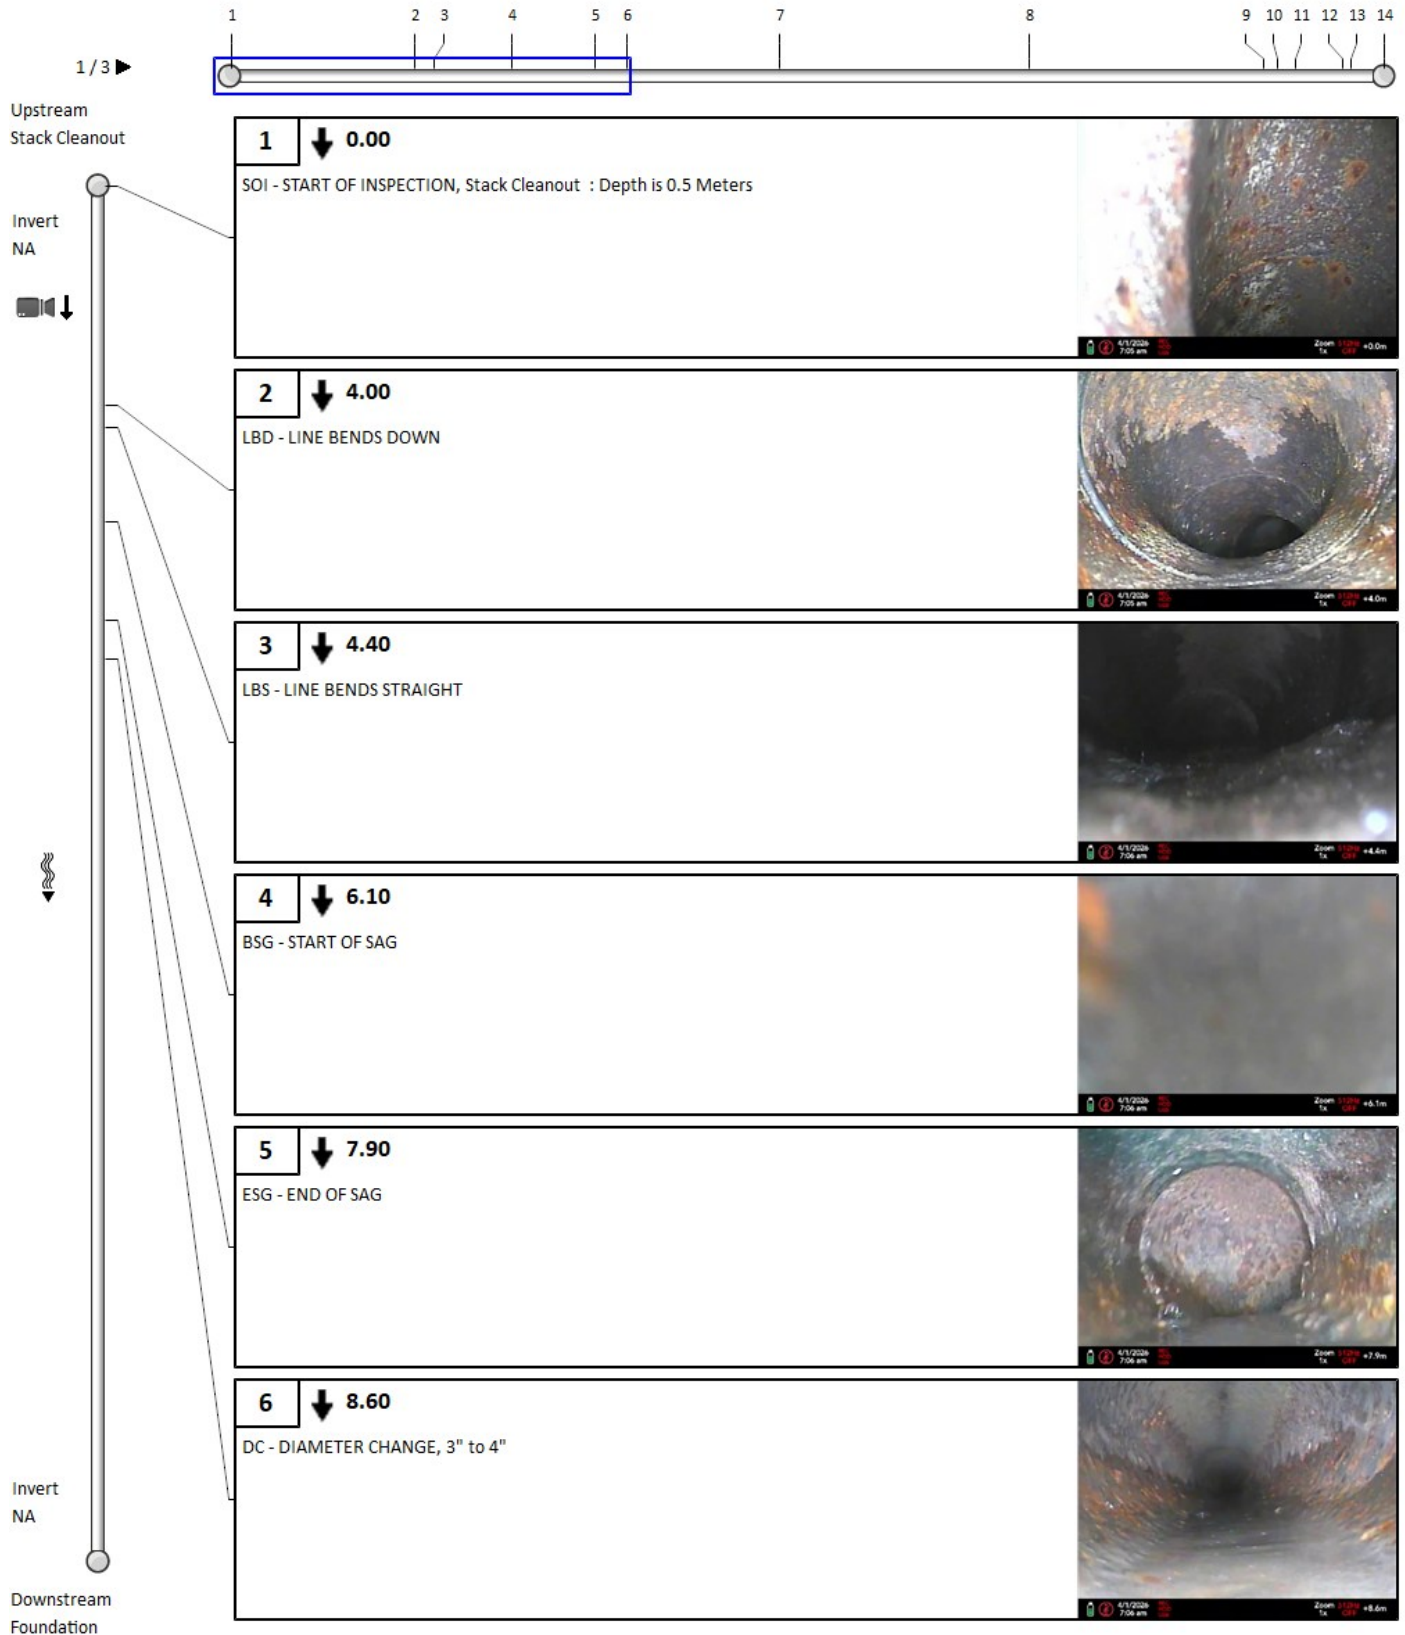
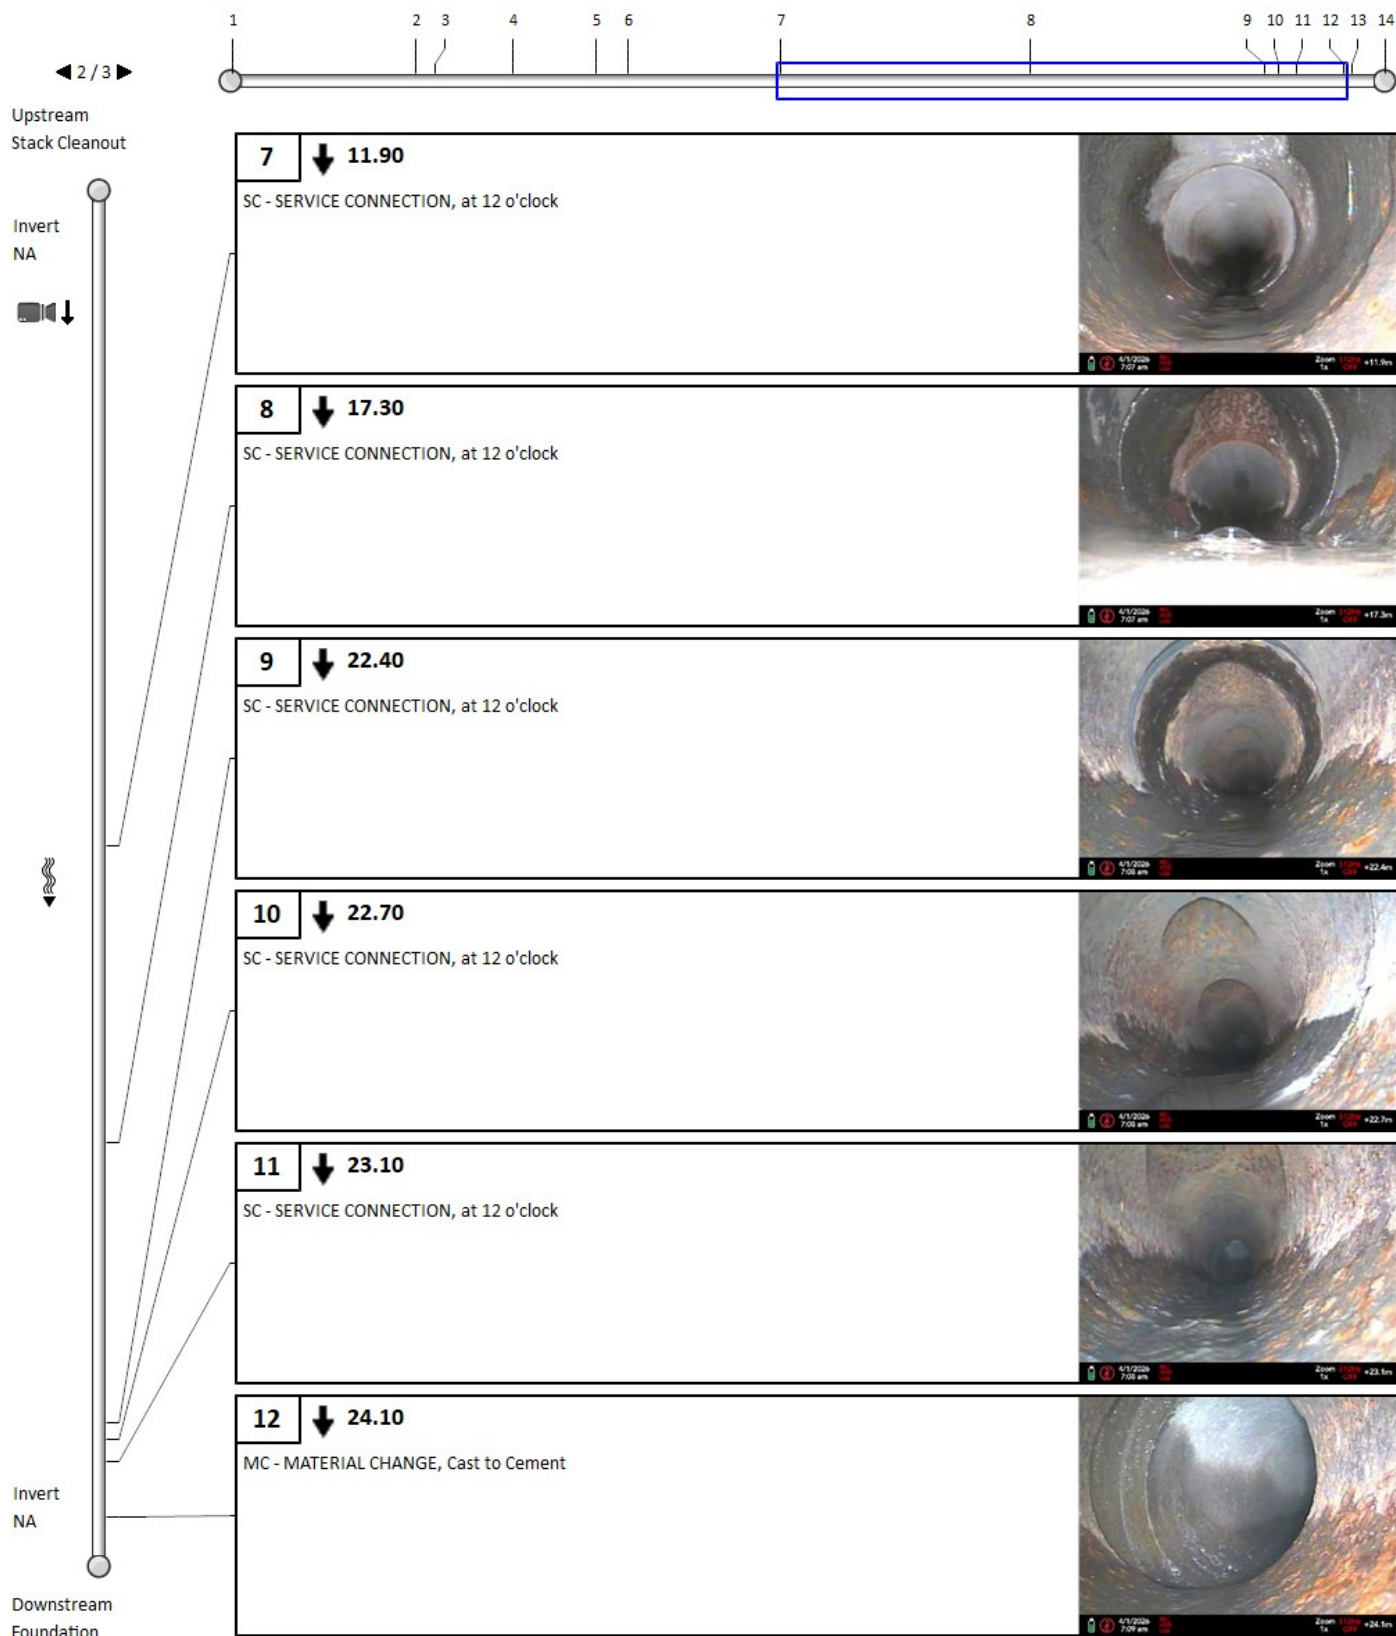
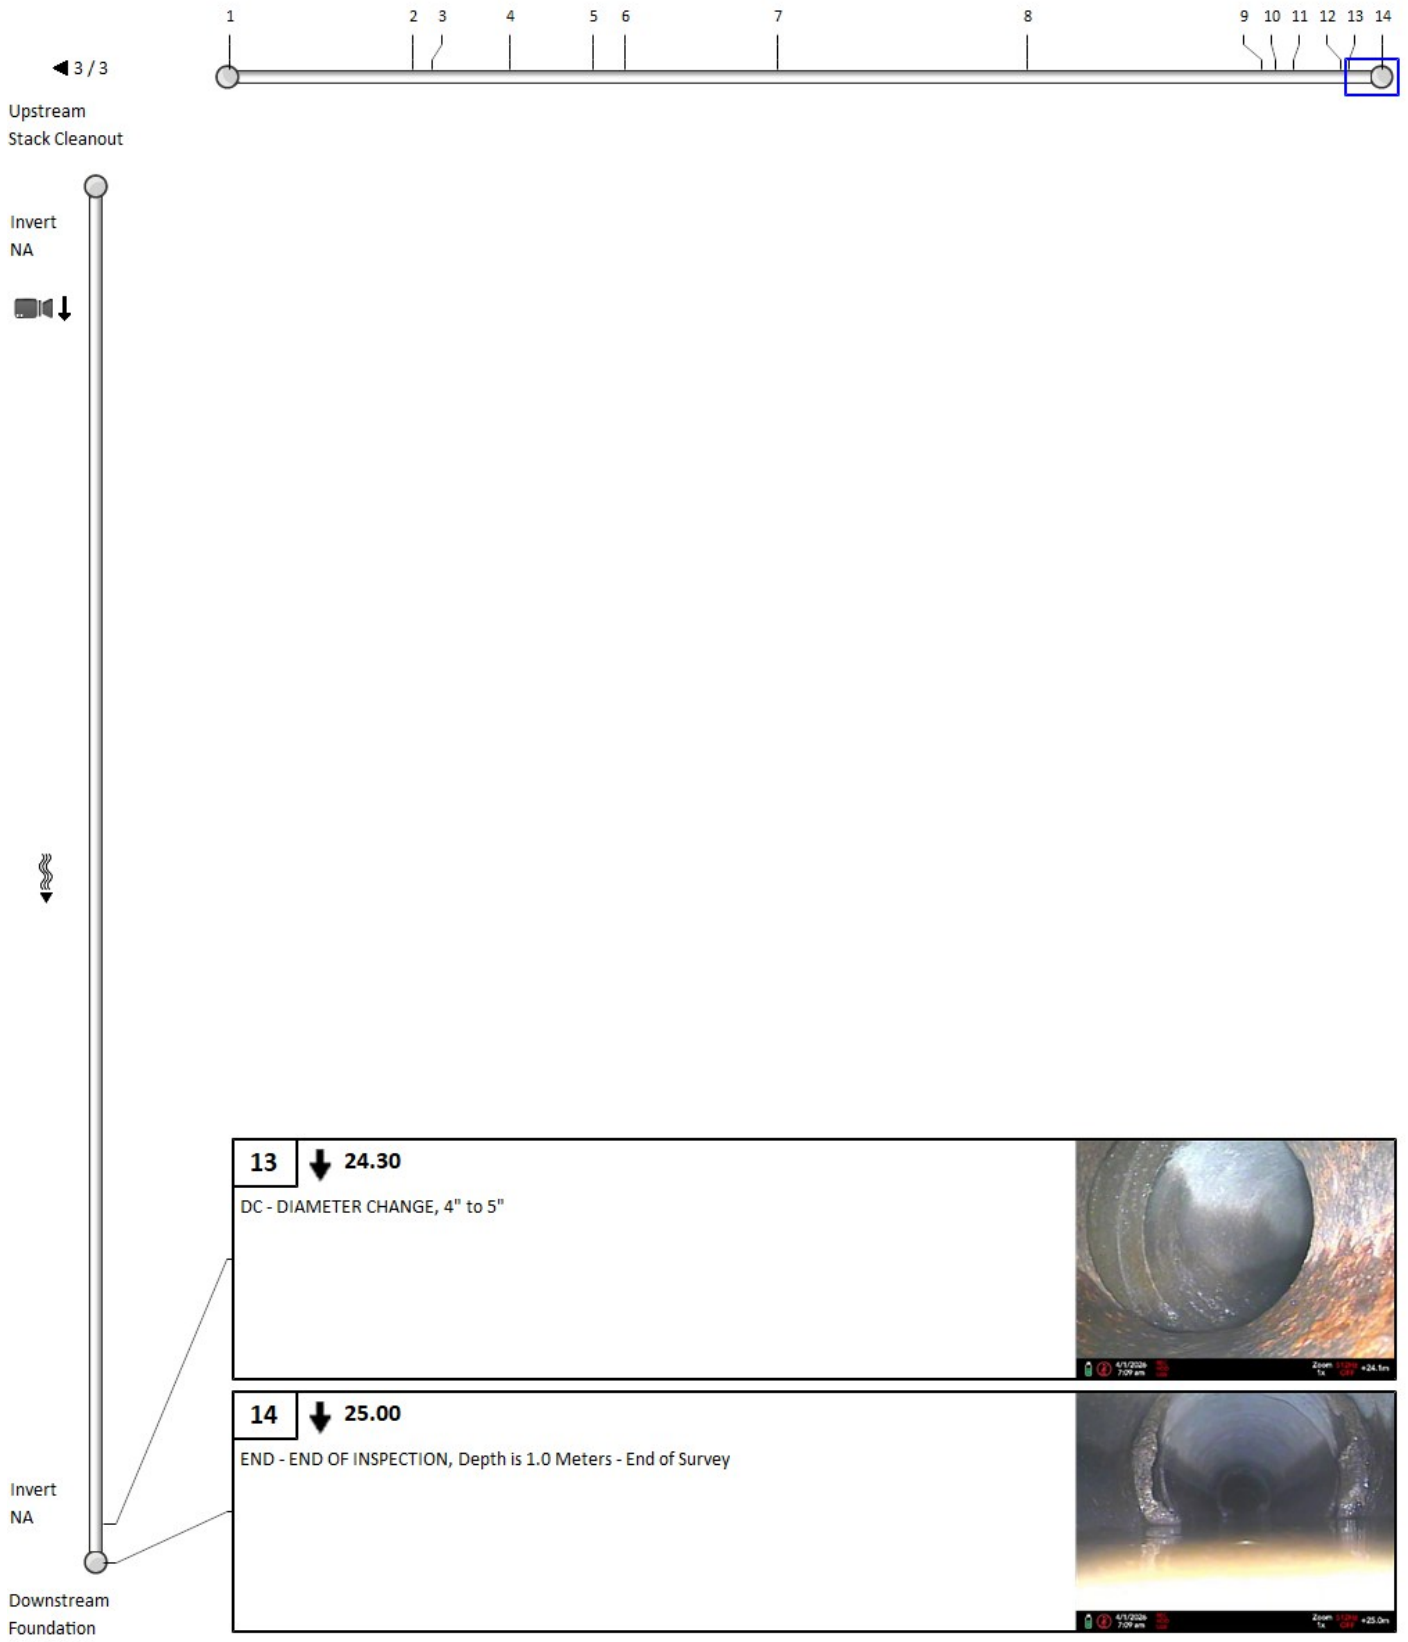
CCTV Inspection of The Storm Lateral From Stack Cleanout to Foundation
--

<b>13</b>	↓ <b>24.30</b>	DC - DIAMETER CHANGE, 4" to 5"	
<b>14</b>	↓ <b>25.00</b>	END - END OF INSPECTION, Depth is 1.0 Meters - End of Survey
