**TREE CONSERVATION REPORT**

Ashbury College  
362 Mariposa Ave.

August 14<sup>th</sup>, 2026

Stantec Consulting Ltd.  
1331 Clyde Avenue  
Ottawa ON K2C 3G4  
Project No. 116501019

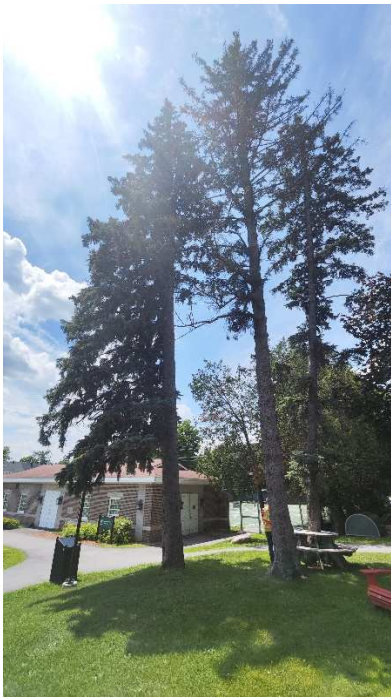
| A photograph showing three tall, slender spruce trees standing in a grassy yard. In the background, a brick house with a white garage door and a picnic table are visible under a bright blue sky with scattered clouds. | <p><b>Photograph 1: Three spruce trees (trees #24-26) anticipated to require removal for construction of new pathway.</b></p> |

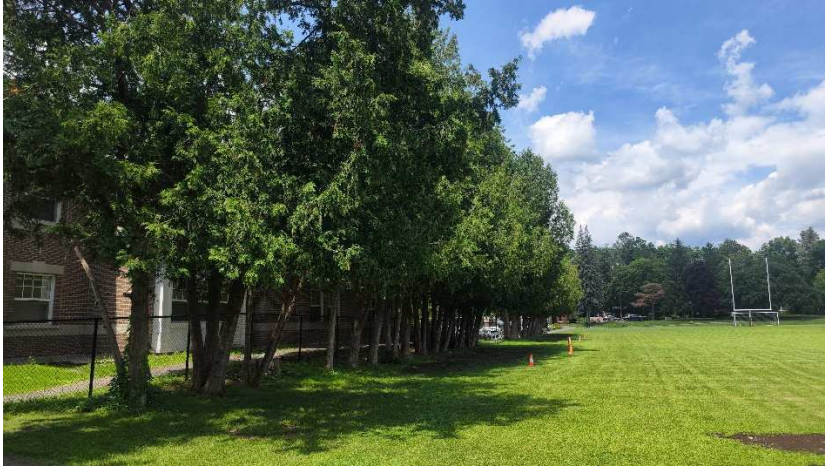
**Photograph 3: Mature cedar groupings (G1 & G2) provide shade and screening along the west side of the existing sports field.**

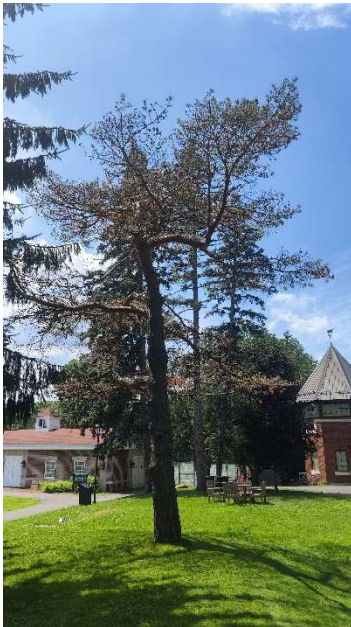
**Photograph 4: Scots Pine (tree #23) in significant decline. It is recommended to remove this tree.**

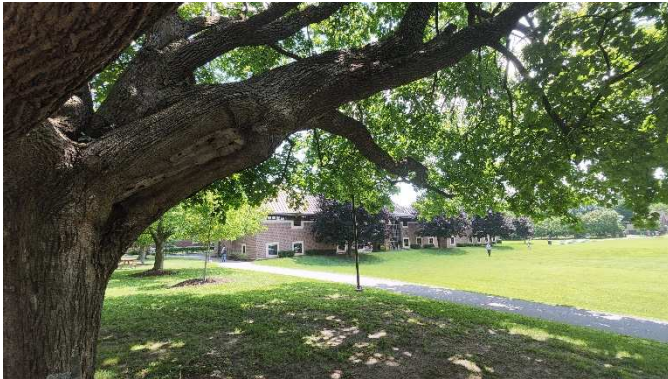
Three trees were identified as requiring further attention because of condition or potential public safety concerns. Tree #16 is a large and significant Sugar Maple located next to a walkway that is often used as a backdrop for class photographs. A large branch extends horizontally over the pathway and exhibits significant wood decay at the junction with the trunk, which may weaken the branch structure and increase the potential for failure. It is recommended that a Certified Arborist assess this branch for mitigation, which may include physical support, bracing, pruning, or removal. Tree #18 is a large Norway Maple with significant trunk rot and a natural lean toward a nearby building. This tree should be considered for removal. Tree #23 is a Scots Pine in significant decline and is recommended for removal, as noted in Appendix B.

| ID # | Botanical Name | Common Name | Total Count | DBH (cm) | Tree Count (by DBH Range) | | | Condition | | | Remarks | | Rationale for Removals | Ownership | Construction Requirement |
|---|---|---|---|---|---|---|---|---|---|---|---|---|---|---|---|
| 16 | <i>Acer saccharum</i> | Sugar Maple | 1 | 82 | 0 | 0 | 1 | F | F | F | branch tip dieback, exposed roots, trunk cavity, wood decay | large cavity on large horizontal branch extending over pathway. *potential hazard: consider pruning | To be protected | Private | Retain / *Prune |

**Photograph 5: Hazardous limb over pathway on a significant/distinctive Sugar Maple (tree #16).**

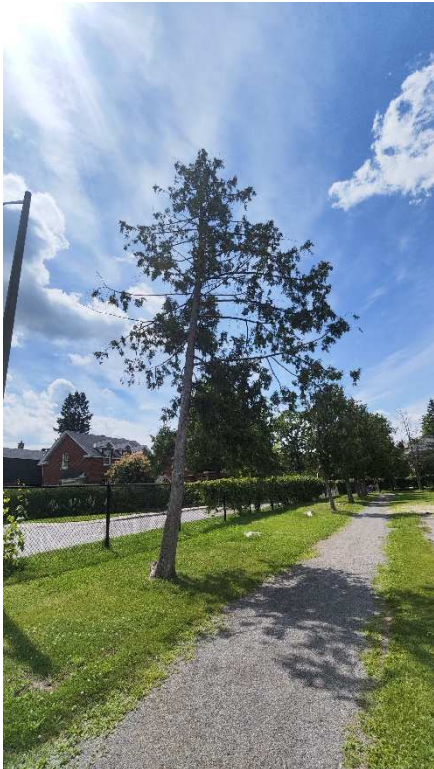
A mature stand of White Cedars (*Thuja occidentalis*) aligned in dense rows adjacent to Maple Lane and Mathews House on the south and southwest sides of the study area has developed a conical form with dense, intertwined canopies. Although heart rot was not identified during the field assessment, mature White Cedars can be susceptible to heart rot and hollow trunks as they age. Several cedar trees within these groupings also have canopies that are significantly suppressed by adjacent cedars and large deciduous trees.

**Photograph 6: Cedar trees along the south side of the existing sports field that no longer form a continuous canopy.**

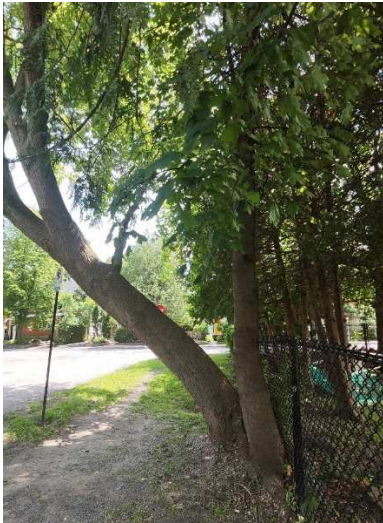
All trees inventoried are privately owned except for five (5) trees (#44, 48-51) growing adjacent to the study area; these five (5) trees are municipally owned.

**Photograph 7: Several trees located outside of private property on municipal right-of-way.**

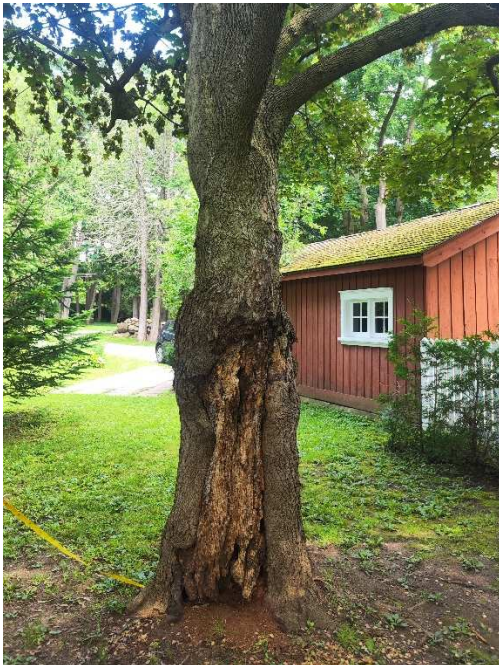
| ID # | Botanical Name | Common Name | Total Count | DBH (cm) | Tree Count (by DBH Range) | | | Condition | | | Remarks | | Rationale for Removals | Ownership | Construction Requirement |
|---|---|---|---|---|---|---|---|---|---|---|---|---|---|---|---|
| 18 | <i>Acer platanoides</i> | Norway Maple | 1 | 64 | 0 | 0 | 1 | P | P | F | trunk cavity, wood decay, natural lean, suppressed canopy vigor, crossing branches | *hazardous tree, significant damage / decay<br>consider removal | To be protected | Private | Retain* |

**Photograph 8: Hazardous tree (#18) near Ashbury House with severe rot in base of trunk.**
