TREE CONSERVATION REPORT

Ashbury College
362 Mariposa Ave.

April 1st, 2026

Stantec Consulting Ltd.
1331 Clyde Avenue
Ottawa ON K2C 3G4
Project No. 160401942

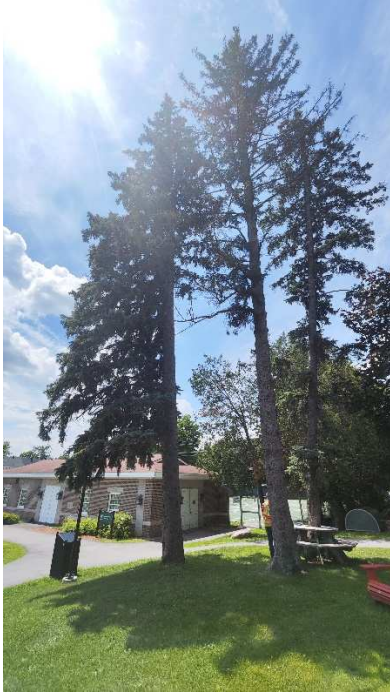
Photograph 1: Three spruce trees (trees #24-26) anticipated to require removal for construction of new pathway.

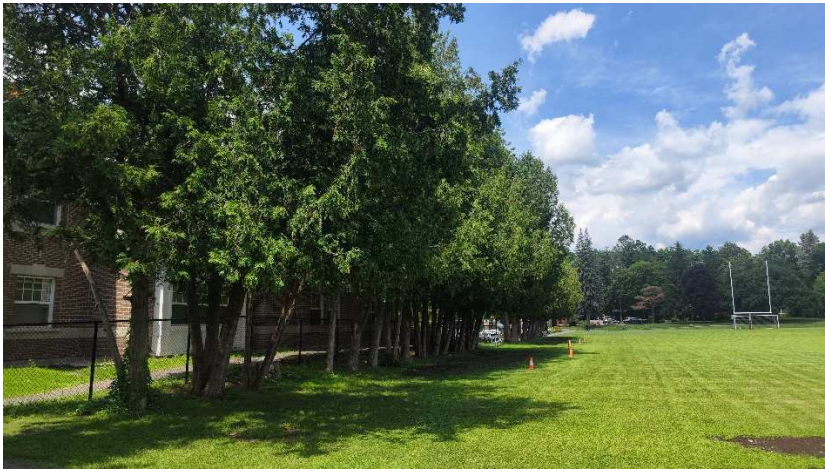
Photograph 3: Mature cedar groupings (G1 & G2) provide shade and screening along the west side of the existing sports field.

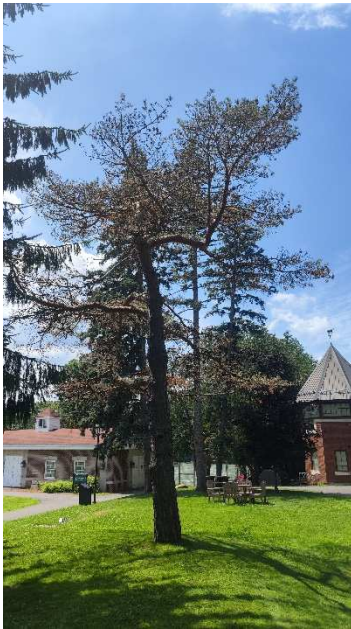
Photograph 4: Scots Pine (tree #23) in significant decline. It is recommended to remove this tree.

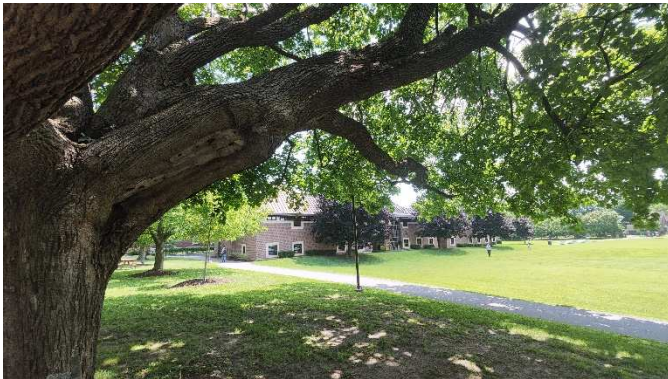
Two trees were assessed as potentially hazardous to the public. Tree #16 is a large and significant Sugar Maple next to a walkway and often used as a backdrop for class photos. It has a large branch extending

horizontally over the pathway with significant wood decay at the junction to the trunk potentially weakening its structure and making it prone to breakage. It is recommended that this branch be considered for potential physical supporting / bracing or pruning / removal to mitigate the risk of fall hazard to pathway and campus users. Tree #18 is a large Norway Maple that has significant rot in the trunk, with a natural lean towards a nearby building. It should be considered for removal.

Photograph 5: Hazardous limb over pathway on a significant / distinctive Sugar Maple (tree #16).

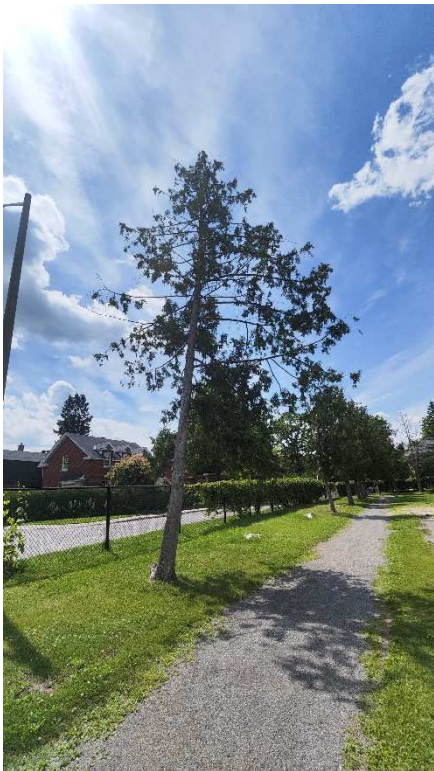
A mature stand of White Cedars (*Thuja occidentalis*) aligned in dense rows adjacent to Maple Lane and Mathews House (south and south-west side of study area) have become conical in form with dense intertwined canopies. It should be noted that although not identified on site, mature White Cedars can be susceptible to heart rot causing hollow trunks as they age. Also, several cedar trees within these groupings have canopies which are significantly suppressed by adjacent cedars and large deciduous trees.

Photograph 6: Cedar trees along the south side of the existing sports field no longer form a continuous canopy.

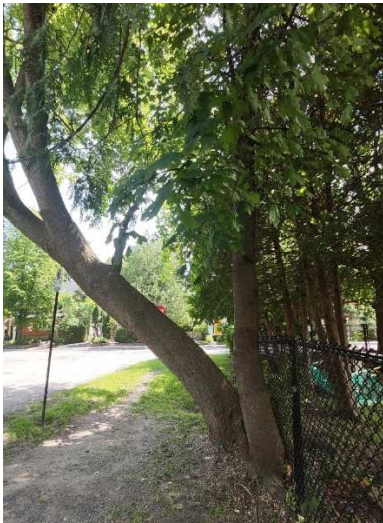
Photograph 7: Several trees located outside of private property on municipal right-of-way.

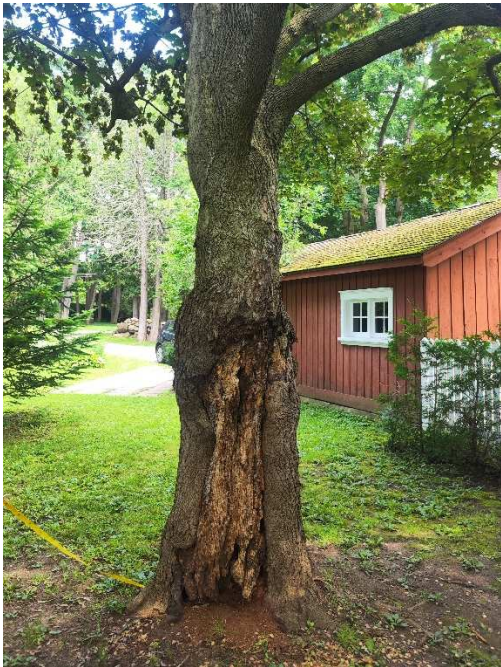
Photograph 8: Hazardous tree (#18) near Ashbury House with severe rot in base of trunk.
