# TREE CONSERVATION REPORT

2180 Montreal Road v2.0

Tree Conservation Report submitted as Partial  
Requirements for a Site Plan Control Application,  
August 28, 2026

**Date of Report:** August 28, 2026

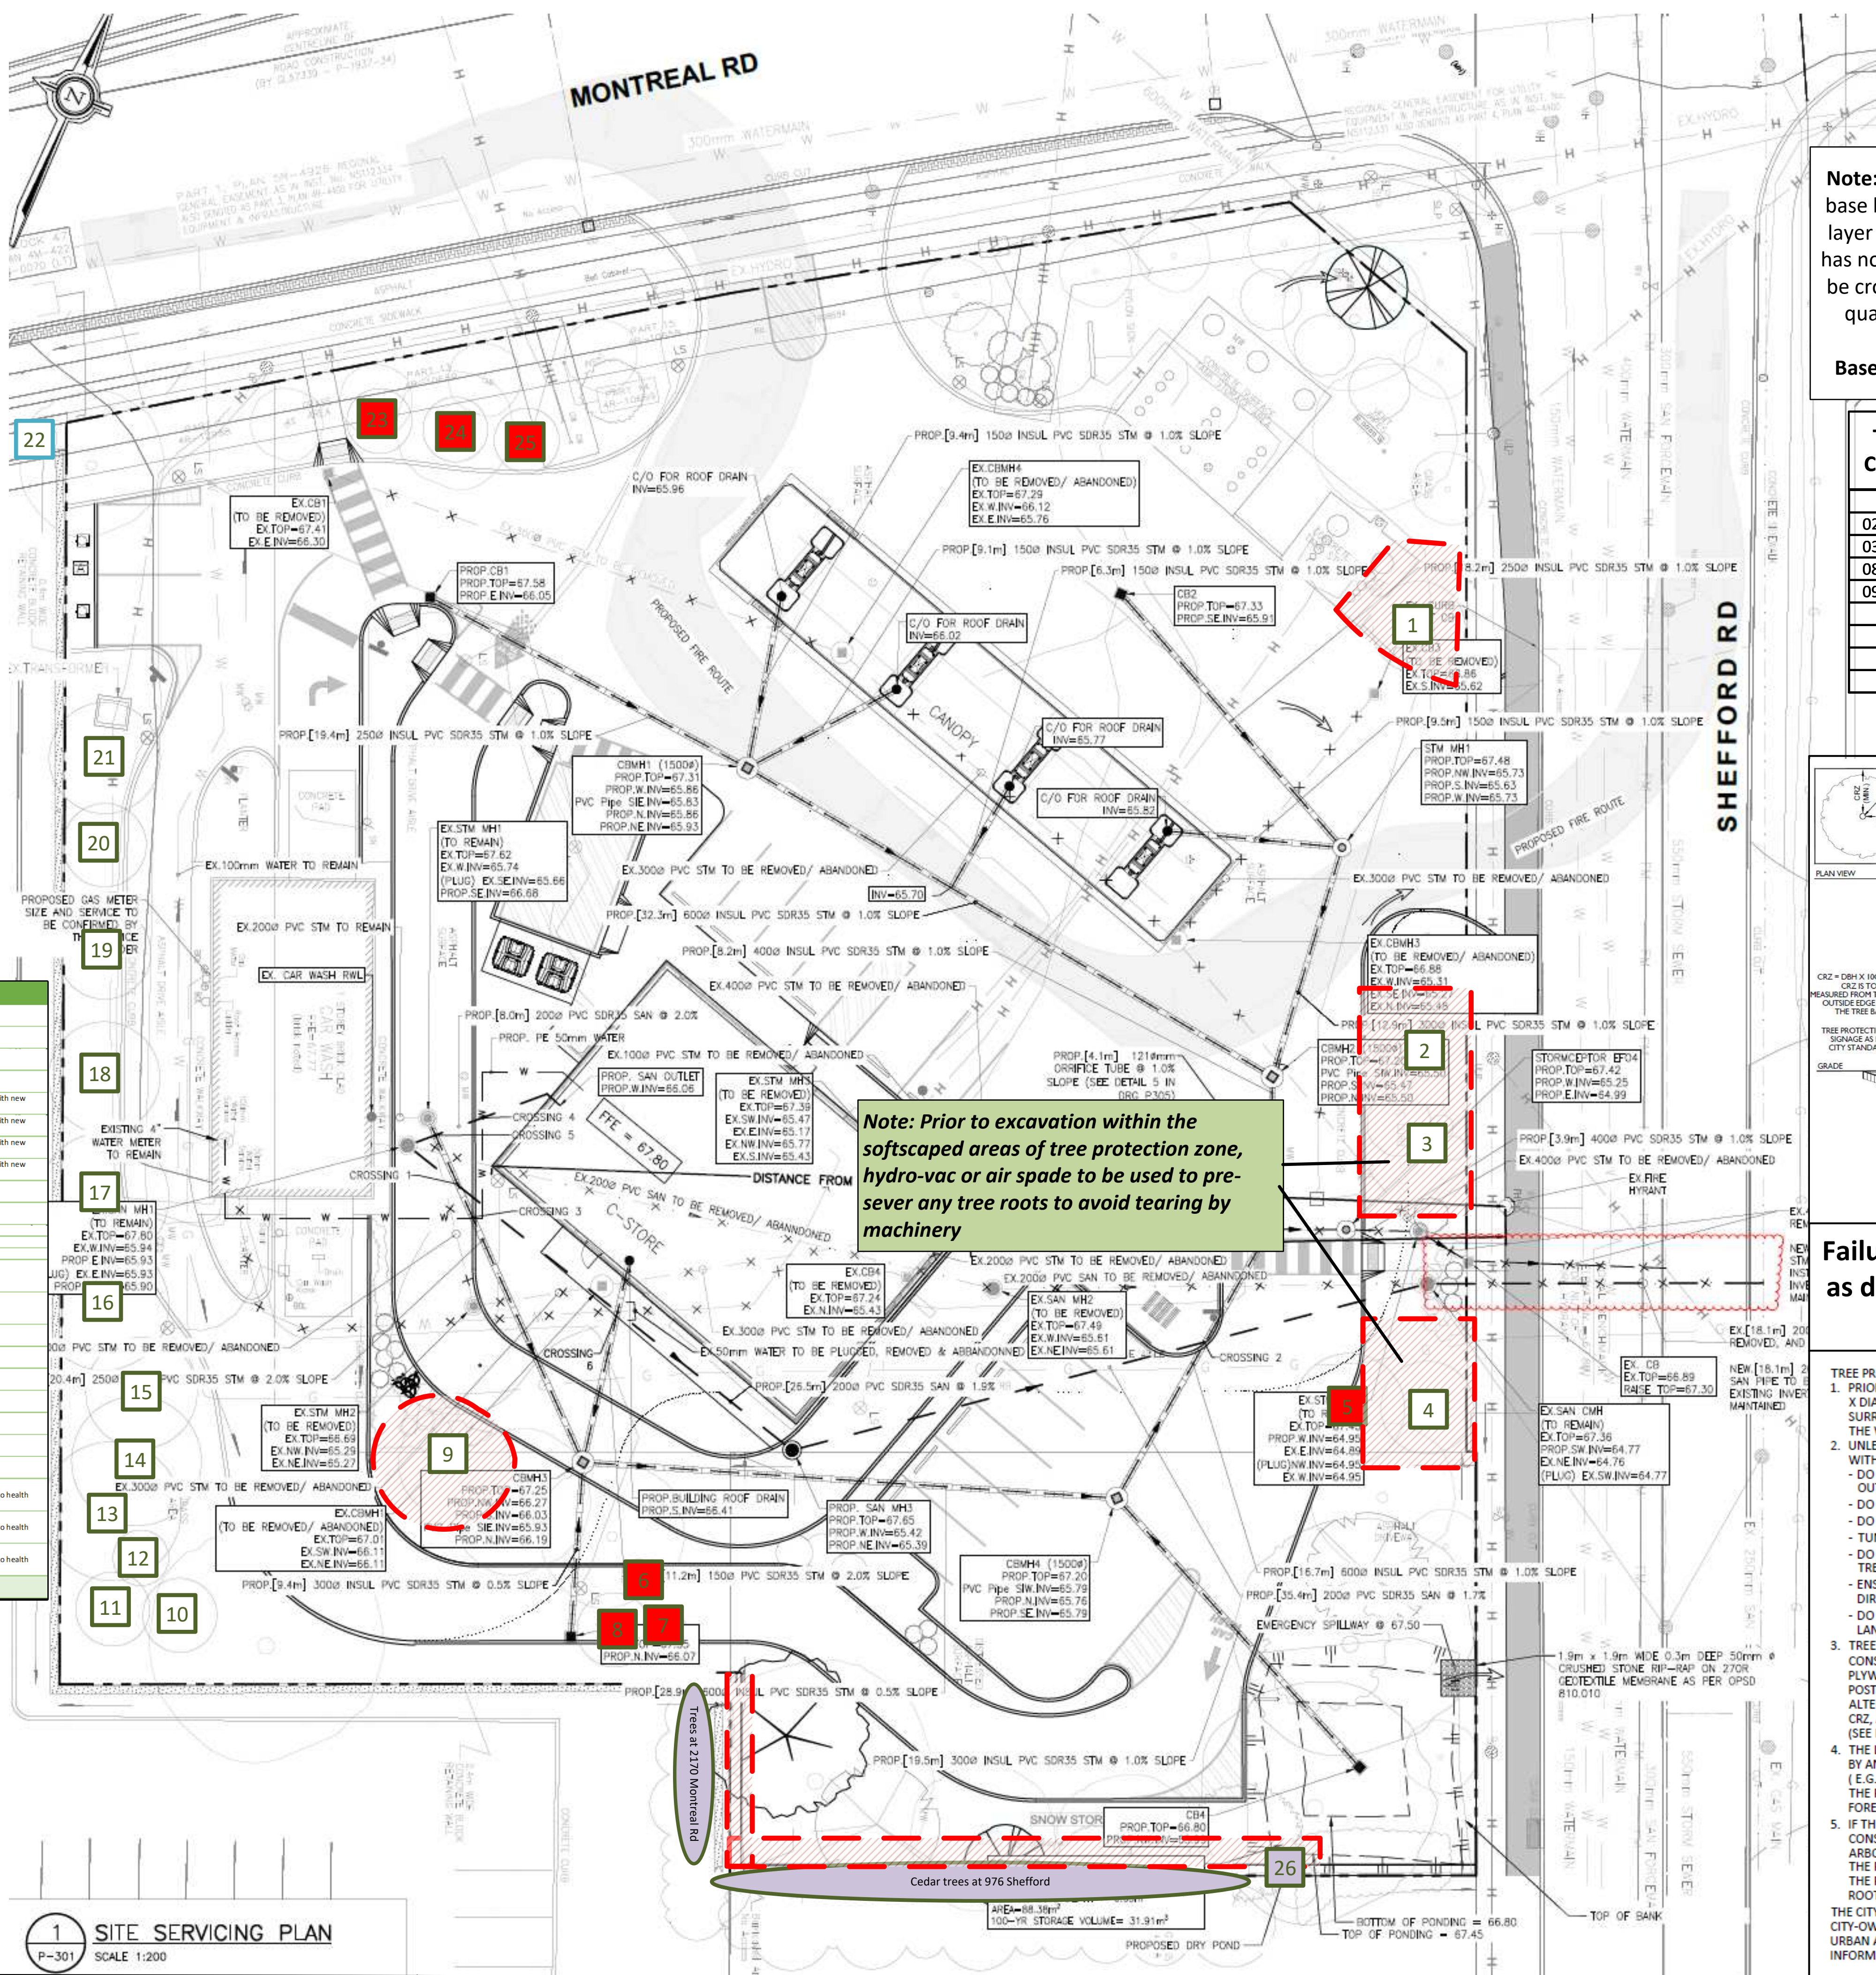
**TCR Map#2: Proposed Development and Conserved Vegetation – 2180 Montreal Rd**

**Map #2: Proposed Development and Conservation**, located in **Appendix 2**, provides a spatial overview of the removals. This map is overlaid onto the **Site Servicing Plan** and identifies the following trees for removal: **5, 6, 7, and 8**.

Detailed **Tree Protection Area** are delineated in **Map #2: Proposed Development and Conservation (Appendix 2)**. These protective barriers must be fully established and inspected prior to the commencement of any site works or heavy machinery mobilization.

**Prior to any site works**, protective fencing should be installed around the Tree Protection Area as indicated in Map#2: Proposed Development and Conserved Vegetation and maintained until all construction on site has been completed as per the City of Ottawa Tree Protection Specifications (March 2021).

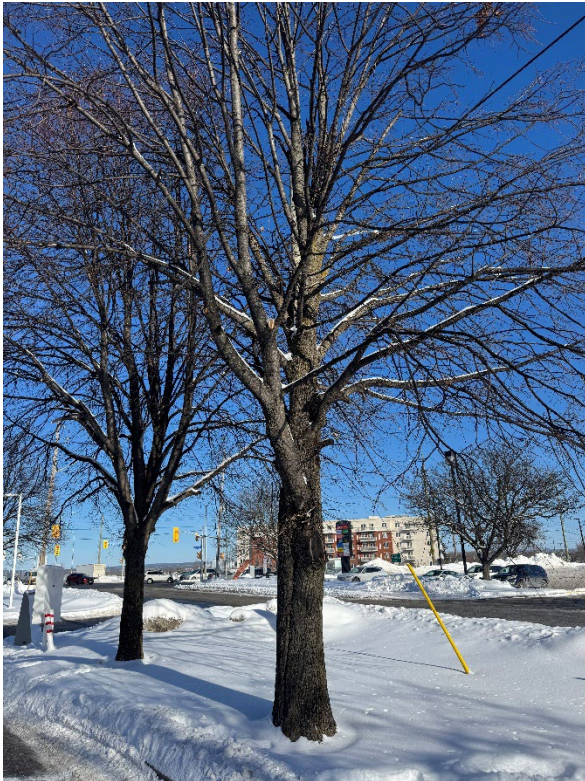
| Tree <sup>1</sup> | Species | Diameter at breast height (cm) | Ownership <sup>2,3</sup> | Condition | Action |
|---|---|---|---|---|---|
| 3 | Littleleaf linden ( <i>Tilia cordata</i> ) | 42 | 2180 Montreal Rd | Fair; poor pruning wounds, frost crack up trunk | Retain and protect |

**Photo 1: Tree 3, Little leaf linden to be removed**

**Note:** *This updated version is based on the updated civil plans dated August 6<sup>th</sup>. The only change made to this Version is status of tree #3. This tree had been identified for removal, and with some design changes, it is now identified for retention.*

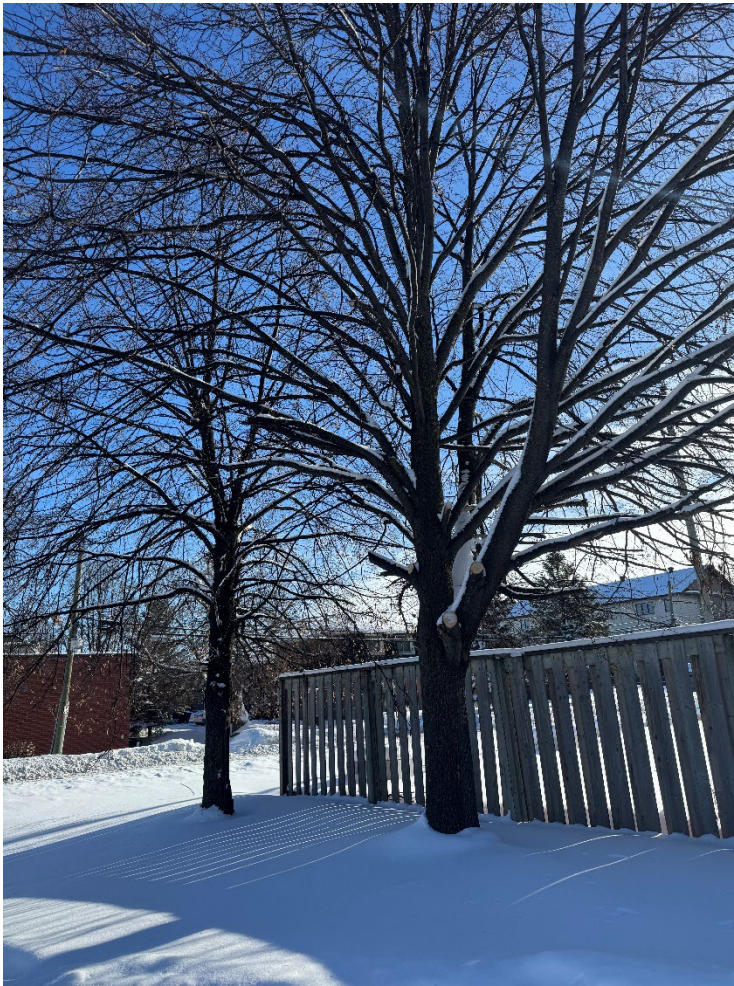
| Tree <sup>1</sup> | Species | Diameter at breast height (cm) | Ownership <sup>2,3</sup> | Condition | Action |
|---|---|---|---|---|---|
| 4 | Littleleaf linden ( <i>Tilia cordata</i> ) | 30 | 2180 Montreal Rd | Good/fair; poor pruning wounds | Retain and protect |
| 5 | Littleleaf linden ( <i>Tilia cordata</i> ) | 37 | 2180 Montreal Rd | Good/fair; poor pruning wounds | Remove; conflict with new hard surface area |

Photo 2: Tree 4 (left) to be retained and tree 5 (right) to be removed

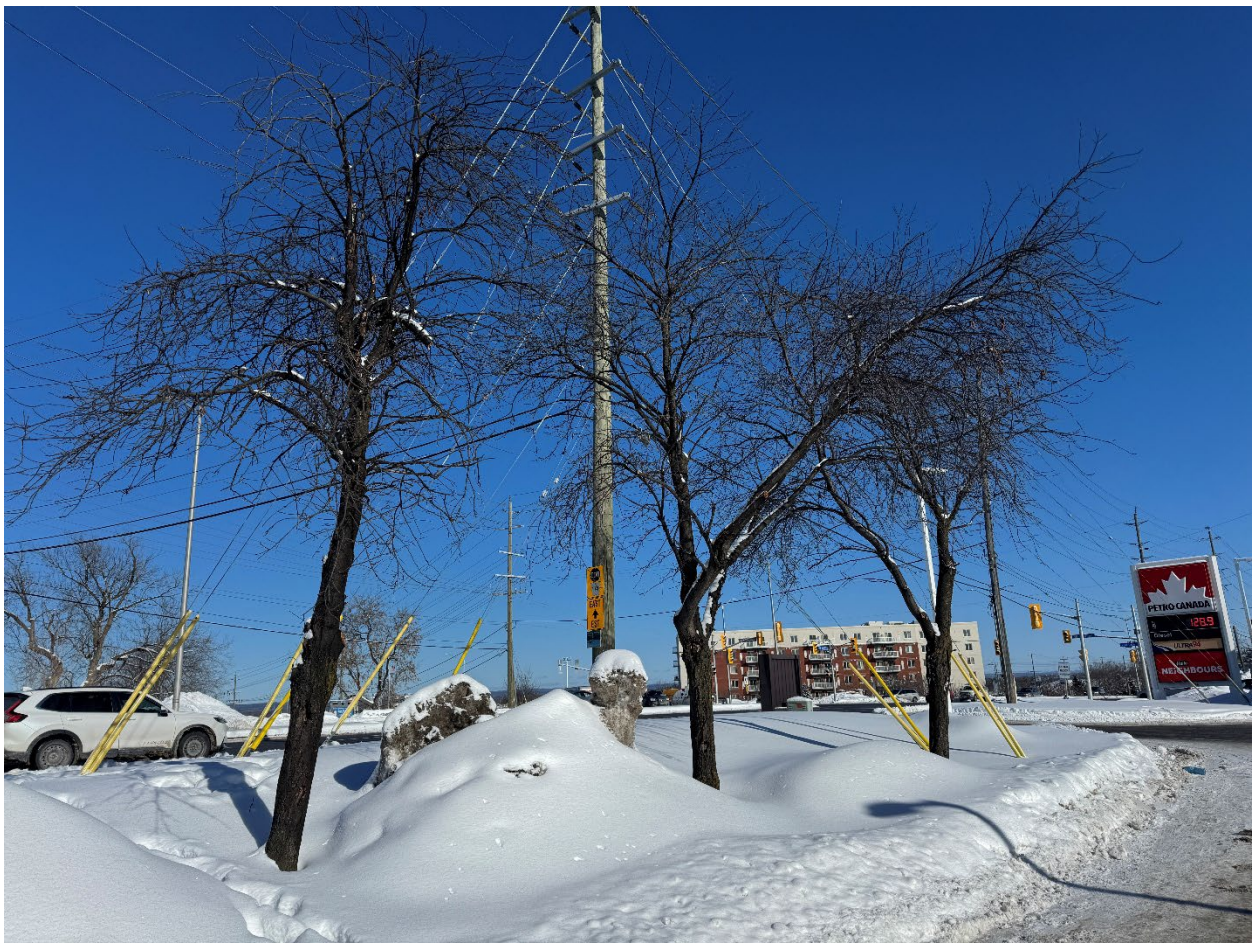
Additionally, **three (3) trees (Trees 23–25)** are recommended for removal and subsequent replacement due to poor health. These specimens are **Cherry trees** exhibiting advanced stages of **Black Knot** (*Apiosporina morbosae*), a progressive fungal disease common to the *Prunus* genus that compromises structural integrity and aesthetic value.

| 23 | Shubert choke cherry ( <i>Prunus virginiana</i> 'Schubert') | 23 | 2180 Montreal Rd | Poor; almost dead | Remove due poor to health |
| 24 | Shubert choke cherry ( <i>Prunus virginiana</i> 'Schubert') | 24 | 2180 Montreal Rd | Poor; blacknot present | Remove due poor to health |
| 25 | Shubert choke cherry ( <i>Prunus virginiana</i> 'Schubert') | 23 | 2180 Montreal Rd | Poor; blacknot present, poor pruning cuts | Remove due poor to health |

Photo 3: Trees 23-25, Shubert choke cherries in poor condition, removal and replacement recommended
