## **STORM & SANITARY SEWER** **CCTV INSPECTION REPORT**

**Report: HYD-26269**

**Completion date: July 14<sup>th</sup> 2026**

**Project: Petro Canada Riverside Ottawa**

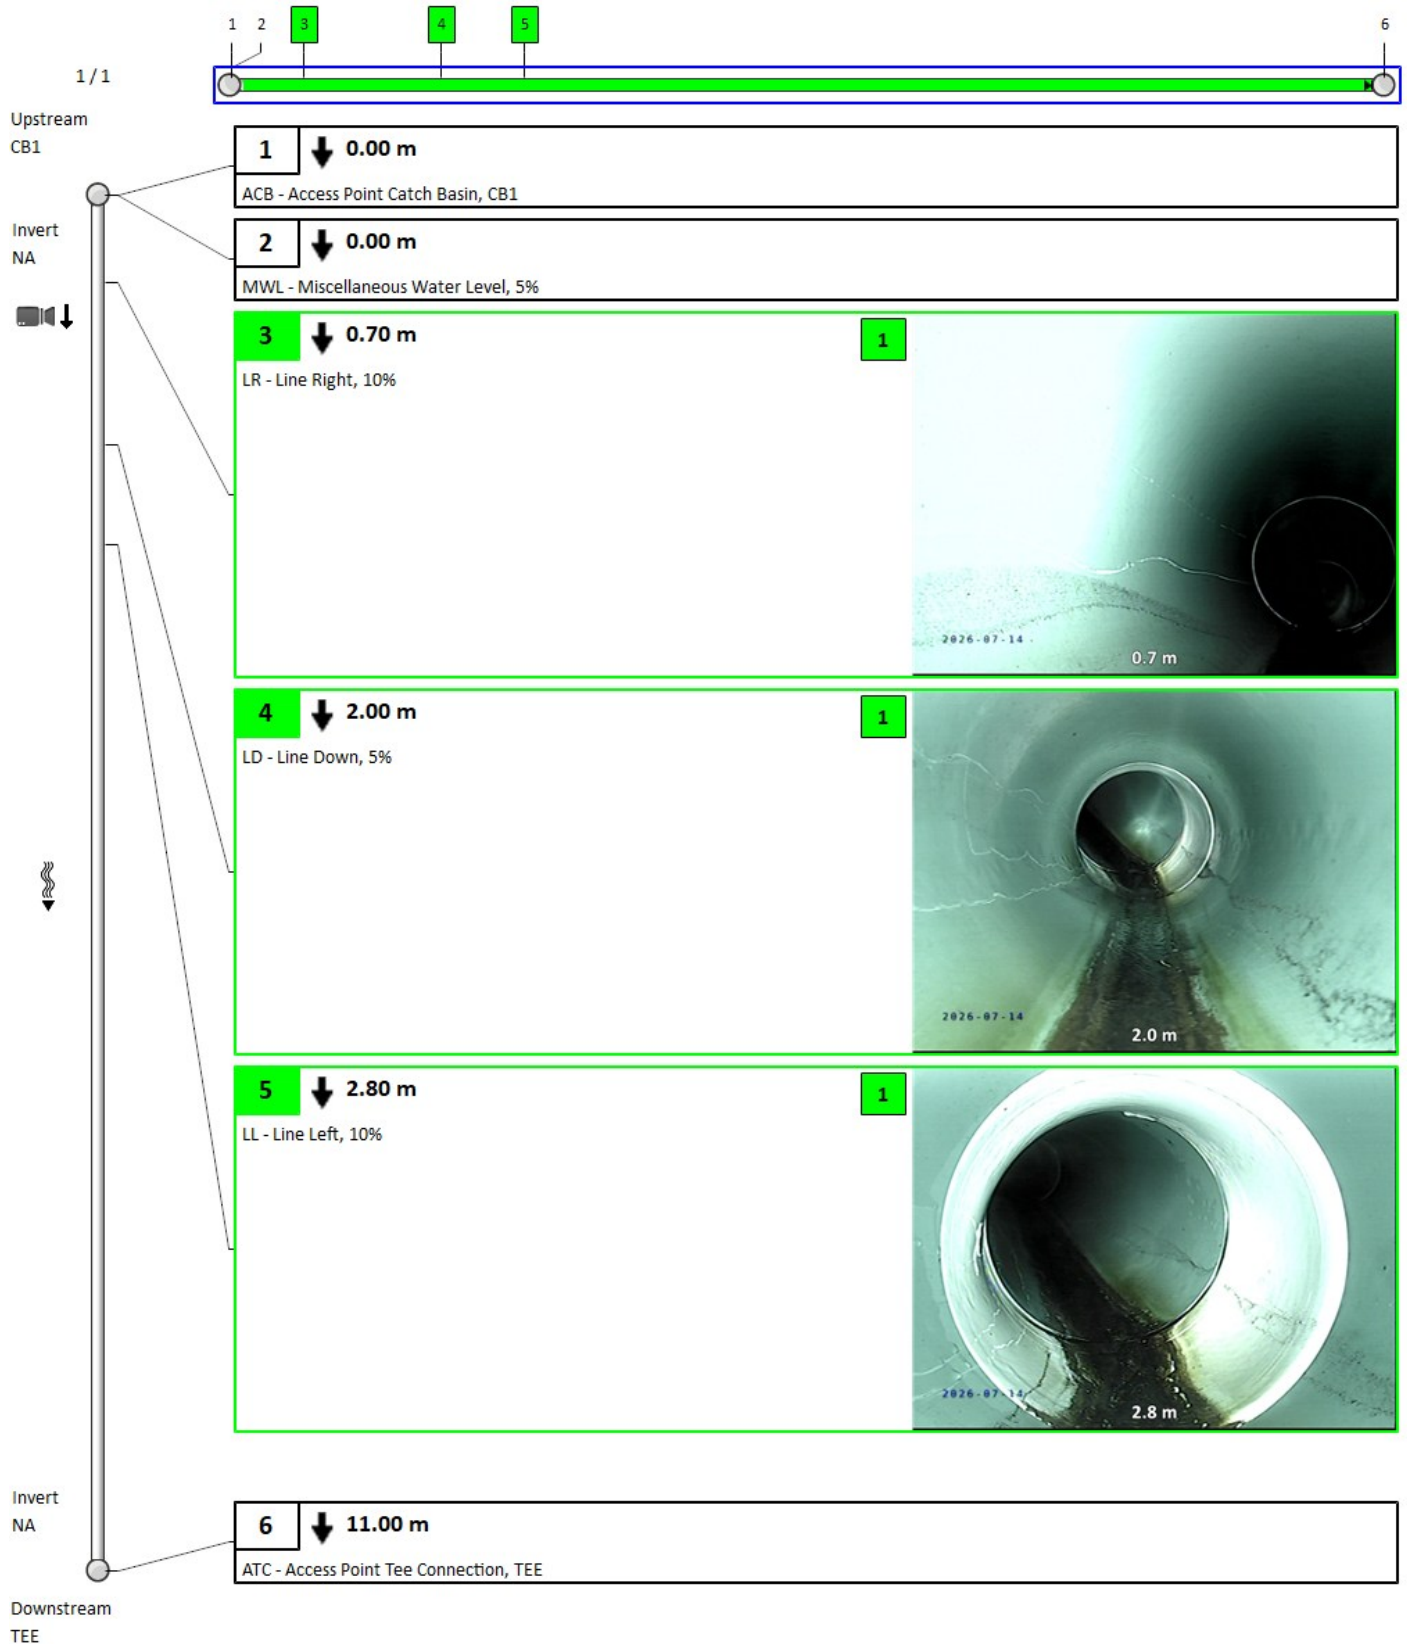
| Pipe: CB1-TEE | Direction of inspection: CB1 --> TEE |

| Structural rating | O&M rating | Overall rating | Failure |
|---|---|---|---|
| Peak: 0 | Peak: 1 | Peak: 1 | Consequence: |
| Quick rating: 0000 | Quick rating: 1300 | Quick rating: 1300 | Likelihood: 1.3 |

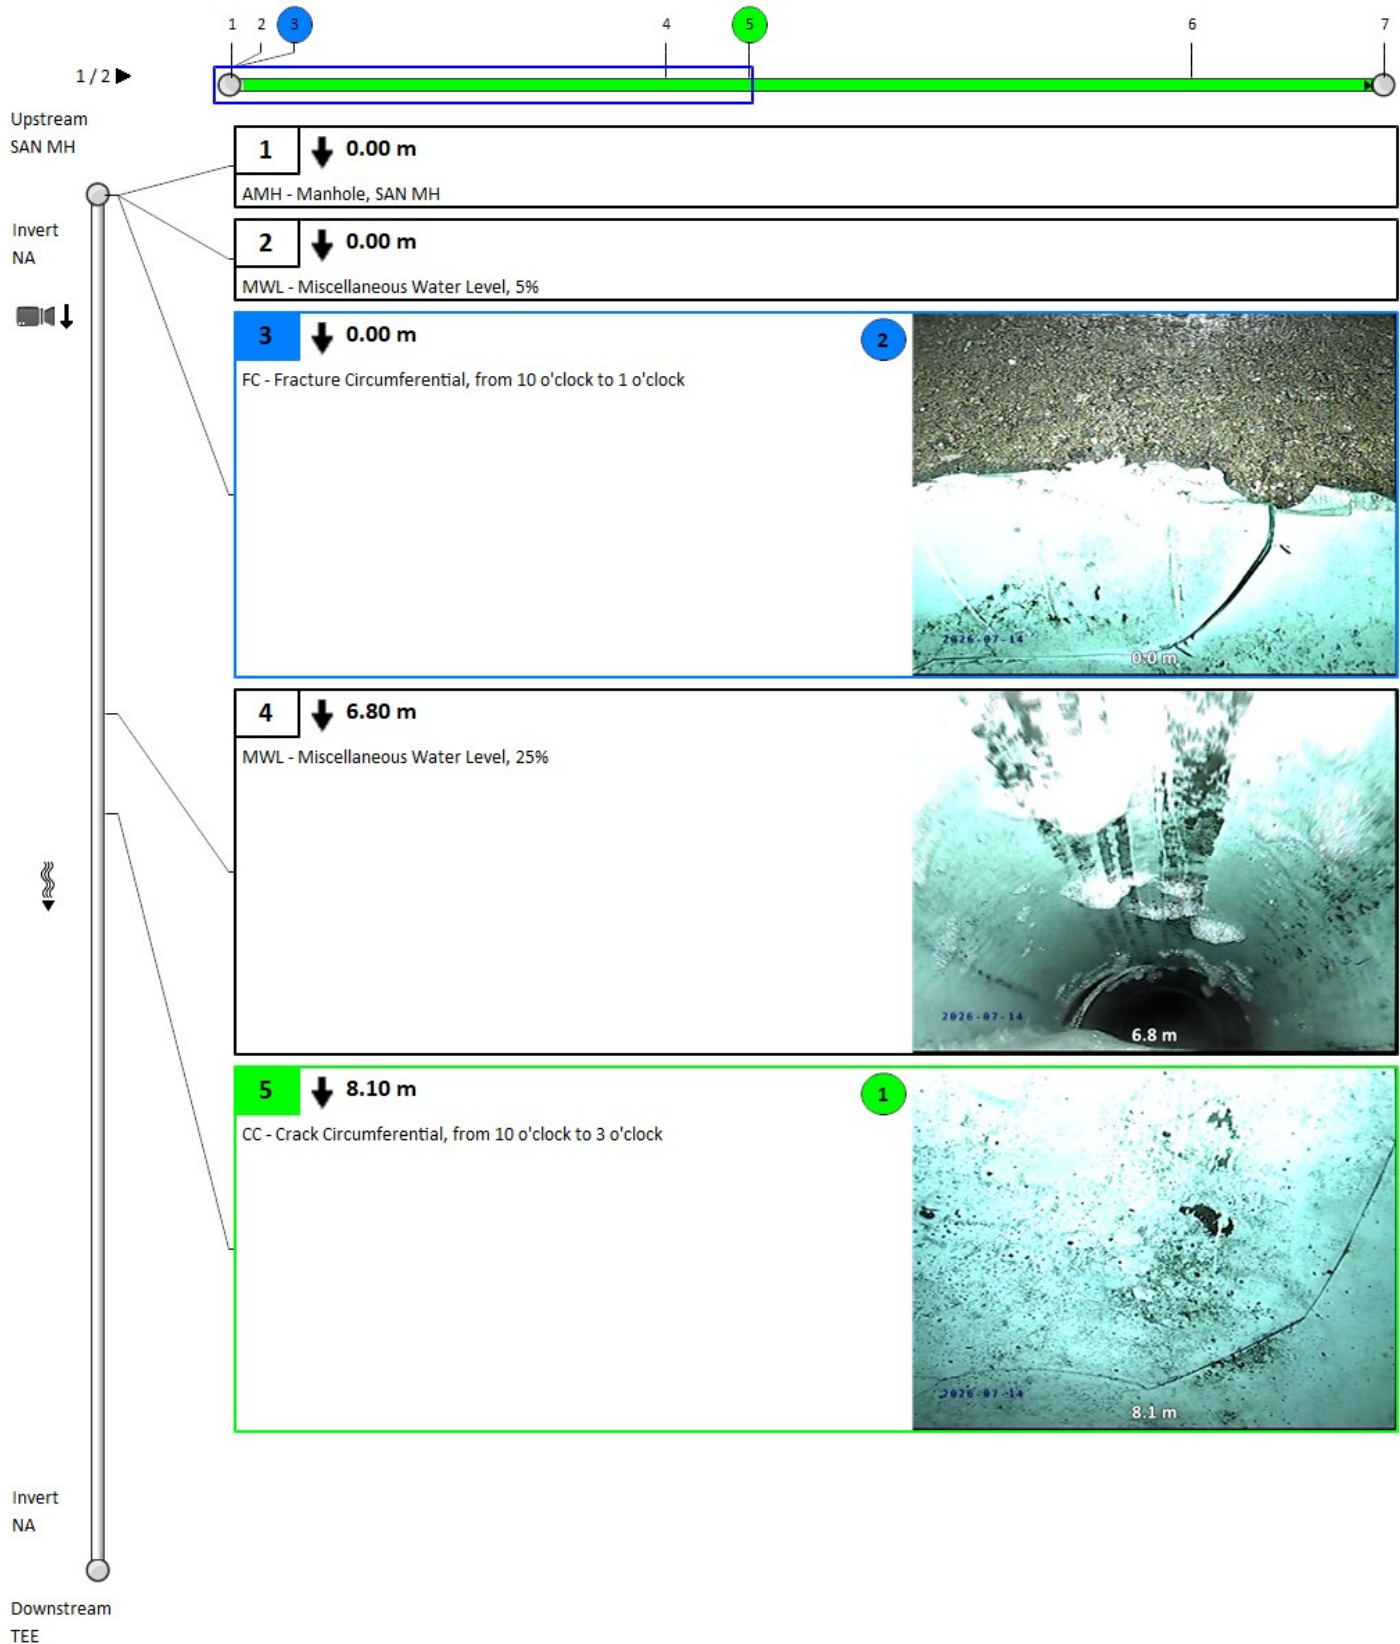
| Pipe: | SAN MH1-TEE | Direction of inspection: | SAN MH --> TEE |

| Structural rating | O&M rating | Overall rating | Failure |
|---|---|---|---|
| Peak: 2 | Peak: 0 | Peak: 2 | Consequence: |
| Quick rating: 2111 | Quick rating: 0000 | Quick rating: 2111 | Likelihood: 2.1 |
