# Arborist Report

## Pre-Construction Assessment Report

106 Eagleson St, Ottawa  
K2L 2P1

**Revised: April 24, 2026**

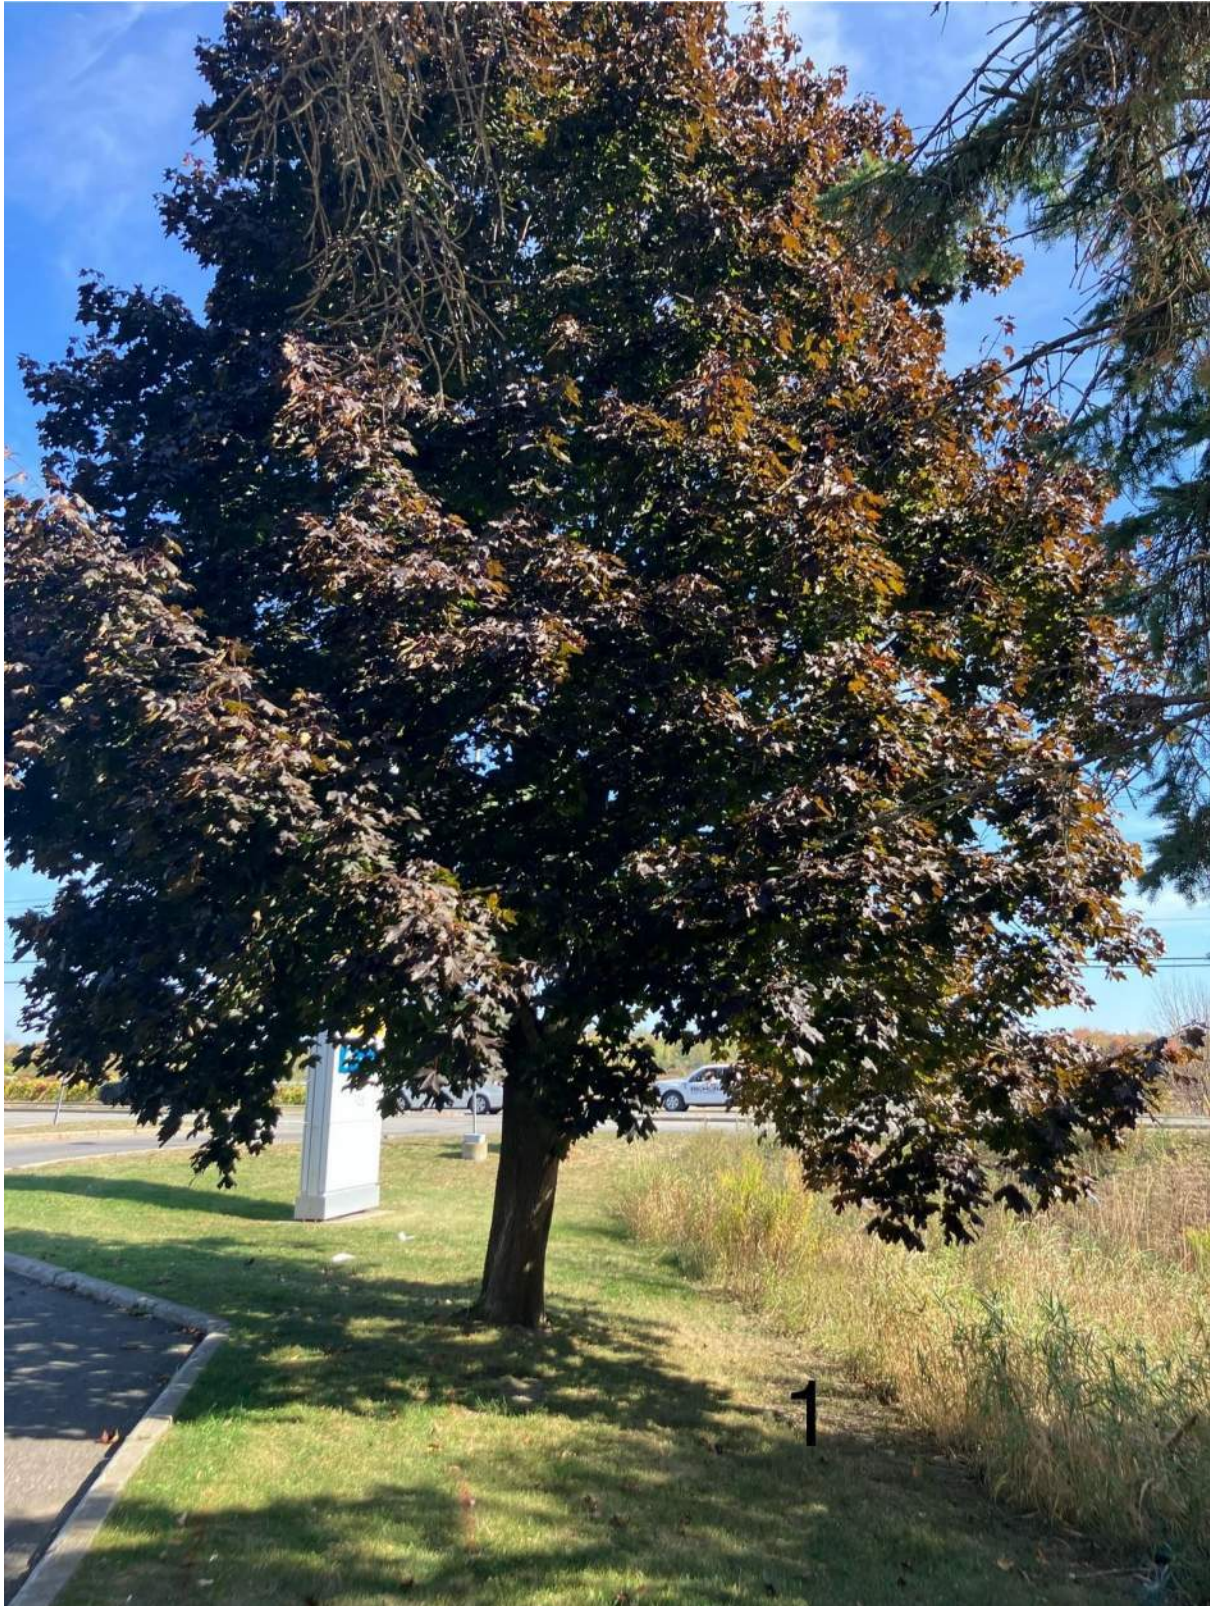
Figure 1 – Tree #1

| Tree Map Number | Species | Botanical | DBH (cm) @ 1.4 m | Tree Ownership | Minimum Tree Protection Distance (m) | Health | Structure | Overall Condition | Tree Height (m) | Crown Width (m) | Deadwood (%) | Construction inside Min TPZ? (Y/N) | Construction Impact (None, Low, Medium, High) | Action | Permit Required? (Y/N) | Notes and Recommendations |
|---|---|---|---|---|---|---|---|---|---|---|---|---|---|---|---|---|
| 1 | Maple, Norway | <i>Acer platanooides</i> | 41 | Private | 4.1 | Good | Good | Good | 9 | 7 | 2 | N | None | Preserve | N | Girdling roots / Lateral crack |

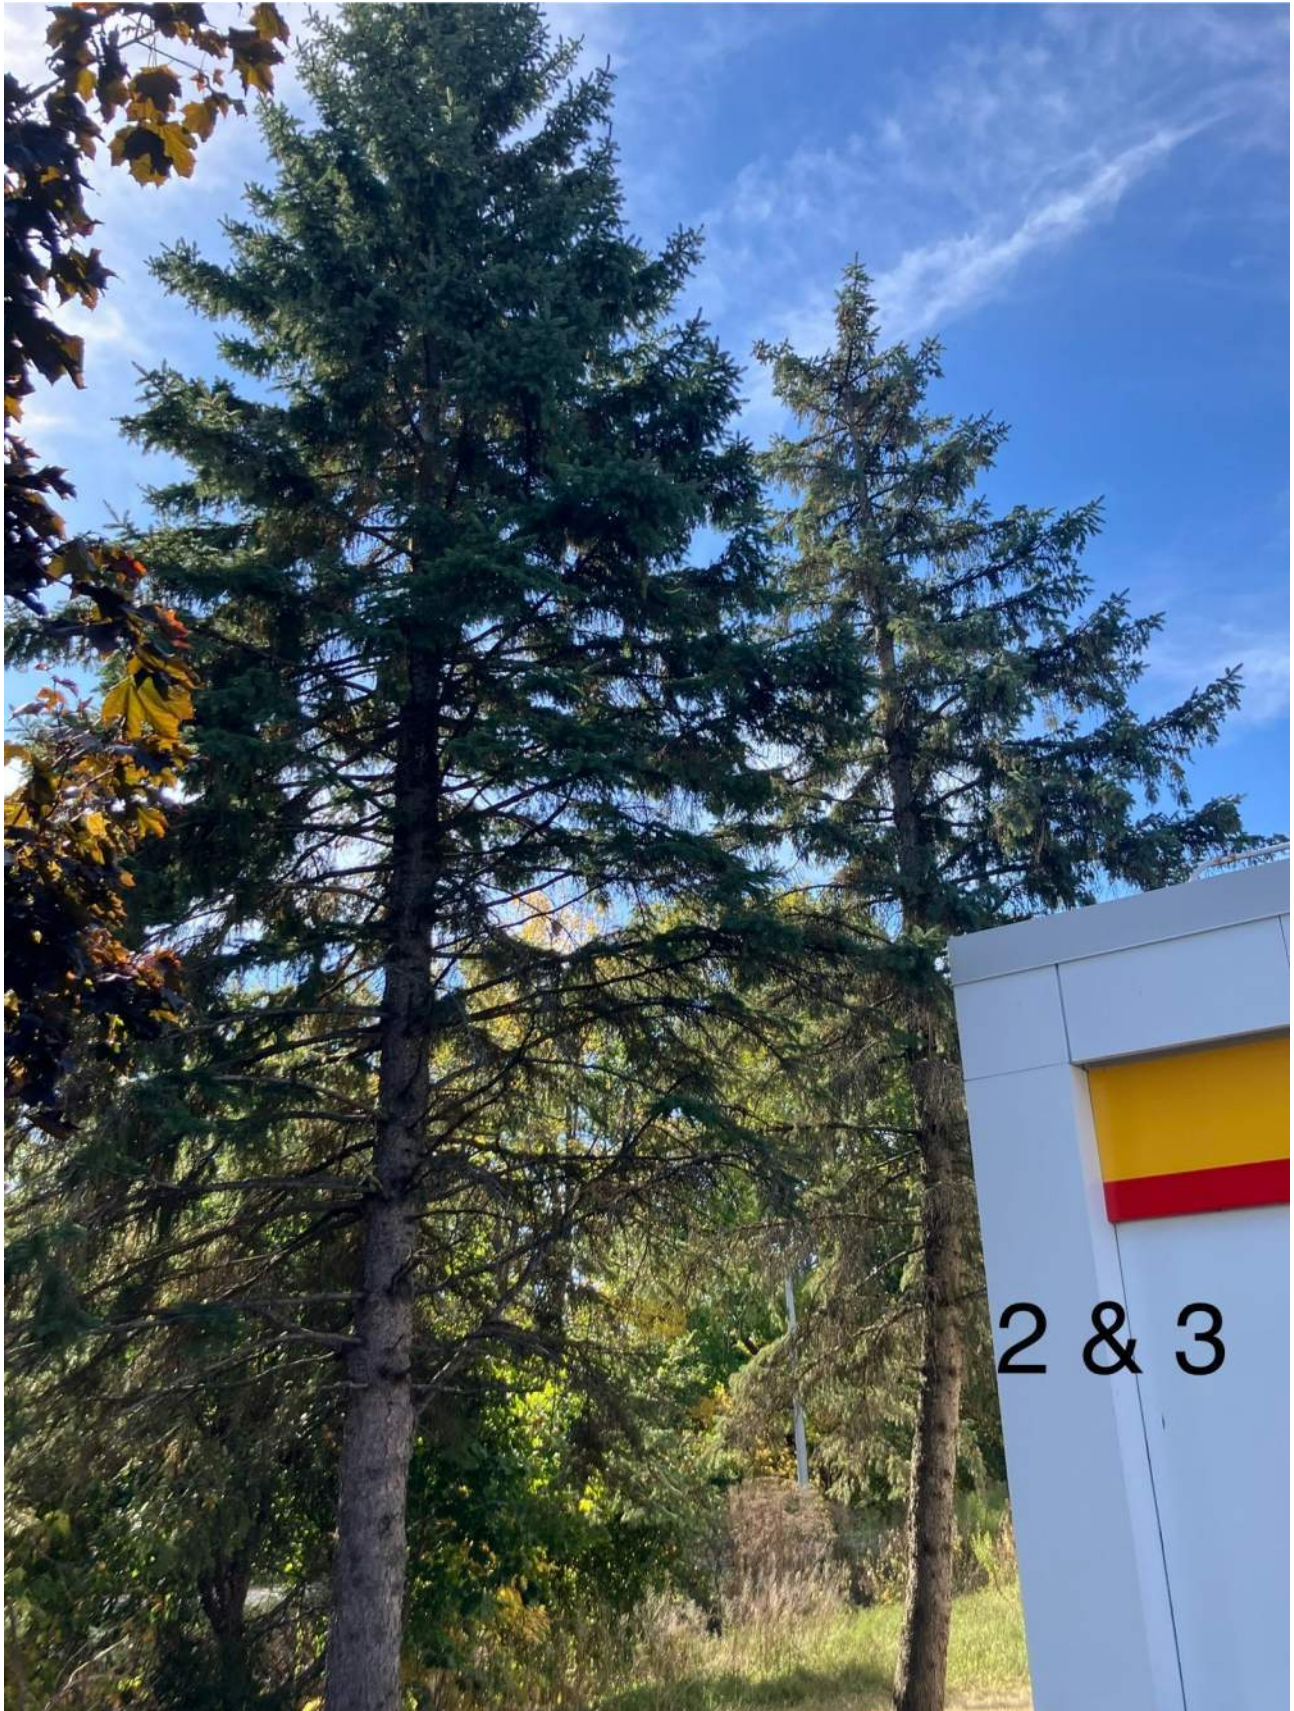
Figure 2 – Tree #2 & #3

| Tree Map Number | Species | Botanical | DBH (cm) @ 1.4 m | Tree Ownership | Minimum Tree Protection Distance (m) | Health | Structure | Overall Condition | Tree Height (m) | Crown Width (m) | Deadwood (%) | Construction inside Min TPZ? (Y/N) | Construction Impact (None, Low, Medium, High) | Action | Permit Required? (Y/N) | Notes and Recommendations |
|---|---|---|---|---|---|---|---|---|---|---|---|---|---|---|---|---|
| 2 | Spruce, spp. | <i>Picea spp.</i> | 40 | Private | 4.0 | Good | Good | Good | 15 | 5 | 2 | N | None | Preserve | N | |
| 3 | Spruce, spp. | <i>Picea spp.</i> | 30 | Private | 3.0 | Good | Good | Good | 9 | 3 | 1 | N | None | Preserve | N | |

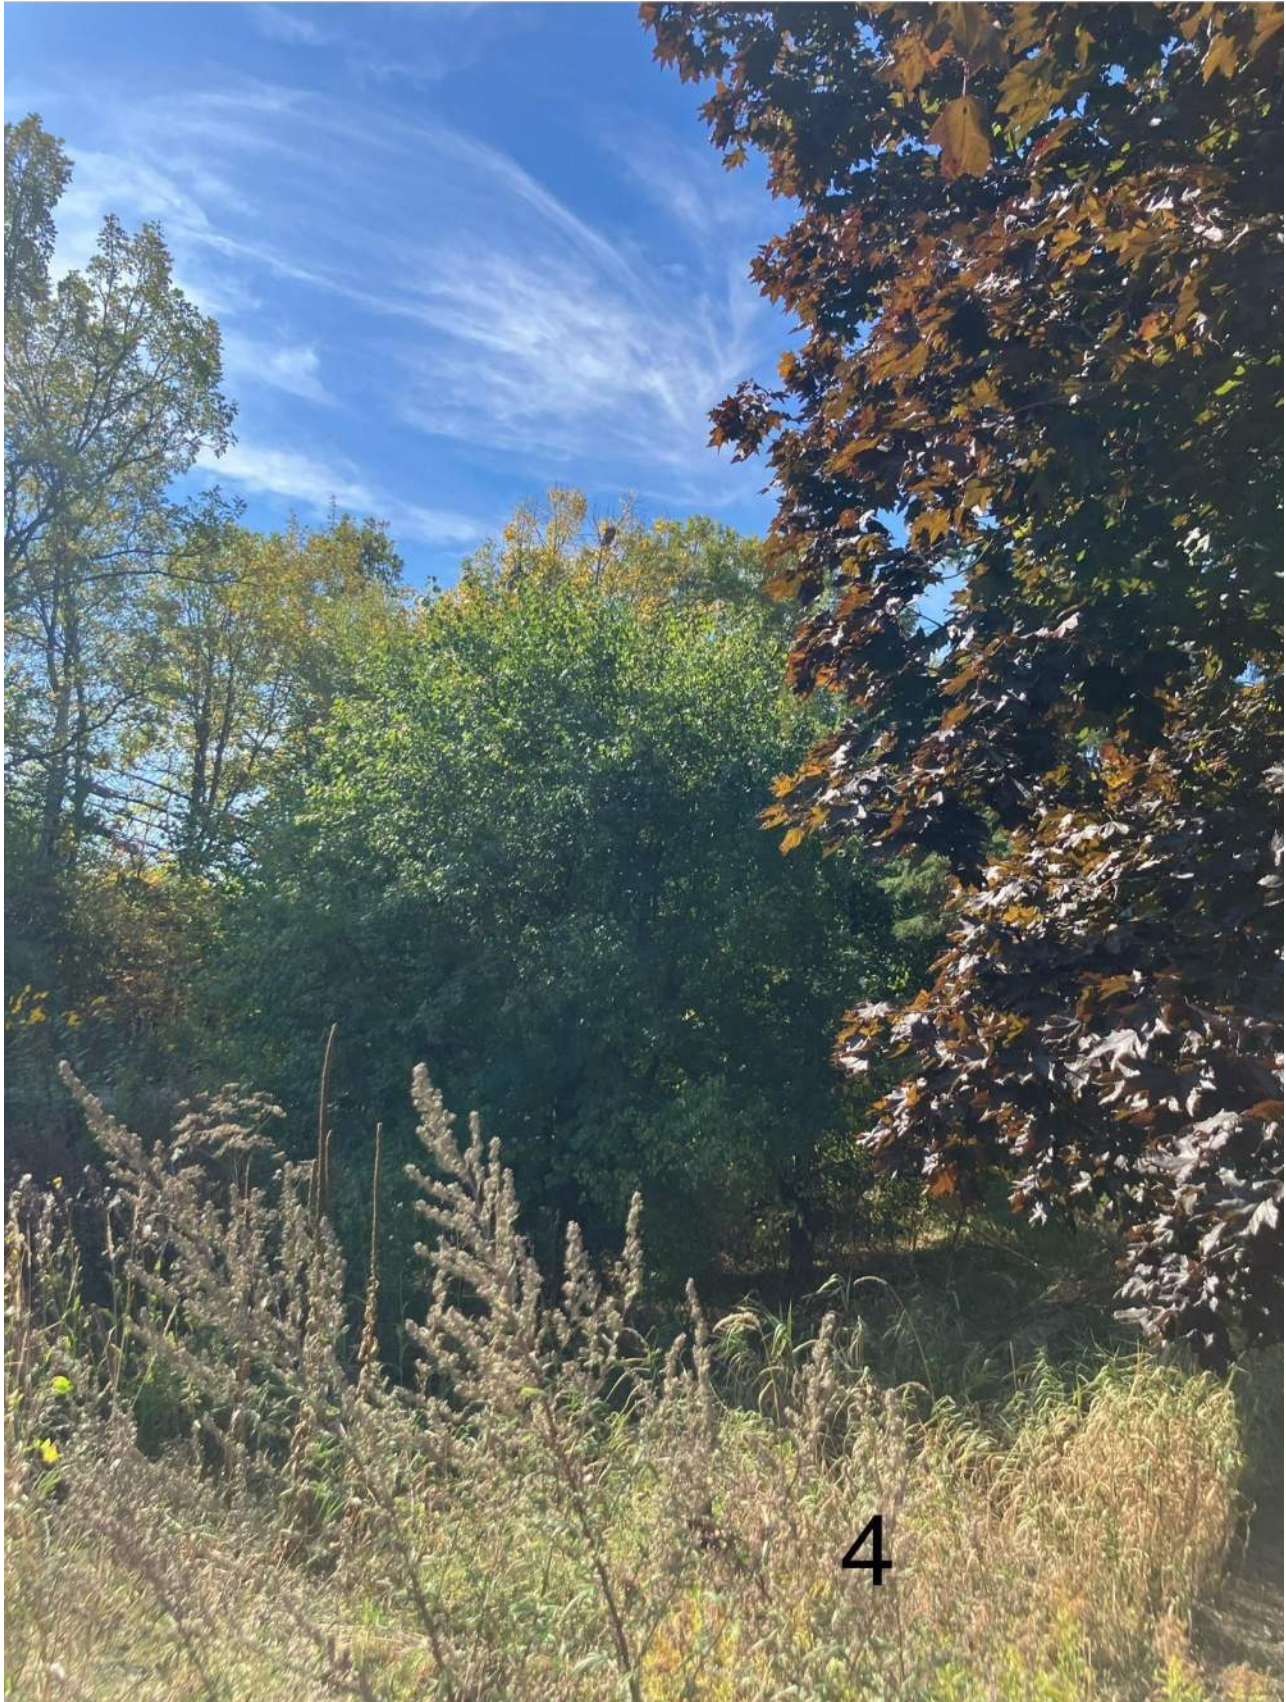
Figure 3 - Tree #4

| Tree Map Number | Species | Botanical | DBH (cm) @ 1.4 m | Tree Ownership | Minimum Tree Protection Distance (m) | Health | Structure | Overall Condition | Tree Height (m) | Crown Width (m) | Deadwood (%) | Construction inside Min TPZ? (Y/N) | Construction Impact (None, Low, Medium, High) | Action | Permit Required? (Y/N) | Notes and Recommendations |
|---|---|---|---|---|---|---|---|---|---|---|---|---|---|---|---|---|
| 4 | Buckthorn, Common | <i>Rhamnus cathartica</i> | 20 | Boundary | 2.0 | Good | Good | Good | 4 | 3 | 1 | N | None | Preserve | N | Multiple stems |

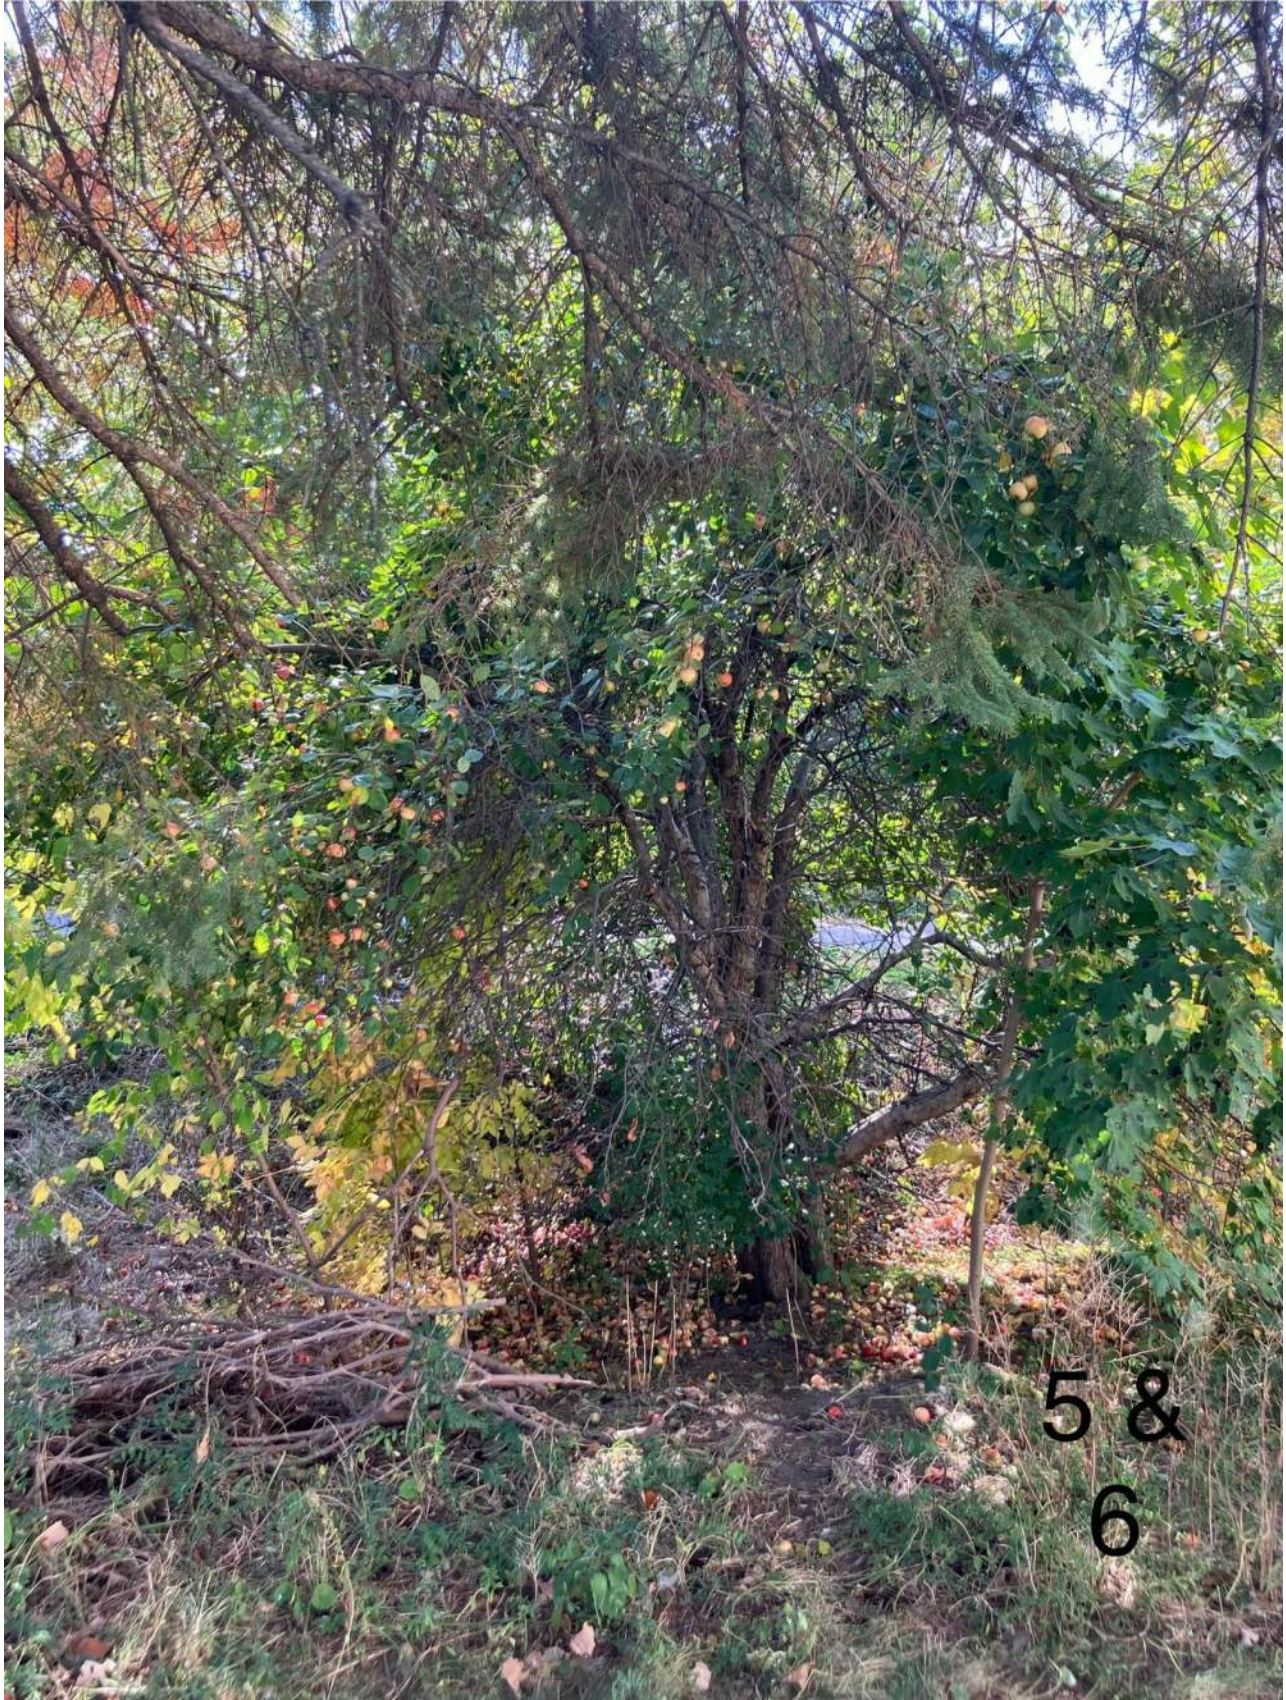
Figure 4 - Tree #5 & #6

| Tree Map Number | Species | Botanical | DBH (cm) @ 1.4 m | Tree Ownership | Minimum Tree Protection Distance (m) | Health | Structure | Overall Condition | Tree Height (m) | Crown Width (m) | Deadwood (%) | Construction inside Min TPZ? (Y/N) | Construction Impact (None, Low, Medium, High) | Action | Permit Required? (Y/N) | Notes and Recommendations |
|---|---|---|---|---|---|---|---|---|---|---|---|---|---|---|---|---|
| 5 | Apple, spp. | <i>Malus spp.</i> | 30 | Private | 3.0 | Good | Good | Good | 4 | 5 | 3 | N | None | Preserve | N | Multiple stems / Cedar rust |
| 6 | Maple, Norway | <i>Acer platanooides</i> | 5 | Private | 0.5 | Good | Good | Good | 4 | 1 | 1 | N | None | Preserve | N | Has black spot |

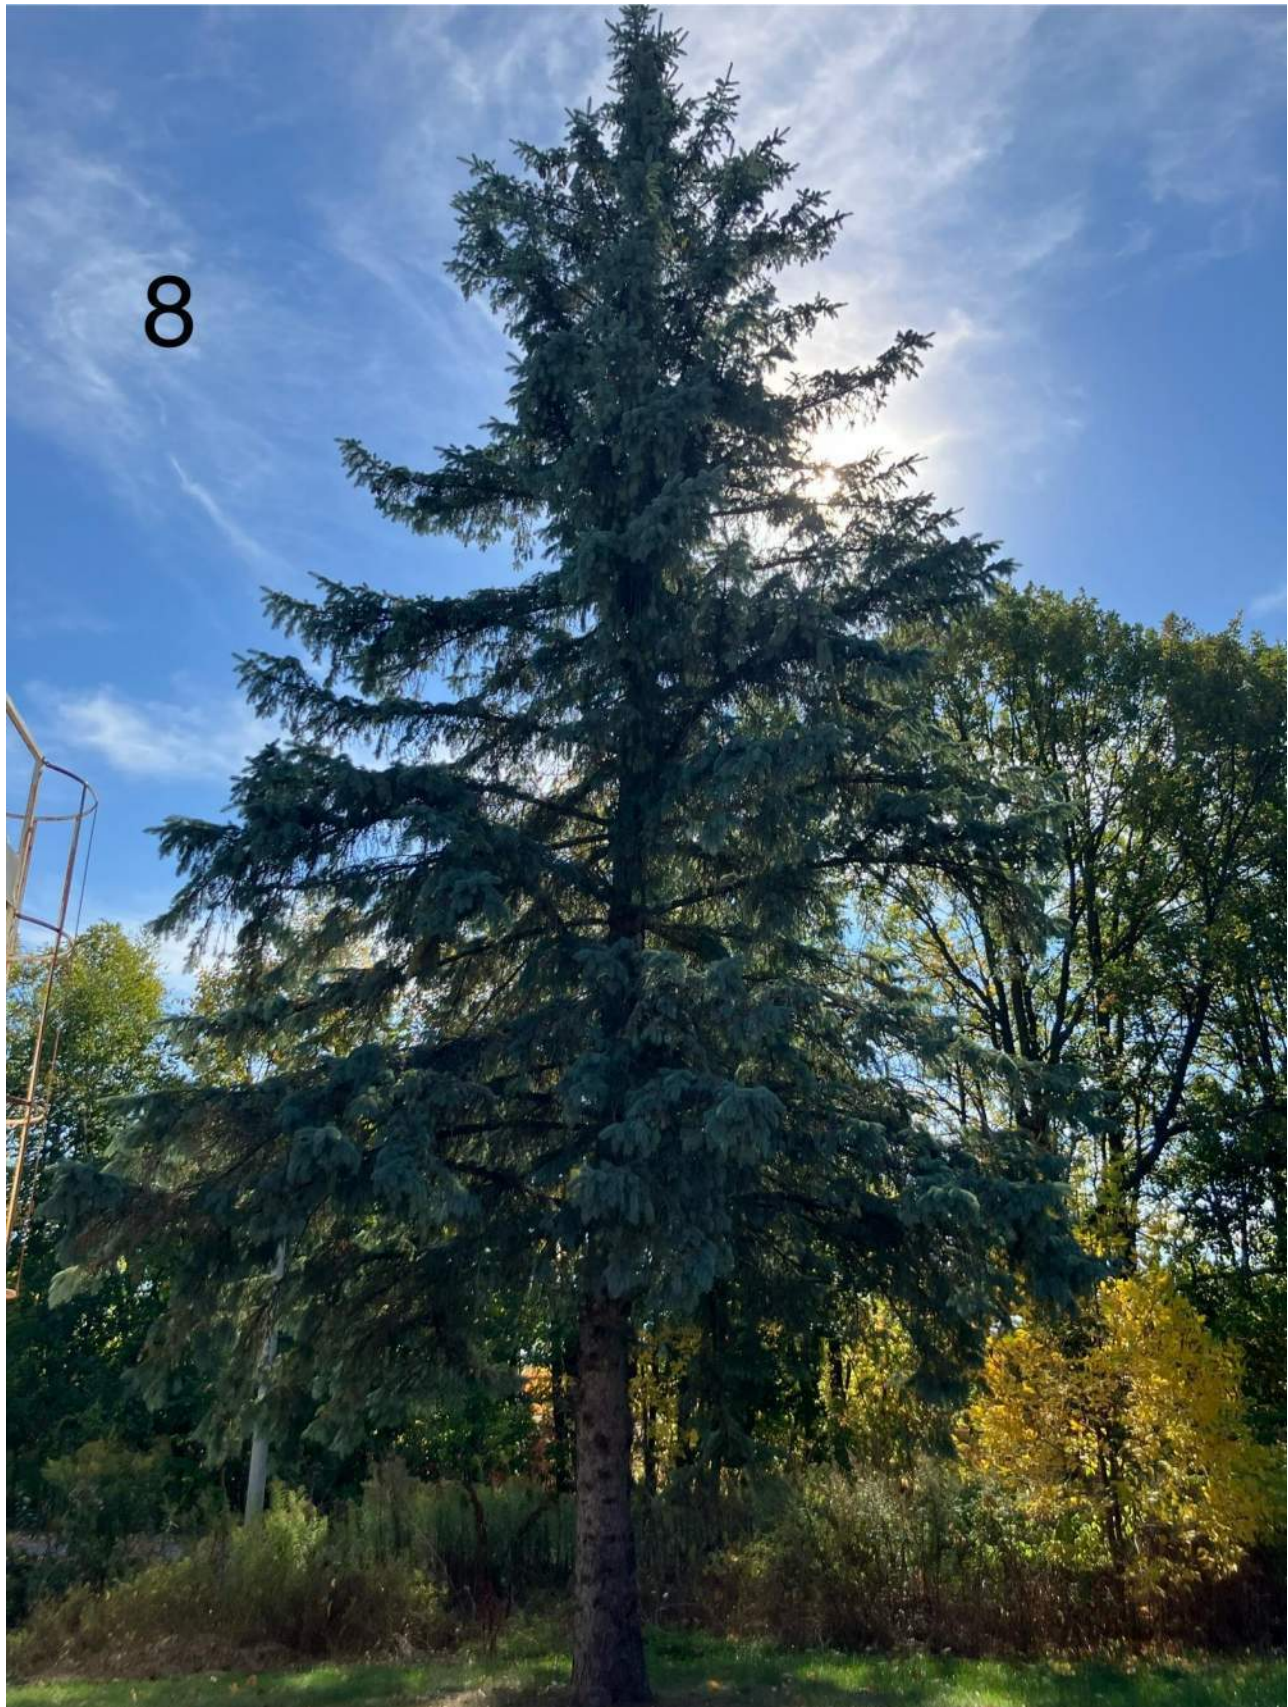
Figure 5 - Tree #7 & 8

| Tree Map Number | Species | Botanical | DBH (cm) @ 1.4 m | Tree Ownership | Minimum Tree Protection Distance (m) | Health | Structure | Overall Condition | Tree Height (m) | Crown Width (m) | Deadwood (%) | Construction inside Min TPZ? (Y/N) | Construction Impact (None, Low, Medium, High) | Action | Permit Required? (Y/N) | Notes and Recommendations |
|---|---|---|---|---|---|---|---|---|---|---|---|---|---|---|---|---|
| 7 | Maple, Manitoba (Box elder) | <i>Acer negundo</i> | 3 | Private | 0.3 | Good | Good | Good | 3 | 1 | 1 | N | None | Preserve | N | Hedge row of 10 stems |
| 8 | Spruce, Colorado | <i>Picea pungens</i> | 35 | Private | 3.5 | Good | Good | Good | 15 | 5 | 3 | N | None | Preserve | N | |

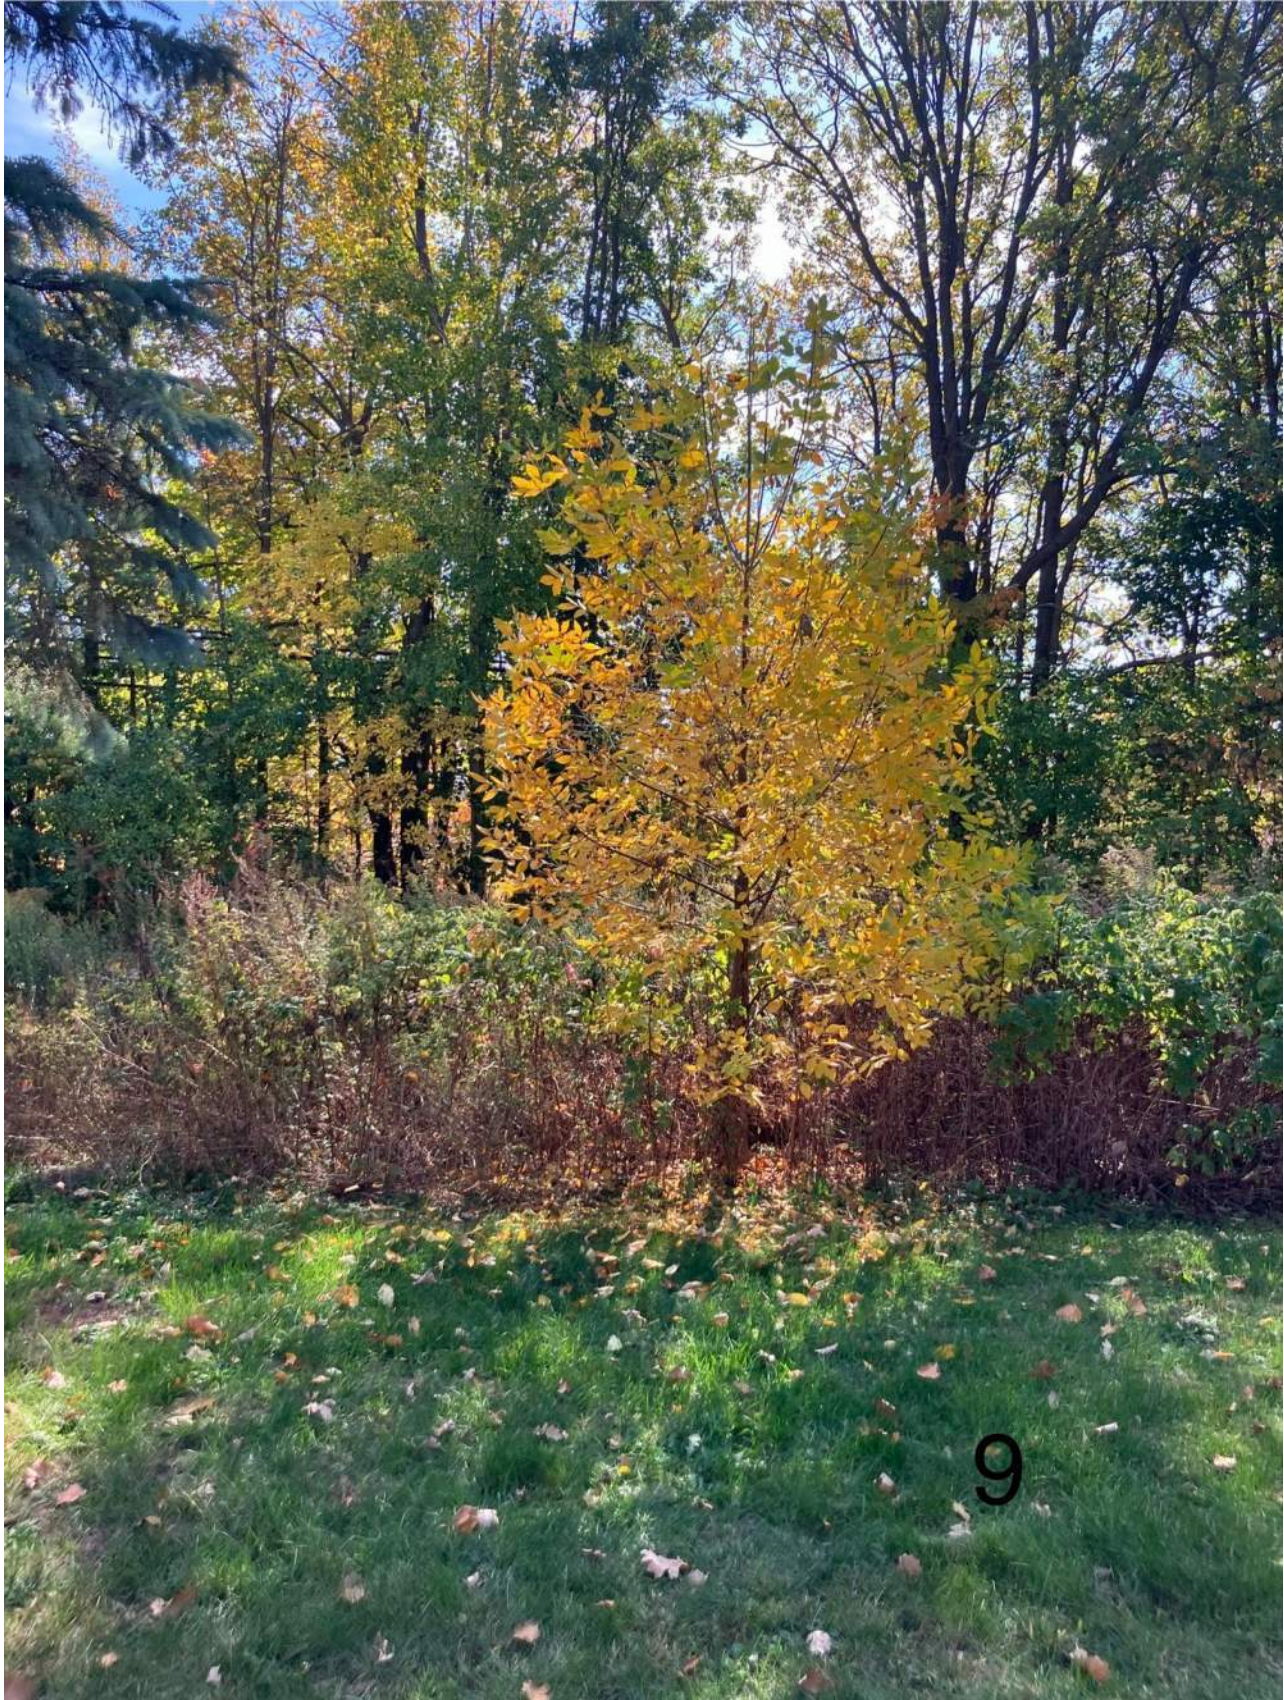
Figure 6 - Tree #9

| Tree Map Number | Species | Botanical | DBH (cm) @ 1.4 m | Tree Ownership | Minimum Tree Protection Distance (m) | Health | Structure | Overall Condition | Tree Height (m) | Crown Width (m) | Deadwood (%) | Construction inside Min TPZ? (Y/N) | Construction Impact (None, Low, Medium, High) | Action | Permit Required? (Y/N) | Notes and Recommendations |
|---|---|---|---|---|---|---|---|---|---|---|---|---|---|---|---|---|
| 9 | Maple, Manitoba (Box elder) | <i>Acer negundo</i> | 6 | Private | 0.6 | Good | Good | Good | 2 | 2 | 1 | N | None | Preserve | N | Mutlti-stem |

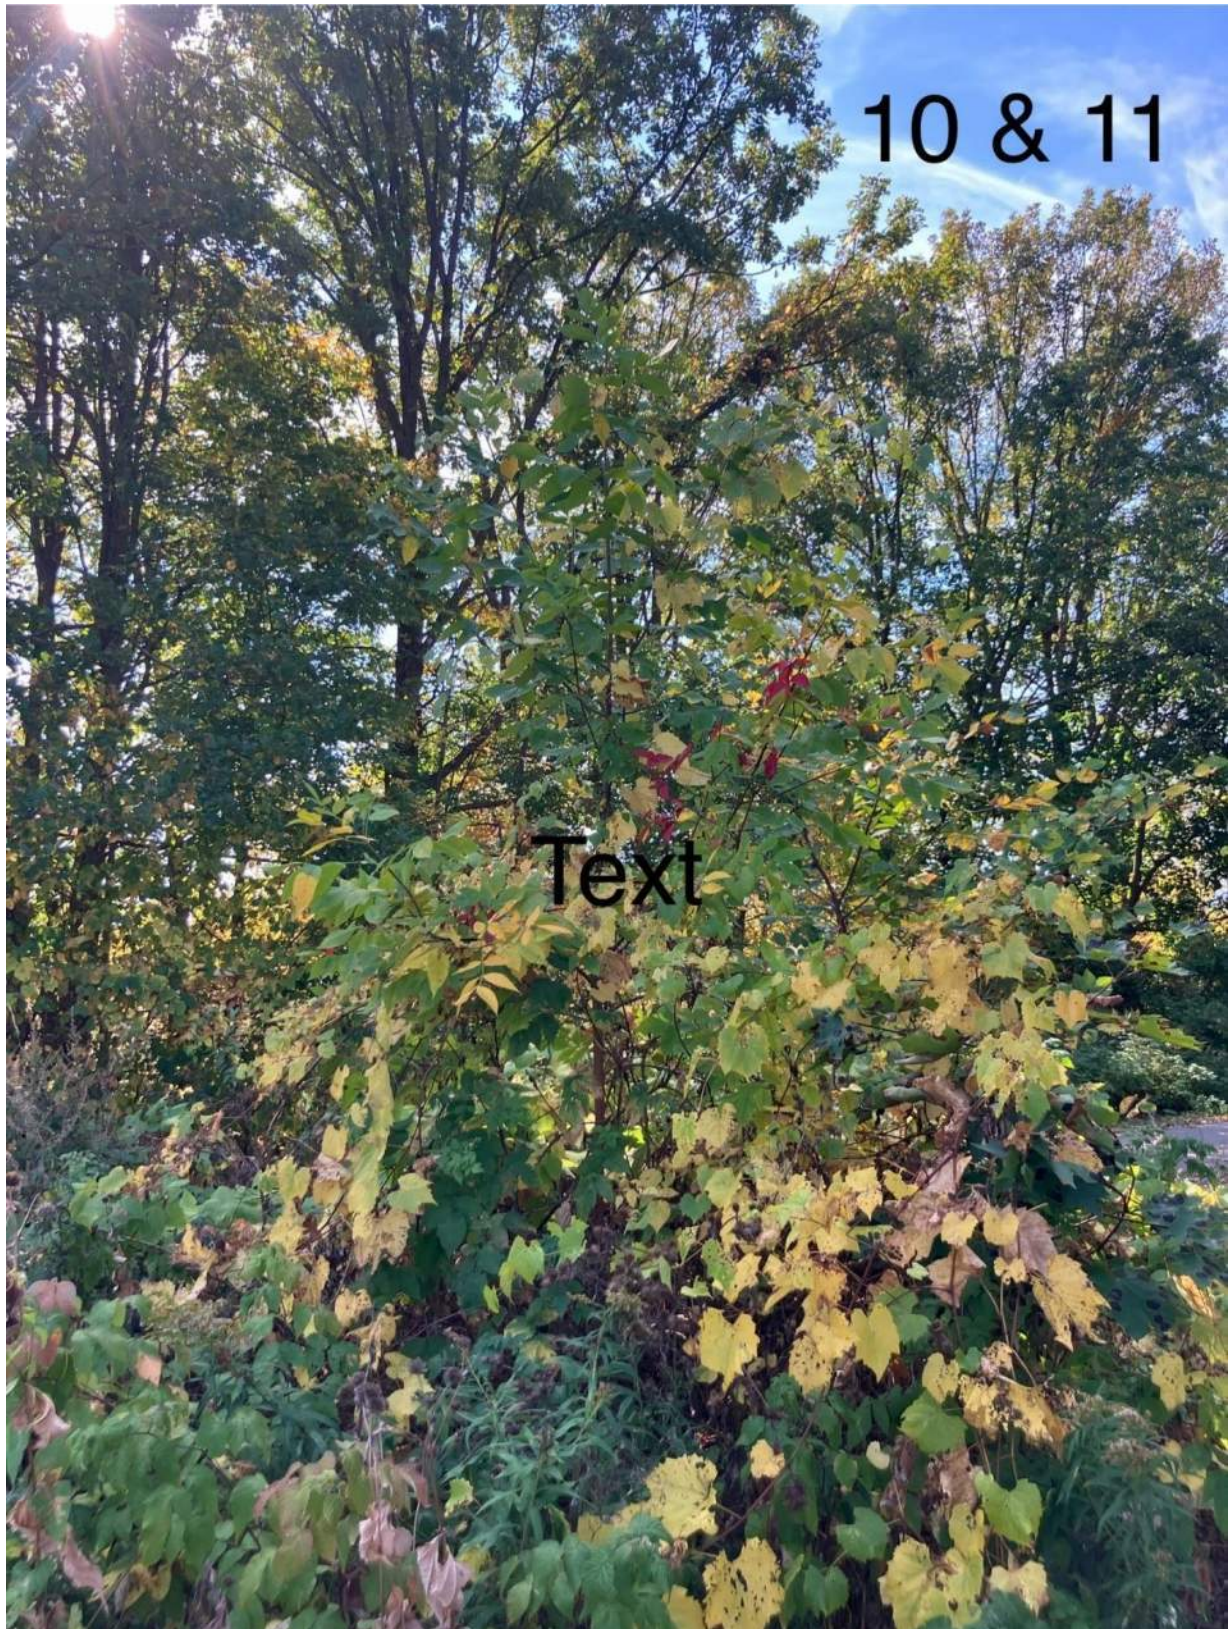
Figure 7 - Tree #10 & #11

| Tree Map Number | Species | Botanical | DBH (cm) @ 1.4 m | Tree Ownership | Minimum Tree Protection Distance (m) | Health | Structure | Overall Condition | Tree Height (m) | Crown Width (m) | Deadwood (%) | Construction inside Min TPZ? (Y/N) | Construction Impact (None, Low, Medium, High) | Action | Permit Required? (Y/N) | Notes and Recommendations |
|---|---|---|---|---|---|---|---|---|---|---|---|---|---|---|---|---|
| 10 | Maple, Manitoba (Box elder) | <i>Acer negundo</i> | 3 | Private | 0.3 | Good | Good | Good | 2 | 1 | 1 | N | None | Preserve | N | Covered in vines |

| Tree Map Number | Species | Botanical | DBH (cm) @ 1.4 m | Tree Ownership | Minimum Tree Protection Distance (m) | Health | Structure | Overall Condition | Tree Height (m) | Crown Width (m) | Deadwood (%) | Construction inside Min TPZ? (Y/N) | Construction Impact (None, Low, Medium, High) | Action | Permit Required? (Y/N) | Notes and Recommendations |
|---|---|---|---|---|---|---|---|---|---|---|---|---|---|---|---|---|
| 11 | Maple, Norway | <i>Acer platanoides</i> | 2 | Private | 0.2 | Fair | Poor | Fair | 1.5 | 1 | 1 | N | None | Preserve | N | Black spot / Covered in vines |

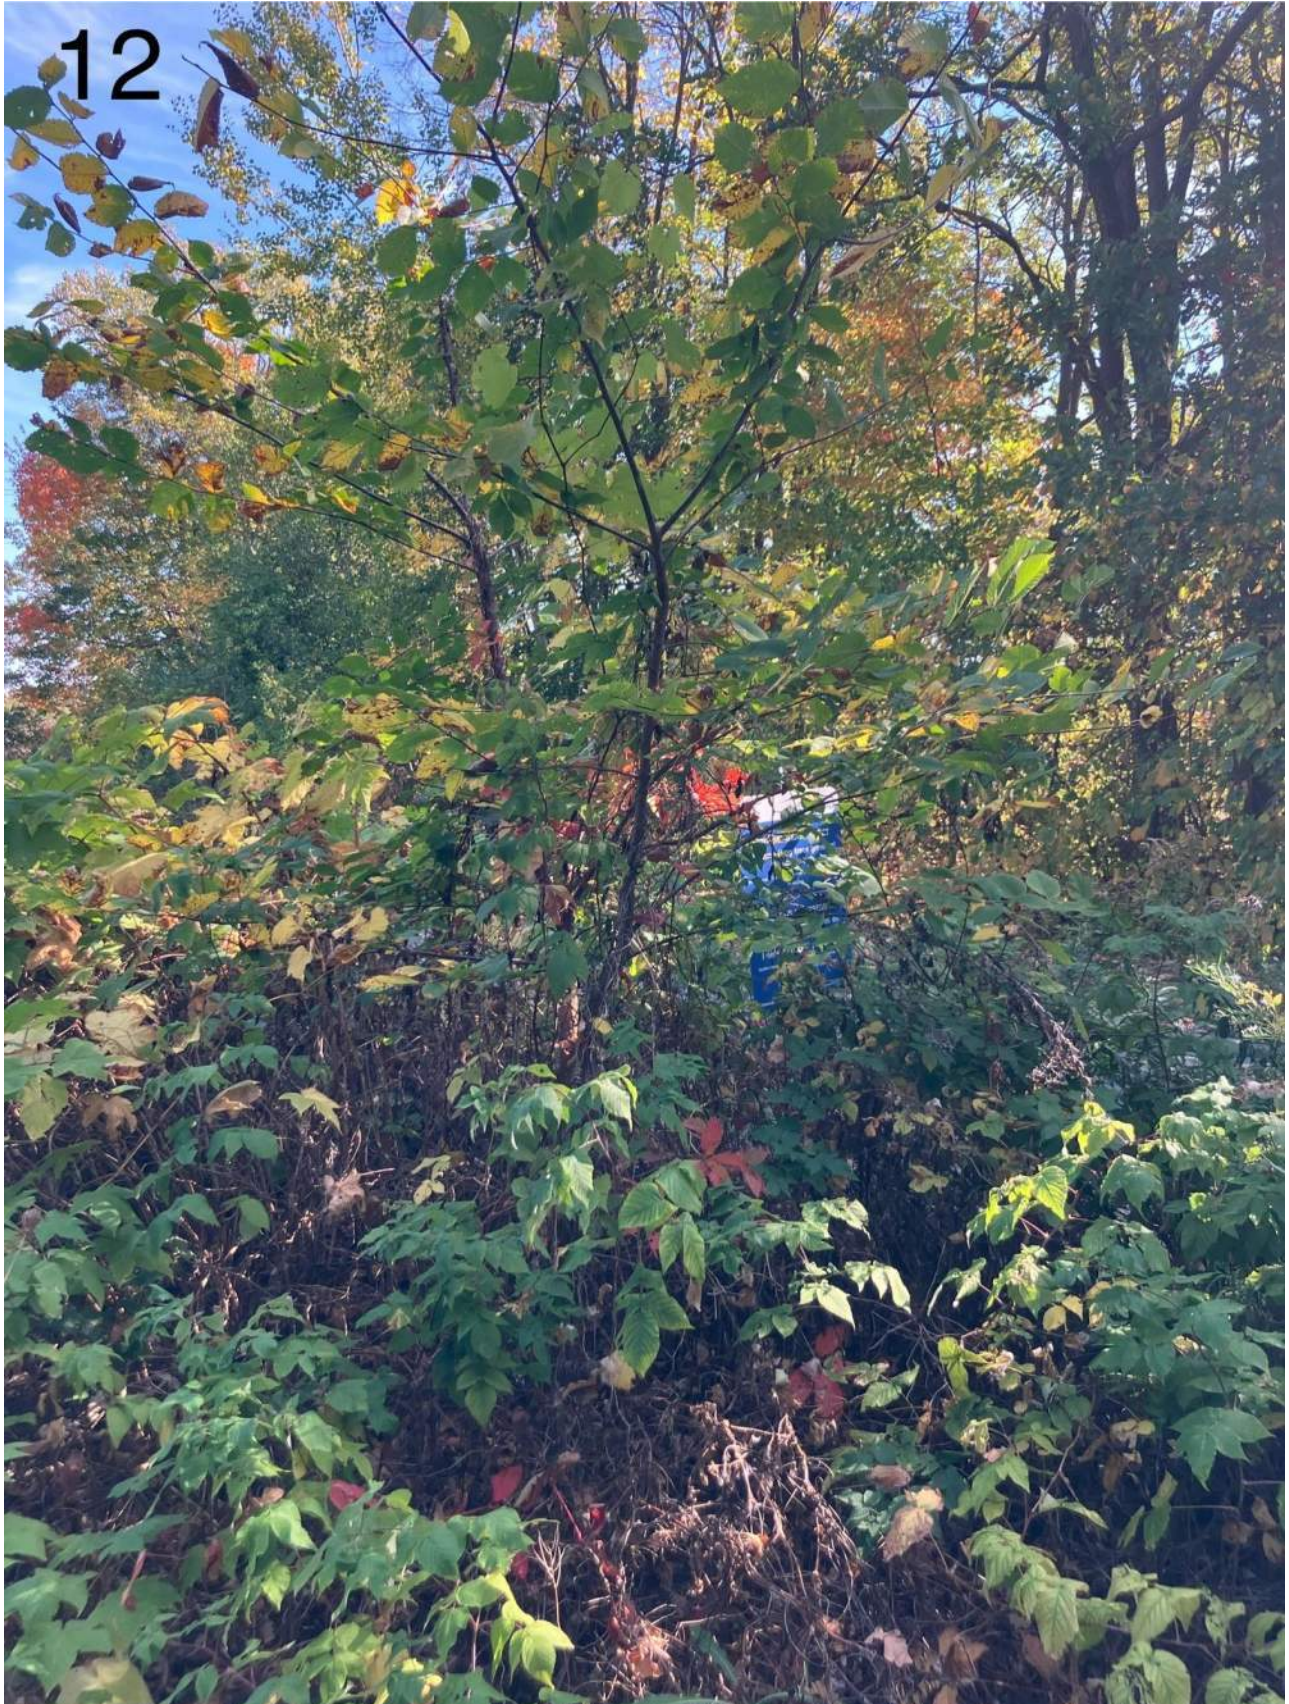
Figure 8 - Tree #12

| Tree Map Number | Species | Botanical | DBH (cm) @ 1.4 m | Tree Ownership | Minimum Tree Protection Distance (m) | Health | Structure | Overall Condition | Tree Height (m) | Crown Width (m) | Deadwood (%) | Construction inside Min TPZ? (Y/N) | Construction Impact (None, Low, Medium, High) | Action | Permit Required? (Y/N) | Notes and Recommendations |
|---|---|---|---|---|---|---|---|---|---|---|---|---|---|---|---|---|
| 12 | Elm, Siberian | <i>Ulmus pumila</i> | 6 | Private | 0.6 | Good | Good | Good | 2 | 1 | 1 | N | None | Preserve | N | Covered in vines |

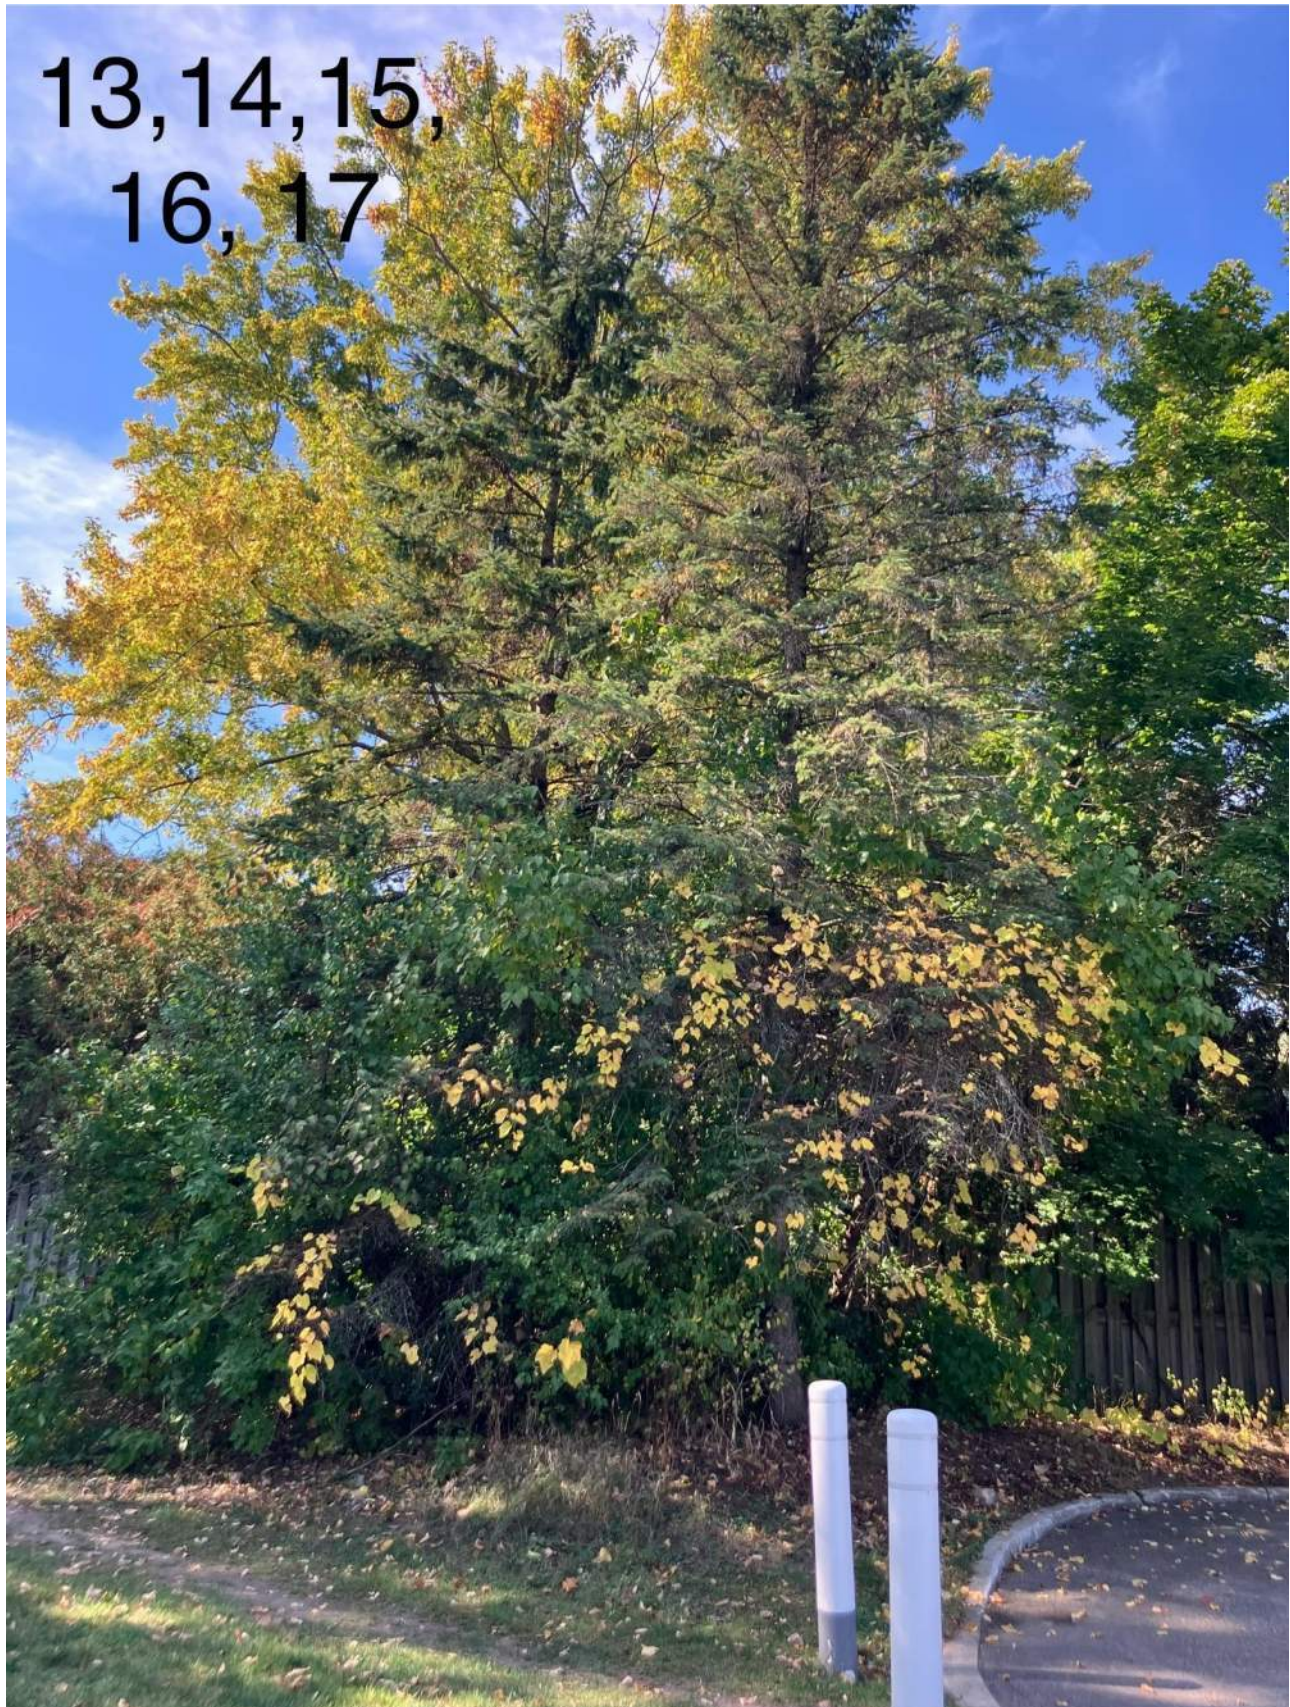
Figure 9 - Tree #13-17

| Tree Map Number | Species | Botanical | DBH (cm) @ 1.4 m | Tree Ownership | Minimum Tree Protection Distance (m) | Health | Structure | Overall Condition | Tree Height (m) | Crown Width (m) | Deadwood (%) | Construction inside Min TPZ? (Y/N) | Construction Impact (None, Low, Medium, High) | Action | Permit Required? (Y/N) | Notes and Recommendations |
|---|---|---|---|---|---|---|---|---|---|---|---|---|---|---|---|---|
| 13 | Lilac spp. | <i>Syringa spp.</i> | 5 | Private | 0.5 | Good | Good | Good | 2 | 5 | 10 | N | None | Preserve | N | 20 Stems |
| 14 | Buckthorn, Common | <i>Rhamnus cathartica</i> | 5 | Private | 0.5 | Good | Good | Good | 1 | 1 | 0 | N | None | Preserve | N | All along western fence line / 35 stems |
| 15 | Spruce, Colorado | <i>Picea pungens</i> | 22 | Private | 2.2 | Good | Good | Good | 11 | 2 | 10 | N | None | Preserve | N | |
| 16 | Spruce, Colorado | <i>Picea pungens</i> | 32 | Private | 3.2 | Fair | Good | Good | 14 | 4 | 10 | N | None | Preserve | N | |
| 17 | Spruce, Colorado | <i>Picea pungens</i> | 16 | Private | 1.6 | Poor | Fair | Poor | 11 | 1 | 15 | N | None | Preserve | N | |
