# Arborist Report

## Pre-Construction Assessment Report

106 Eagleson St, Ottawa  
K2L 2P1

**Revised: April 24, 2026**

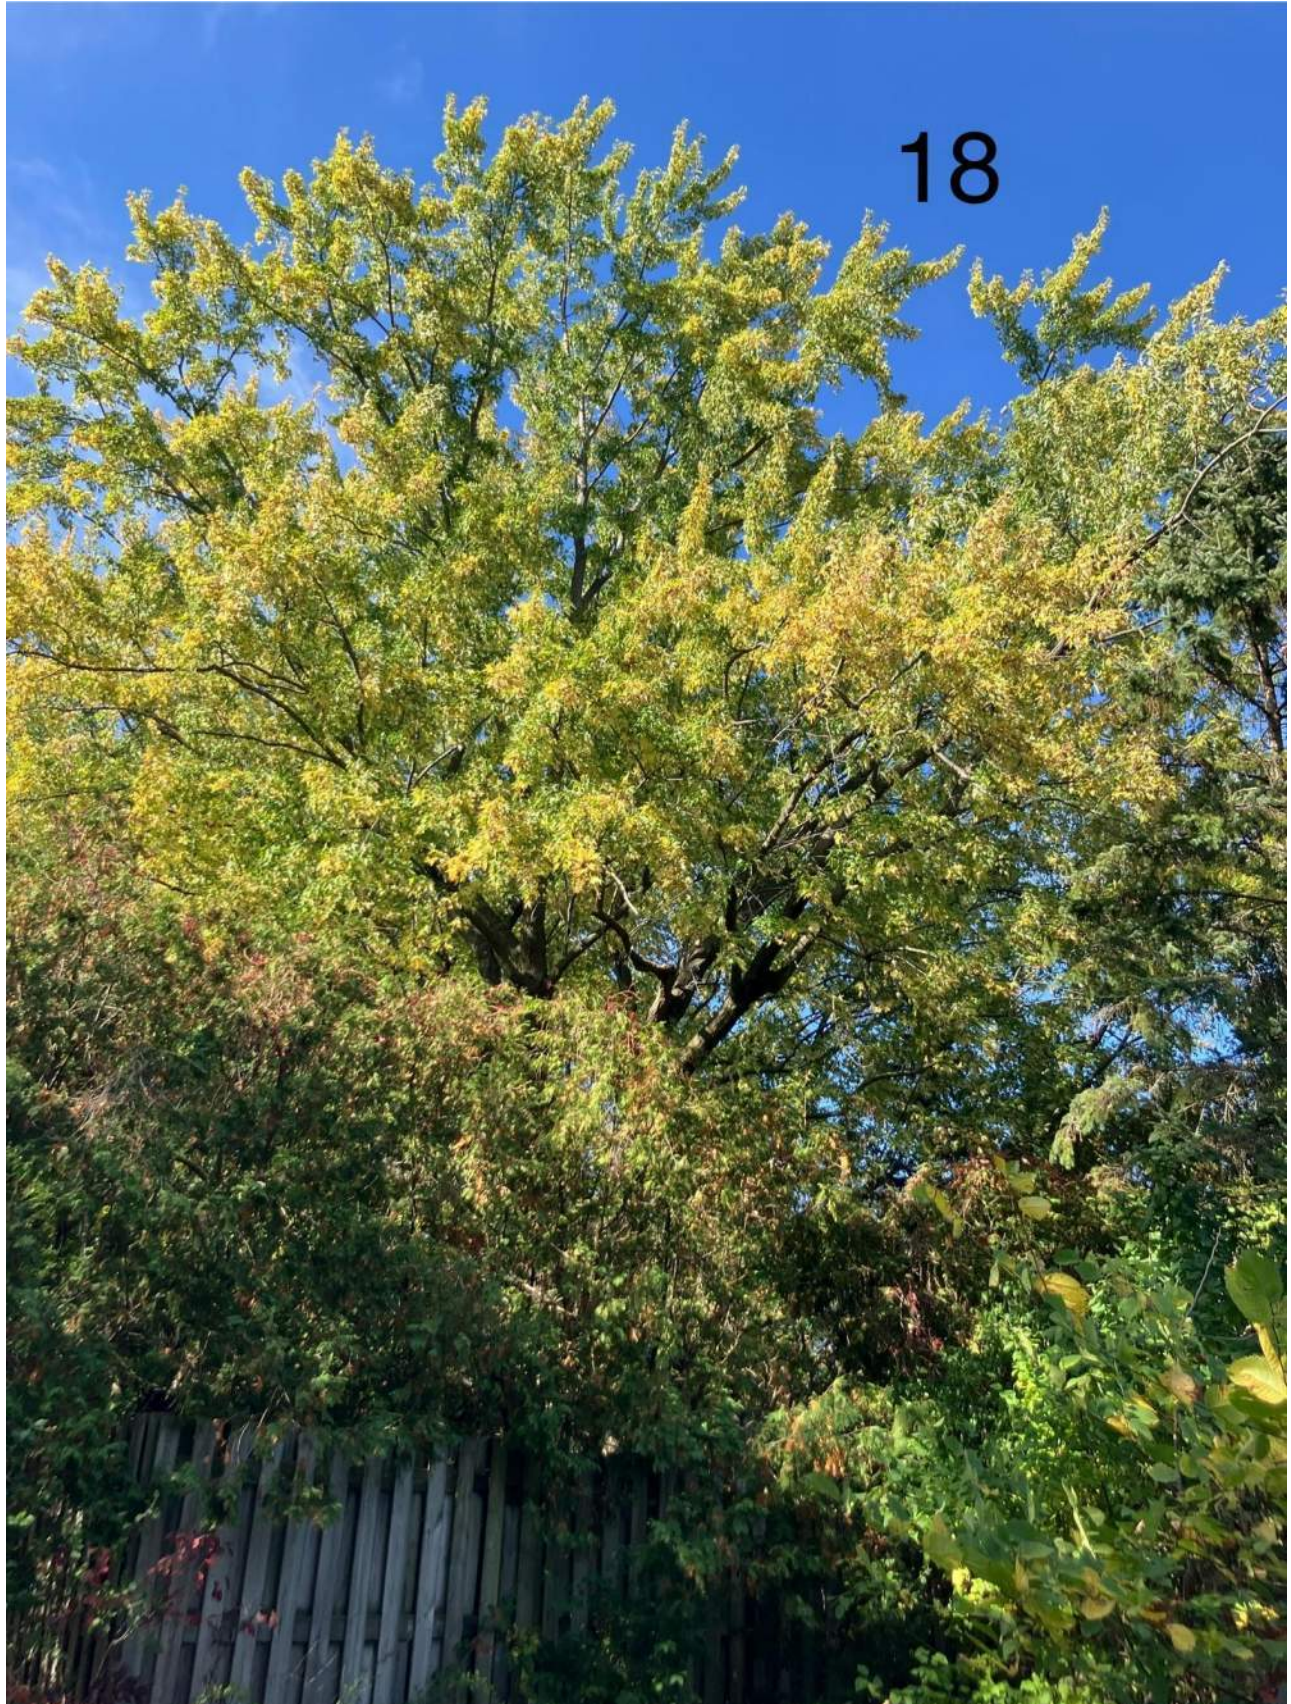
Figure 10 – Tree #18

| Tree Map Number | Species | Botanical | DBH (cm) @ 1.4 m | Tree Ownership | Minimum Tree Protection Distance (m) | Health | Structure | Overall Condition | Tree Height (m) | Crown Width (m) | Deadwood (%) | Construction inside Min TPZ? (Y/N) | Construction Impact (None, Low, Medium, High) | Action | Permit Required? (Y/N) | Notes and Recommendations |
|---|---|---|---|---|---|---|---|---|---|---|---|---|---|---|---|---|
| 18 | Maple, Silver | <i>Acer saccharinum</i> | 95 | Neighbour | 9.5 | Good | Good | Good | 6 | 17 | 2 | N | None | Preserve | N | |

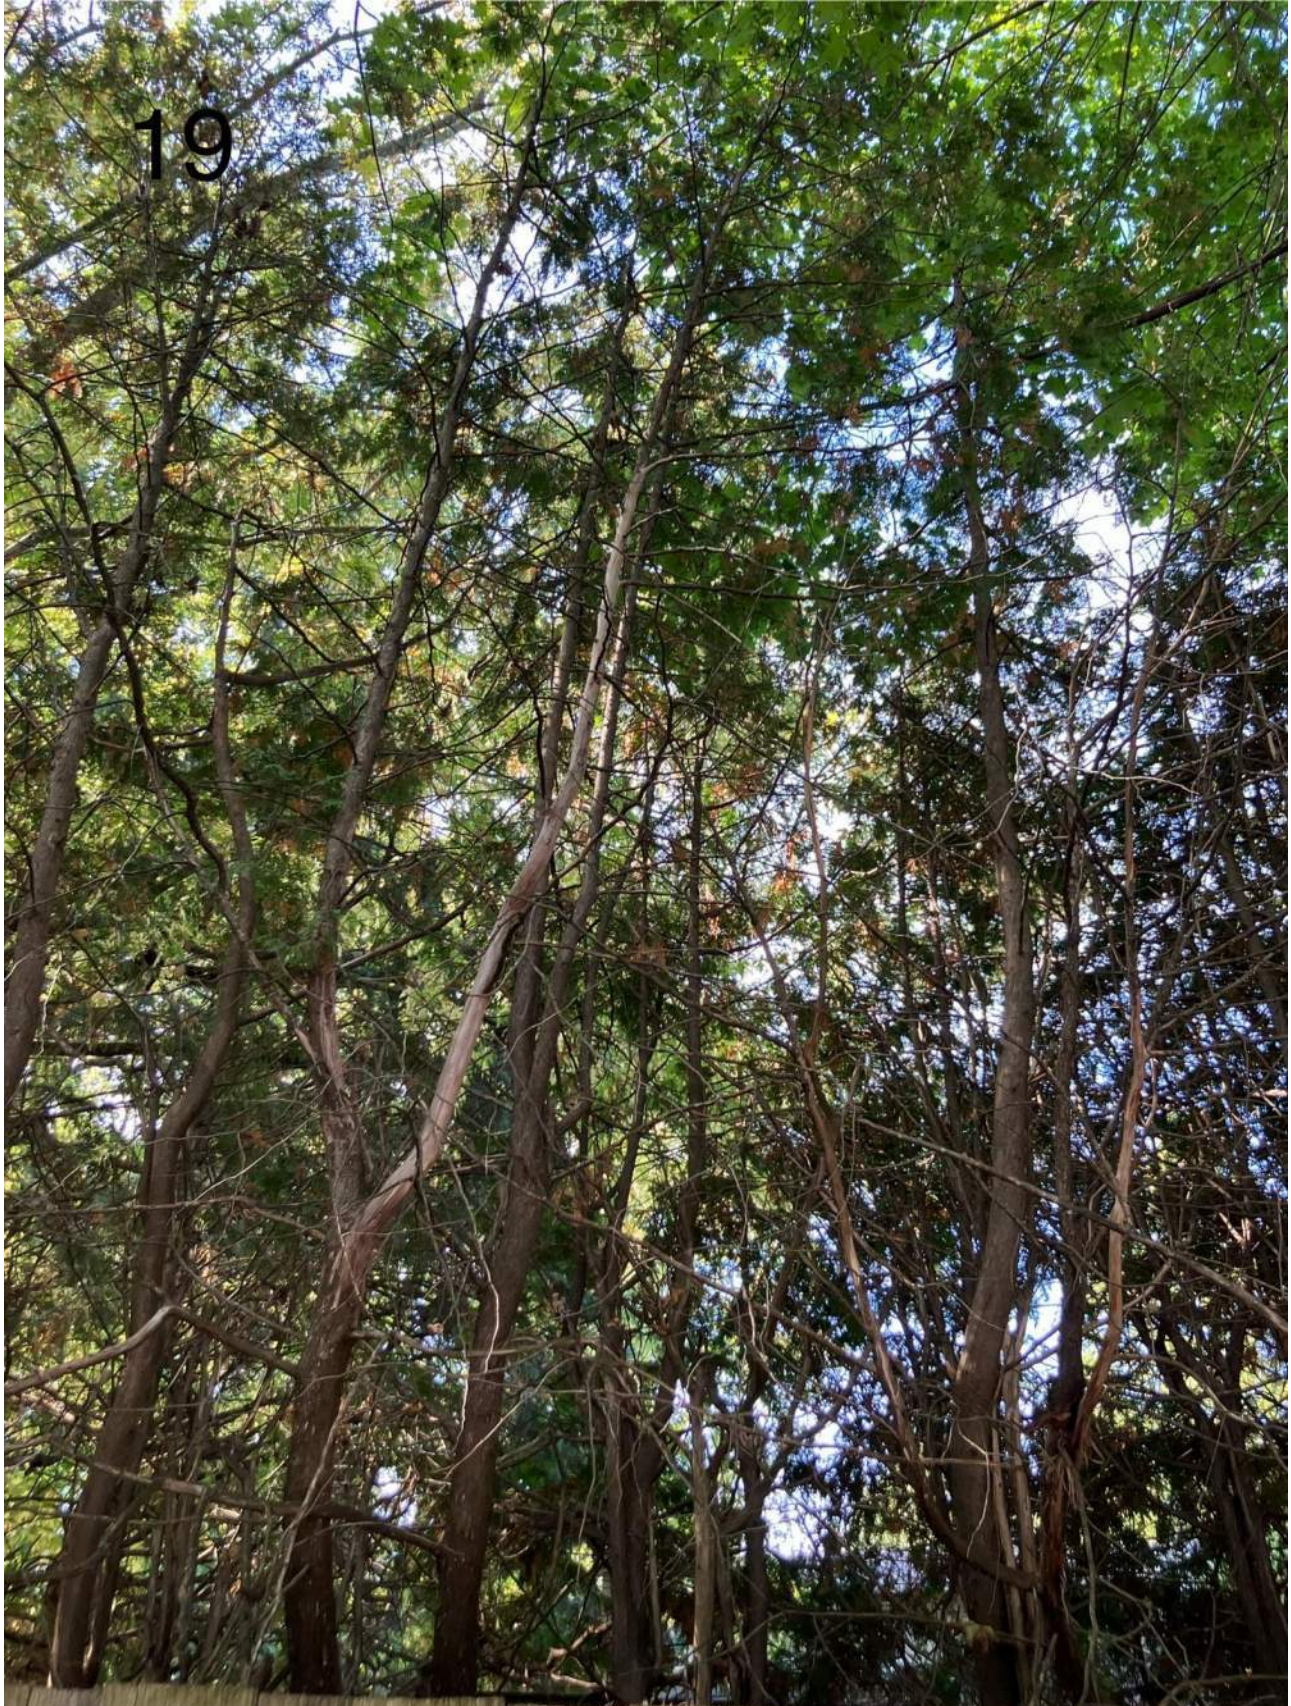
Figure 11 - Tree #19

| Tree Map Number | Species | Botanical | DBH (cm) @ 1.4 m | Tree Ownership | Minimum Tree Protection Distance (m) | Health | Structure | Overall Condition | Tree Height (m) | Crown Width (m) | Deadwood (%) | Construction inside Min TPZ? (Y/N) | Construction Impact (None, Low, Medium, High) | Action | Permit Required? (Y/N) | Notes and Recommendations |
|---|---|---|---|---|---|---|---|---|---|---|---|---|---|---|---|---|
| 19 | Cedar (Arborvitae), Eastern | <i>Thuja occidentalis</i> | 5-15 | Private | 1.5 | Fair | Fair | Fair | 4 | 100 | 20 | N | None | Preserve | N | 250 Cedars / Other side of fence / Lots of dead stems / Vine coverage |

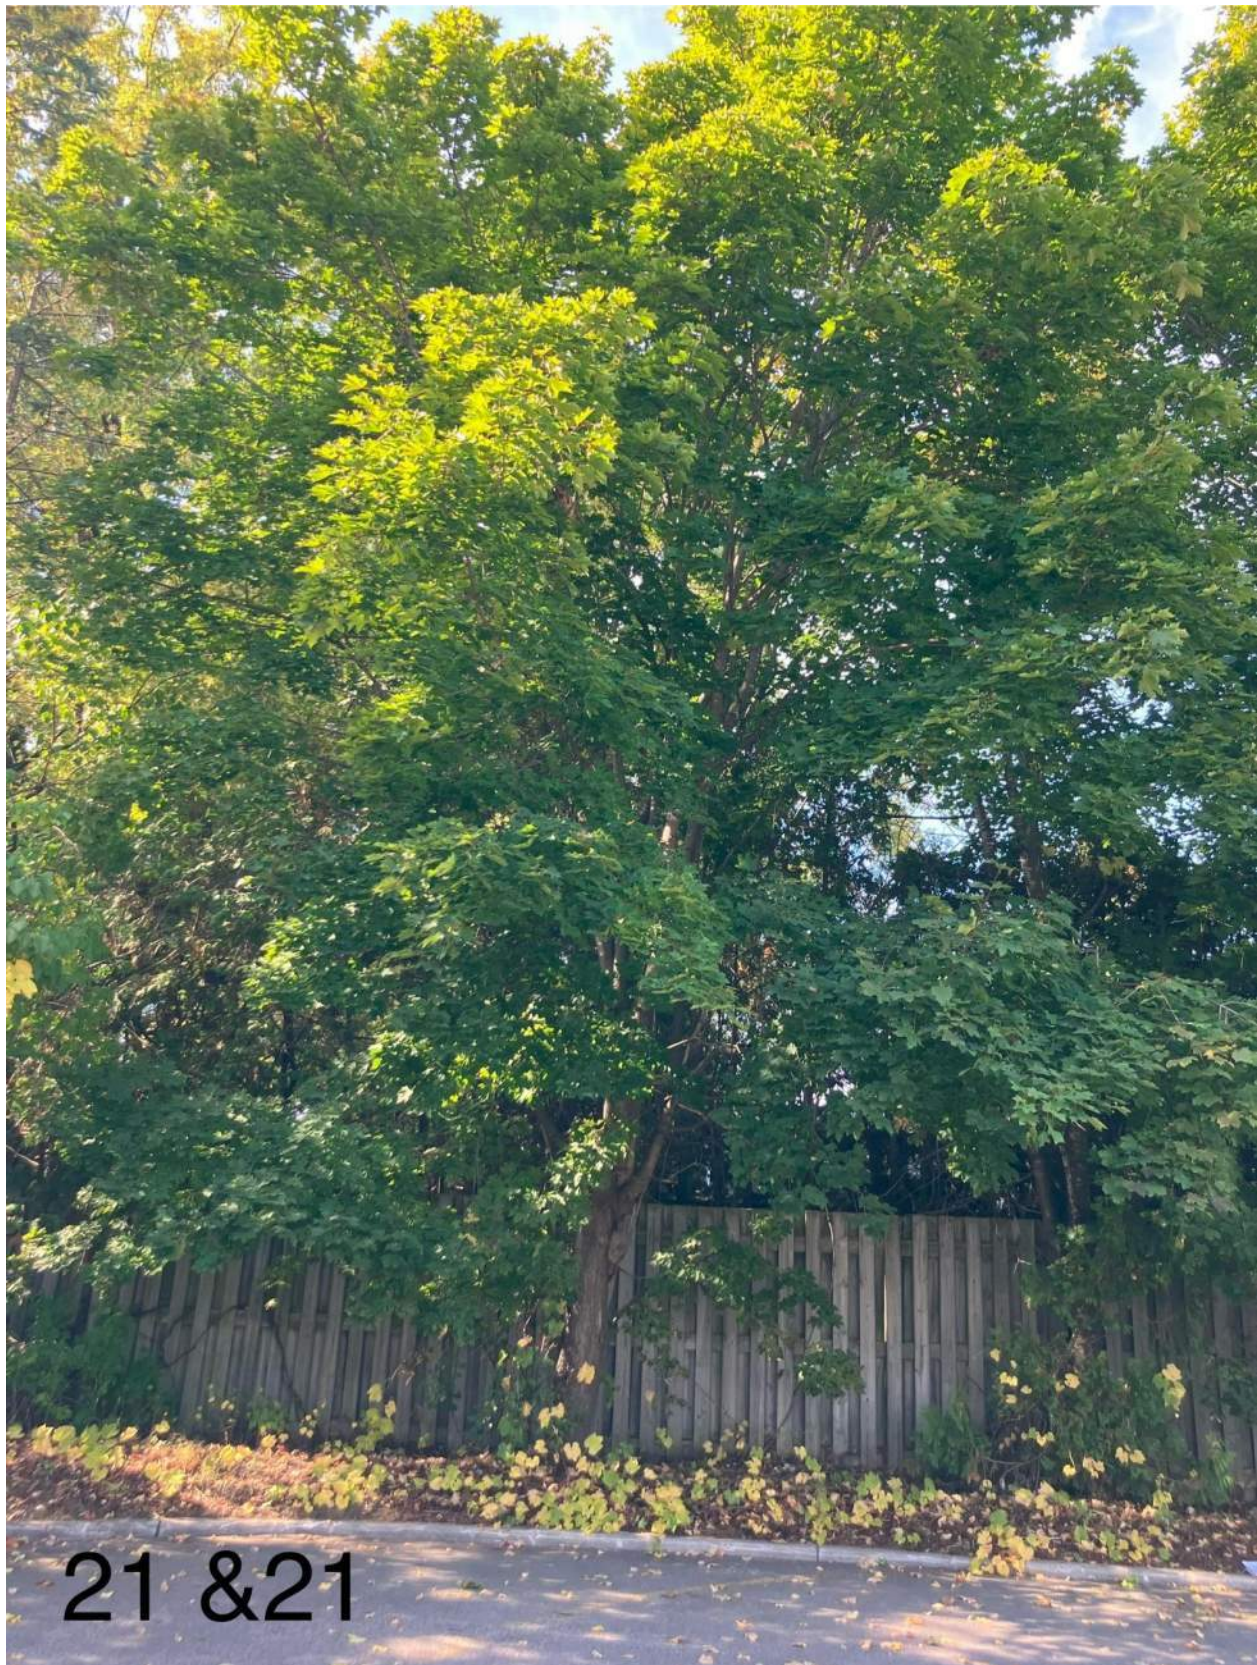
Figure 12 - Tree #20 - 21

| Tree Map Number | Species | Botanical | DBH (cm) @ 1.4 m | Tree Ownership | Minimum Tree Protection Distance (m) | Health | Structure | Overall Condition | Tree Height (m) | Crown Width (m) | Deadwood (%) | Construction inside Min TPZ? (Y/N) | Construction Impact (None, Low, Medium, High) | Action | Permit Required? (Y/N) | Notes and Recommendations |
|---|---|---|---|---|---|---|---|---|---|---|---|---|---|---|---|---|
| 20 | Maple, Norway | <i>Acer platanoides</i> | 39 | Private | 3.9 | Good | Fair | Good | 11 | 4 | 2 | N | None | Preserve | N | Multi-stemmed / Black spot / Included bark |
| 21 | Maple, Norway | <i>Acer platanoides</i> | 31 | Private | 3.1 | Good | Fair | Good | 11 | 2 | 2 | N | None | Preserve | N | Multi-stemmed / Black spot / Included bark |

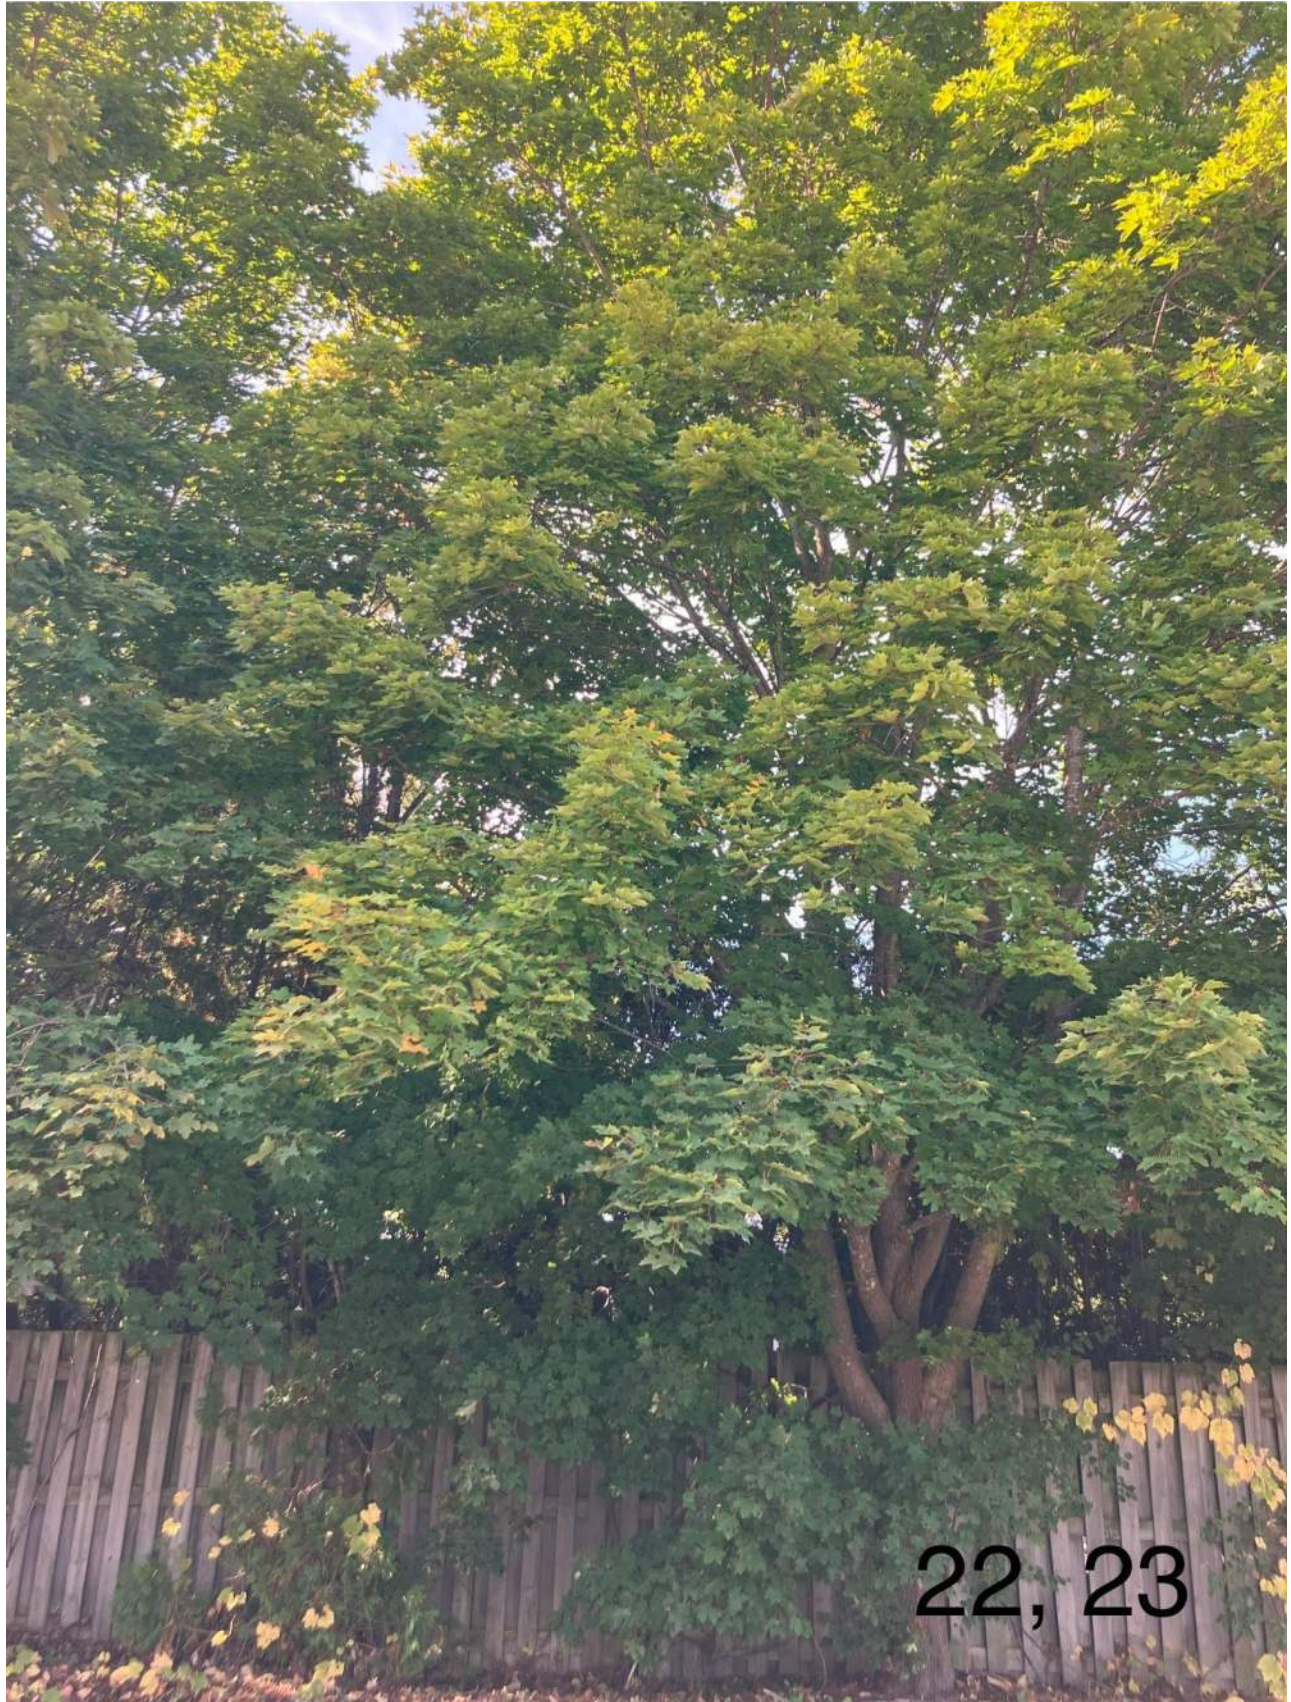
Figure 13 - Tree #22-23

| Tree Map Number | Species | Botanical | DBH (cm) @ 1.4 m | Tree Ownership | Minimum Tree Protection Distance (m) | Health | Structure | Overall Condition | Tree Height (m) | Crown Width (m) | Deadwood (%) | Construction inside Min TPZ? (Y/N) | Construction Impact (None, Low, Medium, High) | Action | Permit Required? (Y/N) | Notes and Recommendations |
|---|---|---|---|---|---|---|---|---|---|---|---|---|---|---|---|---|
| 22 | Maple, Norway | <i>Acer platanoides</i> | 6 | Private | 0.6 | Good | Good | Good | 2 | 2 | 1 | N | None | Preserve | N | Growing through fence / Black spot |
| 23 | Maple, Norway | <i>Acer platanoides</i> | 44 | Private | 4.4 | Good | Fair | Good | 11 | 5 | 2 | N | None | Preserve | N | Black spot / Included bark |

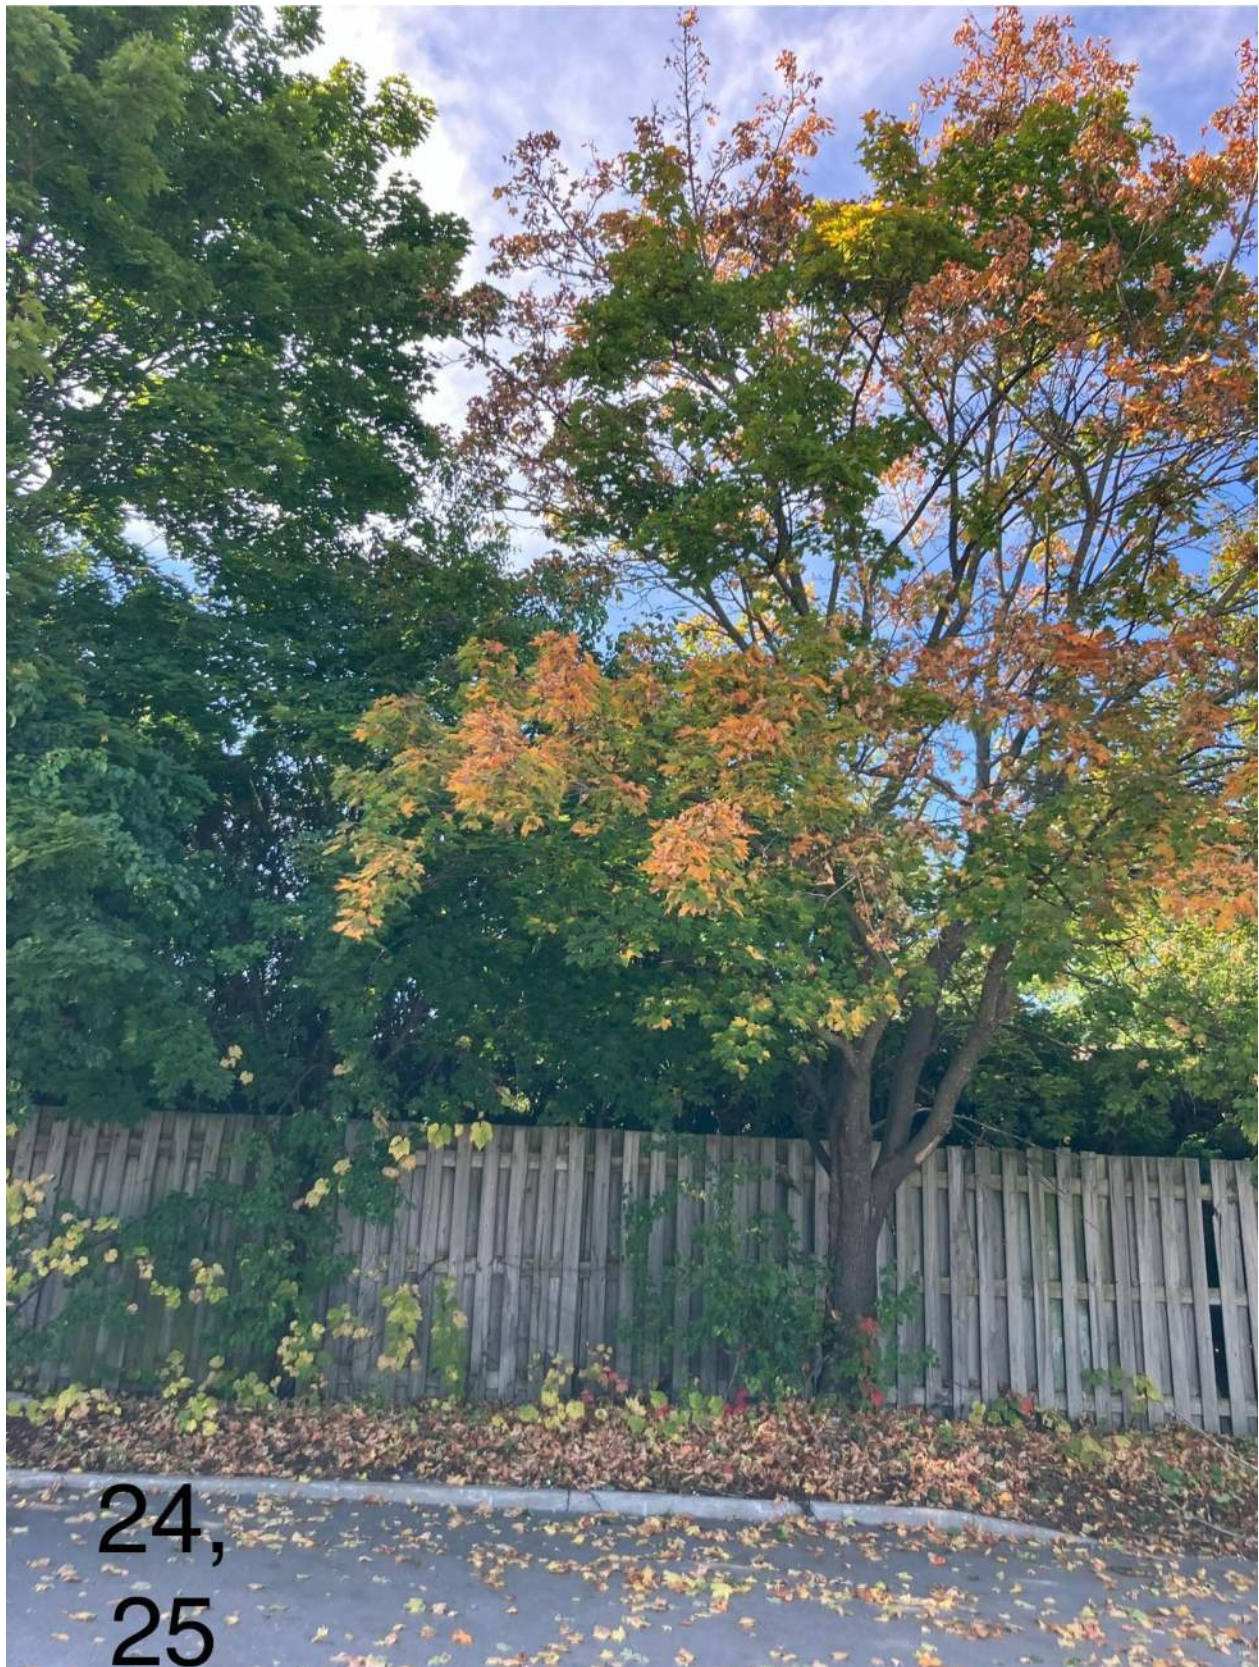
Figure 14 - Tree #24-25

| Tree Map Number | Species | Botanical | DBH (cm) @ 1.4 m | Tree Ownership | Minimum Tree Protection Distance (m) | Health | Structure | Overall Condition | Tree Height (m) | Crown Width (m) | Deadwood (%) | Construction inside Min TPZ? (Y/N) | Construction Impact (None, Low, Medium, High) | Action | Permit Required? (Y/N) | Notes and Recommendations |
|---|---|---|---|---|---|---|---|---|---|---|---|---|---|---|---|---|
| 24 | Buckthorn, Common | <i>Rhamnus cathartica</i> | 15 | Private | 1.5 | Good | Good | Good | 6 | 2 | 1 | N | None | Preserve | N | Mutli-stem |
| 25 | Maple, Norway | <i>Acer platanoides</i> | 37 | Private | 3.7 | Fair | Poor | Fair | 8 | 6 | 7 | N | None | Preserve | N | Large split / Healing cavities |

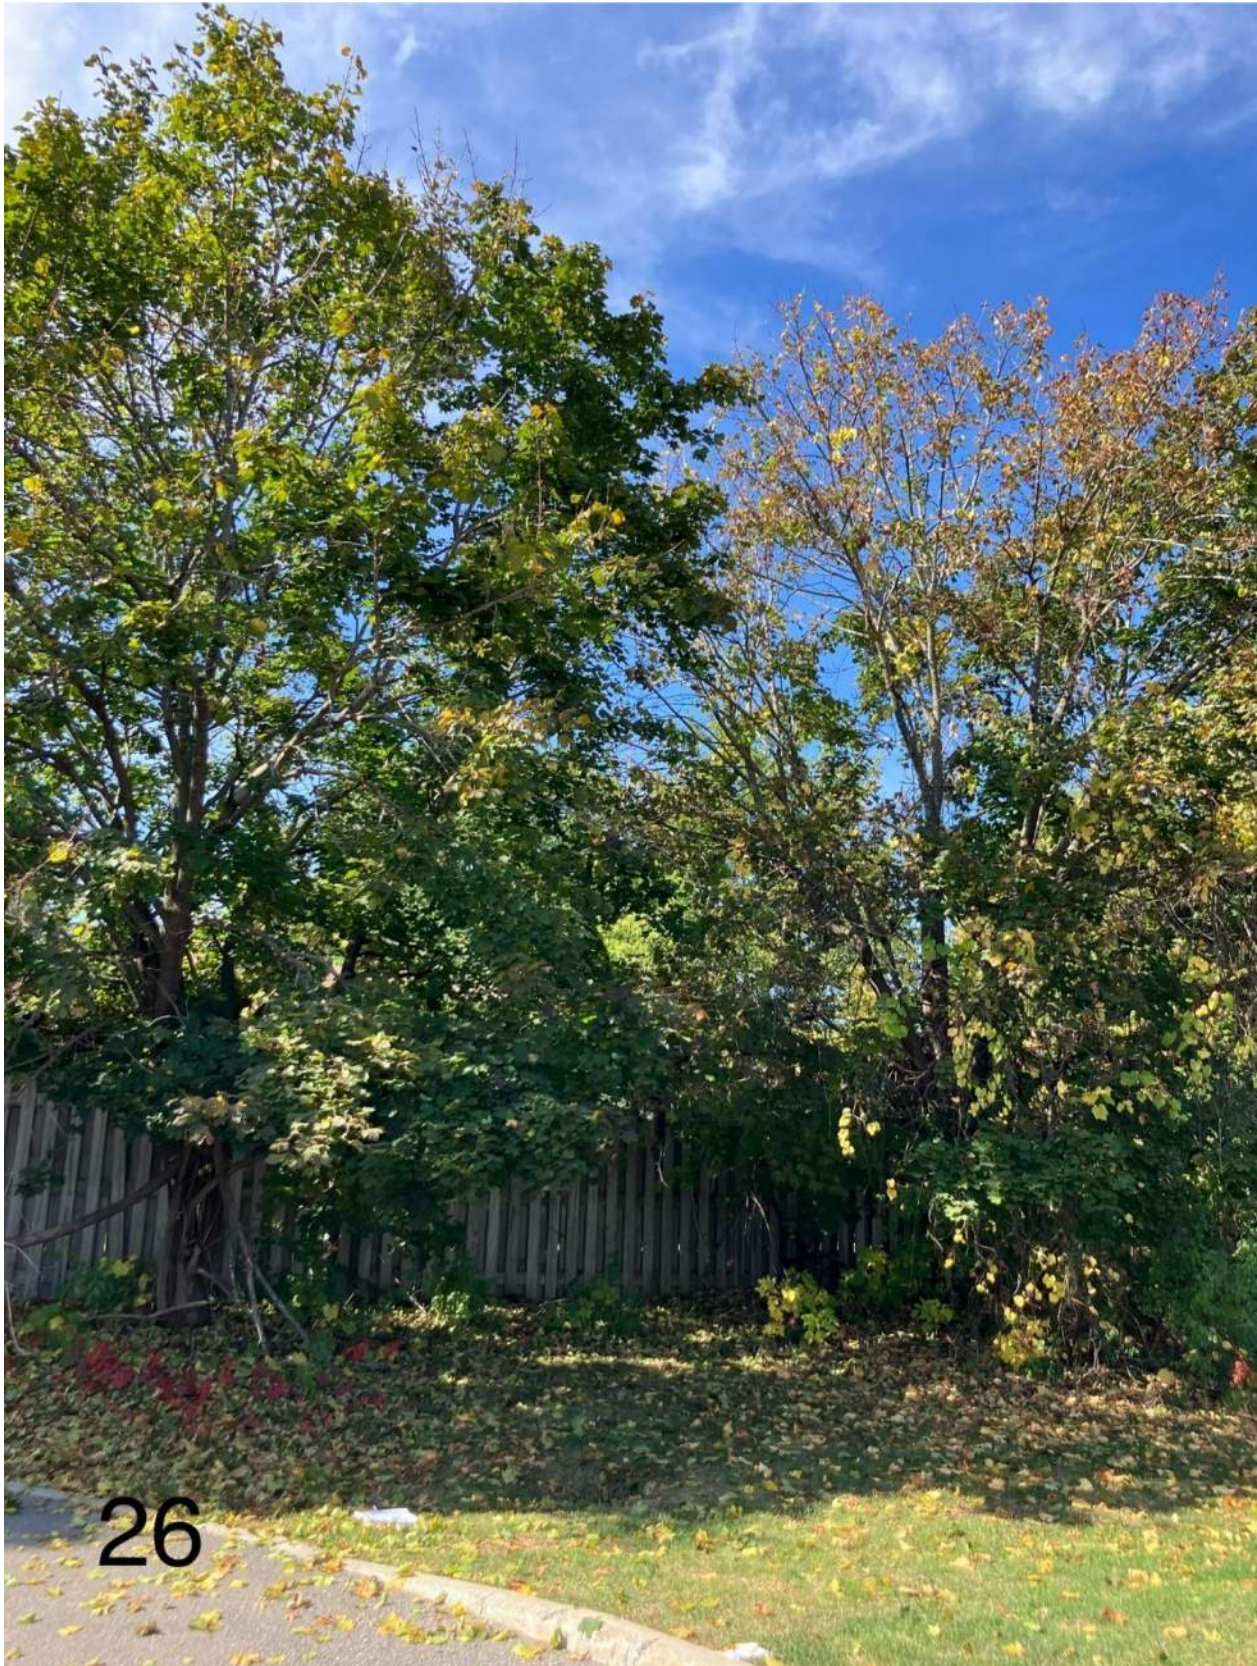
Figure 15 - Tree #26

| Tree Map Number | Species | Botanical | DBH (cm) @ 1.4 m | Tree Ownership | Minimum Tree Protection Distance (m) | Health | Structure | Overall Condition | Tree Height (m) | Crown Width (m) | Deadwood (%) | Construction inside Min TPZ? (Y/N) | Construction Impact (None, Low, Medium, High) | Action | Permit Required? (Y/N) | Notes and Recommendations |
|---|---|---|---|---|---|---|---|---|---|---|---|---|---|---|---|---|
| 26 | Maple, Norway | <i>Acer platanoides</i> | 60 | Private | 6.0 | Fair | Fair | Fair | 8 | 6 | 15 | N | None | Preserve | N | Multi-stem |

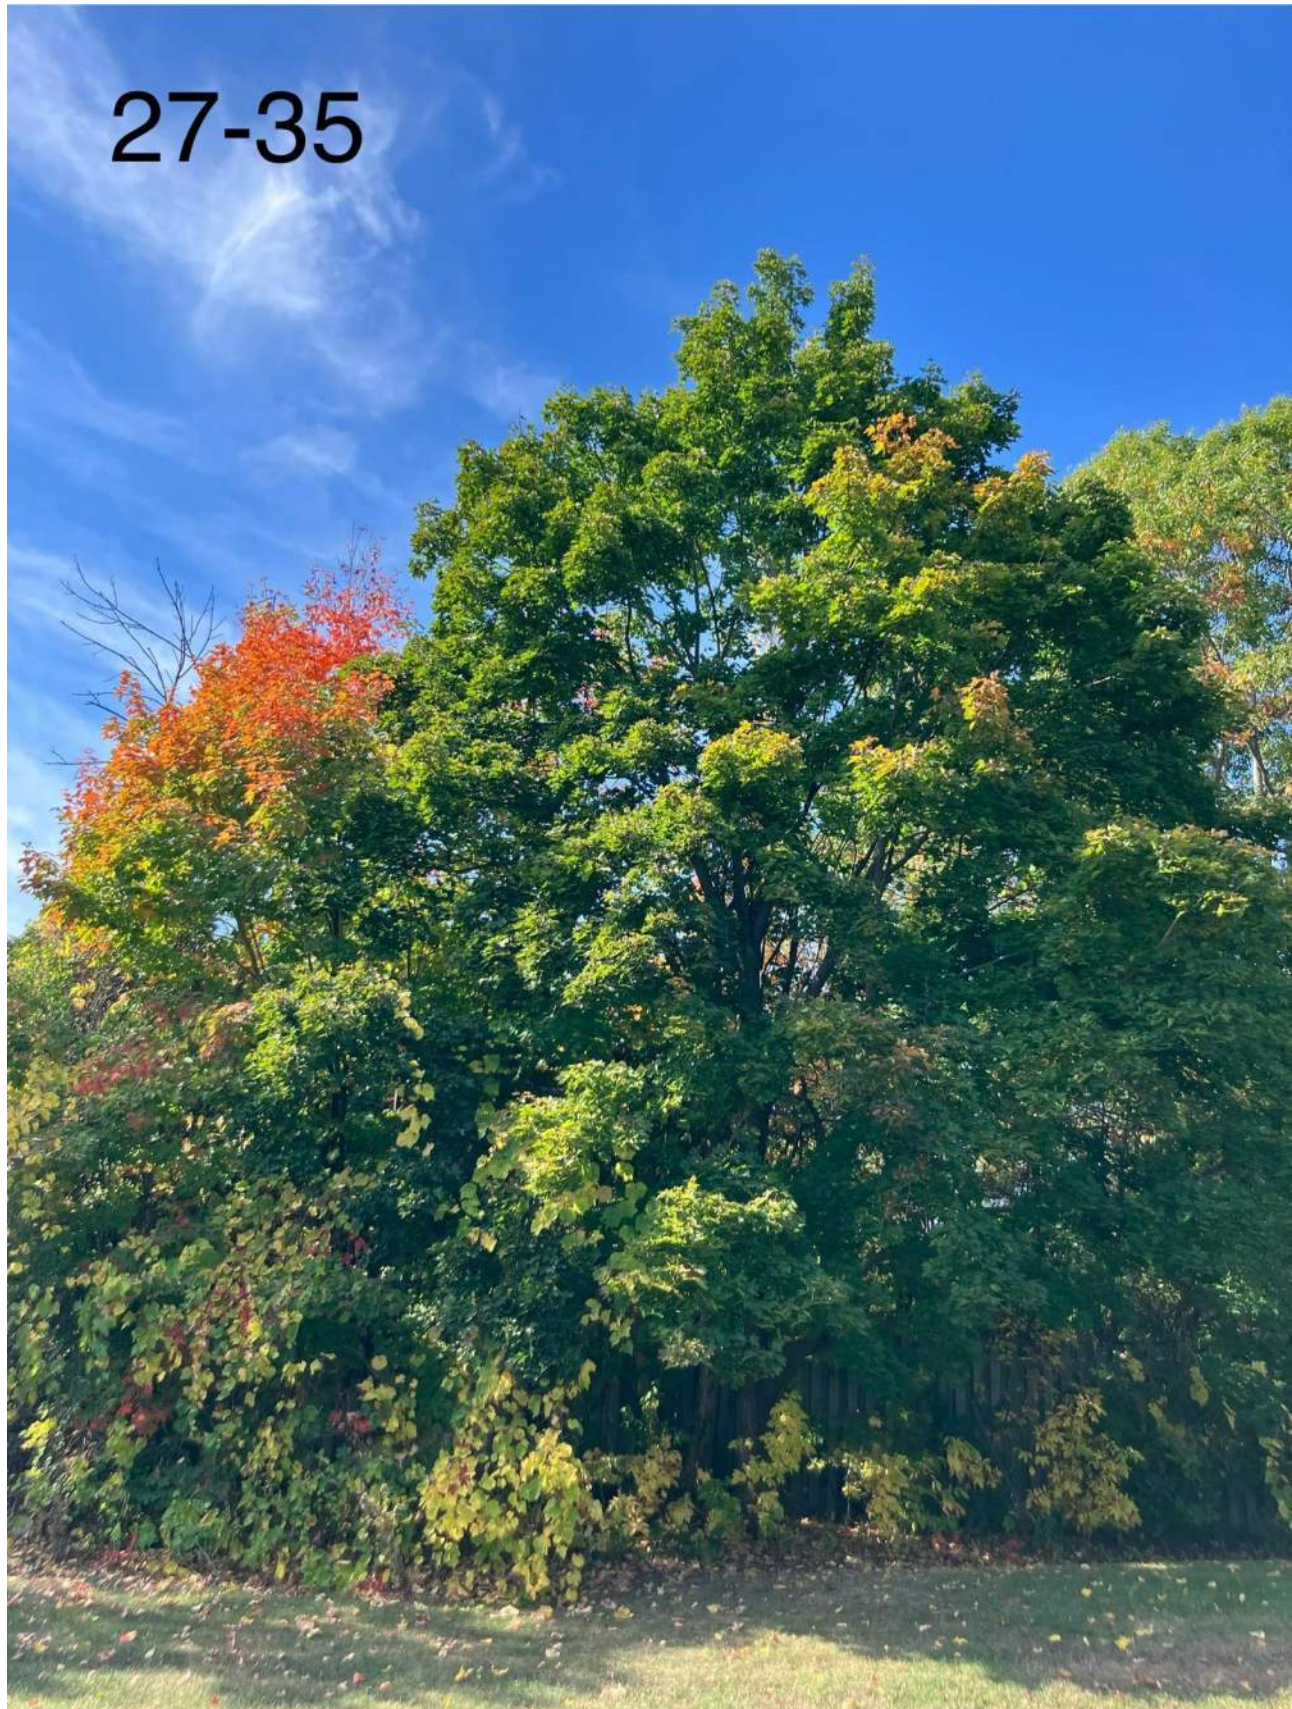
Figure 16 - Tree #27-35

| Tree Map Number | Species | Botanical | DBH (cm) @ 1.4 m | Tree Ownership | Minimum Tree Protection Distance (m) | Health | Structure | Overall Condition | Tree Height (m) | Crown Width (m) | Deadwood (%) | Construction inside Min TPZ? (Y/N) | Construction Impact (None, Low, Medium, High) | Action | Permit Required? (Y/N) | Notes and Recommendations |
|---|---|---|---|---|---|---|---|---|---|---|---|---|---|---|---|---|
| 27 | Maple, Norway | <i>Acer platanoides</i> | 44 | Private | 4.4 | Good | Fair | Good | 8 | 5 | 3 | N | None | Preserve | N | Has canker disease at base / Vines / Black spot |
| 28 | Buckthorn, Common | <i>Rhamnus cathartica</i> | 5 | Private | 0.5 | Good | Good | Good | 3 | 2 | 1 | N | None | Preserve | N | |
| 29 | Cherry, Sargent | <i>Prunus sargentii</i> | 5 | Private | 0.5 | Dead/Dying | Dead/Dying | Dead/Dying | 2 | 1 | 100 | N | High | Remove | N | Dead |
| 30 | Maple, Norway | <i>Acer platanoides</i> | 28 | Private | 2.8 | Good | Good | Good | 8 | 3 | 2 | N | None | Preserve | N | Growing through fence / Vine |
| 31 | Ash, spp. | <i>Fraxinus spp.</i> | 28 | Private | 1.8 | Dead/Dying | Dead/Dying | Dead/Dying | 8 | 2 | 100 | N | High | Remove | N | Dead Ash |
| 32 | Maple, Norway | <i>Acer platanoides</i> | 31 | Private | 3.1 | Good | Good | Good | 8 | 2 | 1 | Y | low | Injure | Y | Multi-stem |

| Tree Map Number | Species | Botanical | DBH (cm) @ 1.4 m | Tree Ownership | Minimum Tree Protection Distance (m) | Health | Structure | Overall Condition | Tree Height (m) | Crown Width (m) | Deadwood (%) | Construction inside Min TPZ? (Y/N) | Construction Impact (None, Low, Medium, High) | Action | Permit Required? (Y/N) | Notes and Recommendations |
|---|---|---|---|---|---|---|---|---|---|---|---|---|---|---|---|---|
| 33 | Ash, spp. | <i>Fraxinus spp.</i> | 56 | Private | 5.6 | Dead/Dying | Dead/Dying | Dead/Dying | 8 | 2 | 100 | N | High | Remove | N | Multi-stem / Dead Ash |
| 34 | Maple, Norway | <i>Acer platanoides</i> | 51 | Private | 5.1 | Good | Fair | Good | 9 | 6 | 1 | Y | High | Remove | Y | Canker disease at base / Black spot |
| 35 | Maple, Norway | <i>Acer platanoides</i> | 8 | Private | 0.8 | Good | Good | Good | 8 | 1 | 1 | N | None | Preserve | N | |

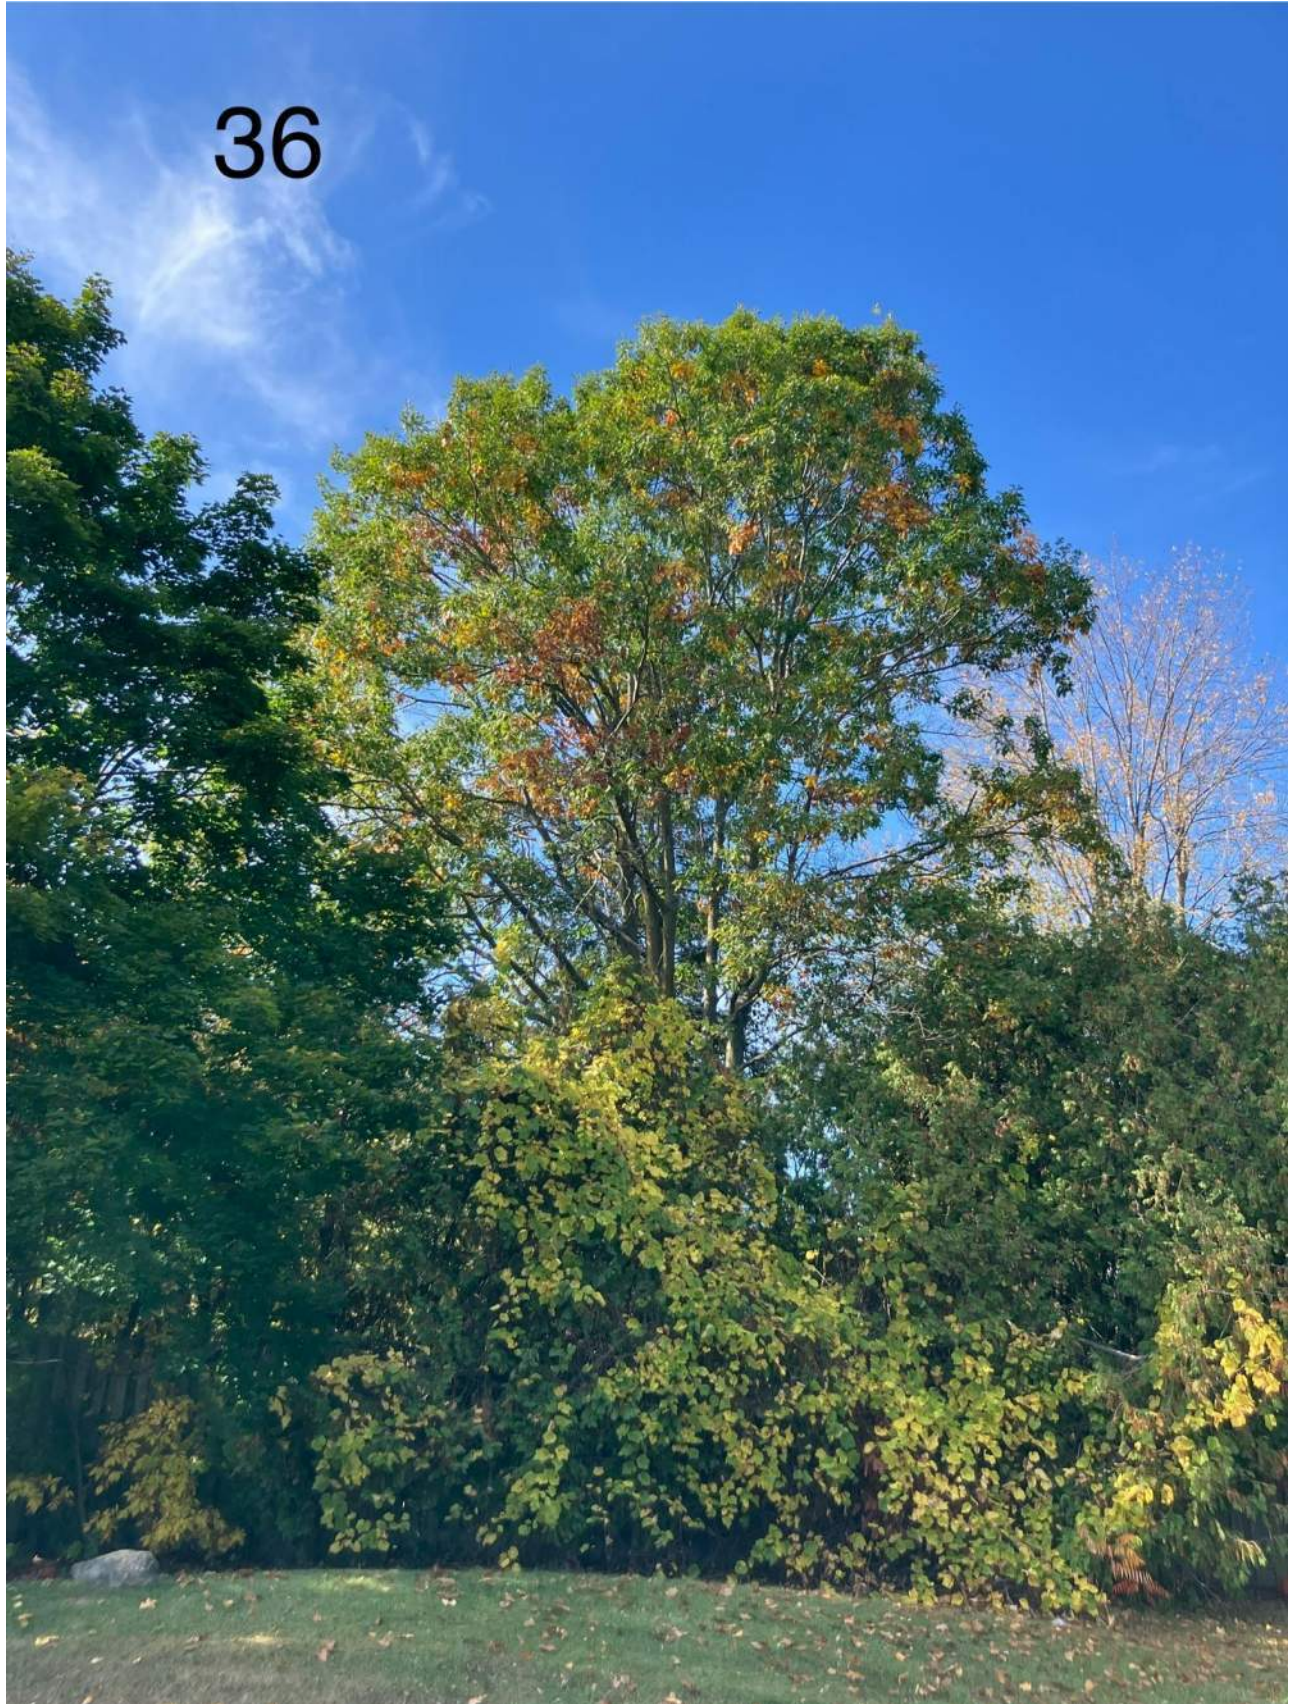
Figure 17 – Tree #36

| Tree Map Number | Species | Botanical | DBH (cm) @ 1.4 m | Tree Ownership | Minimum Tree Protection Distance (m) | Health | Structure | Overall Condition | Tree Height (m) | Crown Width (m) | Deadwood (%) | Construction inside Min TPZ? (Y/N) | Construction Impact (None, Low, Medium, High) | Action | Permit Required? (Y/N) | Notes and Recommendations |
|---|---|---|---|---|---|---|---|---|---|---|---|---|---|---|---|---|
| 36 | Oak, Hybrid | <i>Quercus x</i> | 78 | Private | 7.8 | Good | Good | Good | 13 | 9 | 2 | N | None | Preserve | N | |

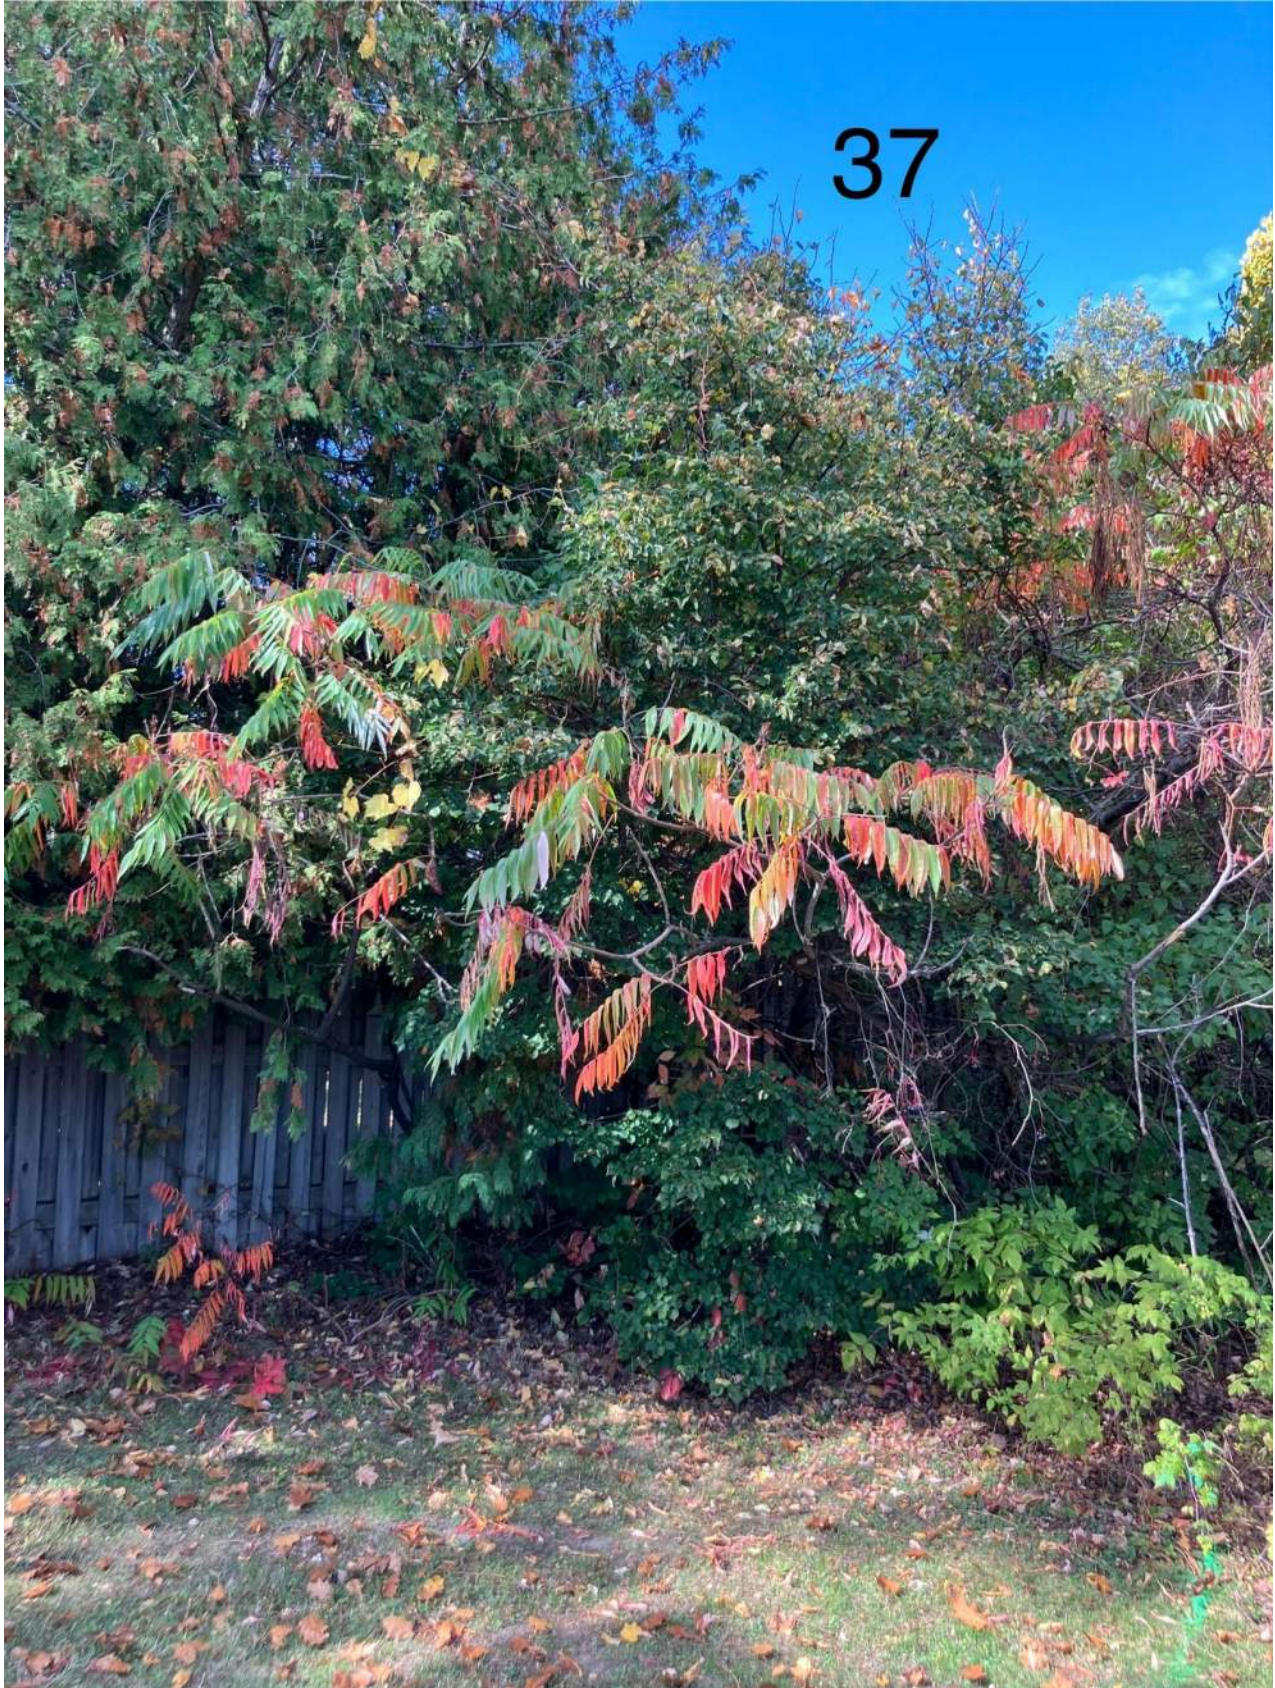
Figure 18 – Tree #37

| Tree Map Number | Species | Botanical | DBH (cm) @ 1.4 m | Tree Ownership | Minimum Tree Protection Distance (m) | Health | Structure | Overall Condition | Tree Height (m) | Crown Width (m) | Deadwood (%) | Construction inside Min TPZ? (Y/N) | Construction Impact (None, Low, Medium, High) | Action | Permit Required? (Y/N) | Notes and Recommendations |
|---|---|---|---|---|---|---|---|---|---|---|---|---|---|---|---|---|
| 37 | Linden, Littleleaf | <i>Tilia cordata</i> | 17 | Private | 1.7 | Good | Poor | Good | 3 | 3 | 1 | N | None | Preserve | N | Trees are growing on a 80 degree angle |
