# Arborist Report

## Pre-Construction Assessment Report

106 Eagleson St, Ottawa  
K2L 2P1

**Revised: April 24, 2026**

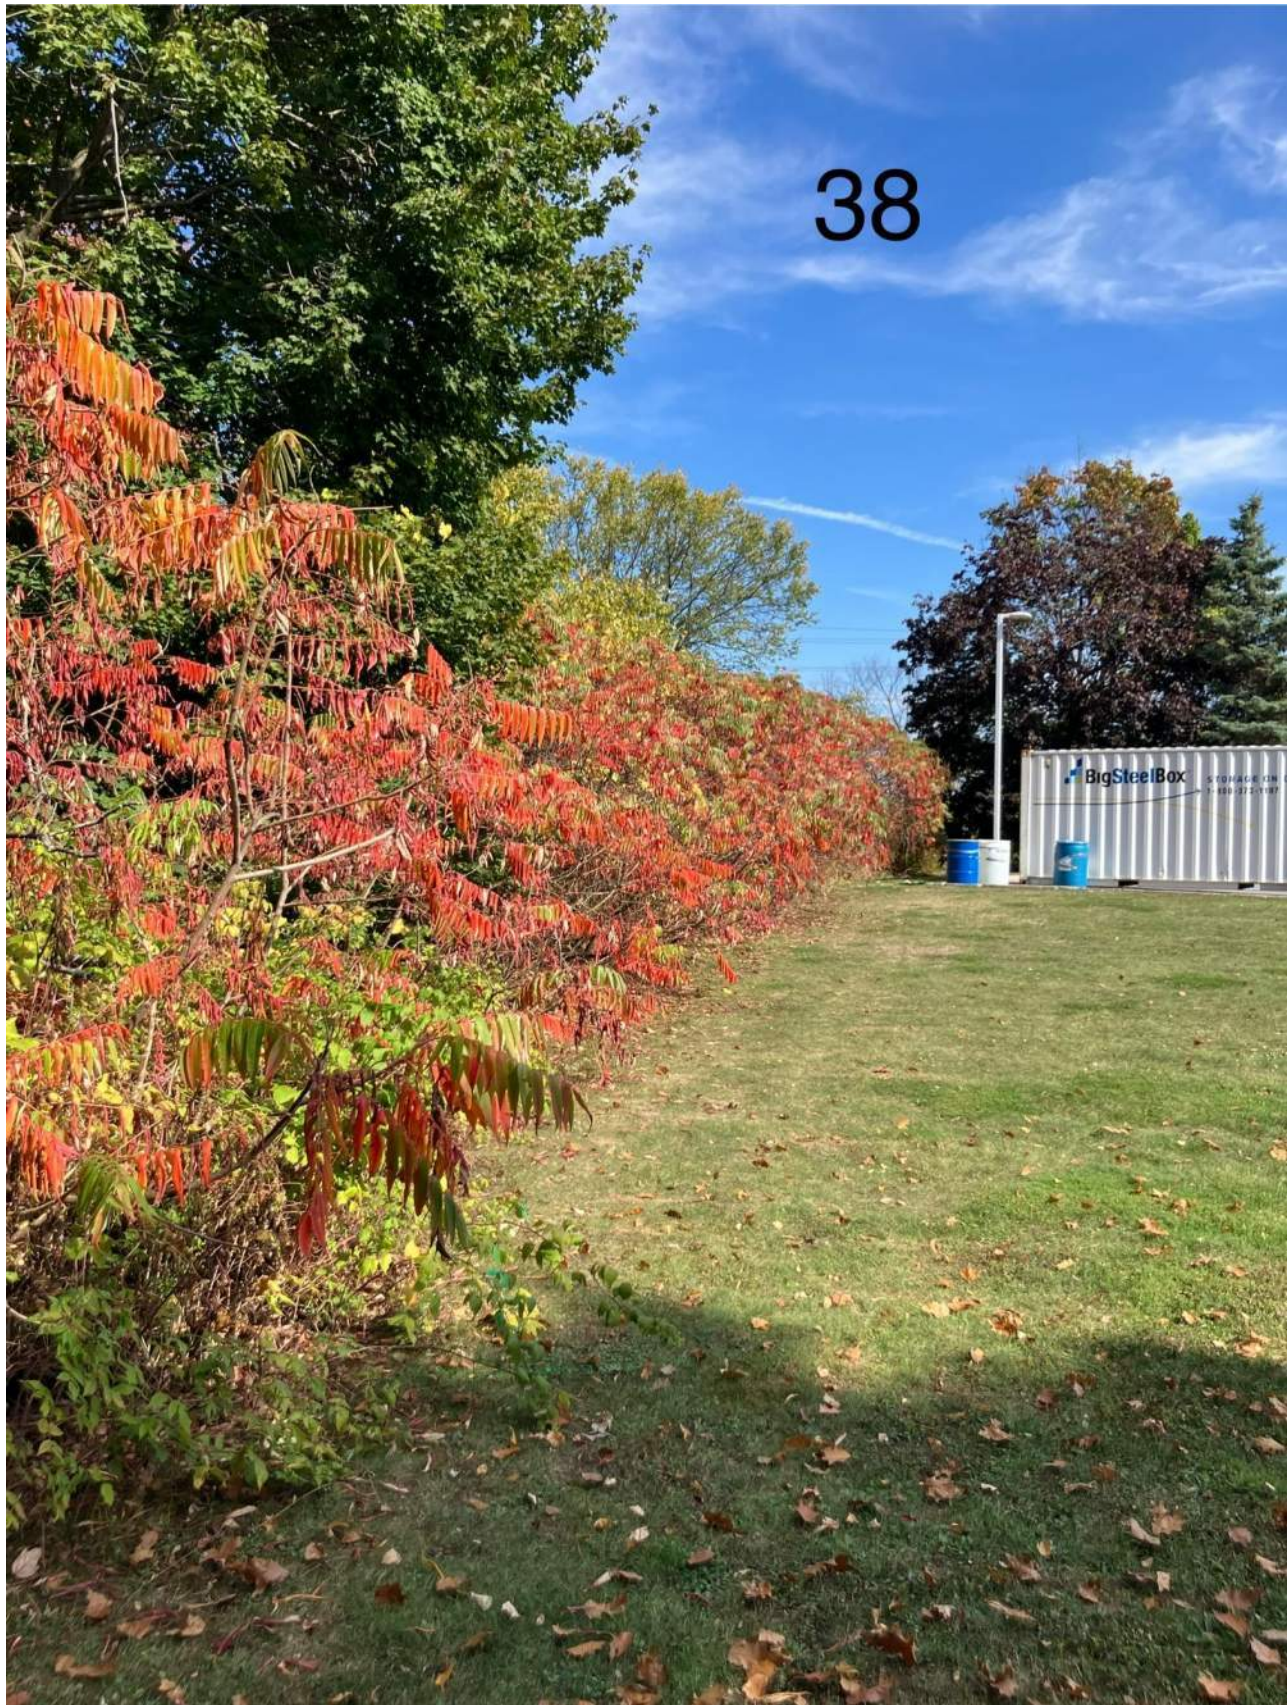
Figure 19 – Tree #38

| Tree Map Number | Species | Botanical | DBH (cm) @ 1.4 m | Tree Ownership | Minimum Tree Protection Distance (m) | Health | Structure | Overall Condition | Tree Height (m) | Crown Width (m) | Deadwood (%) | Construction inside Min TPZ? (Y/N) | Construction Impact (None, Low, Medium, High) | Action | Permit Required? (Y/N) | Notes and Recommendations |
|---|---|---|---|---|---|---|---|---|---|---|---|---|---|---|---|---|
| 38 | Sumac, spp. | <i>Rhus spp.</i> | 2-10 | Private | 1.0 | Good | Good | Good | 3 | 85 | 5 | Y | Low | Injure | N | Approximately 300 Sumac / Some dead stems / 3 meters deep |

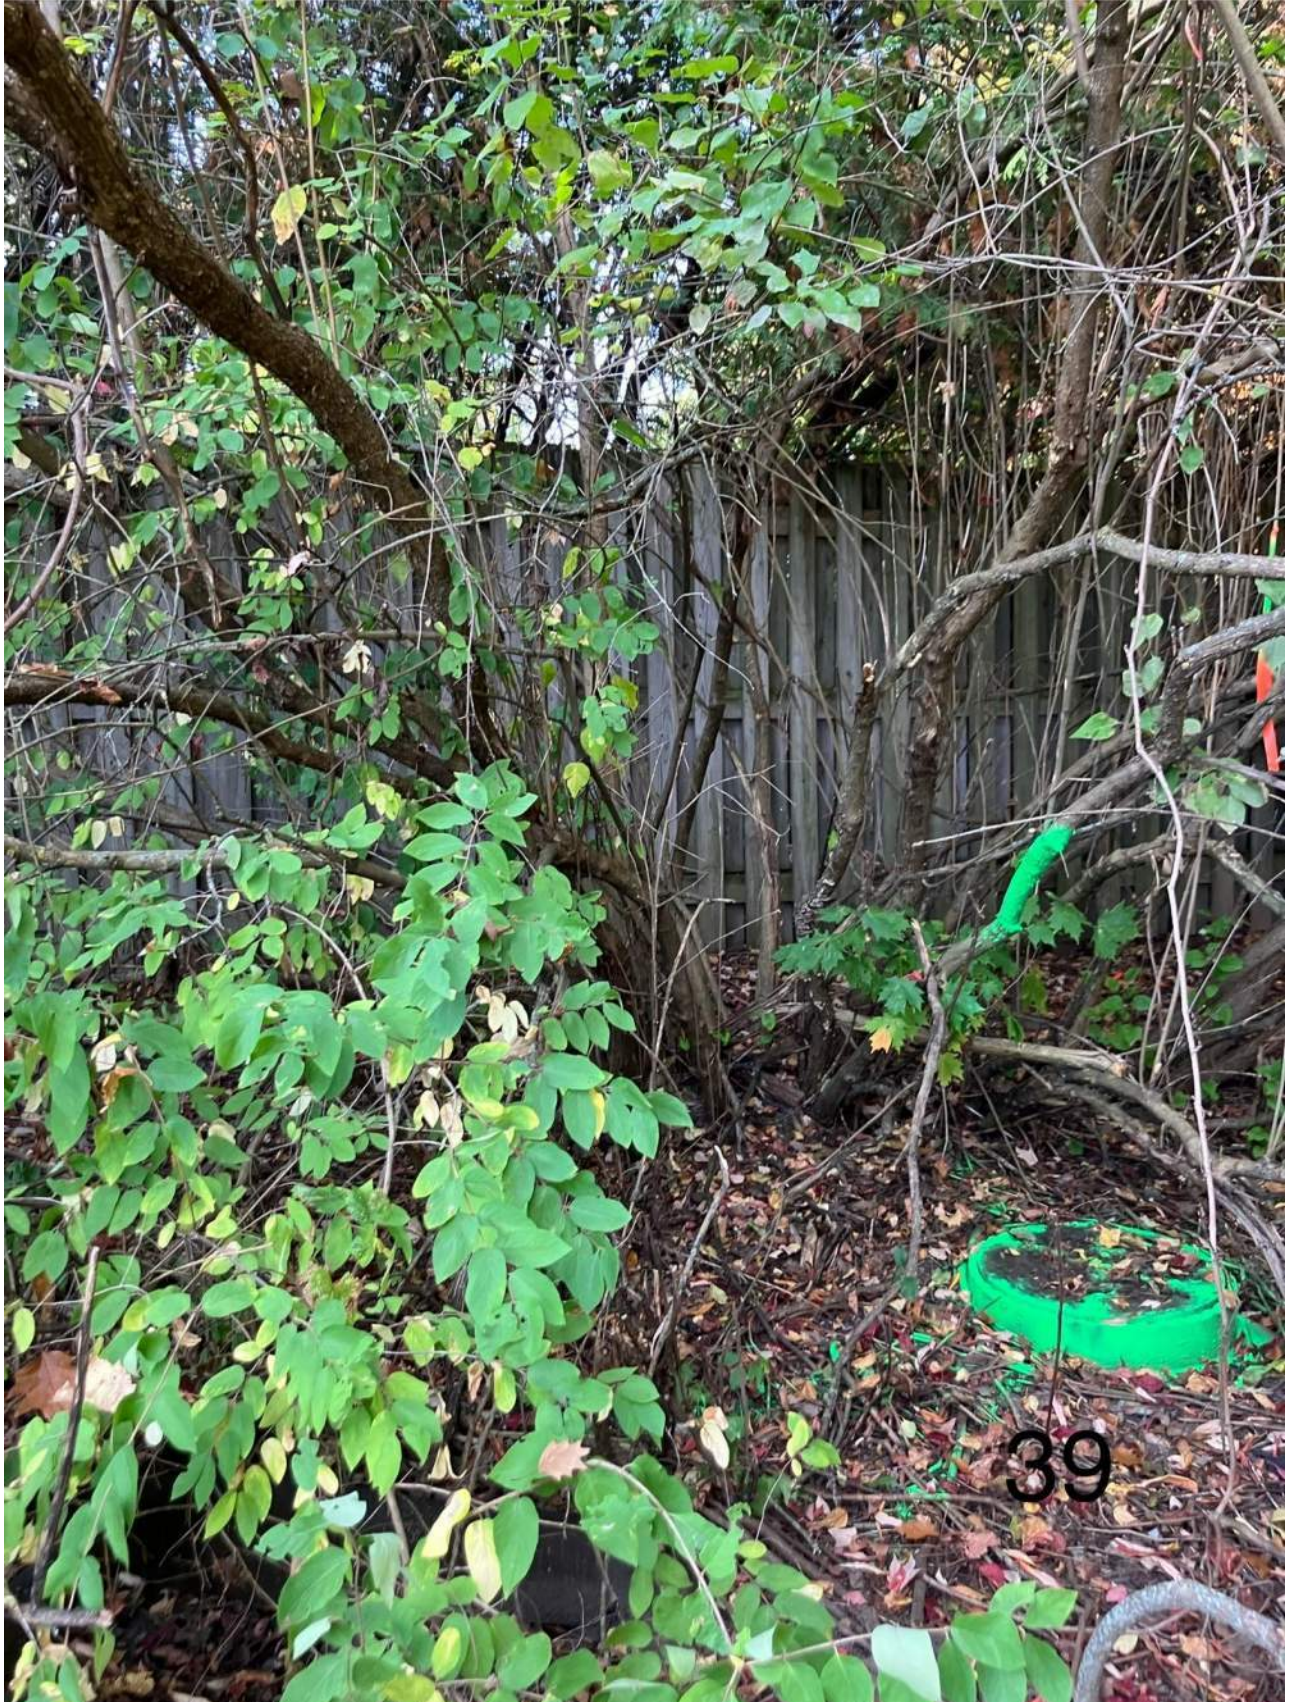
Figure 20 - Tree #39

| Tree Map Number | Species | Botanical | DBH (cm) @ 1.4 m | Tree Ownership | Minimum Tree Protection Distance (m) | Health | Structure | Overall Condition | Tree Height (m) | Crown Width (m) | Deadwood (%) | Construction inside Min TPZ? (Y/N) | Construction Impact (None, Low, Medium, High) | Action | Permit Required? (Y/N) | Notes and Recommendations |
|---|---|---|---|---|---|---|---|---|---|---|---|---|---|---|---|---|
| 39 | Lilac spp. | <i>Syringa spp.</i> | 10 | Private | 1.0 | Fair | Fair | Fair | 3 | 4 | 20 | N | None | Preserve | N | 20 Stems / Bush |

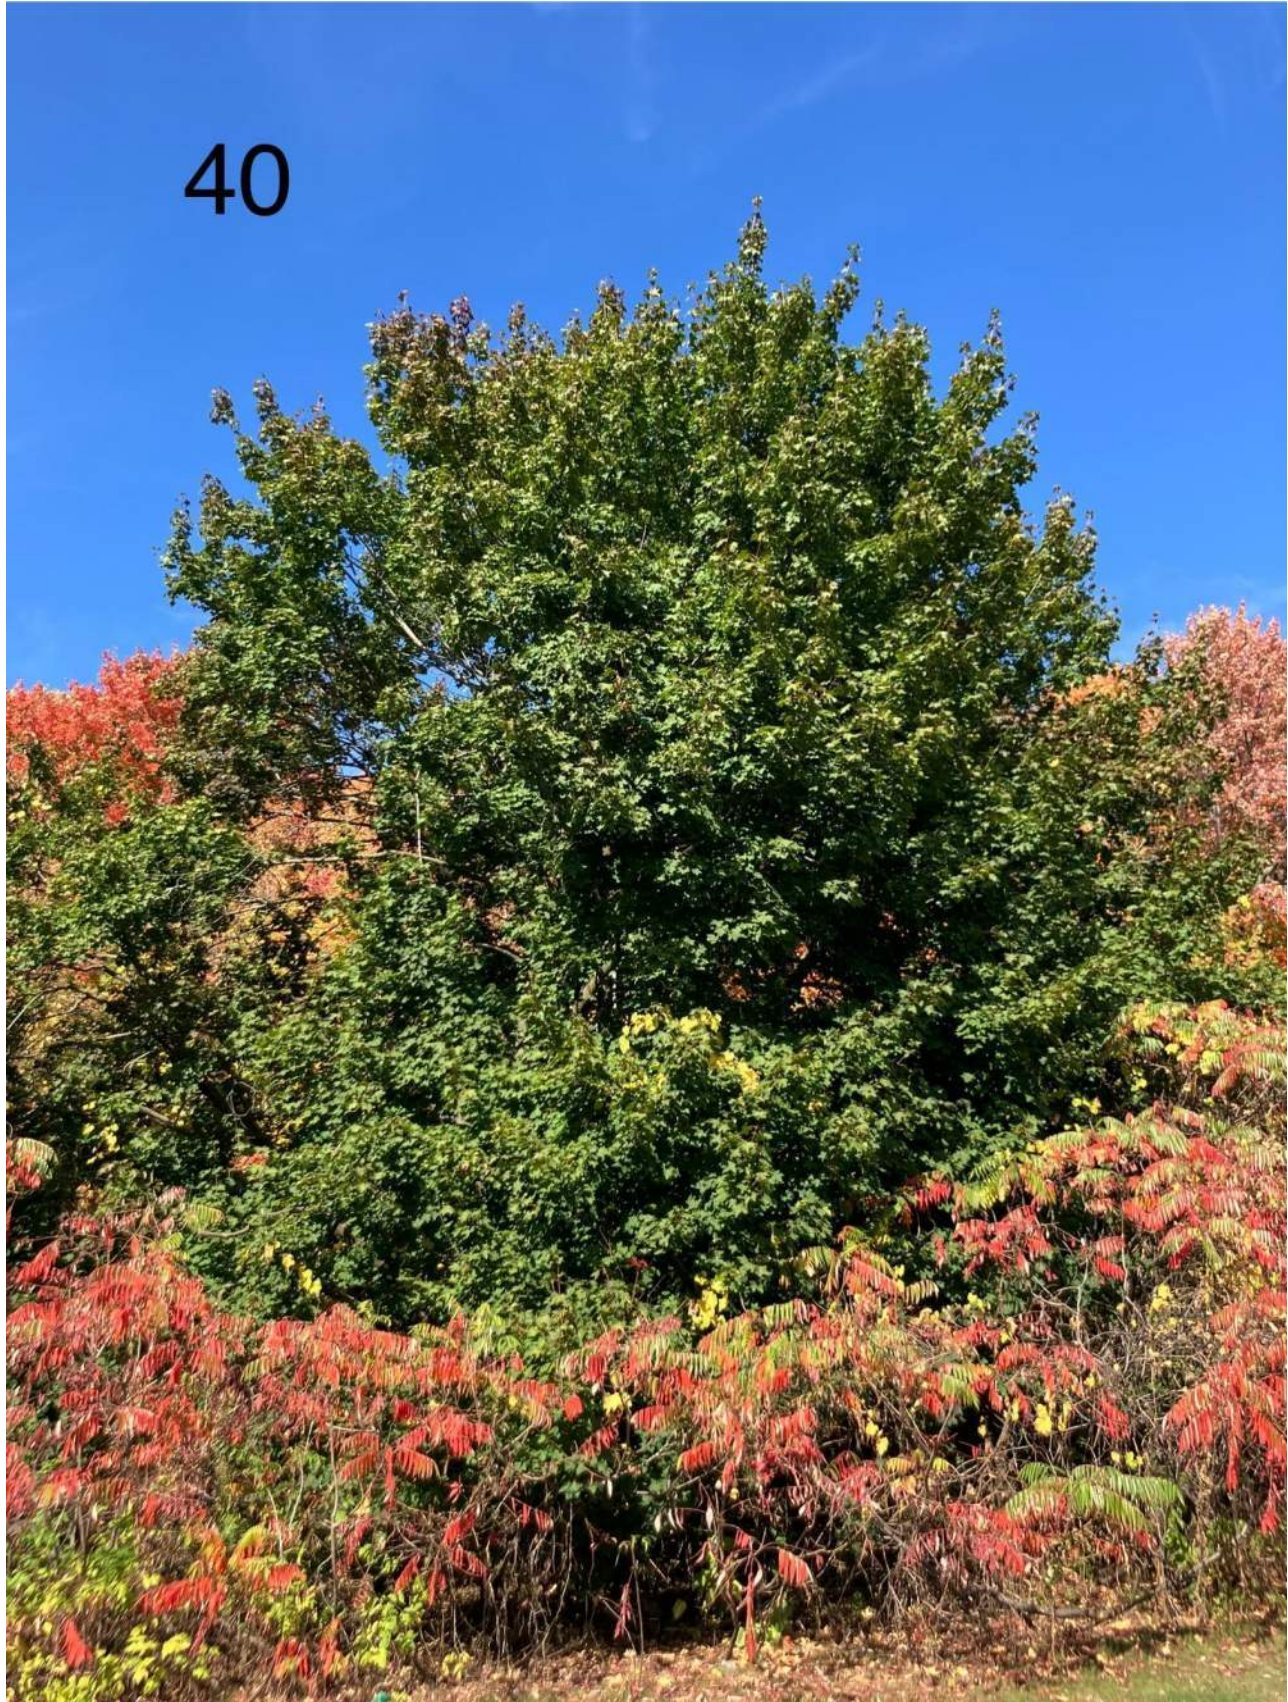
Figure 21 - Tree #40

| Tree Map Number | Species | Botanical | DBH (cm) @ 1.4 m | Tree Ownership | Minimum Tree Protection Distance (m) | Health | Structure | Overall Condition | Tree Height (m) | Crown Width (m) | Deadwood (%) | Construction inside Min TPZ? (Y/N) | Construction Impact (None, Low, Medium, High) | Action | Permit Required? (Y/N) | Notes and Recommendations |
|---|---|---|---|---|---|---|---|---|---|---|---|---|---|---|---|---|
| 40 | Maple, Norway | <i>Acer platanoides</i> | 64 | Private | 6.4 | Good | Fair | Good | 10 | 8 | 3 | N | None | Preserve | N | Large few piece on ground / Black spot |

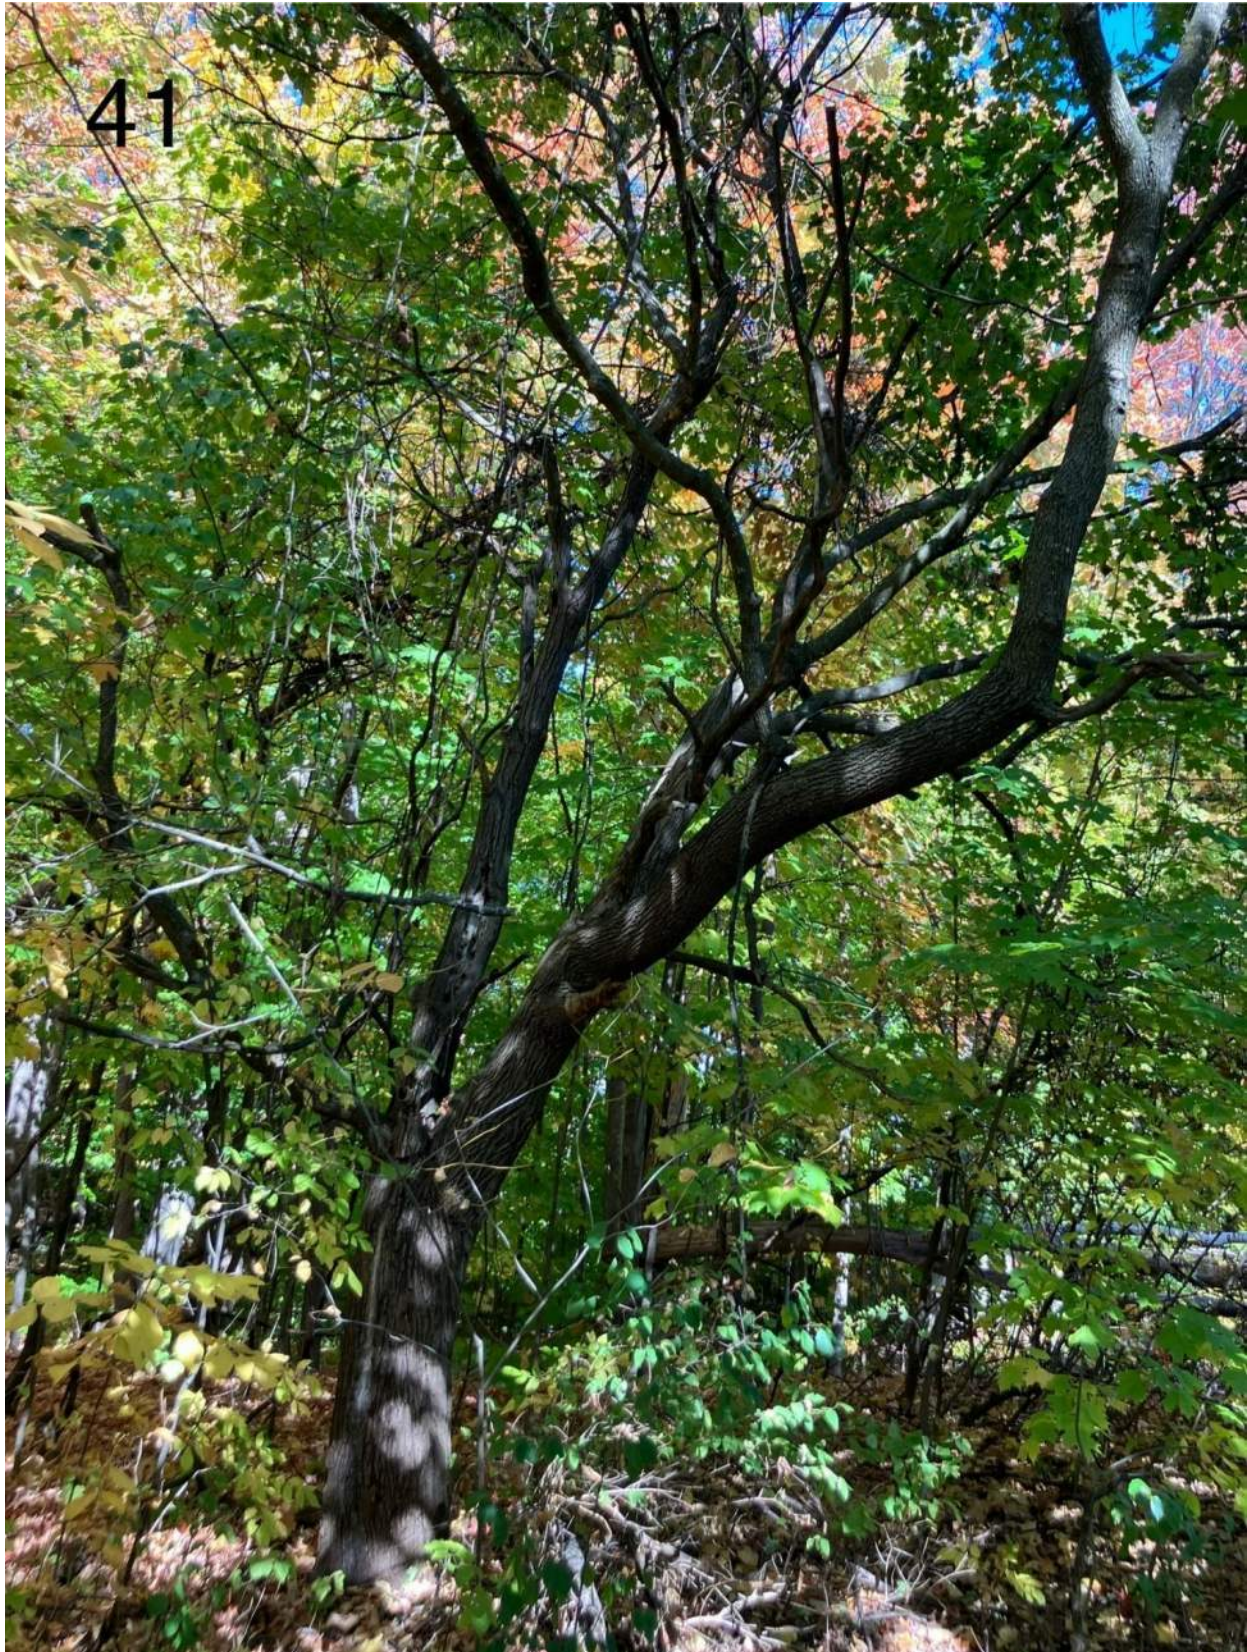
Figure 22 - Tree #41

| Tree Map Number | Species | Botanical | DBH (cm) @ 1.4 m | Tree Ownership | Minimum Tree Protection Distance (m) | Health | Structure | Overall Condition | Tree Height (m) | Crown Width (m) | Deadwood (%) | Construction inside Min TPZ? (Y/N) | Construction Impact (None, Low, Medium, High) | Action | Permit Required? (Y/N) | Notes and Recommendations |
|---|---|---|---|---|---|---|---|---|---|---|---|---|---|---|---|---|
| 41 | Maple, Norway | <i>Acer platanoides</i> | 41 | Private | 4.1 | Fair | Fair | Fair | 10 | 6 | 10 | N | None | Preserve | N | Cavities / Fungal bodies |

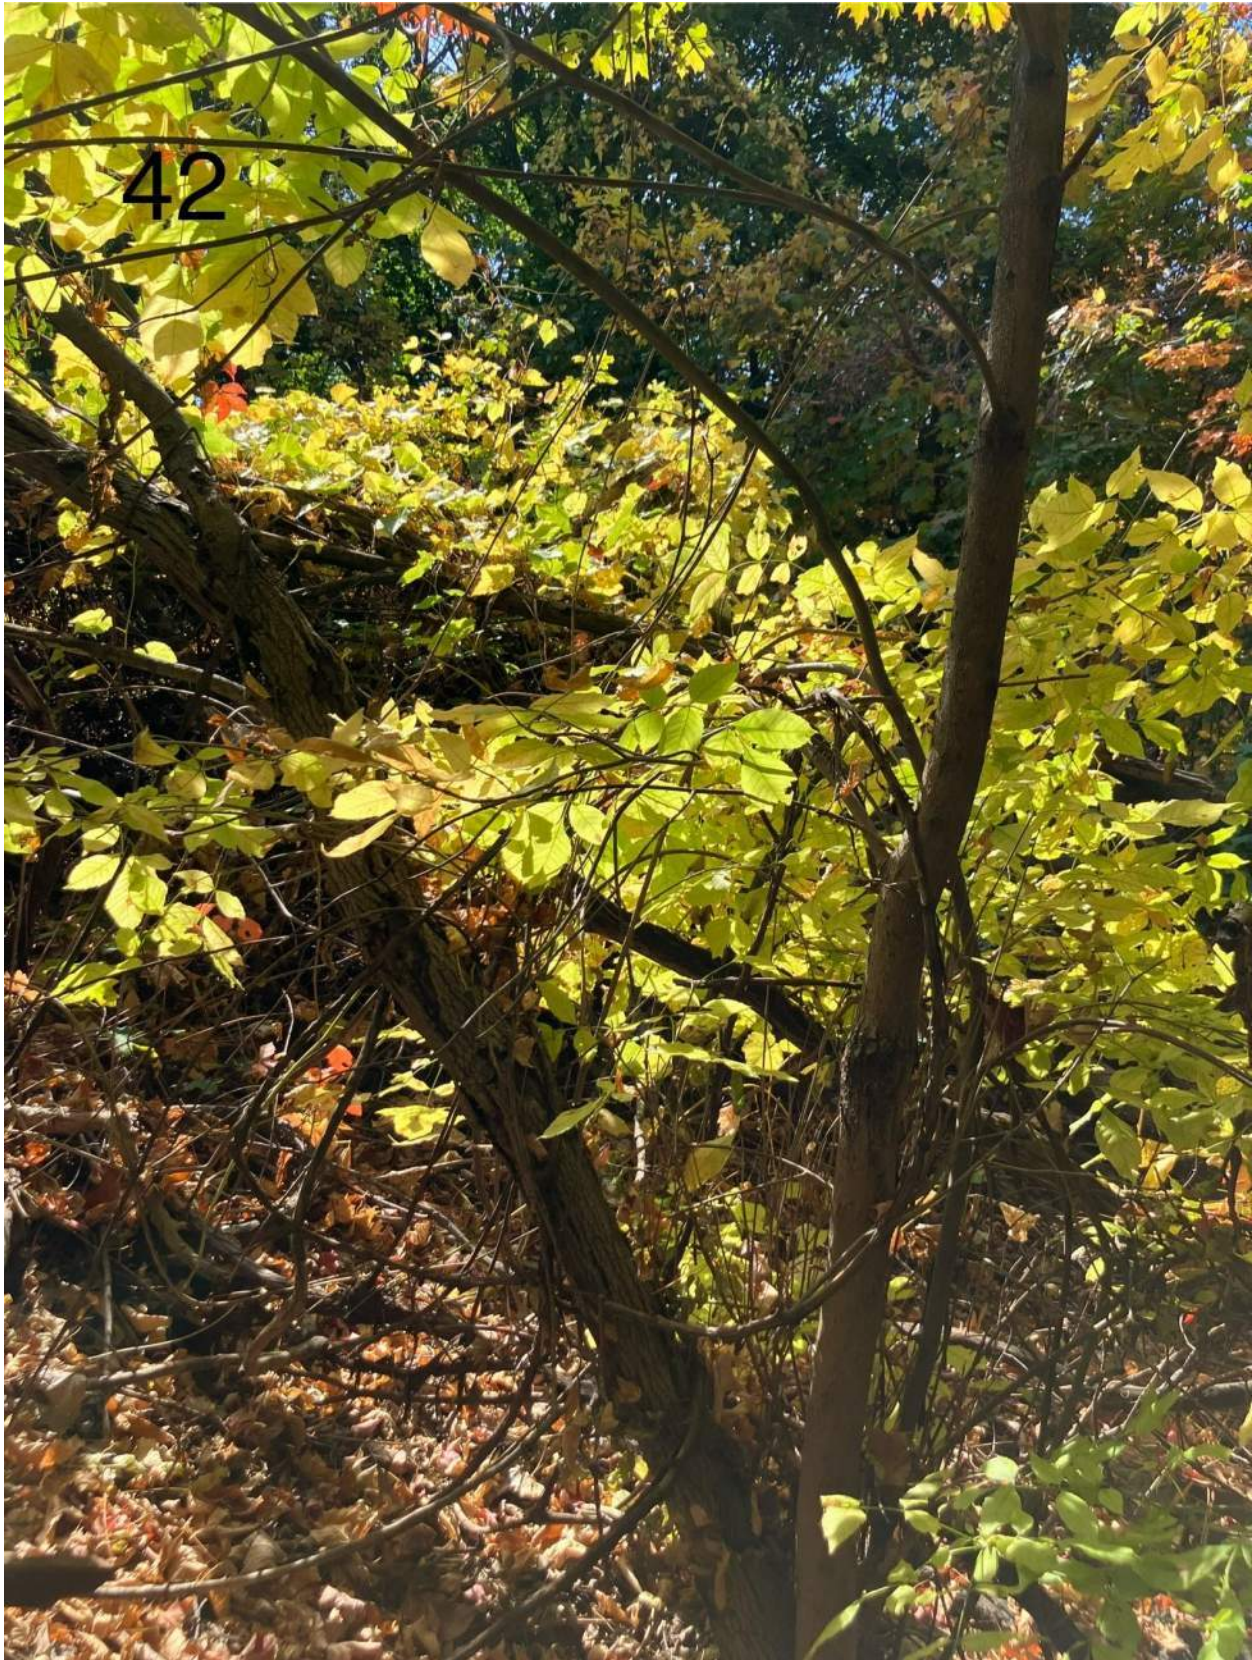
Figure 23 - Tree #42

| Tree Map Number | Species | Botanical | DBH (cm) @ 1.4 m | Tree Ownership | Minimum Tree Protection Distance (m) | Health | Structure | Overall Condition | Tree Height (m) | Crown Width (m) | Deadwood (%) | Construction inside Min TPZ? (Y/N) | Construction Impact (None, Low, Medium, High) | Action | Permit Required? (Y/N) | Notes and Recommendations |
|---|---|---|---|---|---|---|---|---|---|---|---|---|---|---|---|---|
| 42 | Ash, spp. | <i>Fraxinus spp.</i> | 13 | Private | 1.3 | Poor | Poor | Poor | 2 | 3 | 60 | N | None | Preserve | N | Multi-stem / large stem dead / Only suckers alive |

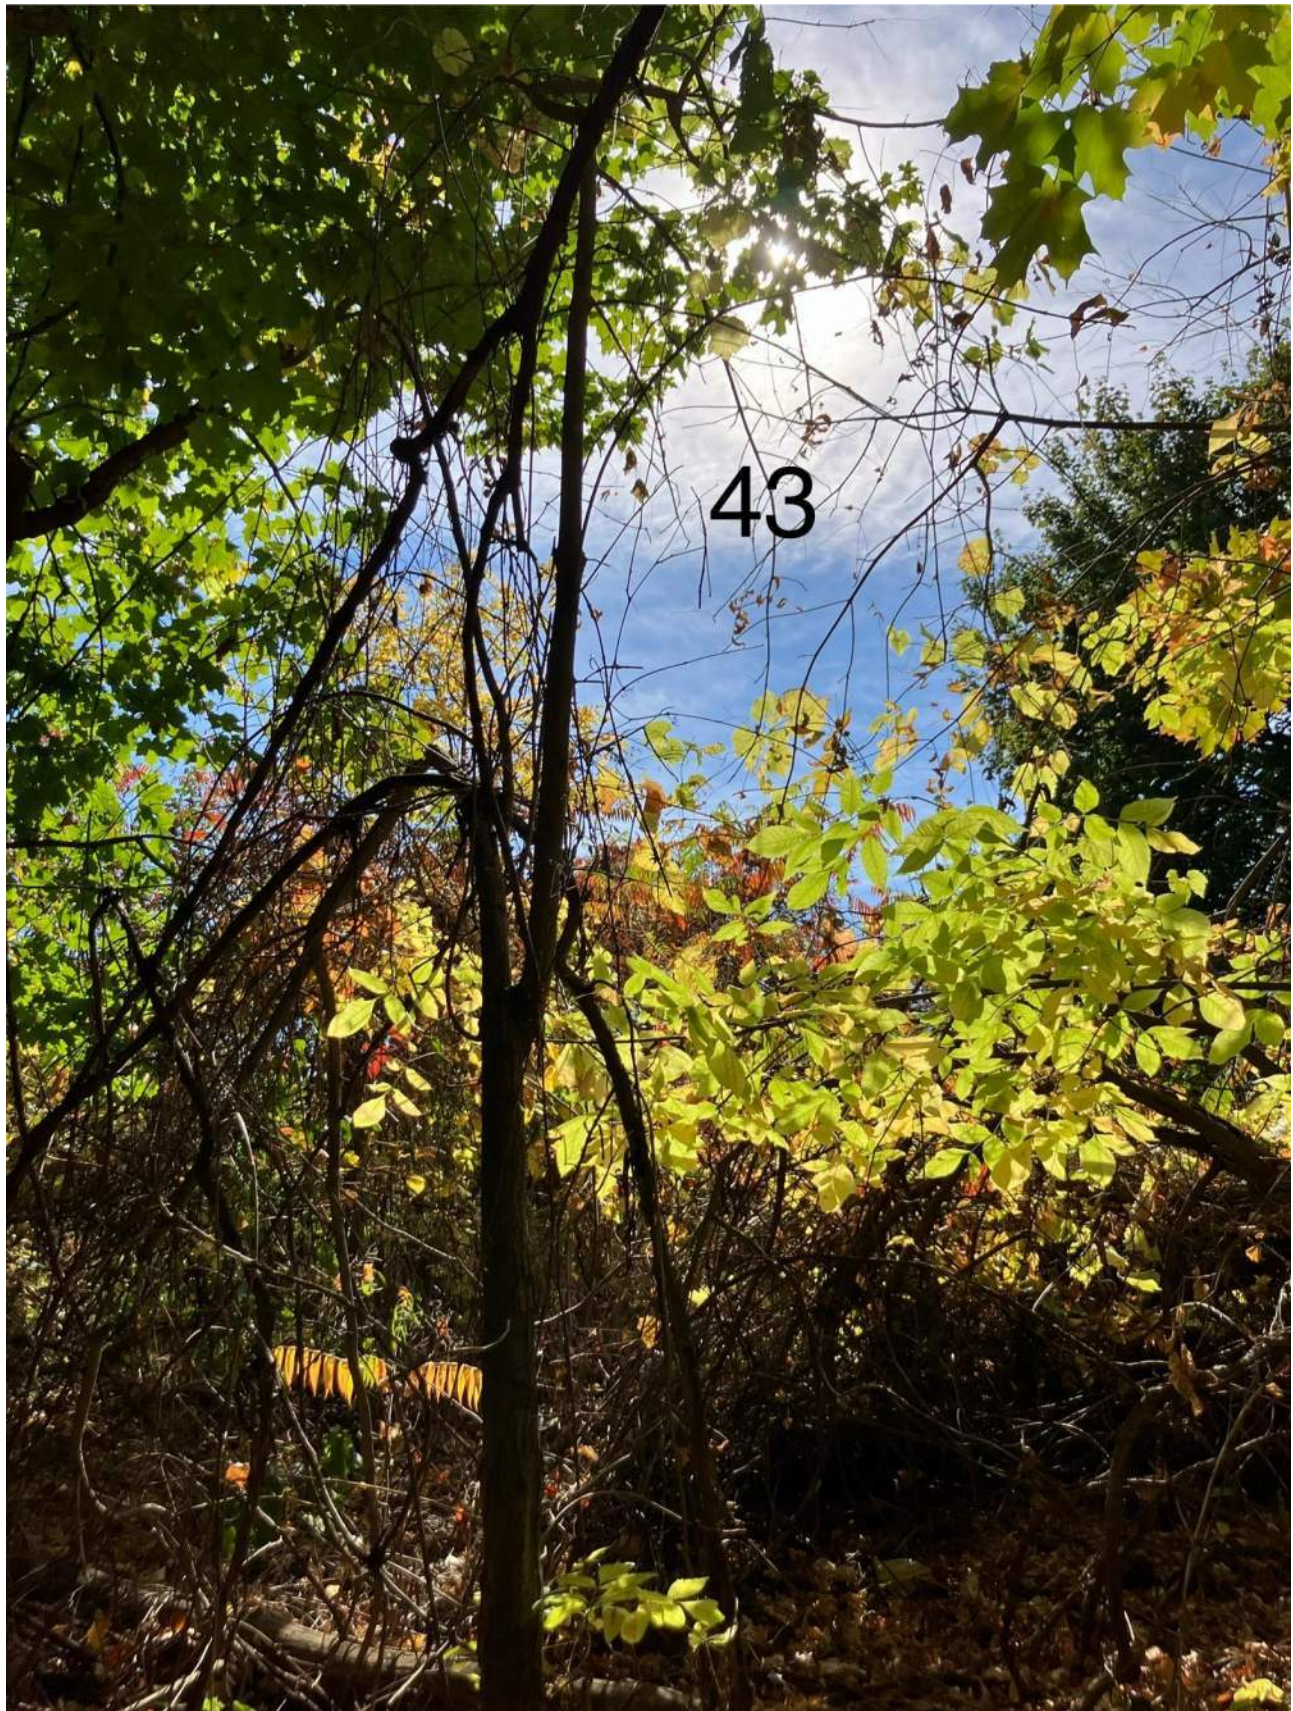
Figure 24 - Tree #43

| Tree Map Number | Species | Botanical | DBH (cm) @ 1.4 m | Tree Ownership | Minimum Tree Protection Distance (m) | Health | Structure | Overall Condition | Tree Height (m) | Crown Width (m) | Deadwood (%) | Construction inside Min TPZ? (Y/N) | Construction Impact (None, Low, Medium, High) | Action | Permit Required? (Y/N) | Notes and Recommendations |
|---|---|---|---|---|---|---|---|---|---|---|---|---|---|---|---|---|
| 43 | Ash, spp. | <i>Fraxinus spp.</i> | 8 | Private | 0.8 | Fair | Good | Good | 3 | 1 | 25 | N | None | Preserve | N | Bush |
