September 20, 2021

**RE: Arborist Report for Rositch Hemphill Architects - For property located at 1511 West 47 Ave., & 6151 - 6261 Granville St., Vancouver, BC**

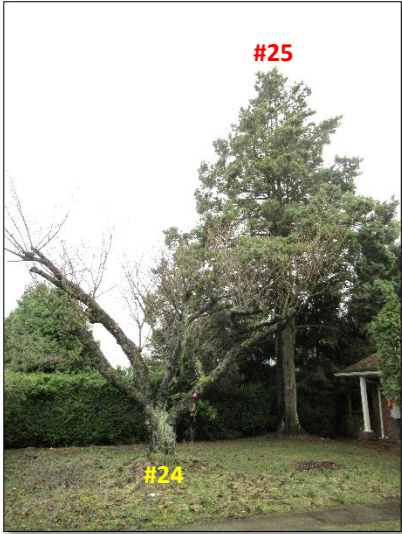
April 6/17 - Trees #24 & #25

| TREE # | SPECIES | DBH (cm) | HEIGHT (m) est. | CRZ (ft.) radius | Condition | OBSERVATIONS & RECOMMENDATIONS |
|---|---|---|---|---|---|---|
| 24 | Cherry<br>( <i>Prunus sp.</i> ) | 99<br>combined<br>(38+31+30) | 7 | 20.4' | Declining | <p>This tree is in decline. It has three stems commencing at 4ft. The canopy has been mutilated. It has been previously topped at multiple heights and cut back quite hard on all sides to contain; the canopy consists of mostly suckering growth commencing at this point. The topping and pruning sites have not callused over, and decay is present. There is evidence of Tortrix borer, and it has canker. There are multiple surface roots exposed, which have sustained damage due to lawn maintenance equipment. The Critical Root Zone radius is 20.4ft. The footprint of the proposed underground parkade and the final lines of excavation are about 19ft from the southwest side of the stem.</p> <p><b>RECOMMENDATIONS:</b><br/><b>REMOVE.</b> Remove tree since it is in decline and due to poor structure. Its removal will also be necessary when the adjacent property is to be developed.</p> |
| 25 | Cypress<br>( <i>Chamaecyparis sp.</i> ) | 79 | 10 | 16.3' | Fair | <p>This tree is quite stressed. It has multiple stems commencing at 12ft; slight bark inclusions were observed. The northwest side of the crown has been raised to provide clearance to an adjacent building. The canopy is rather sparse, and it lacks vigor. The foliage is pale and chlorotic. There is also branch and twig dieback throughout the canopy. The Critical Root Zone radius is 16.3ft. The footprint of the proposed underground parkade and the final lines of excavation are 3.5ft from the south side of the stem.</p> <p><b>RECOMMENDATIONS:</b><br/><b>REMOVE.</b> Removal of this tree is necessary to enable the proposed parkade. The lines of excavation required will result in extensive root loss and soil disturbance causing instability. Also, this species of tree has a sensitive root system; they have a low tolerance to root disturbance or changes in grade and hydrology. The disturbance within the Critical Root Zone during construction will likely cause this tree to decline over time.</p> |

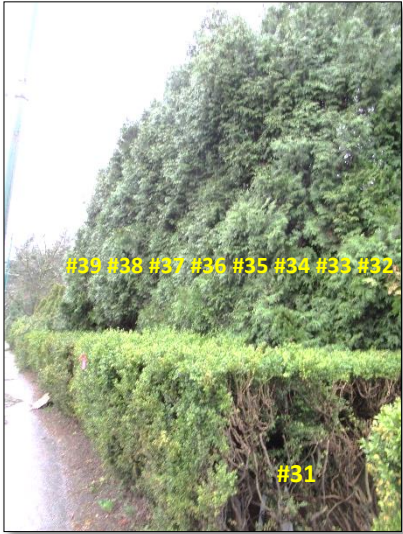
| TREE # | SPECIES | DBH (cm) | HEIGHT (m) est. | CRZ (ft.) radius | Condition | OBSERVATIONS & RECOMMENDATIONS |
|---|---|---|---|---|---|---|
| 31 | Boxwood<br>( <i>Buxus sp.</i> ) | - | 1.5 | 3' | Fair | This hedge may belong to the City; although, it does not appear to be something that would have been planted by them. It has been somewhat maintained. Sections of the hedge have sustained minor snow damage. This hedge is within a dedication. There is an existing walkway through a portion of hedge. The south end of this hedge is within the proposed main access to the proposed building.<br><b>RECOMMENDATIONS:</b><br><b>REMOVE.</b> Obtain consent from the City and remove hedge to enable the proposed main access and unimpeded site and construction access through the front of the properties. |

April 6/19 - Hedge #31 & Trees #32 - #31

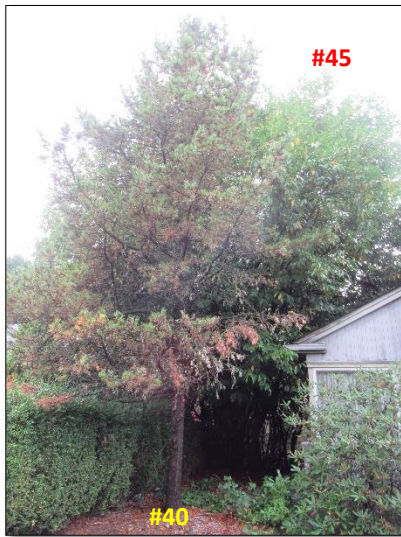
Sept 12/19 - Trees #40 & #45

| TREE # | SPECIES | DBH (cm) | HEIGHT (m) est. | CRZ (ft.) radius | Condition | OBSERVATIONS & RECOMMENDATIONS |
|---|---|---|---|---|---|---|
| 40 | Pine<br>( <i>Pinus sp.</i> ) | 22 | 10 | 4.5' | Fair | <p>This tree is not of a size that requires it to be protected by the City Interim Tree By – Law. It is stressed. The crown is somewhat sparse, and it lacks vigor. The needles are pale and have begun to turn brown. There is minor branch and twig dieback and inner needle shed throughout the canopy. The Critical Root Zone radius is 4.5ft. This tree is within the footprint of the proposed underground parkade.</p> <p><b>RECOMMENDATIONS:</b><br/><b>REMOVE.</b> Remove tree, it is not protected. Also, removal is necessary to enable the proposed underground parkade.</p> |

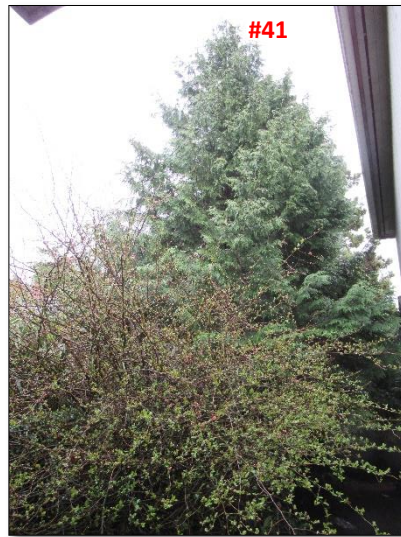
April 6/17 - Tree #41

| TREE # | SPECIES | DBH (cm) | HEIGHT (m) est. | CRZ (ft.) radius | Condition | OBSERVATIONS & RECOMMENDATIONS |
|---|---|---|---|---|---|---|
| 41 | Cedar<br>( <i>Thuja plicata</i> ) | 33 | 12 | 6.8' | Good | <p>This tree appears typical of the species. There is an existing walkway 3ft from the south side, and an existing wood fence adjacent to the north side of the stem. The Critical Root Zone radius is 6.8ft. This tree is within the footprint of the proposed underground parkade.</p> <p><b>RECOMMENDATIONS:</b><br/><b>REMOVE.</b> Removal of this tree is necessary to enable the proposed parkade.</p> |

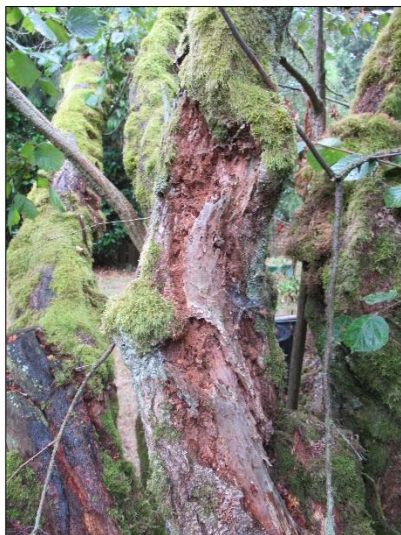
Sept 12/19 - Tree #42

| TREE # | SPECIES | DBH (cm) | HEIGHT (m) est. | CRZ (ft.) radius | Condition | OBSERVATIONS & RECOMMENDATIONS |
|---|---|---|---|---|---|---|
| 42 | Hazelnut<br>( <i>Corylus sp.</i> ) | 97 comb.<br>(35+32+30) | 11 | 20' | Declining | <p>This tree is in severe decline. It has multiple over-extended stems commencing at the base; several of these stems are dead. There is extensive decay commencing at the union, which extends into several stems. The crown has been significantly modified. It has been previously topped at multiple heights, and cut back hard on all sides to contain, and to provide clearance to the single-phase Hydro line, reduction lines, and communication cables; the canopy consists of only a few suckering shoots commencing at this point. Most of the pruning sites have not callused over, and decay and sap rot fungus are present. There is large deadwood and branch dieback throughout the canopy. There is also evidence of boring insect activity. The existing garage is within the Critical Root Zone on the north side, and the existing driveway is within the Critical Root Zone on the northwest side of the stem. There is also an existing wood fence adjacent to the northwest side of the stem; a section of the fence has been cut to allow a stem to pass through. The Critical Root Zone radius is 20ft. This tree is within the footprint of the proposed underground parkade.</p> <p><b>RECOMMENDATIONS:</b><br/><b>REMOVE.</b> Remove tree since it is in decline and due to poor structure. Its removal is also necessary to enable the proposed parkade.</p> |

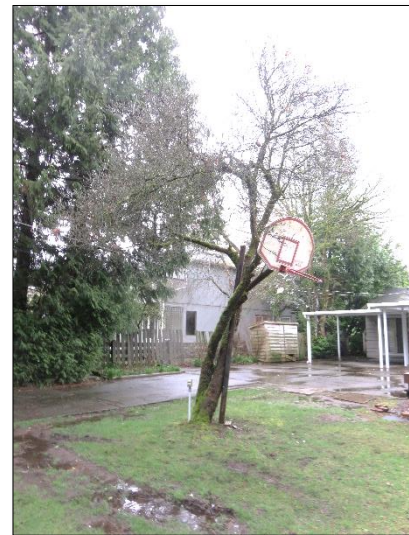
April 6/17 – Tree #60

| TREE # | SPECIES | DBH (cm) | HEIGHT (m) est. | CRZ (ft.) radius | Condition | OBSERVATIONS & RECOMMENDATIONS |
|---|---|---|---|---|---|---|
| 60 | Dogwood<br>( <i>Cornus sp.</i> ) | 35 comb.<br>(20+15) | 7 | 7.2' | Fair | <p>This tree has two stems commencing at 1ft. It has a moderate lean to the southeast. It has been previously topped at multiple heights and cut back on all sides to contain. The canopy has also been raised to provide clearance to the existing service drop. A pole has been installed between the stems. The Critical Root Zone radius is 7.2ft. This tree is within the footprint of the proposed underground parkade.</p> <p><b>RECOMMENDATIONS:</b><br/> <b>REMOVE.</b> Removal of this tree is necessary to enable the proposed parkade.</p> |

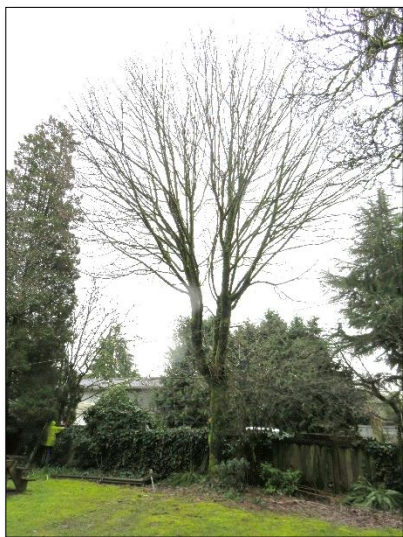
**April 6 /17 - Tree #61**

| TREE # | SPECIES | DBH (cm) | HEIGHT (m) est. | CRZ (ft.) radius | Condition | OBSERVATIONS & RECOMMENDATIONS |
|---|---|---|---|---|---|---|
| 61 | Maple<br>( <i>Acer sp.</i> ) | 58 | 16 | 11.9' | Good | <p>This tree appears typical of the species. There is an existing wood fence adjacent to the south side of the stem. The Critical Root Zone radius is 11.9ft. This tree is within the footprint of the proposed underground parkade.</p> <p><b>RECOMMENDATIONS:</b><br/> <b>REMOVE.</b> Removal of this tree is necessary to enable the proposed parkade.</p> |

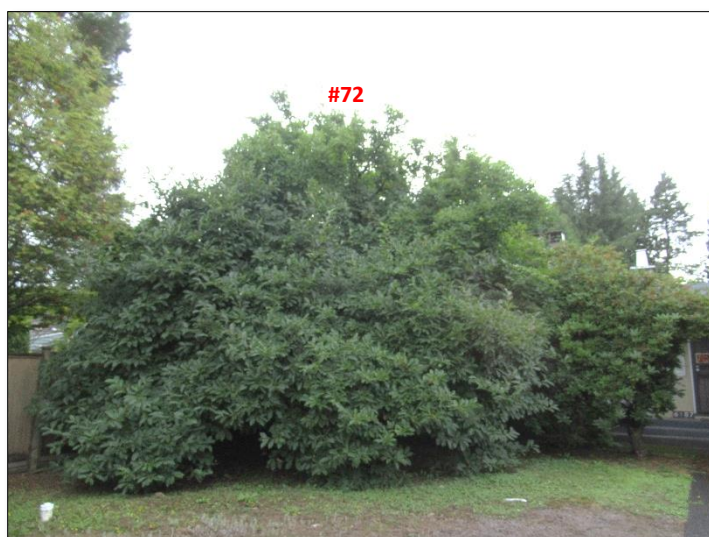
**Sept 12/19 – Tree #72 in behind shrubs**

| TREE # | SPECIES | DBH (cm) | HEIGHT (m) est. | CRZ (ft.) radius | Condition | OBSERVATIONS & RECOMMENDATIONS |
|---|---|---|---|---|---|---|
| 72 | Magnolia<br>( <i>Magnolia sp.</i> ) | 57/survey combined<br>(24+18+15) | 7 | 11.8' | Fair | <p>This tree was viewed from the City boulevard only. It has two stems commencing at the base; these stems divide again further up. It has been previously topped at multiple heights and cut back on all sides to contain. There is an existing wood fence within the Critical Root Zone on the south side of the stem. The Critical Root Zone radius is 11.8ft. This tree is within the footprint of the proposed underground parkade.</p> <p><b>RECOMMENDATIONS:</b><br/><b>REMOVE.</b> Removal of this tree is necessary to enable the proposed parkade.</p> |

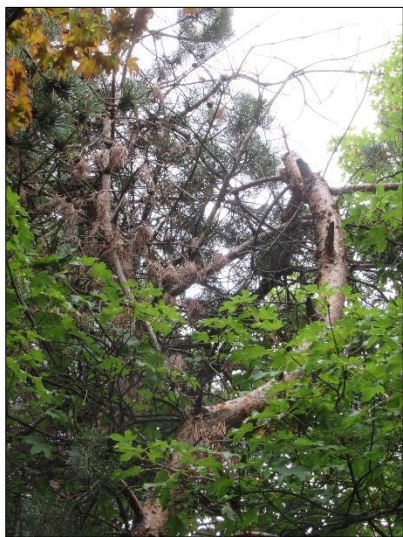
**Sept 12/19 – Tree #82**

| TREE<br># | SPECIES | DBH<br>(cm) | HEIGHT<br>(m) est. | CRZ<br>(ft.)<br>radius | Condition | OBSERVATIONS & RECOMMENDATIONS |
|---|---|---|---|---|---|---|
| 82 | Pine<br>( <i>Pinus sp.</i> ) | 26 | 9 | 5.4' | Fair/poor | <p>This tree is not of a size that requires it to be protected by the City Interim Tree By – Law. It forms part of a group. The top has failed at 20ft; the failure site has not callused over. The crown is somewhat sparse. There is minor branch and twig dieback throughout the canopy. There are also several limbs within the east side of the canopy, which have sustained damage and are still partially attached. It is a landscape berm; the grade slopes downward south and east of the stem. It is within a dedication. The Critical Root Zone radius is 5.4ft. The footprint of the proposed underground parkade is 14ft from the west side of the stem, not including</p> |

| TREE # | SPECIES | DBH (cm) | HEIGHT (m) est. | CRZ (ft.) radius | Condition | OBSERVATIONS & RECOMMENDATIONS |
|---|---|---|---|---|---|---|
| | | | | | | <p>the excavation required, which will extend immediately adjacent to the east property line.</p> <p><b>RECOMMENDATIONS:</b></p> <p><b>REMOVE.</b> Remove tree, it is not protected and has partially failed. Also, removal is necessary to enable the lines of excavation and the proposed parkade. This tree also forms part of a group, which is proposed for removal.</p> |

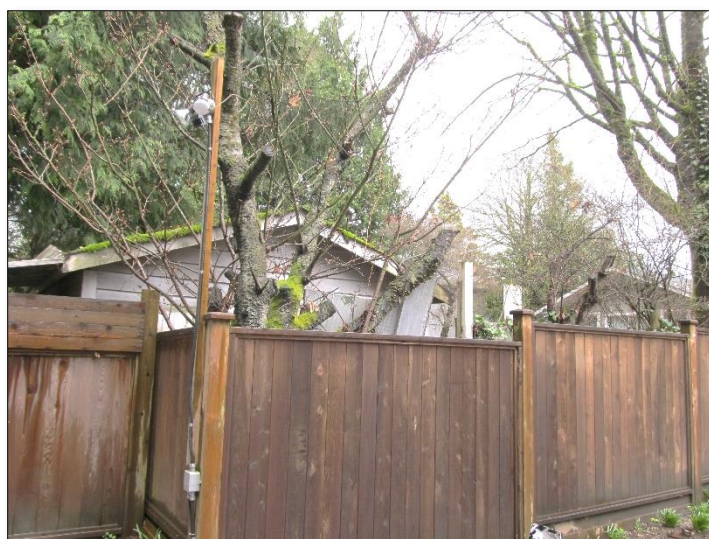
**April 6/17 - Trees #98 & #99**

| TREE # | SPECIES | DBH (cm) | HEIGHT (m) est. | CRZ (ft.) radius | Condition | OBSERVATIONS & RECOMMENDATIONS |
|---|---|---|---|---|---|---|
| 98 | Cherry<br>( <i>Prunus sp.</i> ) | 72 per combined<br>(24+24+24) | 7 | 14.9' | Declining | <p>A through inspection of this tree was impeded due to several existing fences, which are adjacent to the north, south and west sides of the stem. This tree is in decline. The canopy has been mutilated. It has been previously topped at multiple heights and cut back quite hard on all sides to contain; the canopy consists of only a few suckering shoots commencing at the topping sites. The pruning sites have not callused over, and some decay and sap rot fungus is present. The entire crown has also been raised to provide clearance to the existing fences, and an existing shed, which is 3ft from the north side of the stem. There is also large deadwood throughout the canopy. The Critical Root Zone radius is 14.9ft. This tree is within the footprint of the proposed underground parkade.</p> <p><b>RECOMMENDATIONS:</b><br/> <b>REMOVE.</b> Remove tree since it is in decline and to enable the proposed parkade.</p> |
| 99 | Dogwood<br>( <i>Cornus sp.</i> ) | 30 | 4 | 6.2' | Poor | <p>A through inspection of this tree was impeded due to several existing fences, which are adjacent to the north and south sides of the stem. The canopy has been mutilated. It has been previously topped at multiple heights and cut back quite hard on all sides to contain; the pruning sites have not callused over, and some decay is present. The Critical Root Zone radius is 6.2ft. This tree is within the footprint of the proposed underground parkade.</p> <p><b>RECOMMENDATIONS:</b><br/> <b>REMOVE.</b> Remove tree due to poor structure. It is not a good candidate for long-term retention as the canopy has been mutilated to the extent that it is beyond restorative pruning. Its removal is also necessary to enable the proposed parkade.</p> |

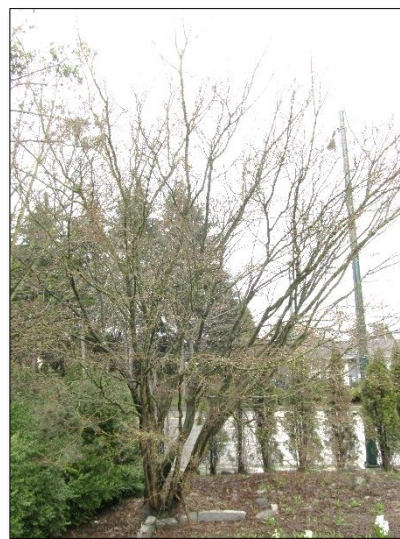
**April 6/17 - Tree #101 & Hedge #100**

| TREE # | SPECIES | DBH (cm) | HEIGHT (m) est. | CRZ (ft.) radius | Condition | OBSERVATIONS & RECOMMENDATIONS |
|---|---|---|---|---|---|---|
| 100 | Cedar<br>( <i>Thuja occidentalis</i> ) | - | 1.5 | 2' | Poor/dead | <p>This hedge belongs to the City; although, it does not appear to be something that would have been planted by them. It has not been maintained. Sections of the hedge are dead, and the remaining portion of the hedge is rather sparse. It is within a dedication. There is an existing concrete walkway adjacent to the south portion of hedge.</p> <p><b>RECOMMENDATIONS:</b><br/> <b>REMOVE.</b> Obtain consent from the City and remove hedge since a portion of the hedge is dead</p> |

| TREE # | SPECIES | DBH (cm) | HEIGHT (m) est. | CRZ (ft.) radius | Condition | OBSERVATIONS & RECOMMENDATIONS |
|---|---|---|---|---|---|---|
| 101 | Japanese Maple<br>( <i>Acer palmatum</i> ) | 38 comb.<br>(13+13+12) | 7 | 7.8' | Fair | <p>This tree has four stems commencing at base. There is minor branch dieback throughout the canopy, which is most likely as a result of Verticillium wilt; this will continue to cause dieback and the tree will decline over time. This tree is within a dedication. The Critical Root Zone radius is 7.8ft. The footprint of the proposed underground parkade is 12ft from the west side of the stem, not including the excavation required, which will extend immediately adjacent to the east property line.</p> <p><b>RECOMMENDATIONS:</b><br/><b>REMOVE.</b> Remove tree as it is not a good candidate for long-term retention due to disease, which will cause the tree to decline over time. Removal is also necessary to enable the lines of excavation and the proposed parkade.</p> |

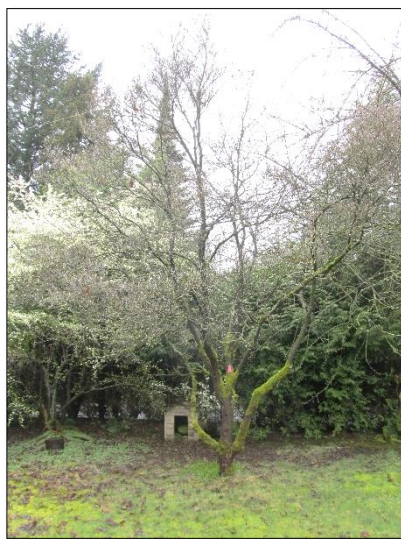
**April 6/17 - Tree #105**

| TREE # | SPECIES | DBH (cm) | HEIGHT (m) est. | CRZ (ft.) radius | Condition | OBSERVATIONS & RECOMMENDATIONS |
|---|---|---|---|---|---|---|
| 105 | Dogwood<br>( <i>Cornus sp.</i> ) | 37<br>combined<br>(15+12+10) | 8 | 7.6' | Fair | <p>This tree has three stems commencing at 1ft. The canopy is asymmetrical and is heavily weighted to the south due to the spreading canopy of the adjacent tree. The crown of this tree is somewhat sparse. There is also branch and twig dieback throughout the canopy. The Critical Root Zone radius is 7.6ft. This tree is within the footprint of the proposed underground parkade.</p> <p><b>RECOMMENDATIONS:</b></p> <p><b>REMOVE.</b> Removal of this tree is necessary to enable the proposed parkade.</p> |

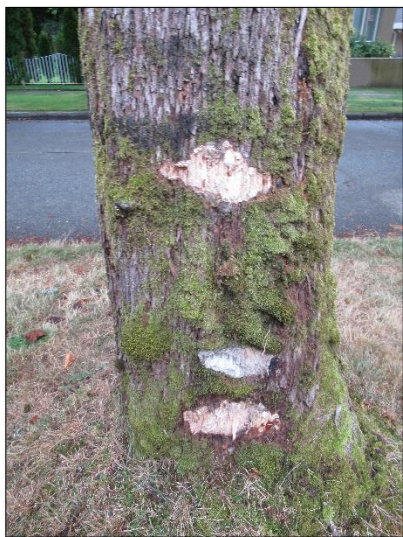
Sept 12/19 – Tree #124  
Fungal conks removed (REMOVED)
