131, 139 PARKDALE AVE & 122 FORWARD AVE

Tree Conservation Report

CIMA+ file number: A0001295
17 December 2025 - Review 000

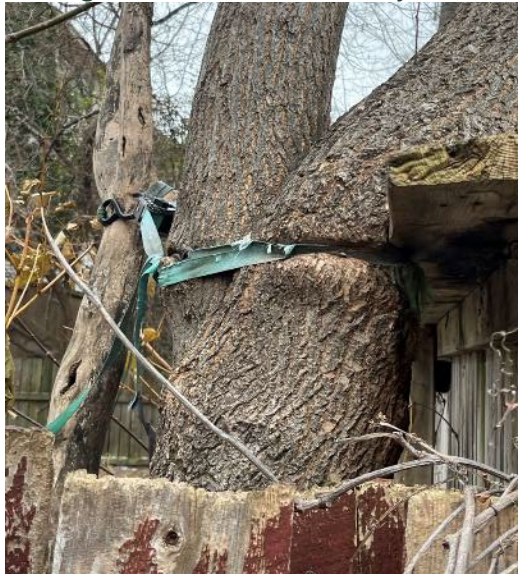
Photo 3: Tree 5's girdled trunk and growth against fence (November 18, 2025)
