# Findlay Creek Conceptual Channel Design

**4795 Bank Street Subdivision**  
Ottawa, Ontario

GEO Morphix Project No. 26028

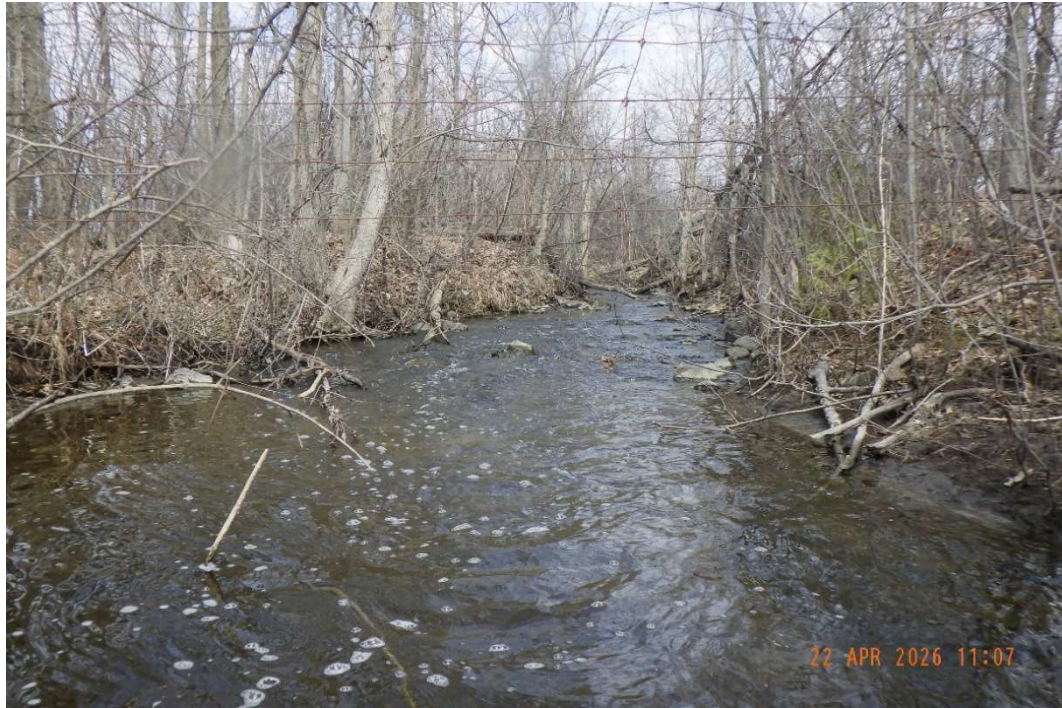
**Photo 1: Reach FC-1b**  
Findlay Creek, Ottawa, Ontario  
Photo Direction: Upstream

View of the downstream extent of Findlay Creek within the subject lands. Riparian vegetation consisted primarily of trees and shrubs with moderate-good canopy cover.

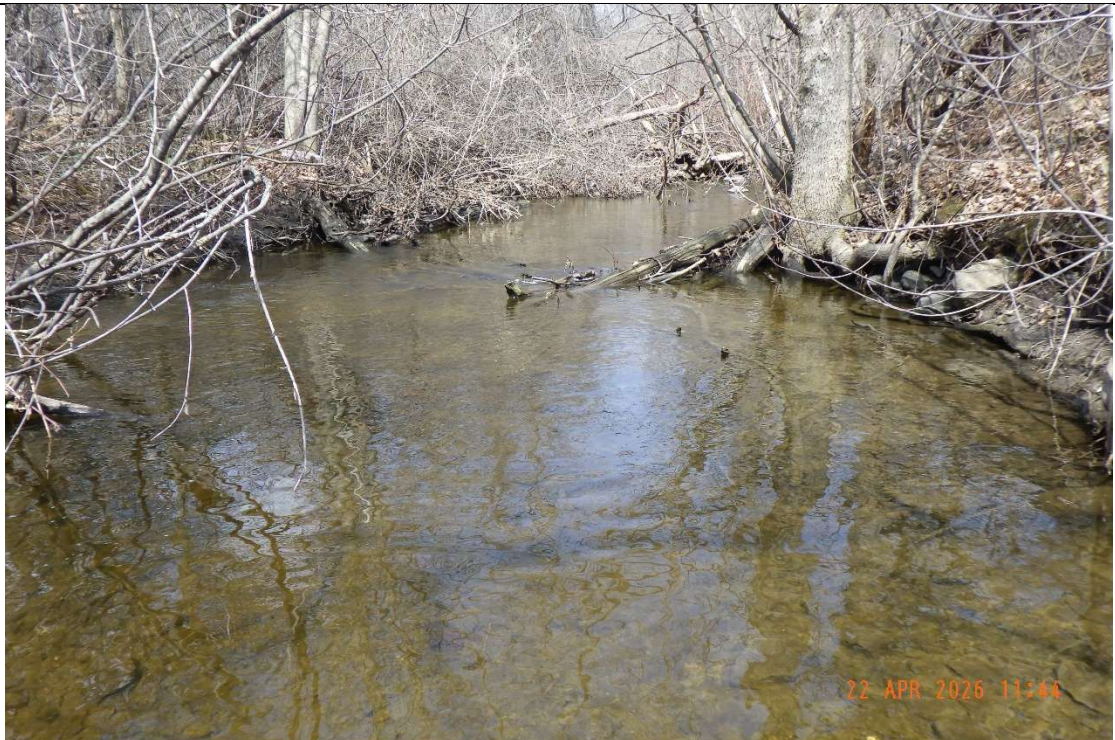
**Photo 2: Reach FC-1b**  
Findlay Creek, Ottawa, Ontario  
Photo Direction: Upstream

The channel was partially confined and had a low sinuosity.  
The channel was defined and had moderate to steep sloped banks.

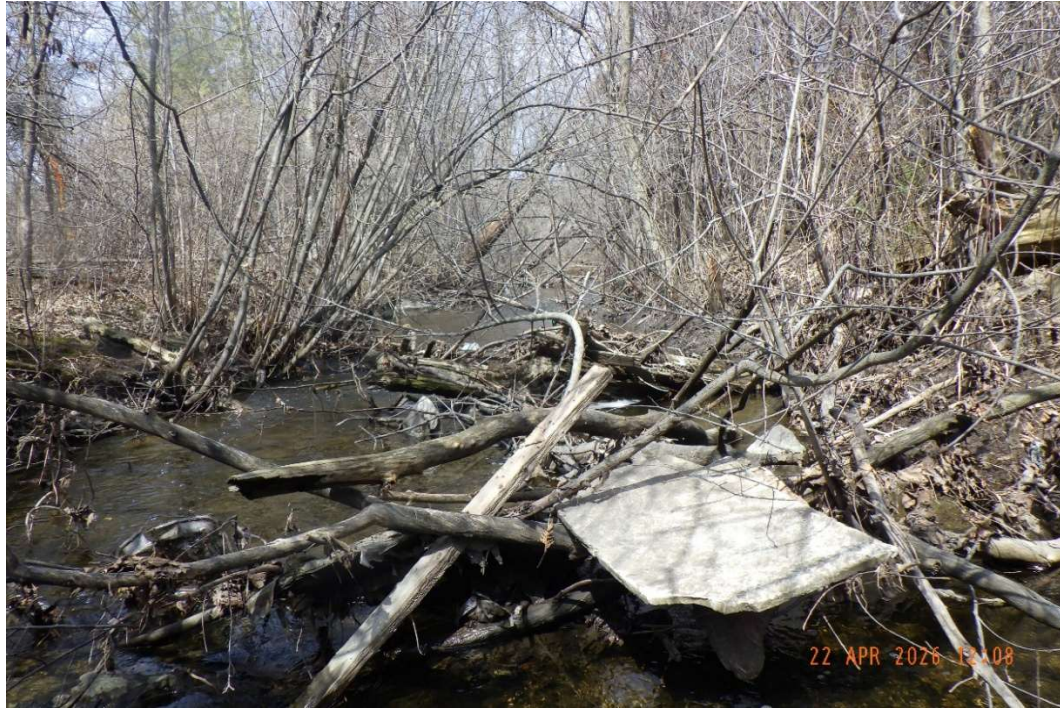
**Photo 3: Reach FC-1b**  
Findlay Creek, Ottawa, Ontario  
Photo Direction: Upstream

Leaning trees and woody debris jams were common throughout the watercourse.

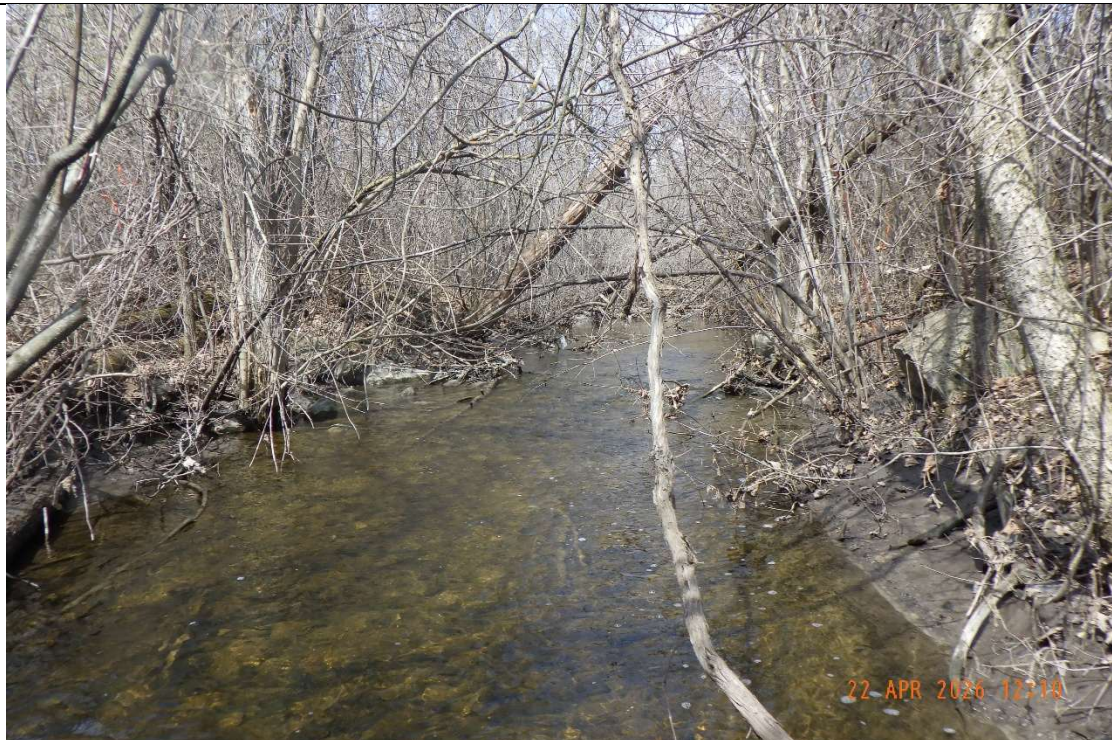
**Photo 4: Reach FC-1b**  
Findlay Creek, Ottawa, Ontario  
Photo Direction: Upstream

Bank erosion was observed along both banks for portions of the channel.

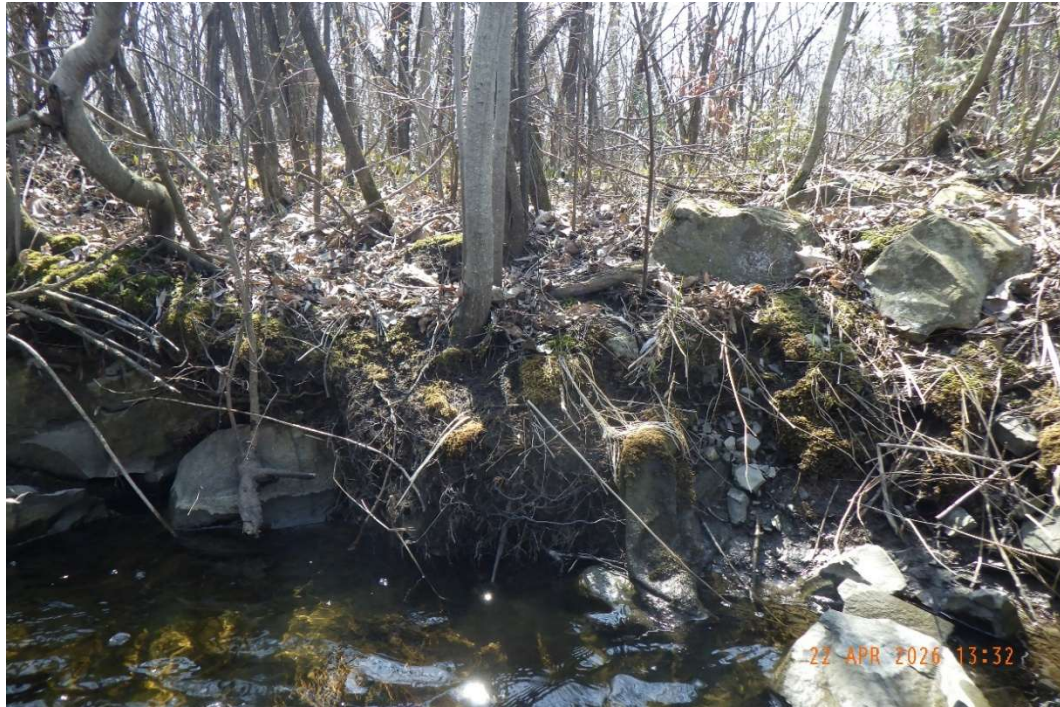
**Photo 5: Reach FC-1b**  
Findlay Creek, Ottawa, Ontario  
Photo Direction: Left bank

Banks consisted of clay, silt, rootlets, and sporadic boulders. Exposed tree roots were observed within the banks throughout the channel.

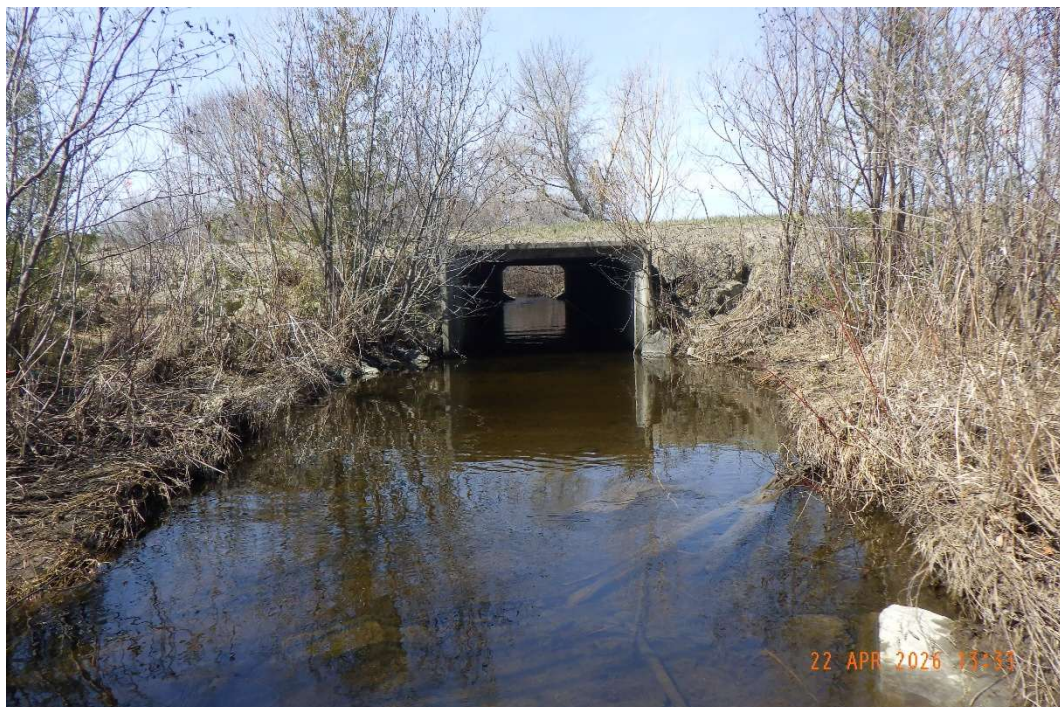
**Photo 6: Reach FC-1b**  
Findlay Creek, Ottawa, Ontario  
Photo Direction: Upstream

Culvert at the upstream extent of Reach FC-1b. Rip rap was observed at the extent of the culvert, and more grasses and herbaceous material was present on the channel banks.

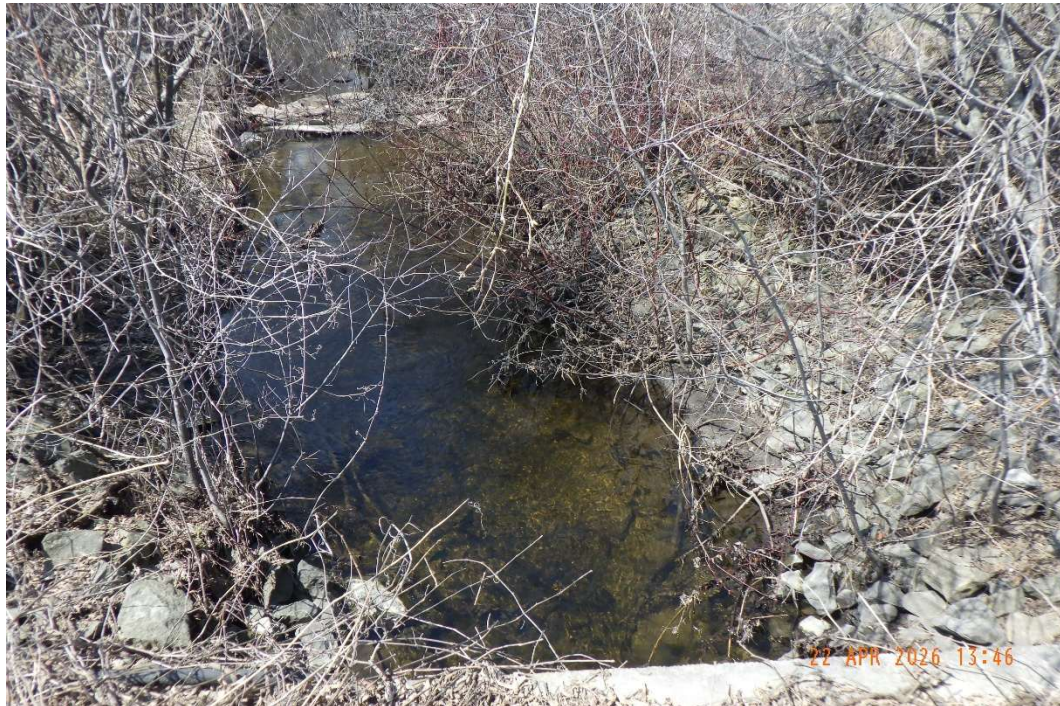
**Photo 7: Reach FC-1a**  
Findlay Creek, Ottawa, Ontario  
Photo Direction: Upstream

Rip rap bank armoring along both sides of the bank, and within the mouth of the culvert can be observed at the downstream extent of Reach FC-1a.

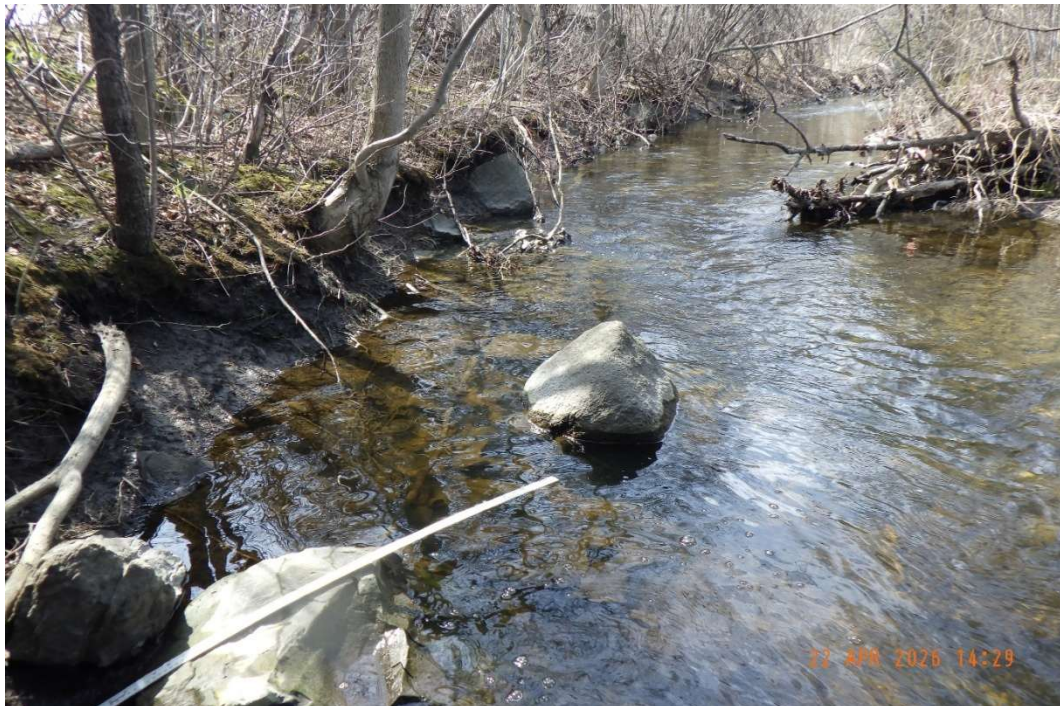
**Photo 8: Reach FC-1a**  
Findlay Creek, Ottawa, Ontario  
Photo Direction: Upstream

Bed substrate ranged from silt to boulders. While the substrate consisted mostly of gravel and cobble, large sporadic boulders and patches of fine sediments were found throughout the site

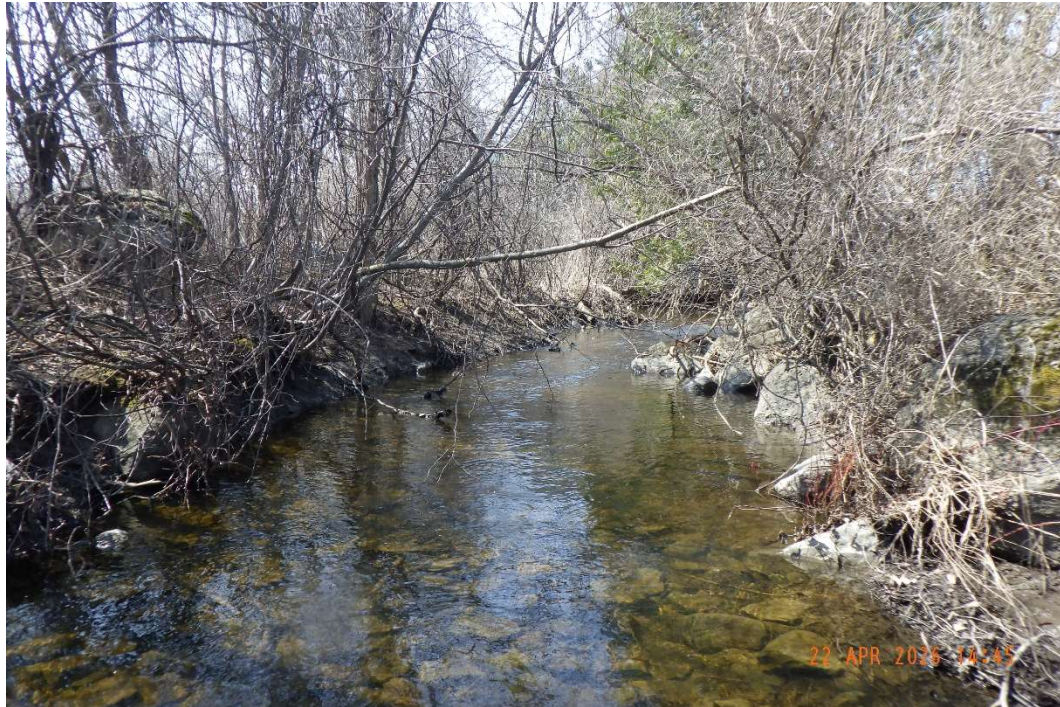
**Photo 9: Reach FC-1a**

Large boulders were present throughout the reach along the banks. Treefalls and leaning trees were common. The channel was generally straight with low sinuosity.

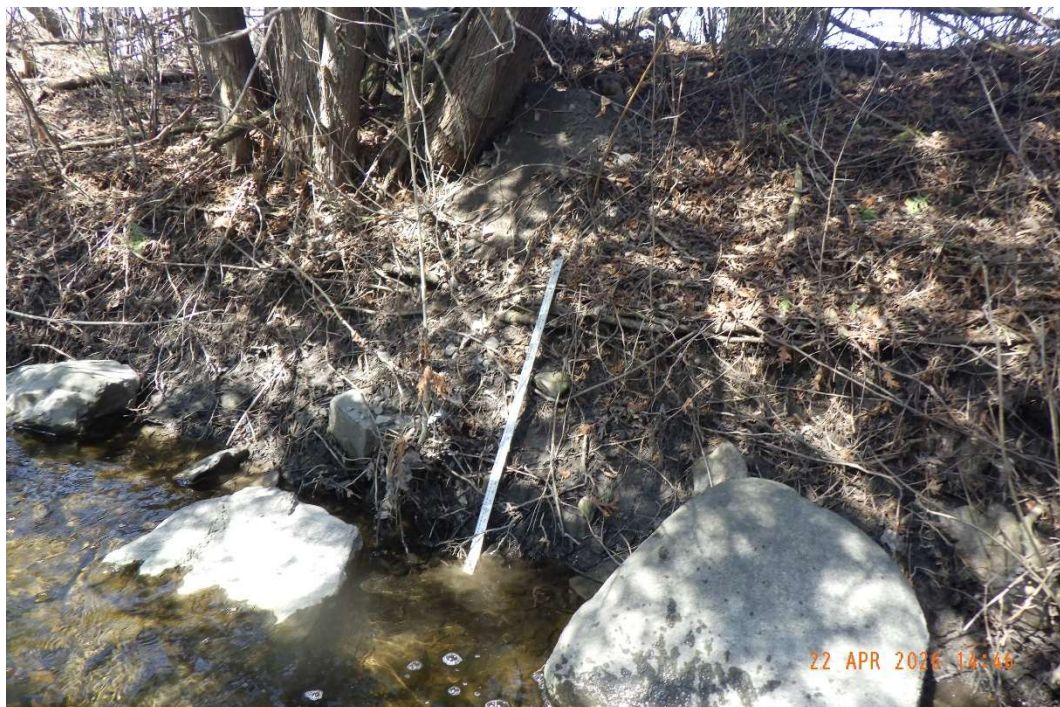
**Photo 10: Reach FC-1a**

Bankfull heights ranged from 0.63 to 0.73 m.  
The top of bank heights for some sections of the channel were greater than 1.0m.

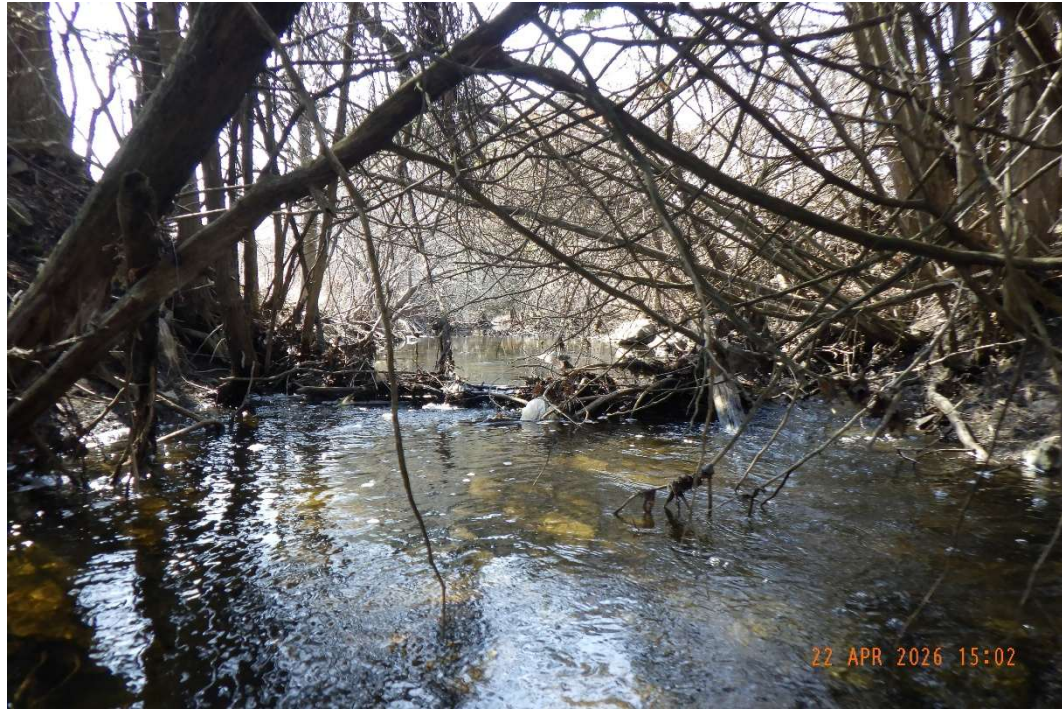
**Photo 11: Reach FC-1a**  
Findlay Creek, Ottawa, Ontario  
Photo Direction: Upstream

Multiple woody debris jams were observed, some causing backwatering upstream.  
Treefalls and leaning trees were common.

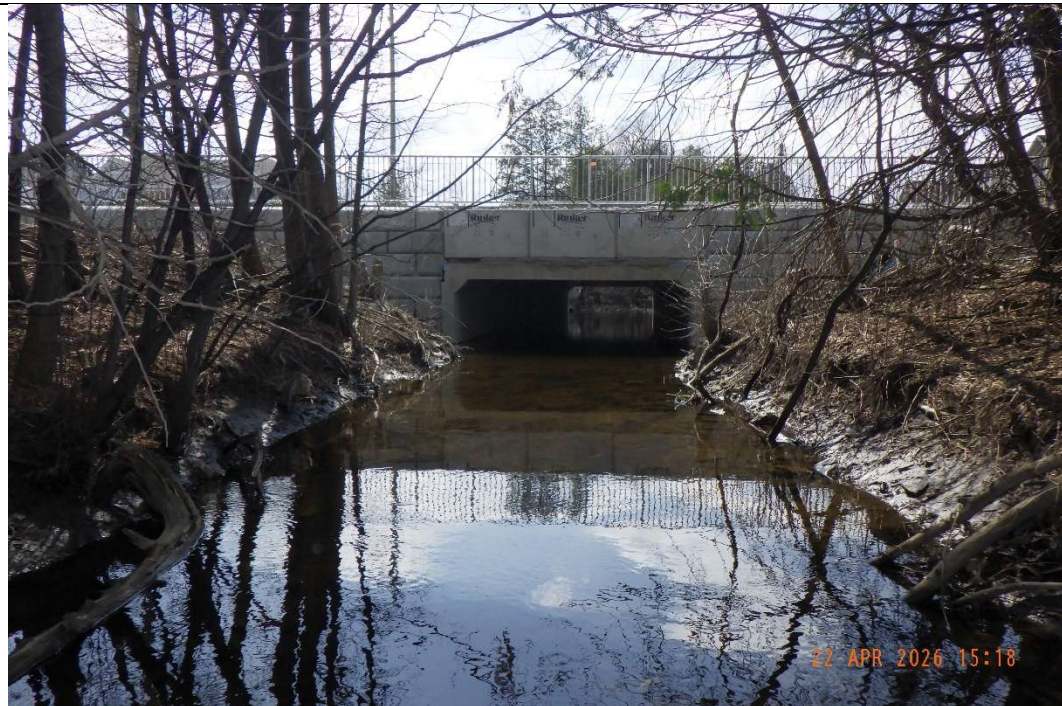
**Photo 12: Reach FC-1a**  
Findlay Creek, Ottawa, Ontario  
Photo Direction: Upstream

Photo of the Bank Street crossing at the upstream extent of Reach FC-1a.  
Note bank erosion along both sides of the channel.

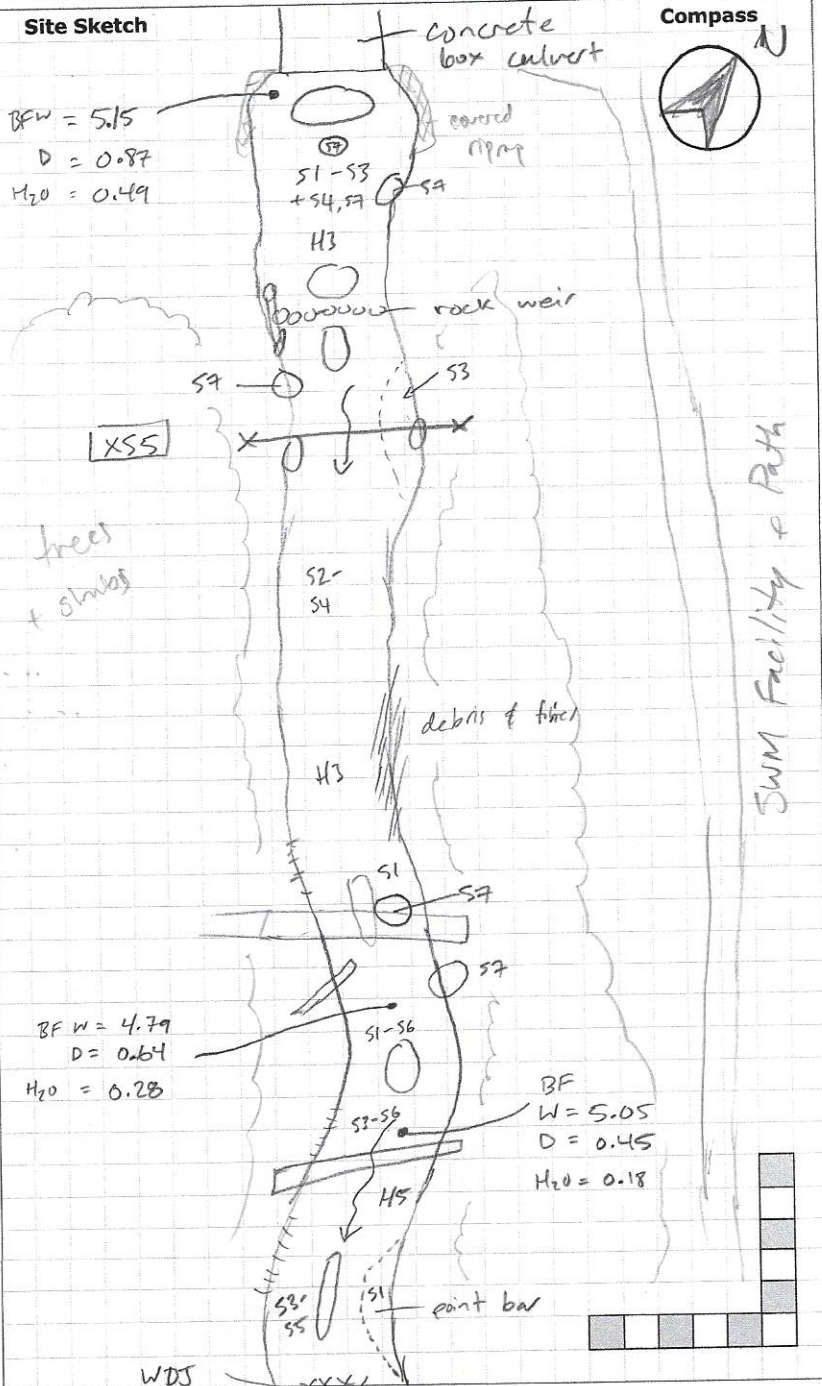
**Notes:** more fines recent further up + observed on banks,

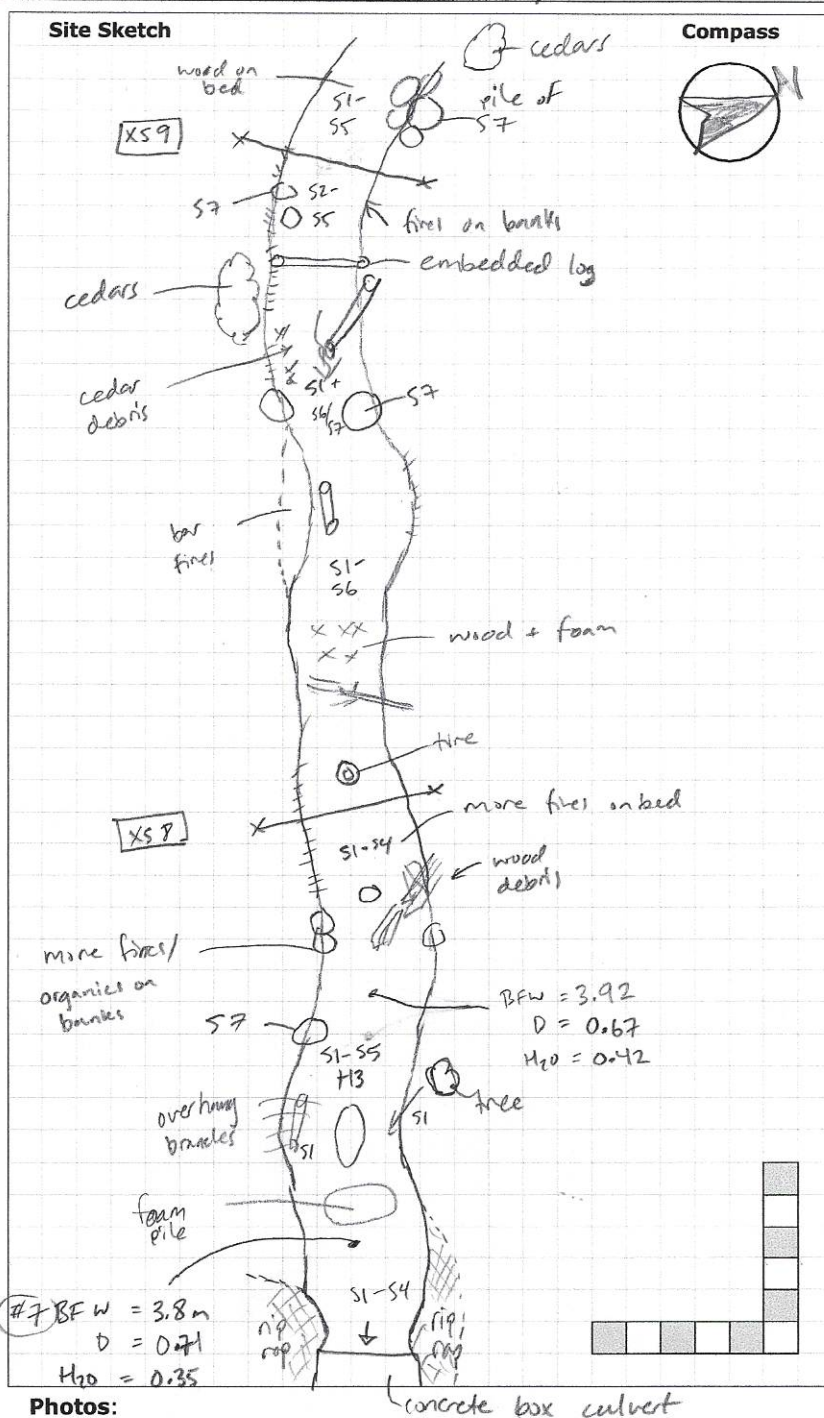
**Notes:** more woody debris on bed + banks, generally finer materials but lots of large boulders
