TREE CONSERVATION REPORT

500 Edgeworth Ave

Tree Conservation Report submitted as Partial
Requirements for a Site Plan Control and Zoning
Bylaw Amendment Application, April 2, 2026

Dendron Forestry Services

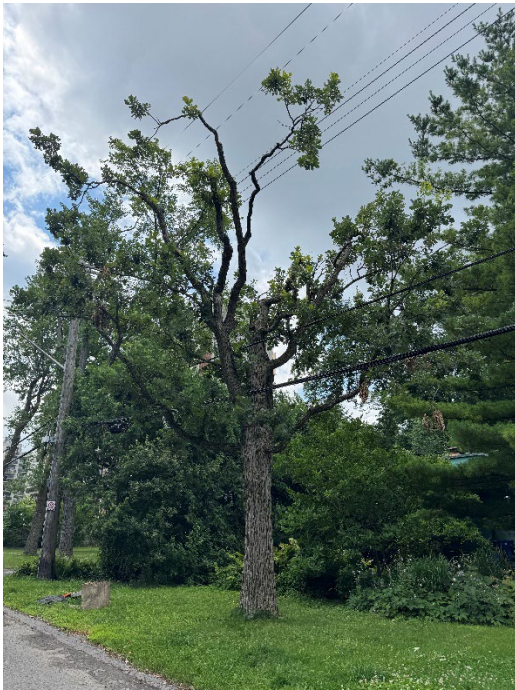
Picture 3: Tree 4, city-owned bur oak

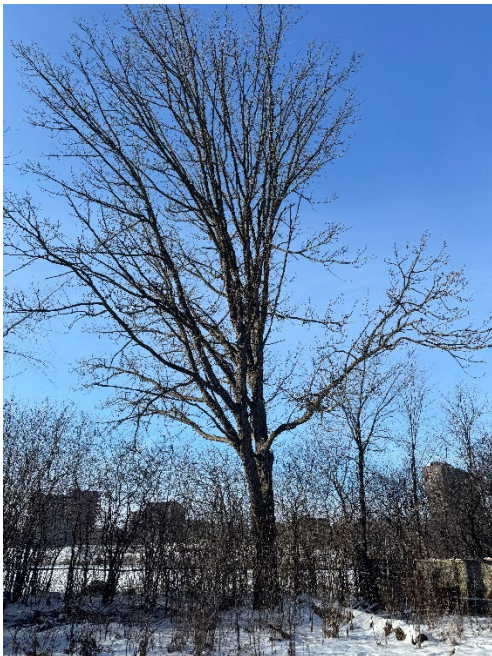
Picture 4: tree 10, bur oak at the rear of 508 Edgeworth

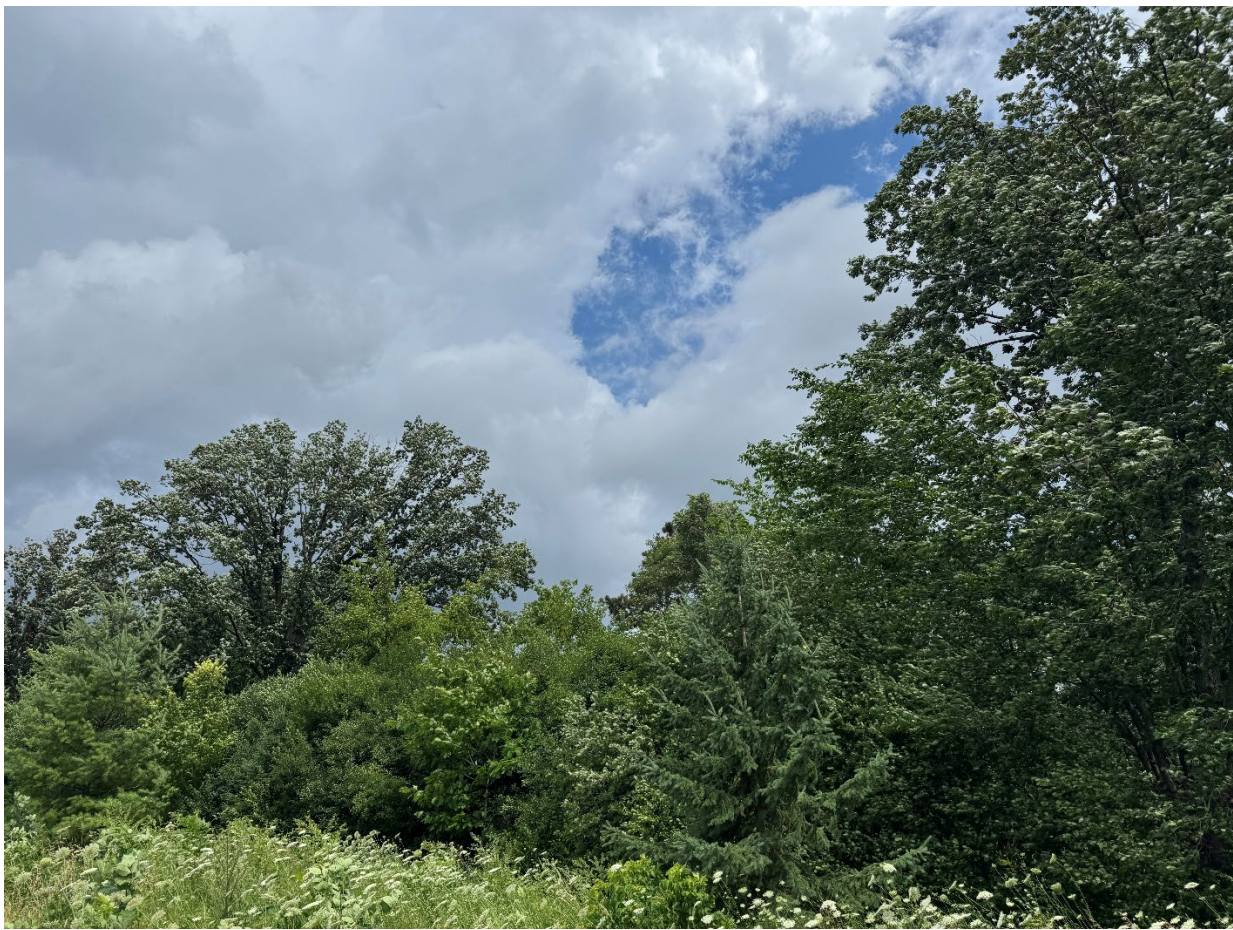
In addition to those trees identified on TCR maps, there is also a line of thick buckthorn shrubs along the edge of the NCC property. Due to their invasive nature, these should all be removed along with the trees that need to be removed to accommodate the excavation and make the area free of any risks of tree failures. During deep excavations such as this, the falling distance increases for those trees along the edge, resulting in higher consequences of failure for the construction crews working below.

Picture 8: Taken from the NCC property, row of buckthorn along the property line interspersed with recently planted trees along the west side

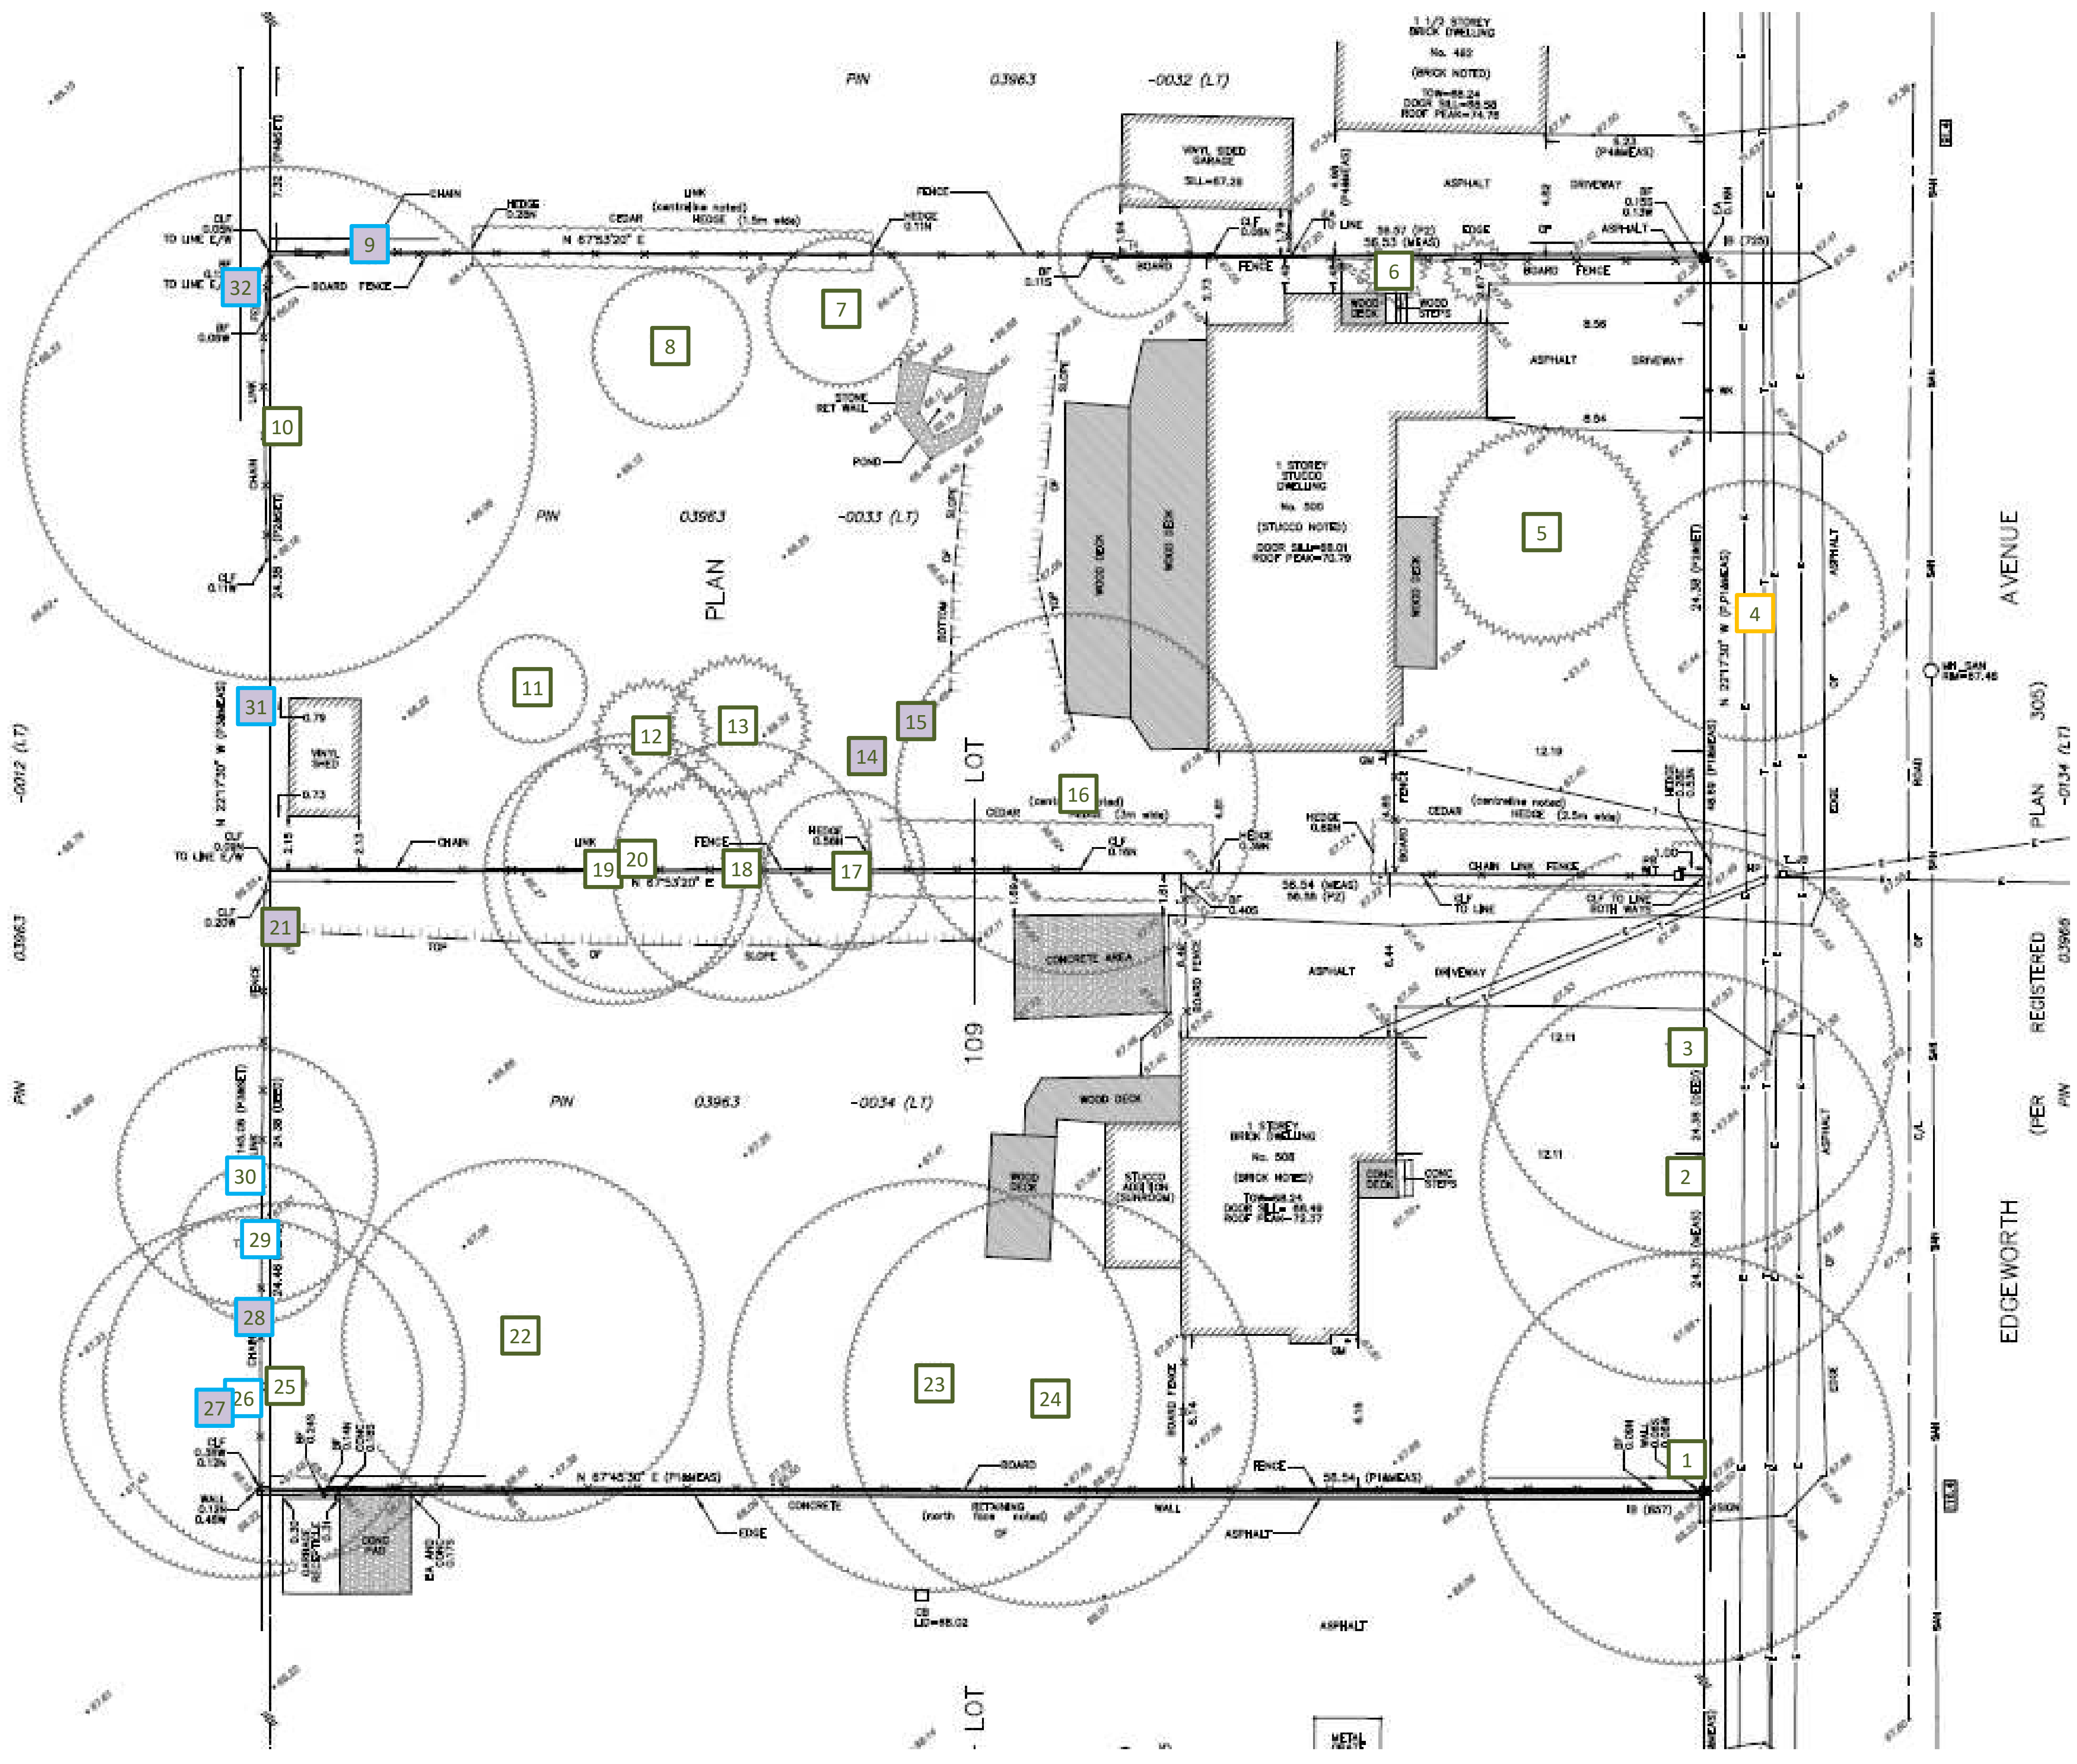
TCR Map#1: Existing Vegetation – 500 Edgeworth Ave

Tree#	Species	Diameter at breast height (cm)	Ownership ^{1,3}	Condition
1	Sugar maple (<i>Acer saccharum</i>)	59	Subject properties	Fair; pruned for hydro clearance, epicormic shoots, old branch attachment wound with decay at 4 m grade
2	Sugar maple (<i>Acer saccharum</i>)	55	Subject properties	Fair; pruned for hydro clearance, low vigour, epicormic shoots, decay in upper canopy
3	Sugar maple (<i>Acer saccharum</i>)	57	Subject properties	Fair; asymmetric crown
4	Bur oak (<i>Quercus macrocarpa</i>)	54	Subject properties	Fair; directly under hydro lines, woodpecker holes in centre stem
5	White pine (<i>Pinus strobus</i>)	43	Subject properties	Good/fair; slight lean at base, minor chlorosis
6	Eastern white cedar (<i>Thuja occidentalis</i>)	17, 19, 14, 15	Subject properties	Good/fair
7	White birch (<i>Betula papyrifera</i>)	18	Subject properties	Good
8	Apple (<i>Malus spp</i>)	24	Subject properties	poor; many epicormic shoots

9 ¹	Manitoba maple (<i>Acer negundo</i>)	12 (est)	Adjacent property at 492 Edgeworth	Fair; heavy lean
10	Bur oak (<i>Quercus macrocarpa</i>)	78	Subject properties	Good; asymmetric crown, some deadwood
11	Apple (<i>Malus spp</i>)	16	Subject properties	Poor; epicormic shoots, significant decay
12	Scots pine (<i>Pinus sylvestris</i>)	13	Subject properties	Fair; thin top
13	Austrian pine (<i>Pinus nigra</i>)	41	Subject properties	Fair; thin crown with dieback, sapsucker holes,
14 ¹	Eastern white cedar (<i>Thuja occidentalis</i>)	13	Subject properties	Good
15 ¹	Eastern white cedar (<i>Thuja occidentalis</i>)	13	Subject properties	Good
16	Sugar maple (<i>Acer saccharum</i>)	120	Subject properties	Poor/fair; old branch attachment wound, multi-stemmed
17	Siberian elm (<i>Ulmus pumila</i>)	23	Subject properties	Fair/good; vigorous growth, growing within fence
18	Siberian elm (<i>Ulmus pumila</i>)	31	Subject properties	Fair/good; growing within chain link fence

19	Siberian elm (<i>Ulmus pumila</i>)	32	Subject properties	Fair; growing within chain link fence
20	Siberian elm (<i>Ulmus pumila</i>)	10, 29, 16	Subject properties	Fair
21 ¹	Manitoba maple (<i>Acer negundo</i>)	14	Subject properties	Good
22	Sugar maple (<i>Acer saccharum</i>)	31, 32, 34	Subject properties	Fair/good; lean
23	Sugar maple (<i>Acer saccharum</i>)	29, 44	Subject properties	Fair; lean
24	Sugar maple (<i>Acer saccharum</i>)	43, 68	Subject properties	Fair/poor; topped, decay at base, old branch attachment wounds with decay
25	Bur oak (<i>Quercus macrocarpa</i>)	49	Subject properties	Good; asymmetrical crown
26	Bur oak (<i>Quercus macrocarpa</i>)	52	NCC	Good/fair; asymmetric crown, epicormic shoots
27 ¹	American elm (<i>Ulmus americana</i>)	17, 18, 11, 9	NCC	Fair; multi-stemmed, included bark in unions
28 ¹	American elm (<i>Ulmus americana</i>)	12	NCC	Good
29 ¹	American elm (<i>Ulmus americana</i>)	18	NCC	Good

30	Oakleaf mountain ash (<i>Sorbus Thuringiaca</i>)	26	NCC	Poor; high level of decay, heavy lean, sapsucker holes
31 ¹	American elm (<i>Ulmus americana</i>)	20	NCC	Good
32 ¹	American elm (<i>Ulmus americana</i>)	22	NCC	Good

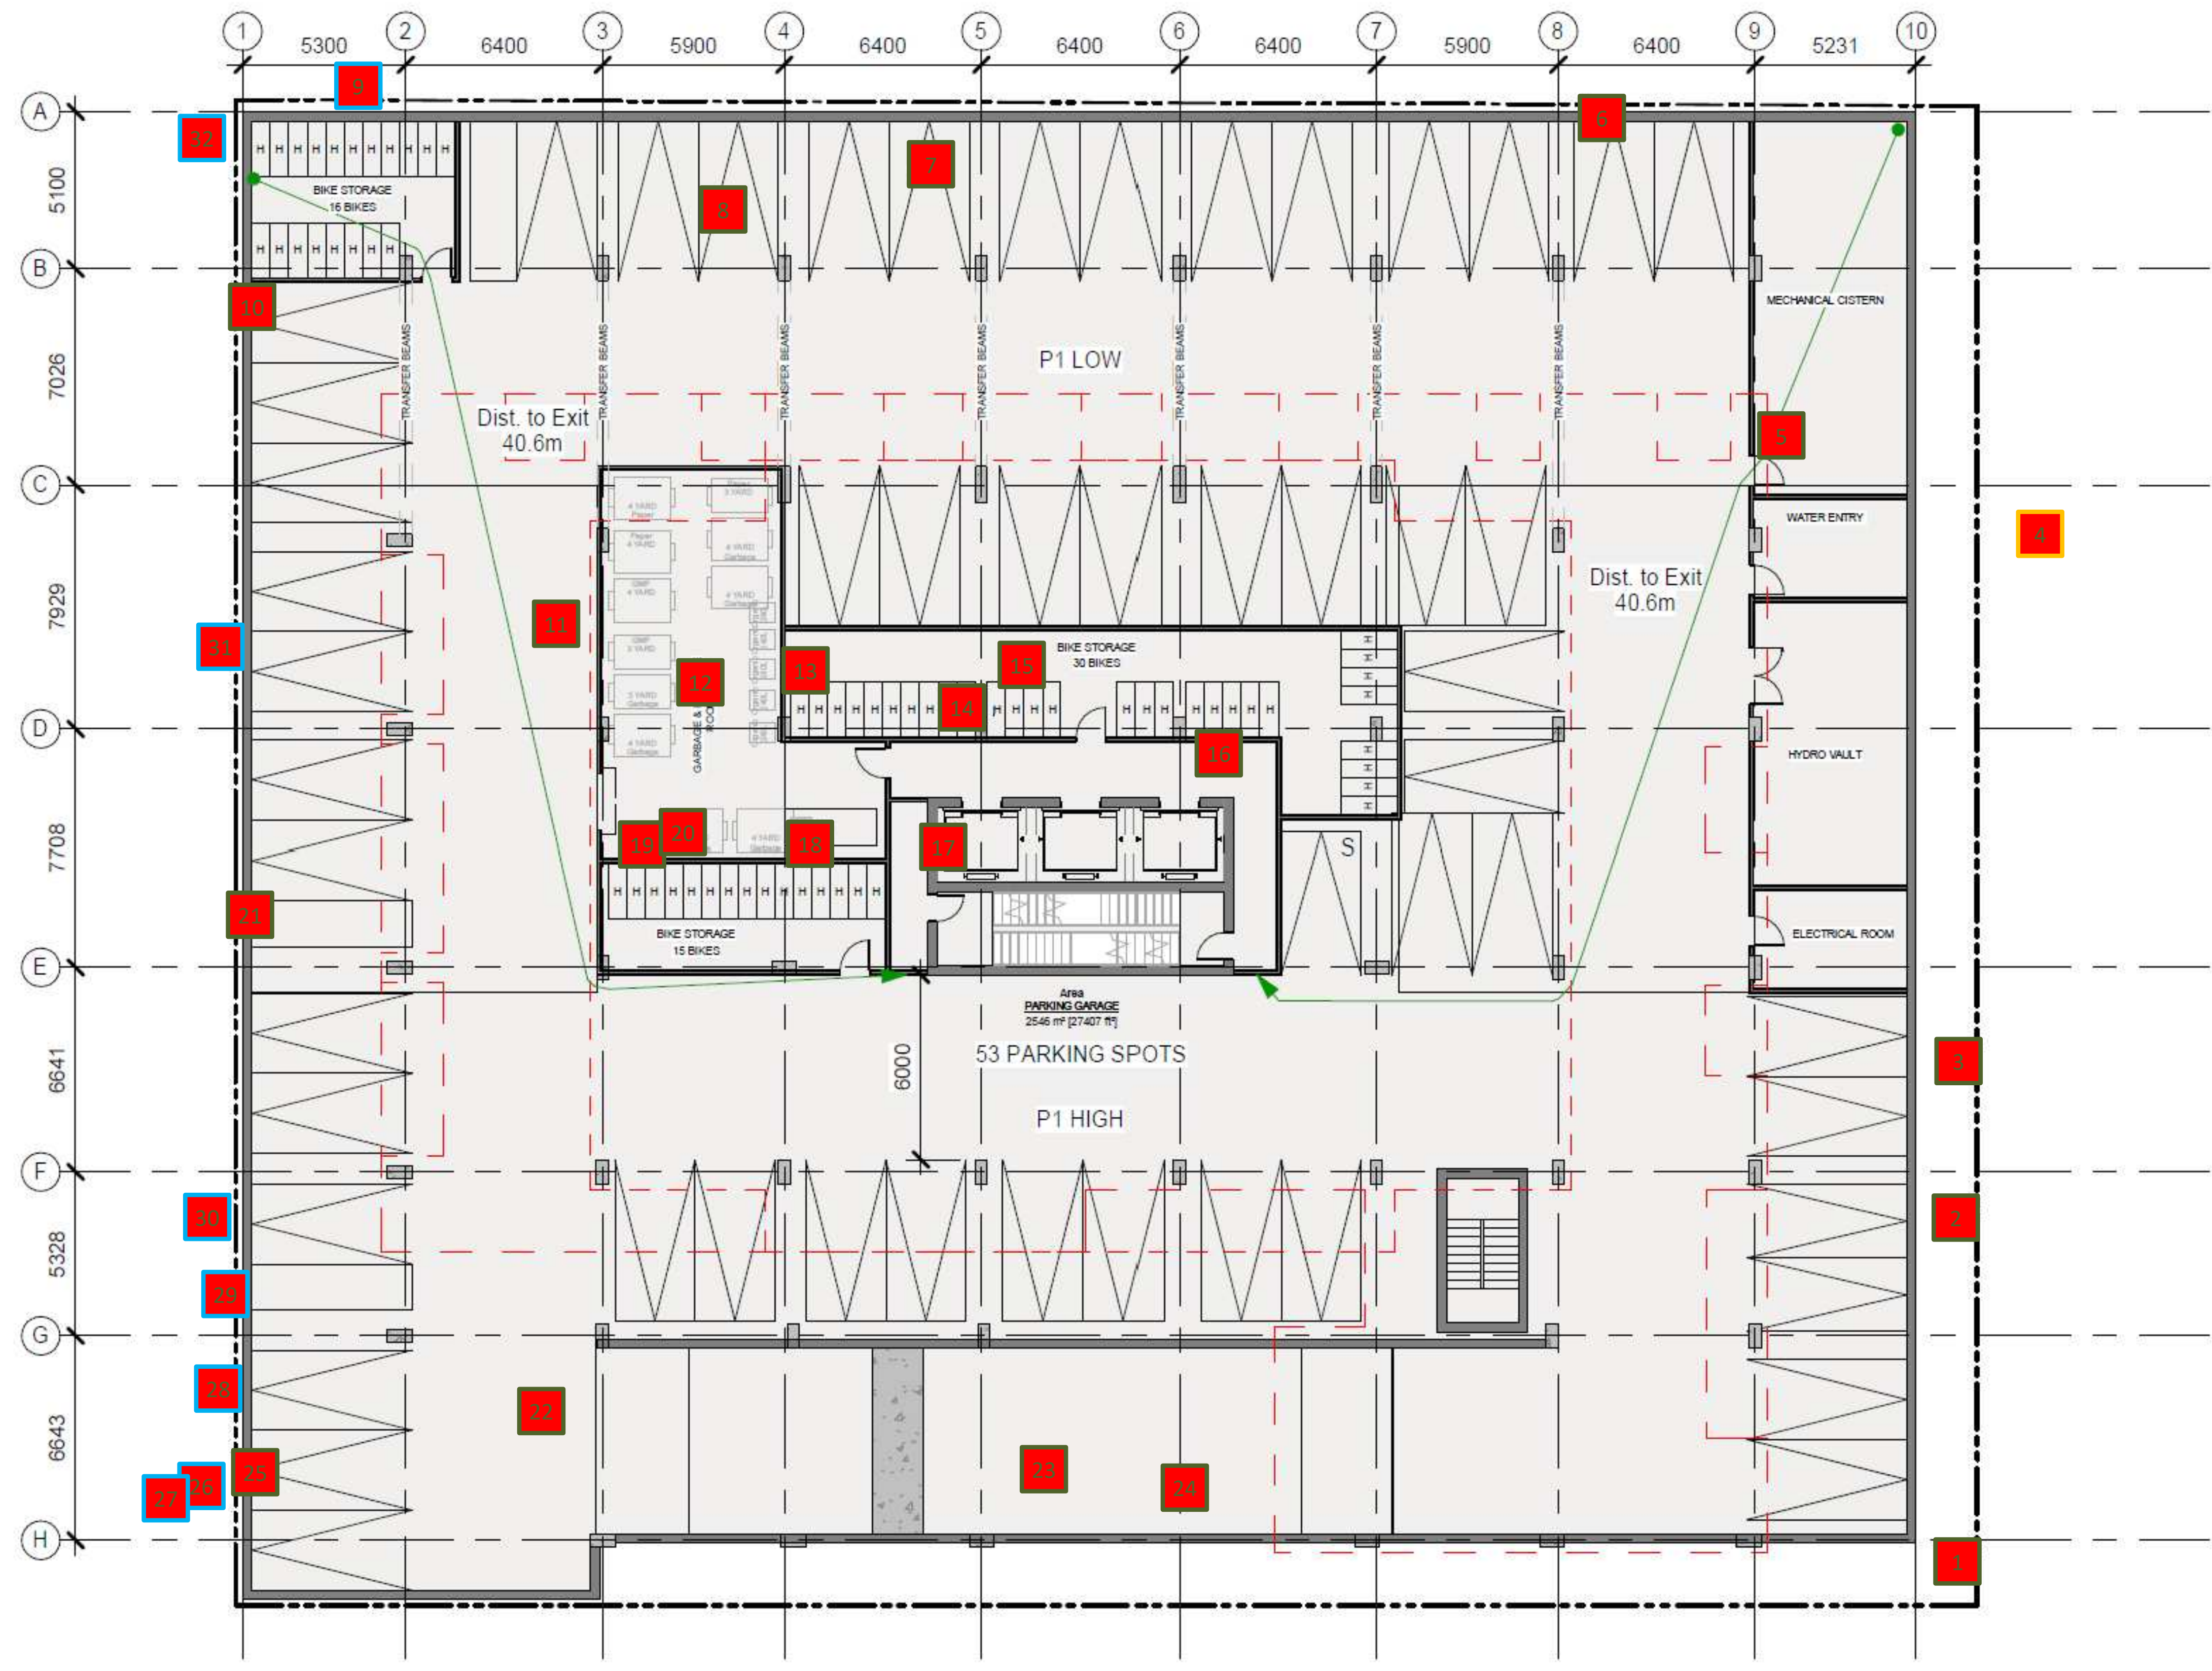
TCR Map#2: Proposed Development and Conserved Vegetation – 500 Edgeworth Ave

The proposed intensification on this site will make tree preservation for all trees onsite unattainable. There is a 2-storey underground parking lot that will require excavation of the entire site, impacting all trees including those close to the property lines on adjacent properties. Permission for tree removal from the adjacent property owners is required prior to the issuance of a Tree Permit from the City of Ottawa.
