# TREE CONSERVATION REPORT

2180 Montreal Road v2.0

Tree Conservation Report submitted as Partial  
Requirements for a Site Plan Control Application,  
August 28, 2026

Dendron Forestry Services

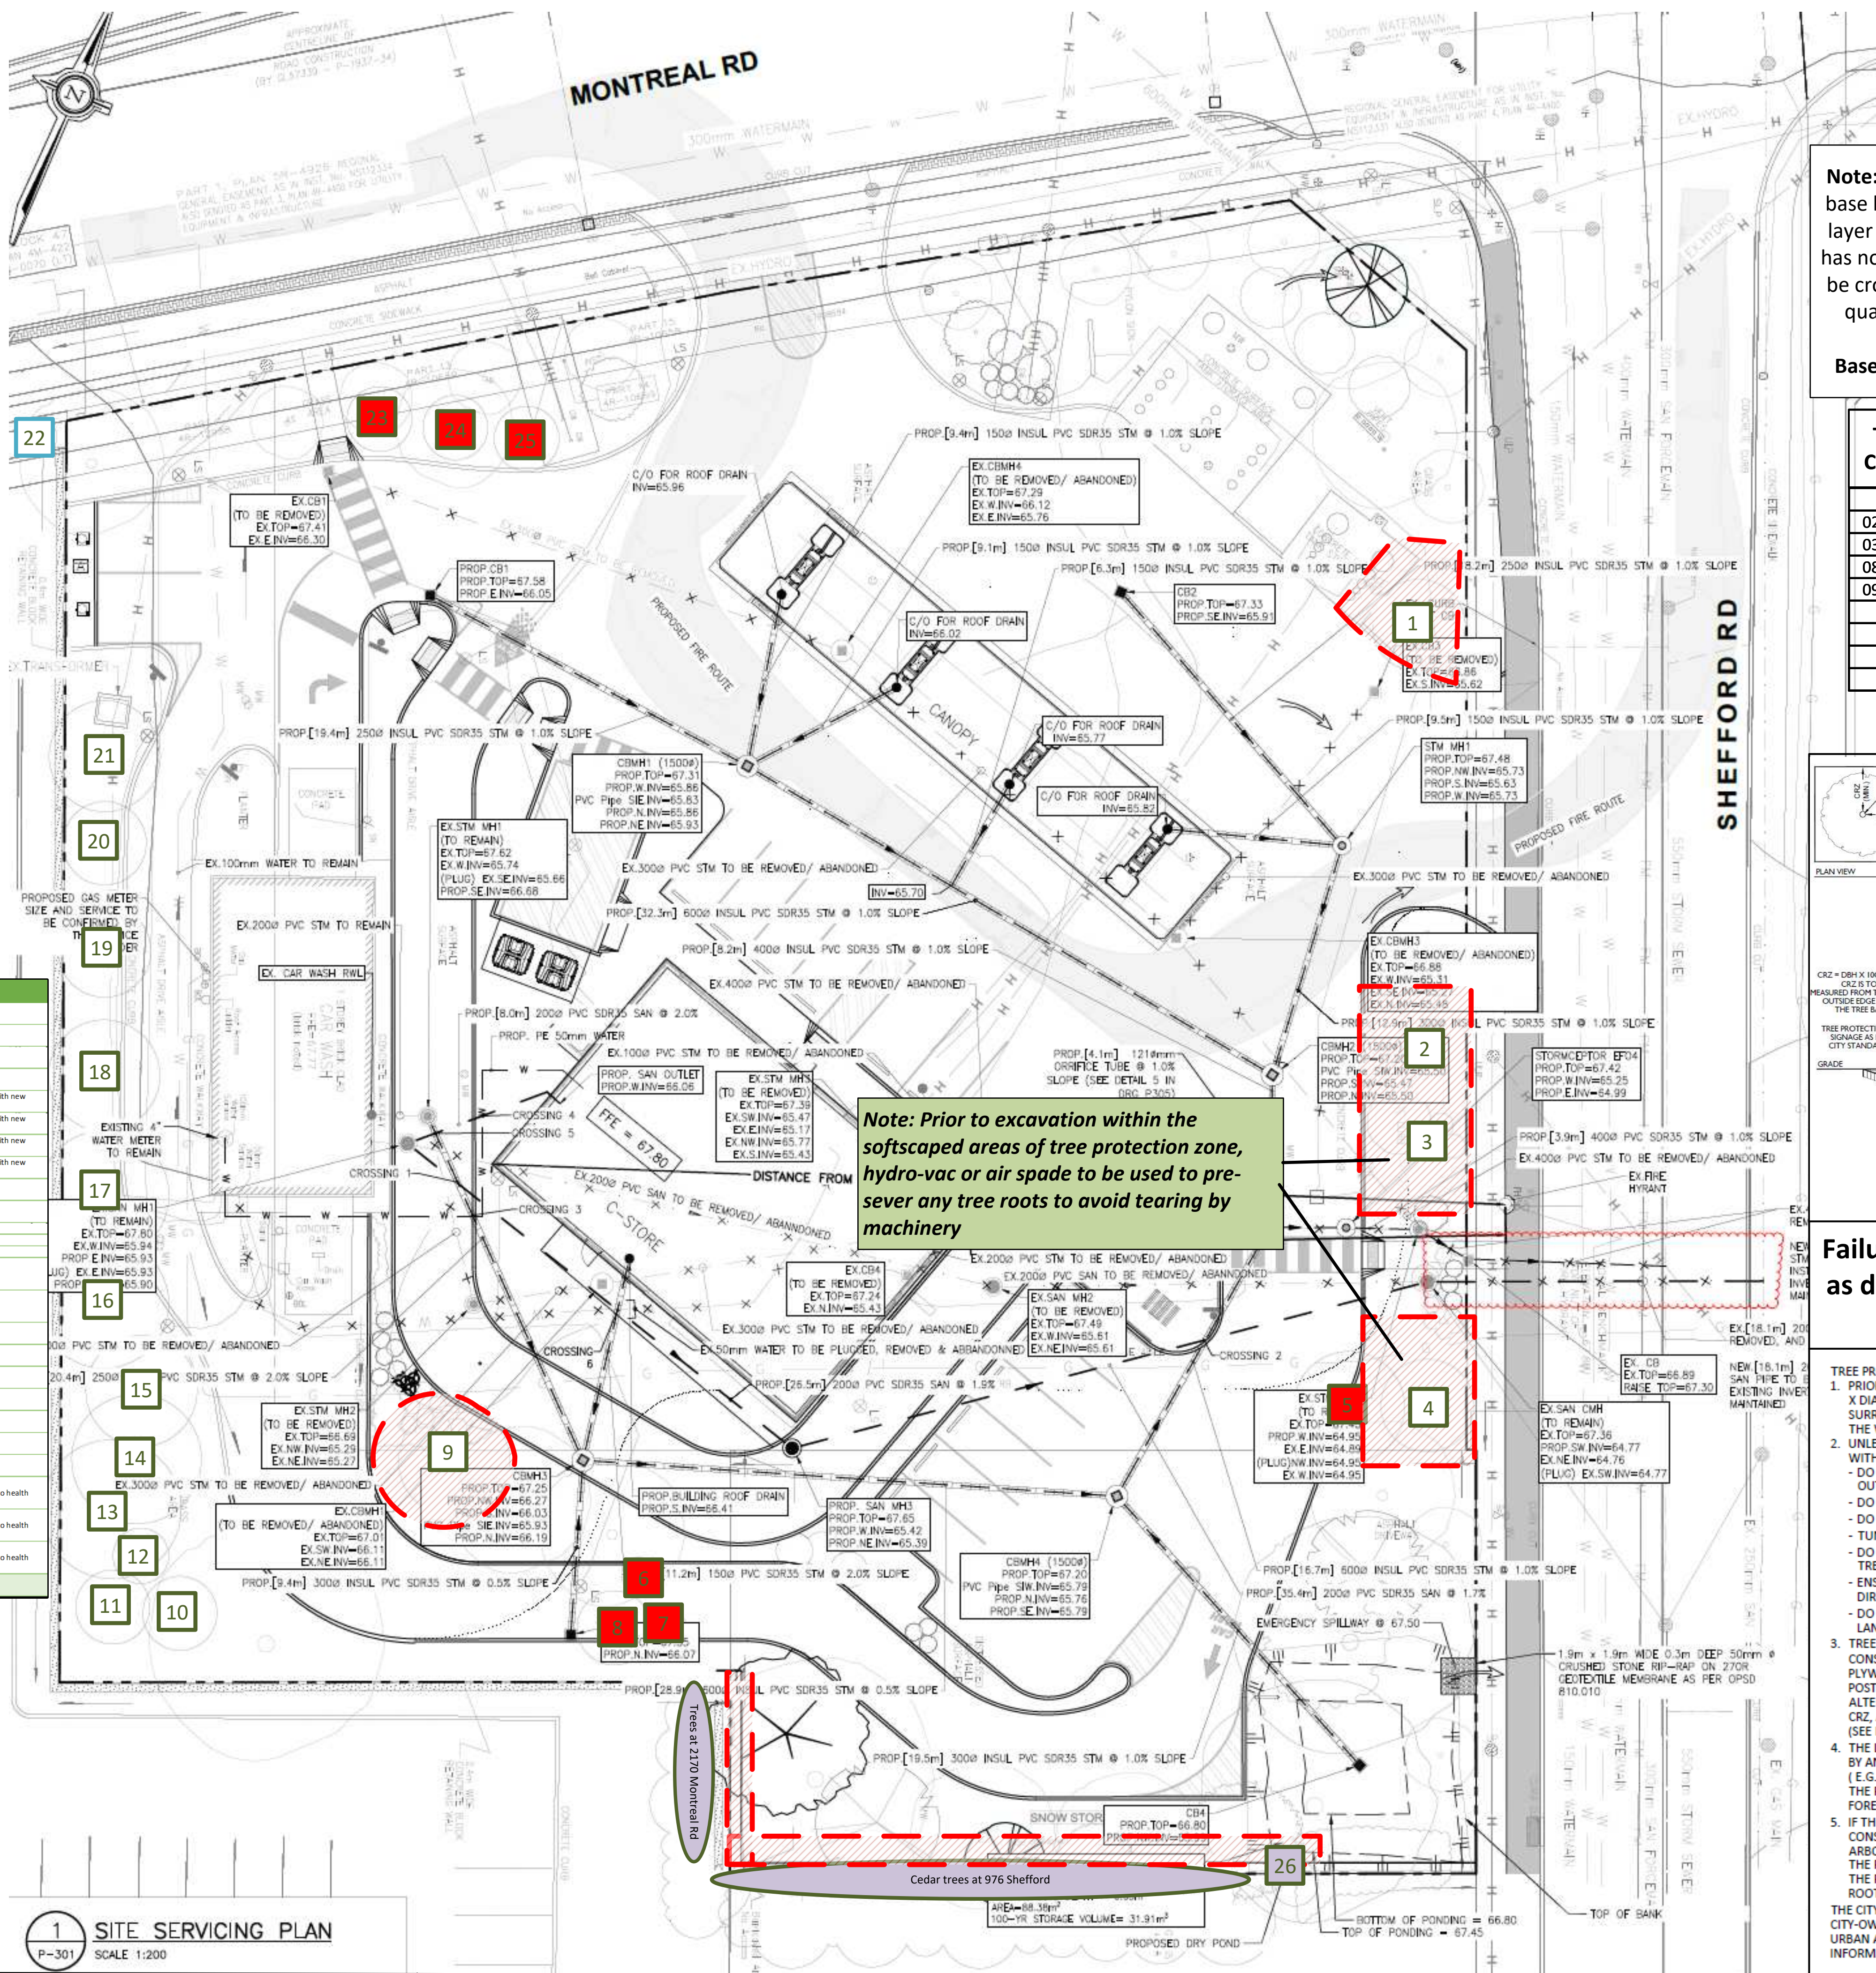
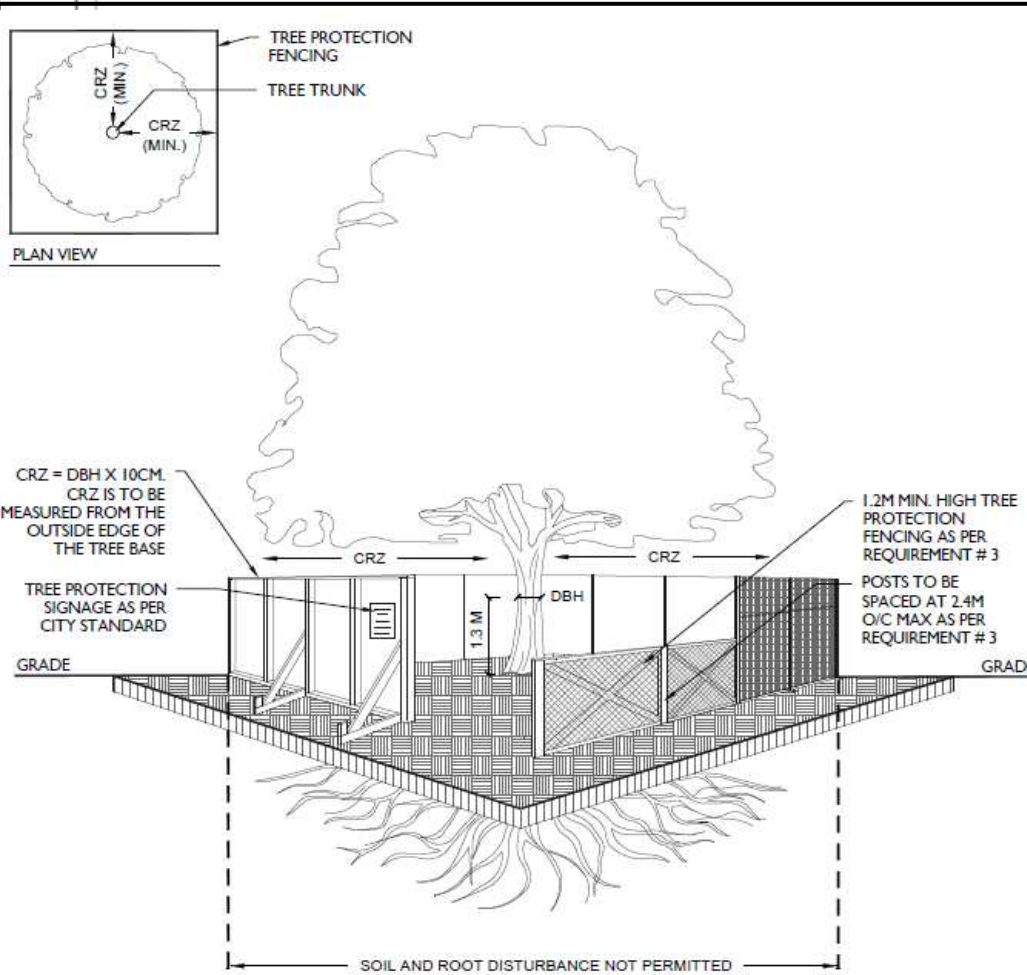
**TCR Map#2: Proposed Development and Conserved Vegetation – 2180 Montreal Rd**

**Map #2: Proposed Development and Conservation**, located in **Appendix 2**, provides a spatial overview of the removals. This map is overlaid onto the **Site Servicing Plan** and identifies the following trees for removal: **5, 6, 7, and 8**.

**Prior to any site works**, protective fencing should be installed around the Tree Protection Area as indicated in Map#2: Proposed Development and Conserved Vegetation and maintained until all construction on site has been completed as per the City of Ottawa Tree Protection Specifications (March 2021).
