# Findlay Creek Conceptual Channel Design

**4795 Bank Street Subdivision**  
Ottawa, Ontario

GEO Morphix Project No. 26028

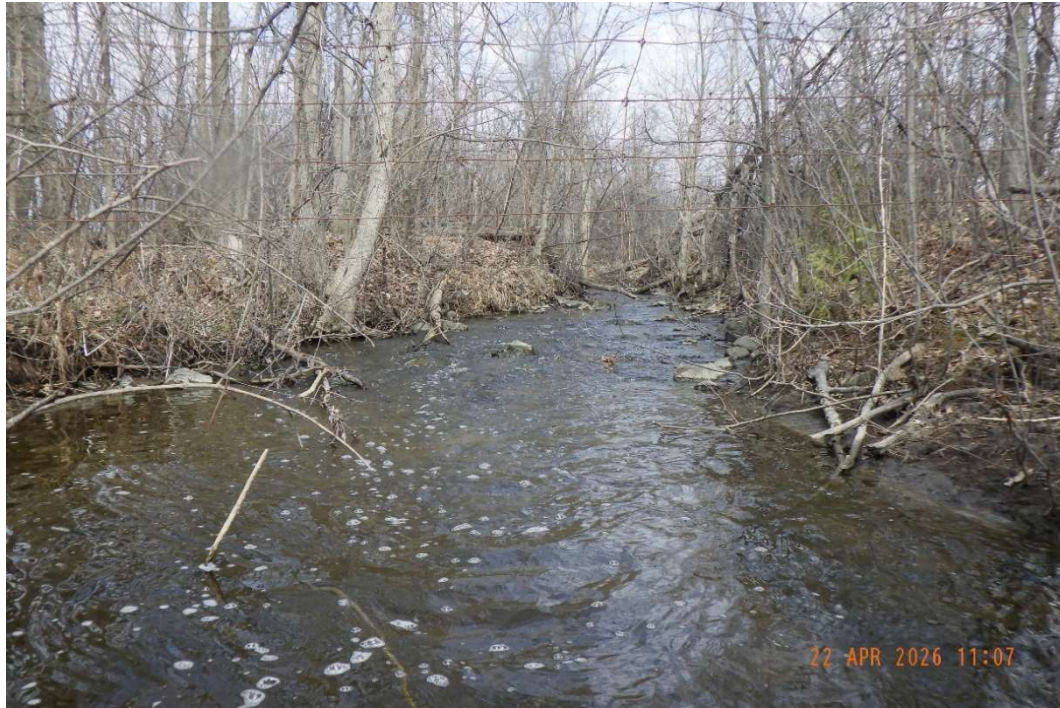
**Photo 1: Reach FC-1b**  
Findlay Creek, Ottawa, Ontario  
Photo Direction: Upstream

View of the downstream extent of Findlay Creek within the subject lands. Riparian vegetation consisted primarily of trees and shrubs with moderate-good canopy cover.

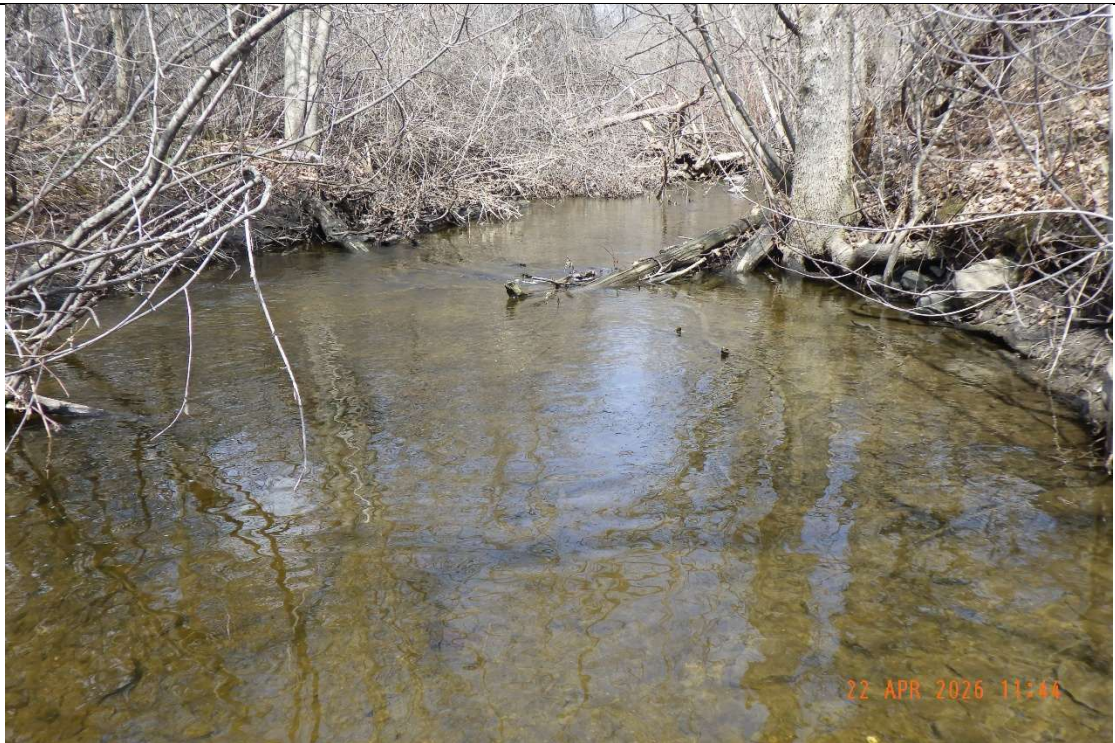
**Photo 2: Reach FC-1b**  
Findlay Creek, Ottawa, Ontario  
Photo Direction: Upstream

The channel was partially confined and had a low sinuosity.  
The channel was defined and had moderate to steep sloped banks.

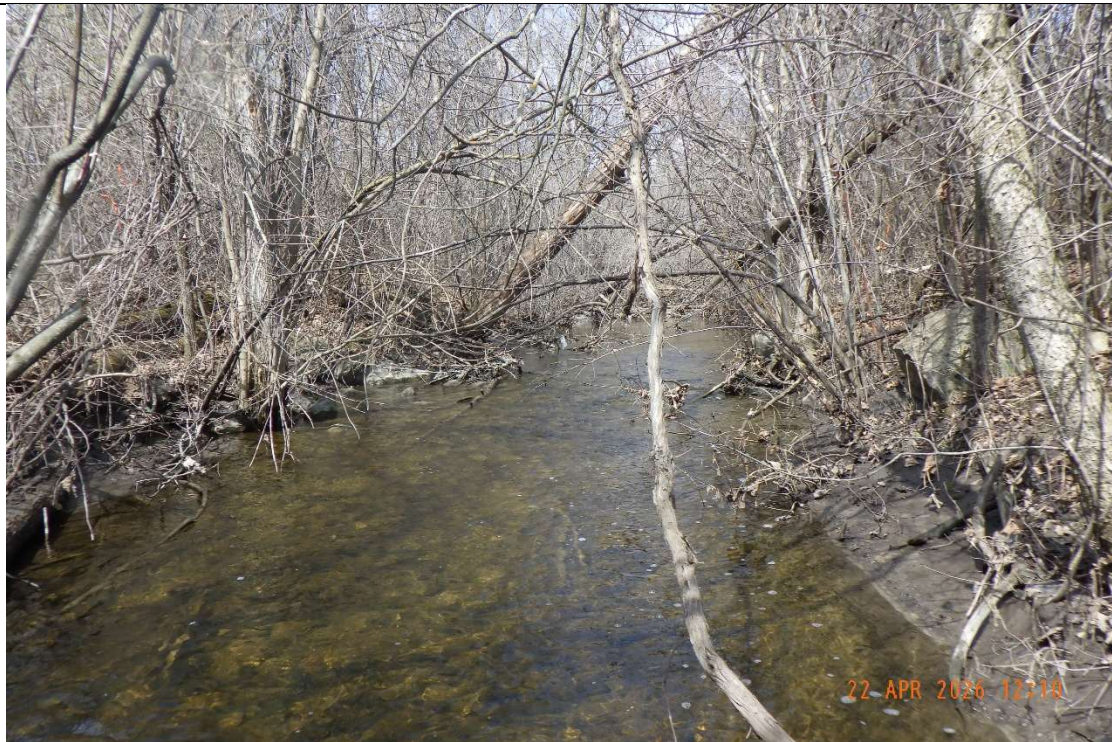
**Photo 4: Reach FC-1b**  
Findlay Creek, Ottawa, Ontario  
Photo Direction: Upstream

Bank erosion was observed along both banks for portions of the channel.

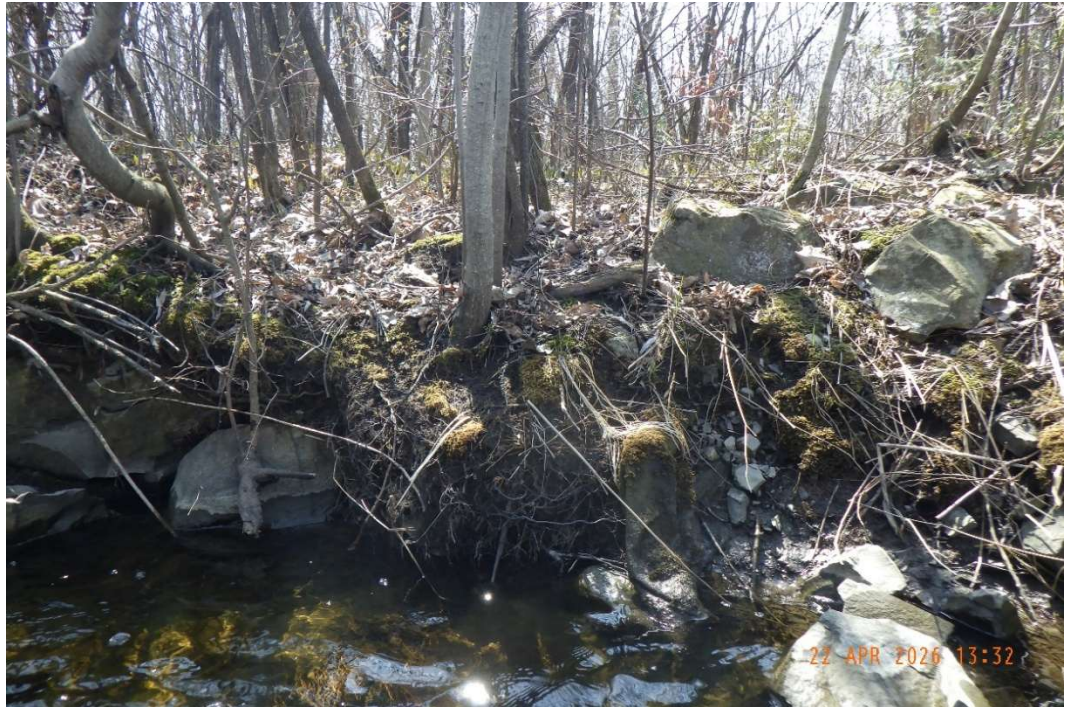
**Photo 5: Reach FC-1b**  
Findlay Creek, Ottawa, Ontario  
Photo Direction: Left bank

Banks consisted of clay, silt, rootlets, and sporadic boulders. Exposed tree roots were observed within the banks throughout the channel.

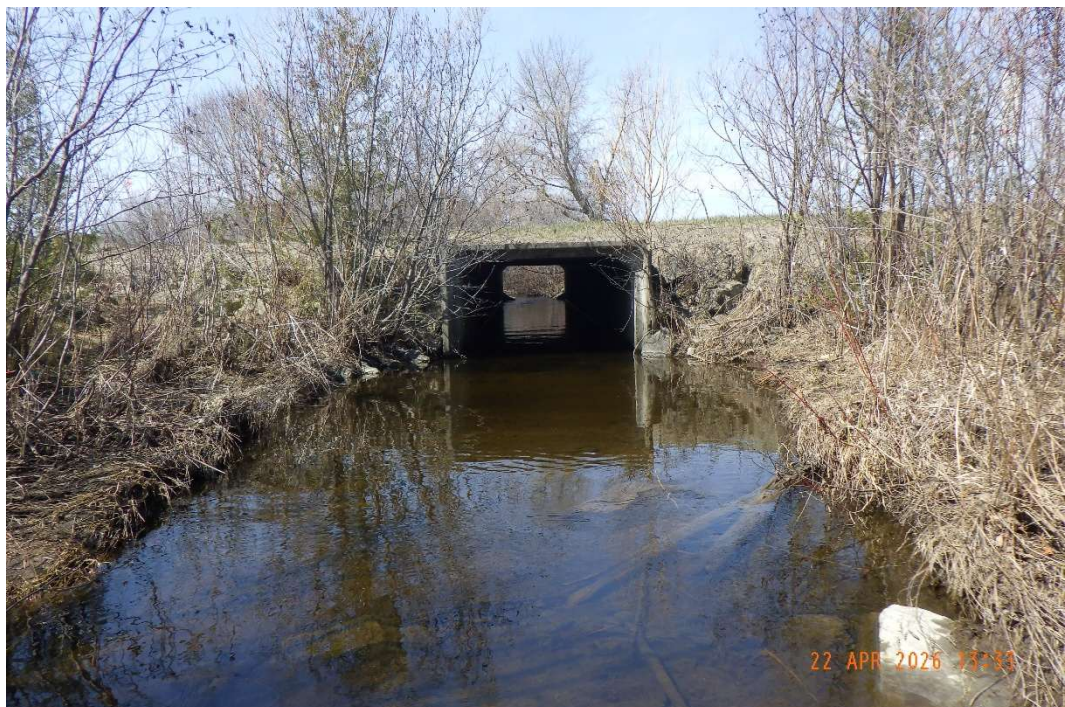
**Photo 6: Reach FC-1b**  
Findlay Creek, Ottawa, Ontario  
Photo Direction: Upstream

Culvert at the upstream extent of Reach FC-1b. Rip rap was observed at the extent of the culvert, and more grasses and herbaceous material was present on the channel banks.

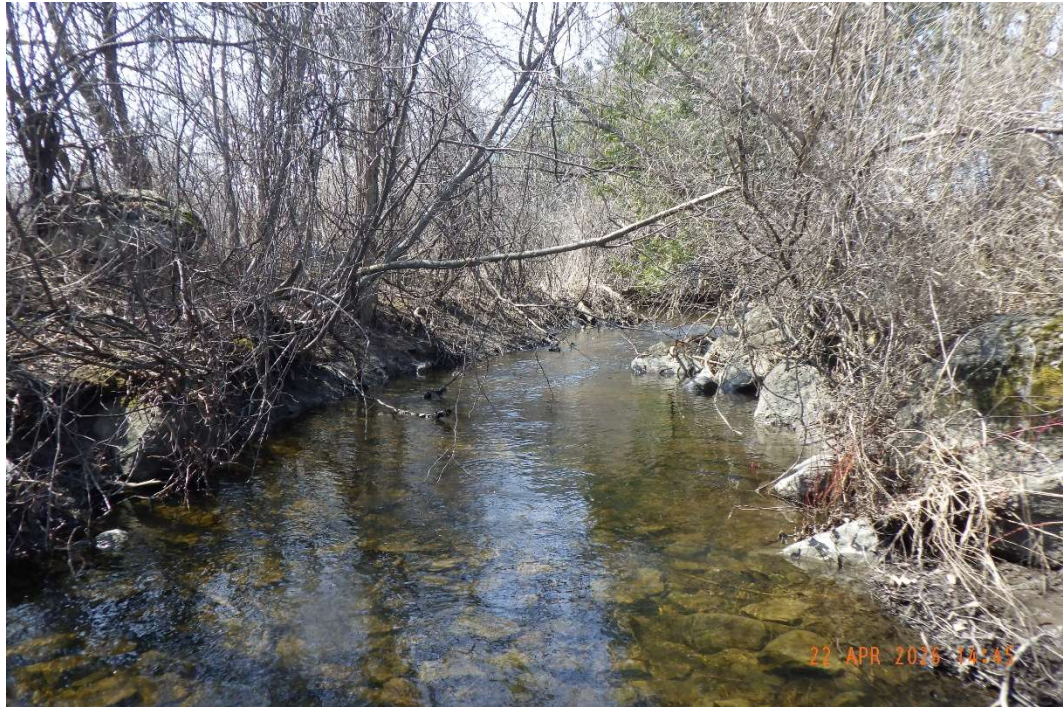
**Photo 9: Reach FC-1a**

Large boulders were present throughout the reach along the banks. Treefalls and leaning trees were common. The channel was generally straight with low sinuosity.

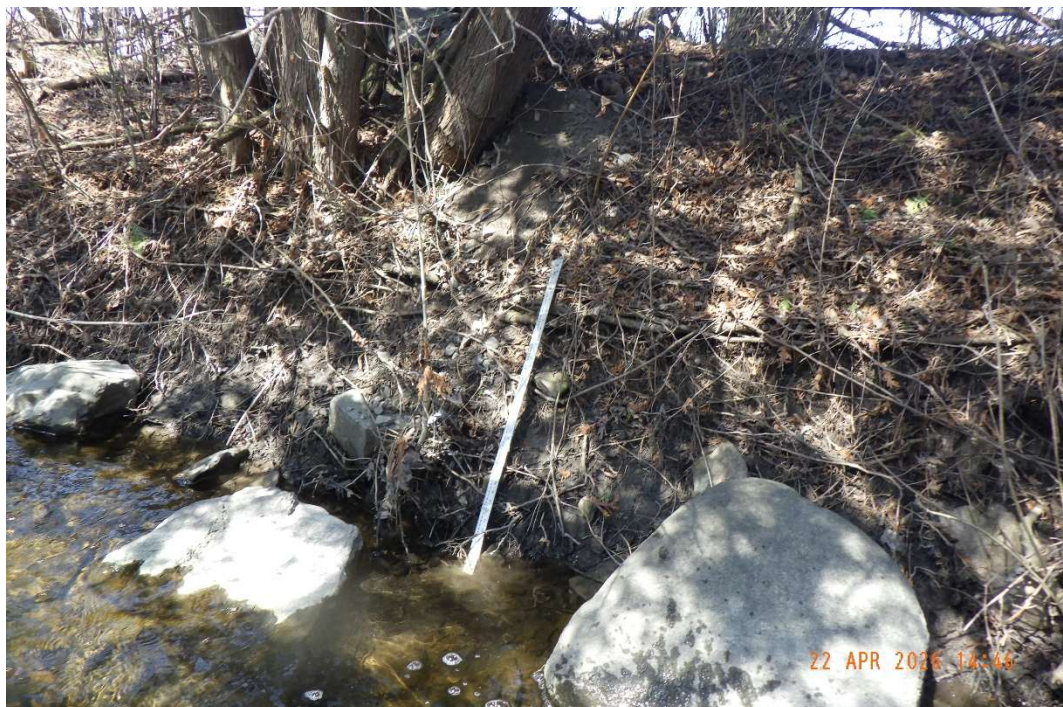
**Photo 10: Reach FC-1a**

Bankfull heights ranged from 0.63 to 0.73 m.  
The top of bank heights for some sections of the channel were greater than 1.0m.

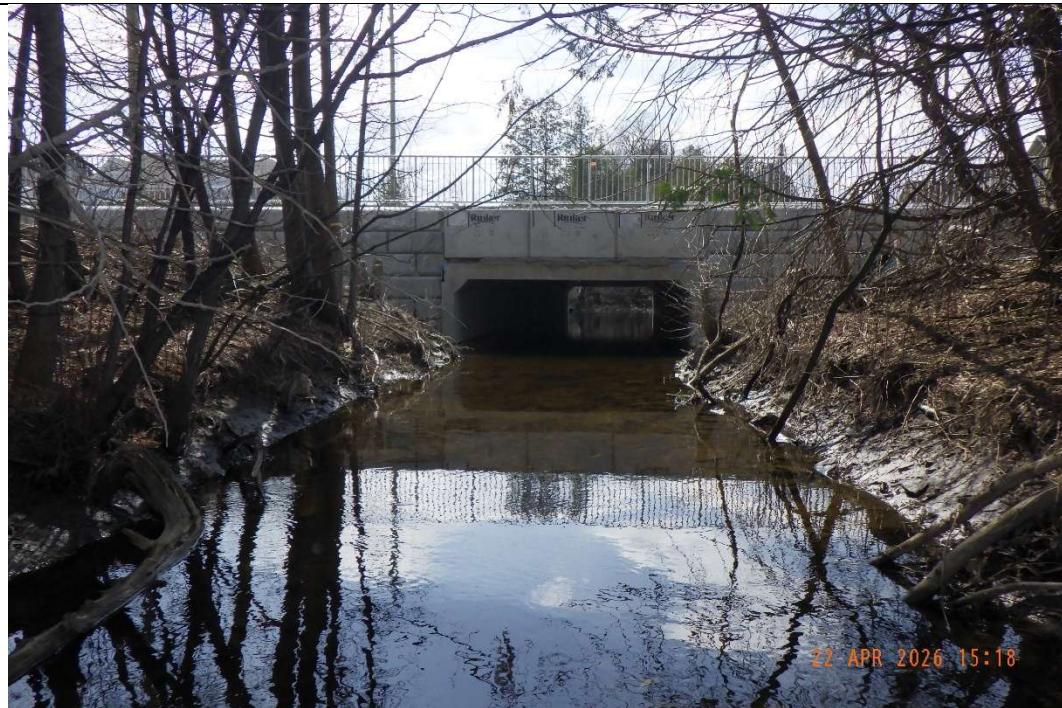
**Photo 12: Reach FC-1a**  
Findlay Creek, Ottawa, Ontario  
Photo Direction: Upstream

Photo of the Bank Street crossing at the upstream extent of Reach FC-1a.  
Note bank erosion along both sides of the channel.

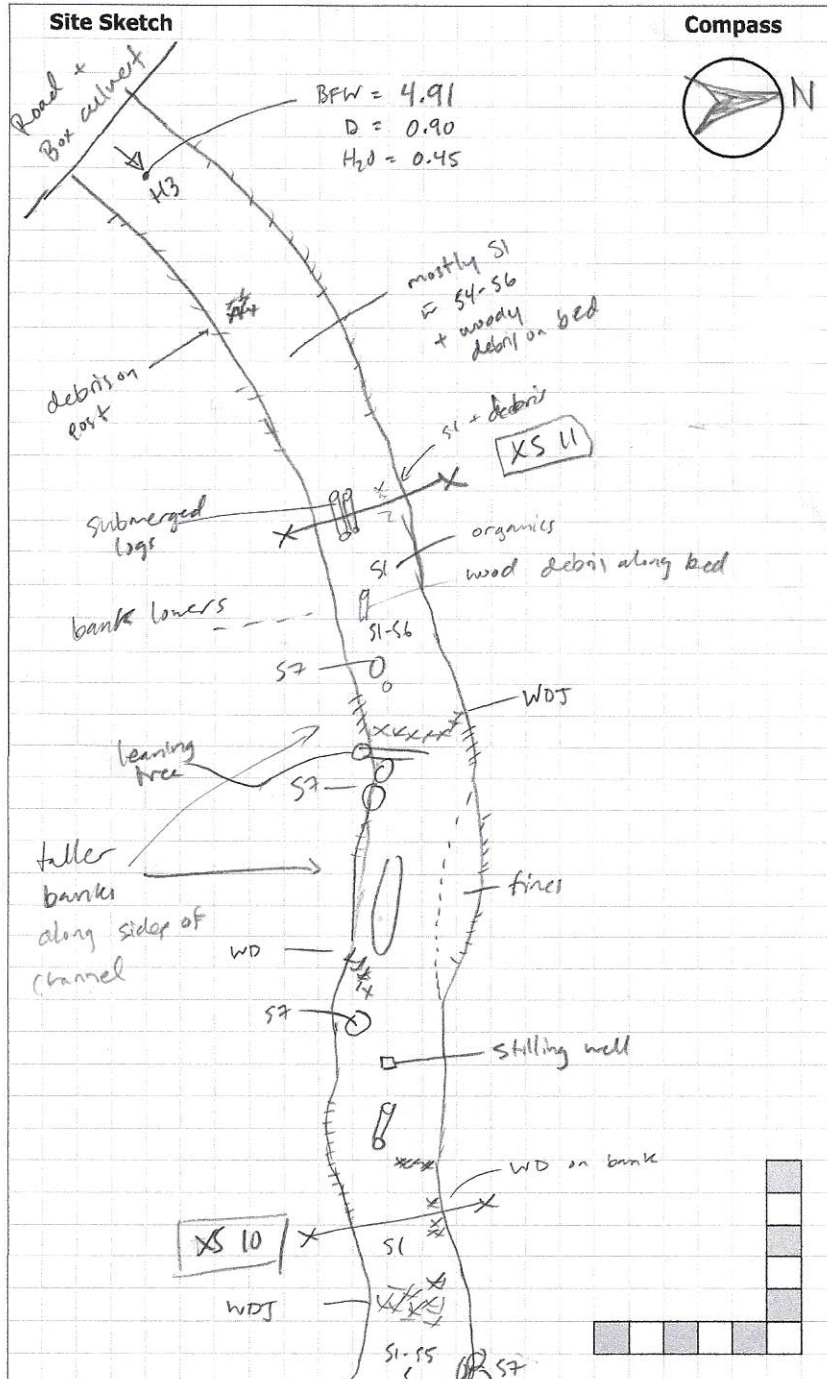
Notes: finer continue up

- fill piles / berms observed along channel banks (not continuous) but taller than 'natural' sections  
- bank erosion observed on both toes
