# 2510 St. Laurent Blvd – Tree Conservation Report

Prepared for Claridge Homes  
by Arcadis | IBI Group

March 19, 2026

<b>CLIENT:</b>	Claridge Homes
<b>PROJECT NAME:</b>	Walkley Conroy
<b>REPORT TITLE:</b>	2510 St Laurent Blvd - Tree Conservation Report
<b>ARCADIS REFERENCE:</b>	140253
<b>VERSION:</b>	5.0
<b>ORIGINATOR:</b>	Brittany Semmler, Ecologist (Edited by Brenda Van Ryswyk)
<b>REVIEWER:</b>	Casey Little, Senior Ecologist, Certified ISA Arborist

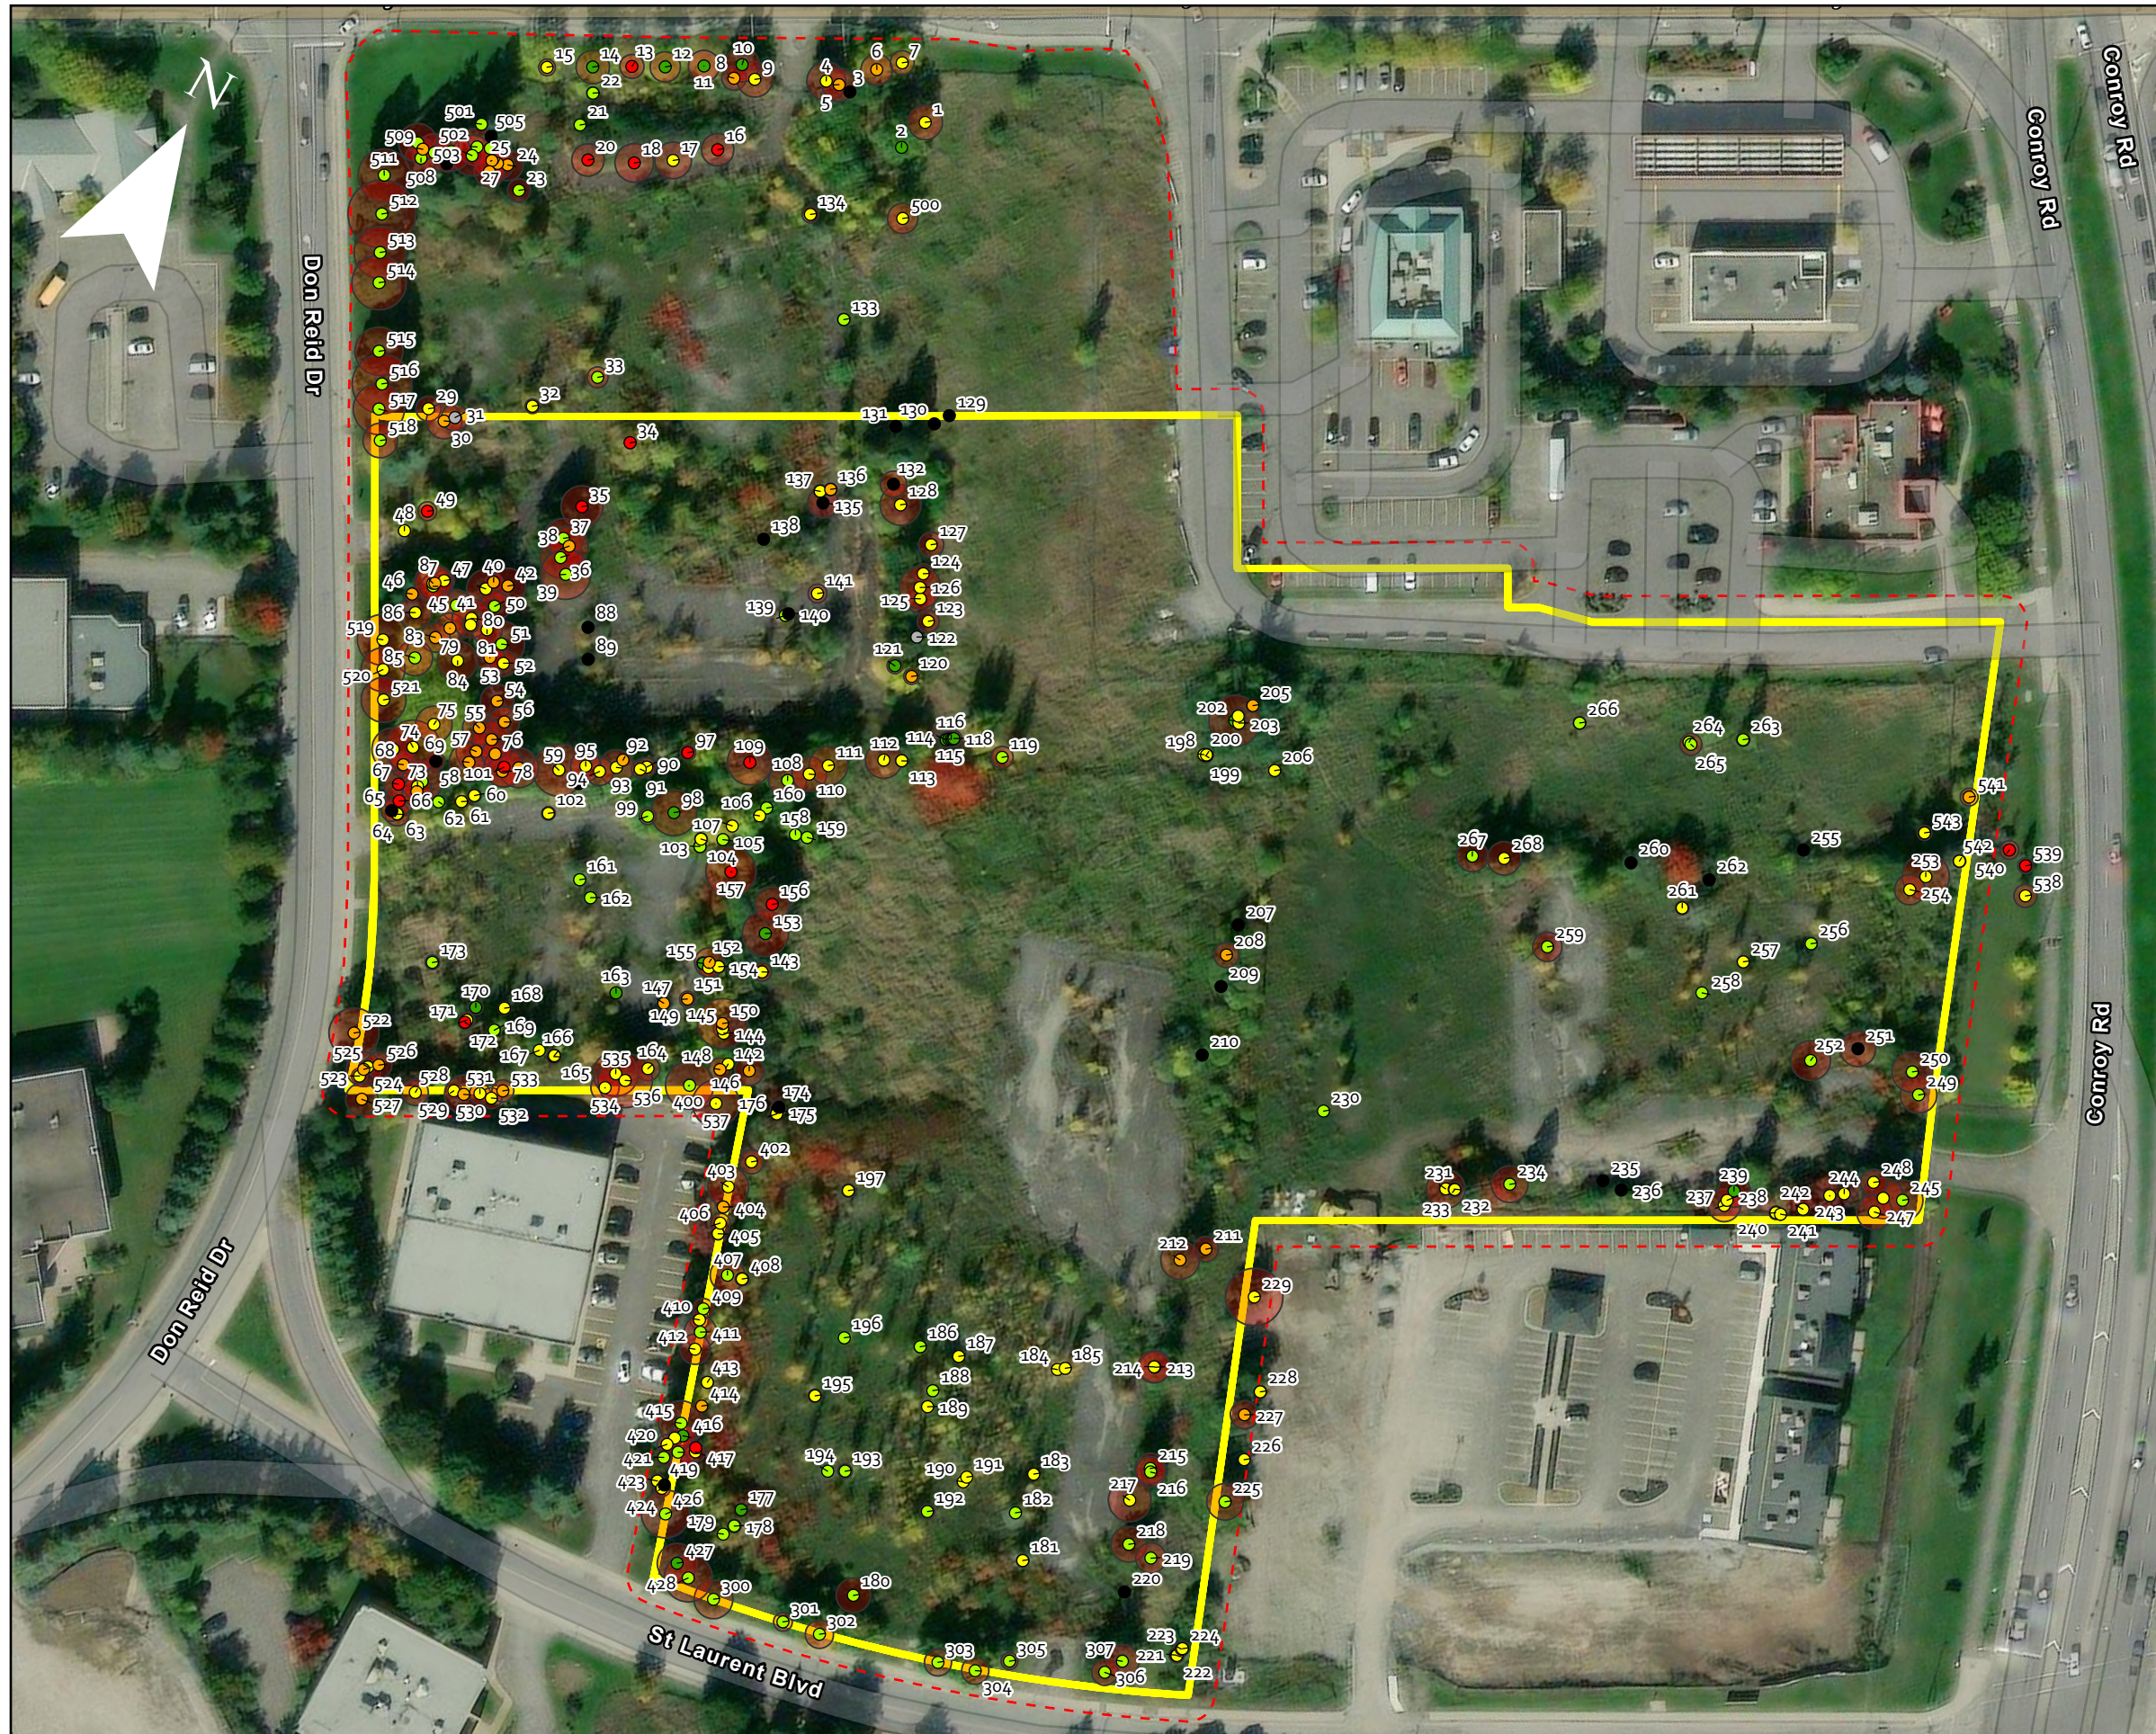
**Figure: 2**

The following **Table 1** provides a summary of the tree inventory results with a full Tree Inventory and Preservation Plan included in **Appendix A**. **Figure 2** below displays the tree locations and associated health conditions.

**2510 St. Laurent Blvd:  
 Current Vegetation  
 (Map 1 as per City Guidelines)**

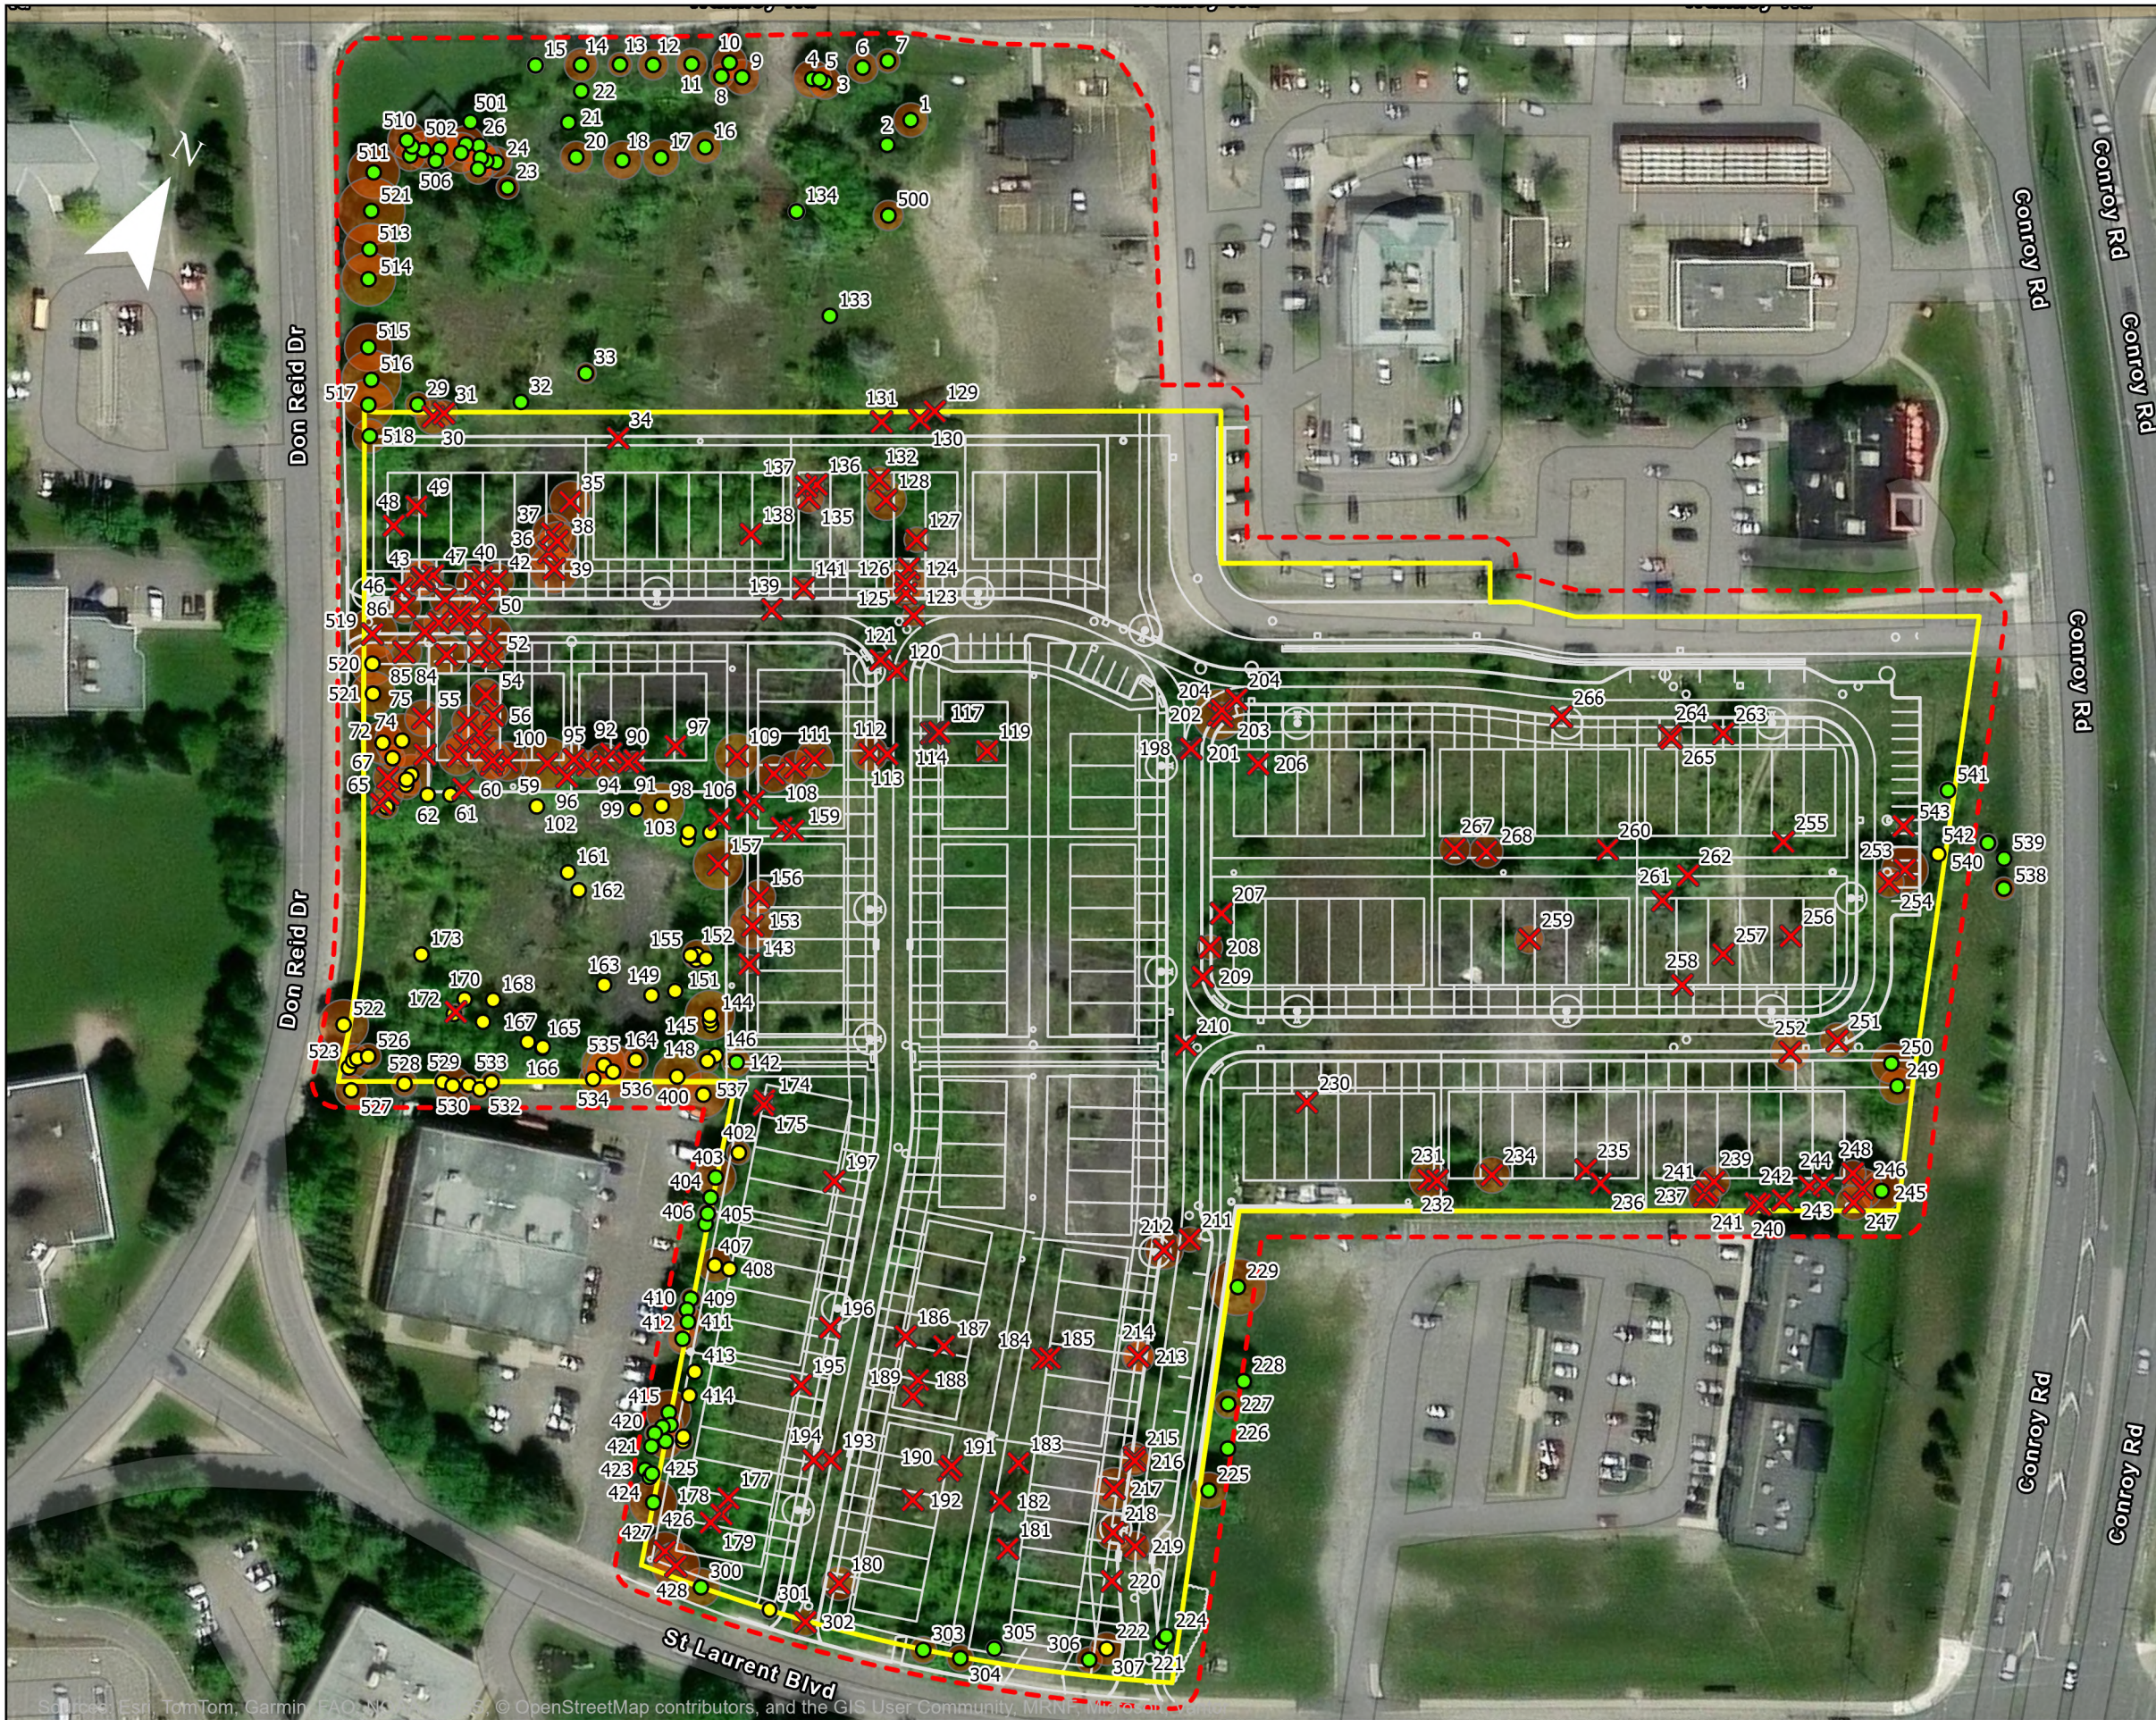
**Figure: 3**

**Figure 3** below displays the results of the tree inventory overlaid with the current site plan. Recommendations for removal, retention, and potential for retention are included.

The Critical Root Zone (CRZ) of **190 trees are in direct conflict with the proposed site plan and or grading limits and will require removal (Appendix A). One additional tree (301) has been proposed for removal and replacement due to a trunk wound.** Physical impacts on the CRZ by construction activities rapidly deteriorates the overall health, quality, and ecological service of the tree. Therefore, tree locations that will impact majority of the CRZ have been recommended for removal.

Title: 2510 St. Laurent Blvd:  
Tree Impact Assessment  
and Recommendations  
(Map 2 as per City Guidelines)
