**RE: TREE PROTECTION PLAN FOR 2040 ARROWSMITH DRIVE, OTTAWA**

This tree protection plan was prepared by IFS Associates Inc. (IFS Inc.) in support of a building permit for 2040 Arrowsmith Drive in Ottawa. The need for this report is related to trees protected under the City of Ottawa's Tree Protection By-law (By-law No. 2020-340). The work proposed includes demolishing existing buildings and construction of a six-storey mixed-use building (see plan on page 7 of this report). A driveway with retaining wall and curb is proposed for the rear of the building and is adjacent to a stand of trees on the neighbouring property at 2000 Jasmine Crescent. This plan details efforts to ensure the successful retention of these trees.

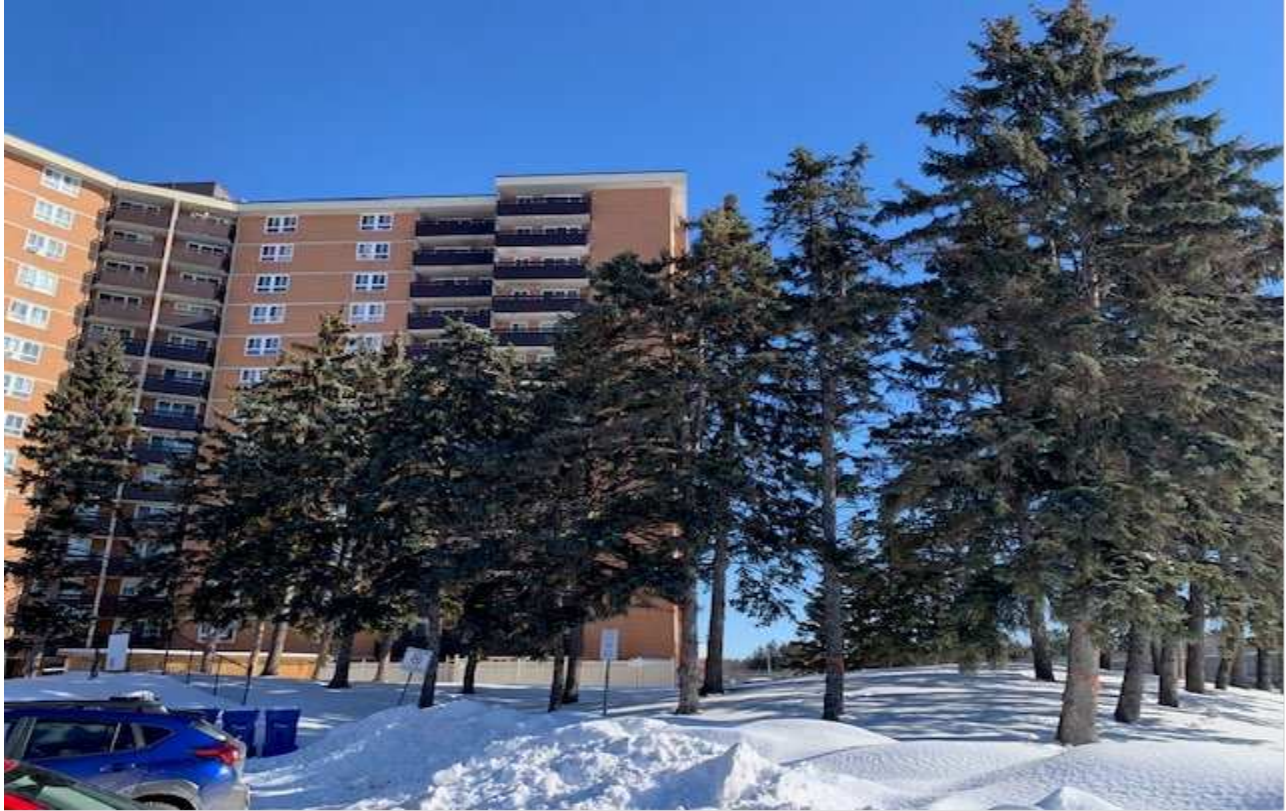
Picture 1. Trees #8 to 23 (left to right) – Colorado spruce trees on and adjacent to 2040 Arrowsmith Drive

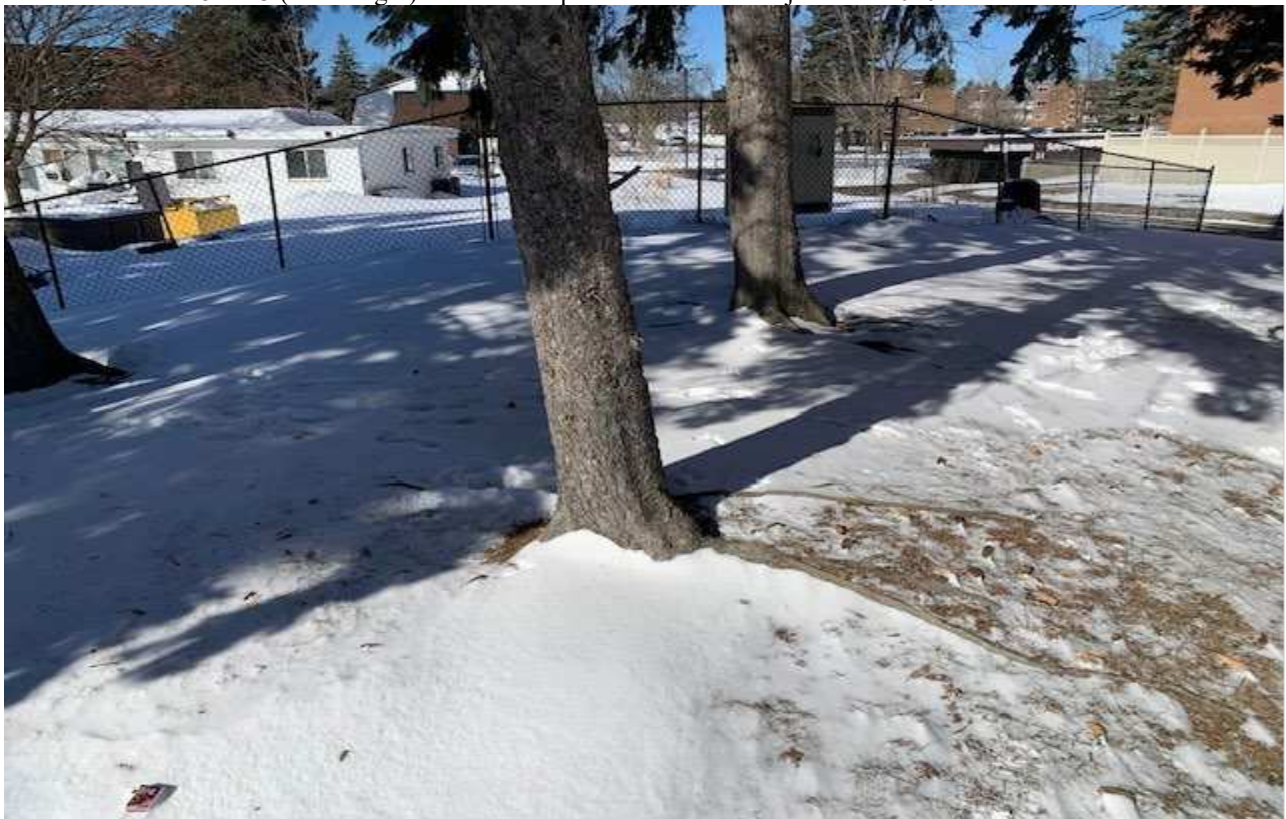
Picture 2. Rooting conditions below Colorado spruce trees on and adjacent to 2040 Arrowsmith Drive (note exposed surface roots)
