Tree Conservation Report
For the property at 1883 Stittsville Main, Stittsville, ON

2024-06-21

Project Number: Matt 1707

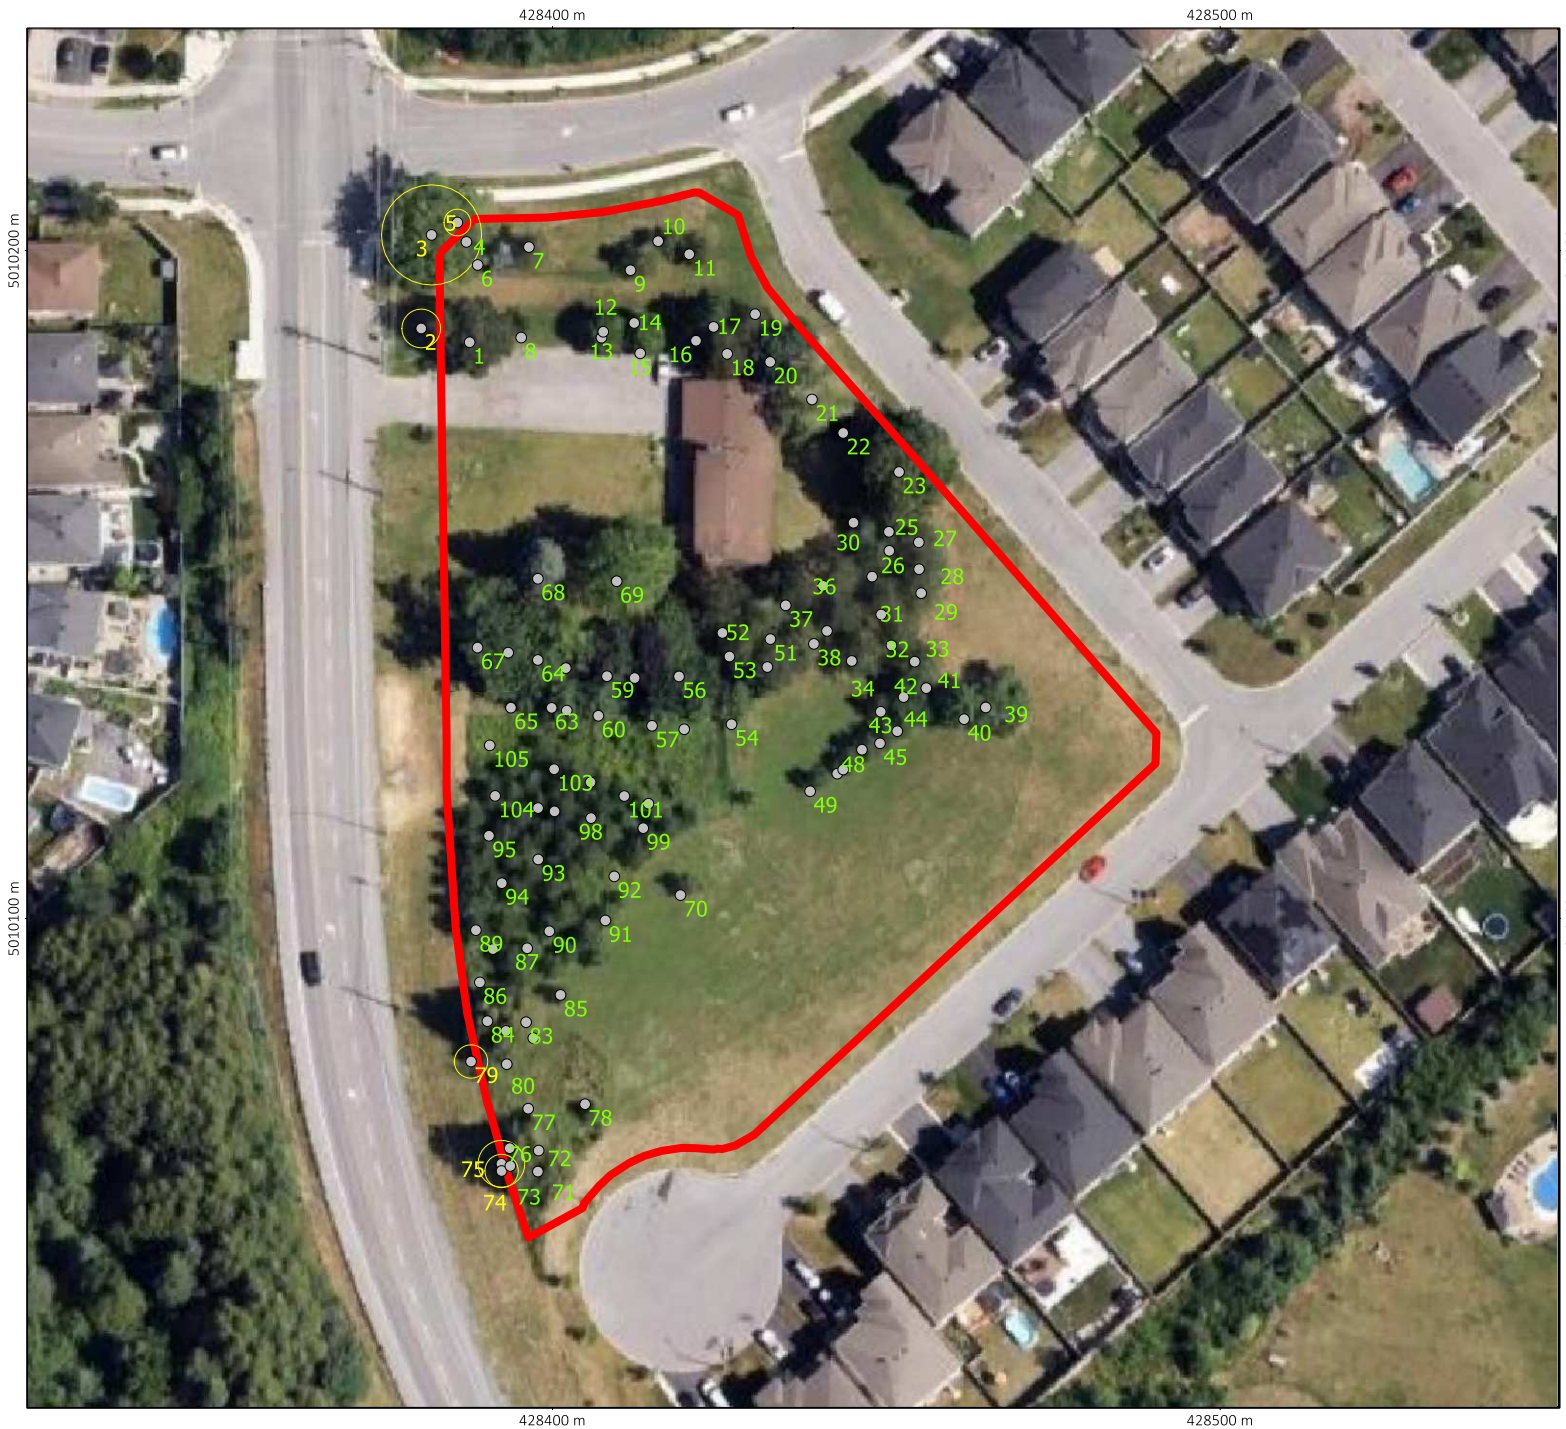
Figure 1 Tree Locations

An inventory of trees on the Site was performed on June 7, 2024, following guidelines set forth by the City of Ottawa, 2020. All trees with a DBH \geq 10 cm having a potential to be removed under the proposed development were identified, enumerated, mapped, their DBH measured, and their general health and condition documented (see Appendix A for detailed tree conditions). Additionally, any trees on adjacent property whose CRZ could potentially be affected by the proposed development were included in the inventory. The general locations of the trees are documented in Figure 1.

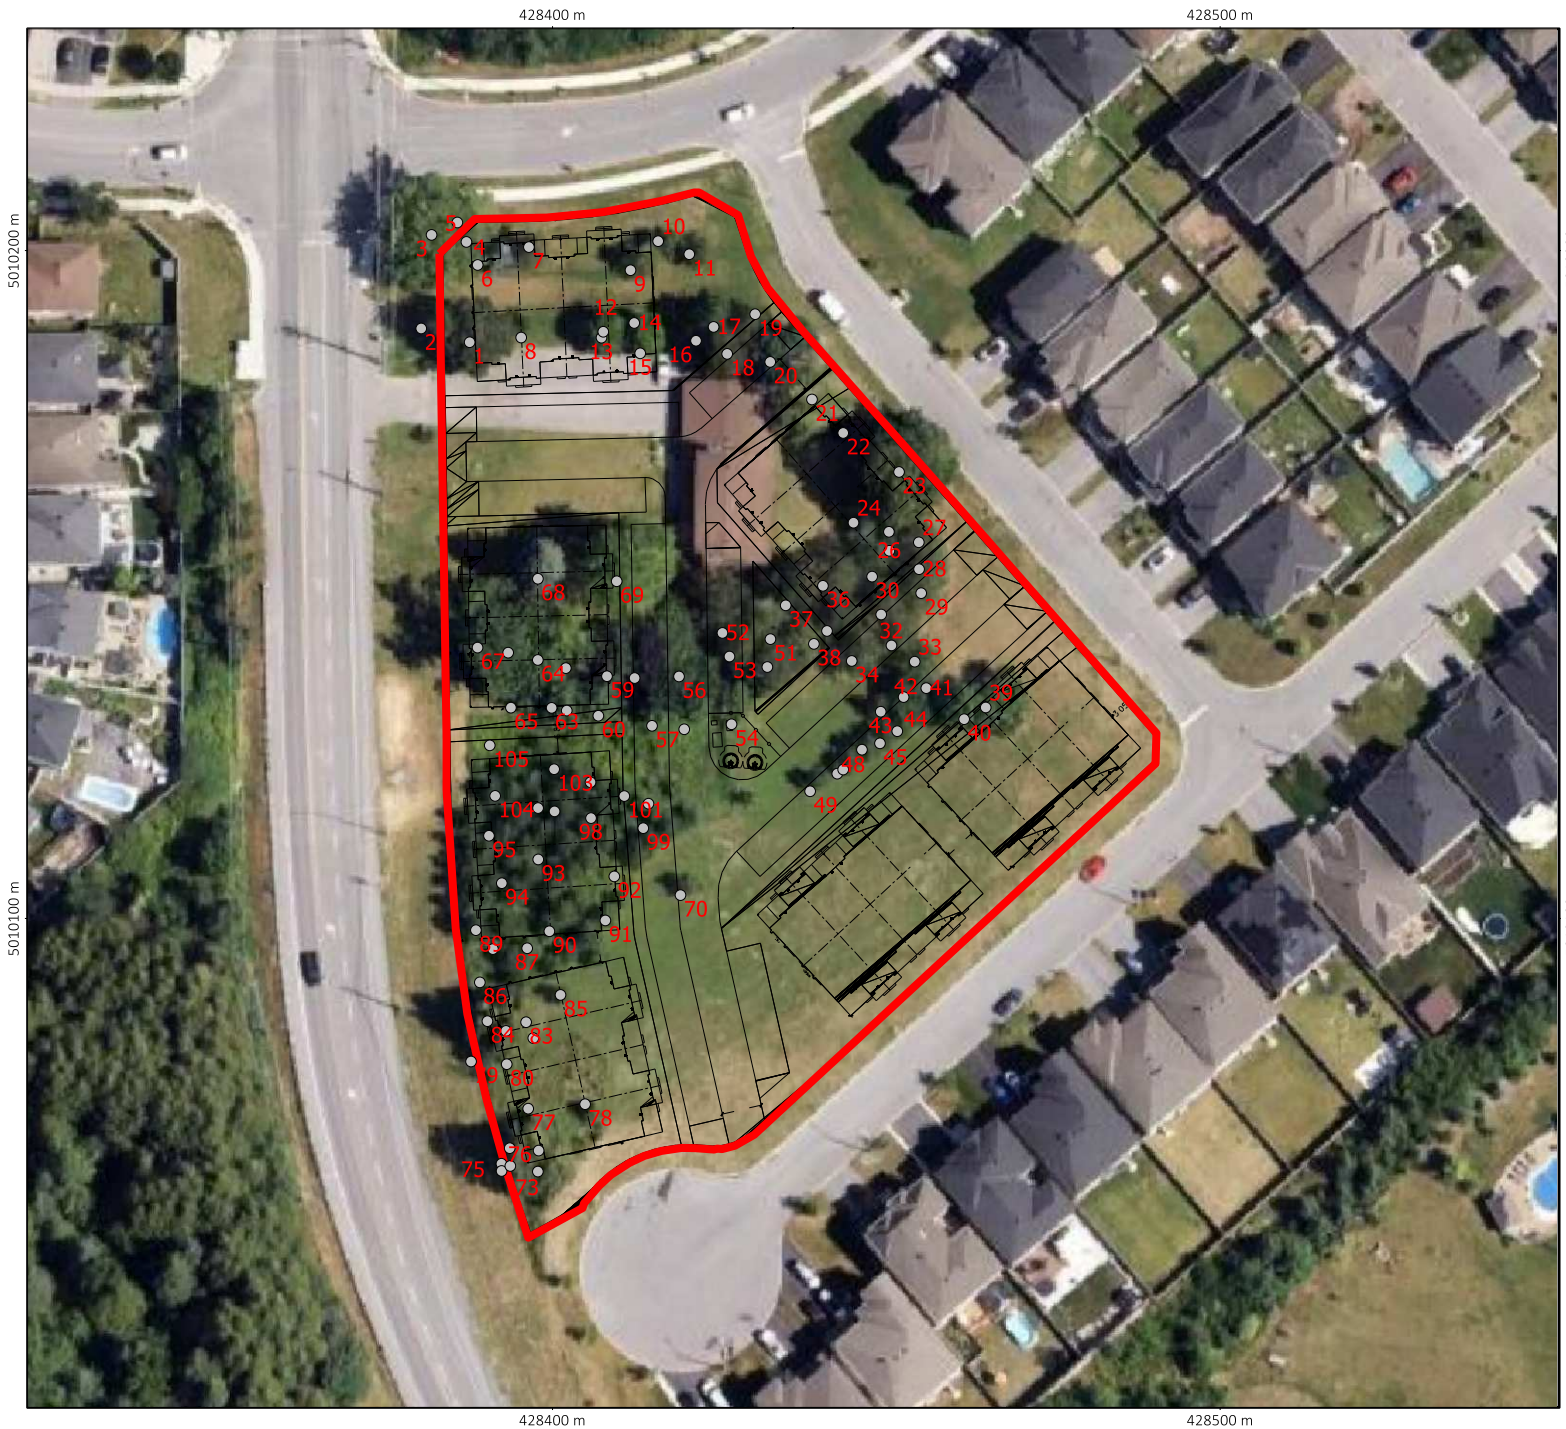
Figure 2 Tree Results Following Excavation

The proposed development is to build 84 units on Site with parking areas and some small, amenity areas. All 99 trees currently located on the Site will be removed to accommodate site grading and construction. Six City trees co-located on the property boundaries or having significant portions of their critical root zones (CR) that extend into areas subject to ground works area also too close to the proposed development to permit their retention. All 105 trees will be removed. No other trees in the broader vicinity area sufficiently close to the Site to be impacted by site development.
