# TREE CONSERVATION REPORT

The Ottawa Hospital – Riverside Campus Staff Parking Lot

Revision 02

March 2025

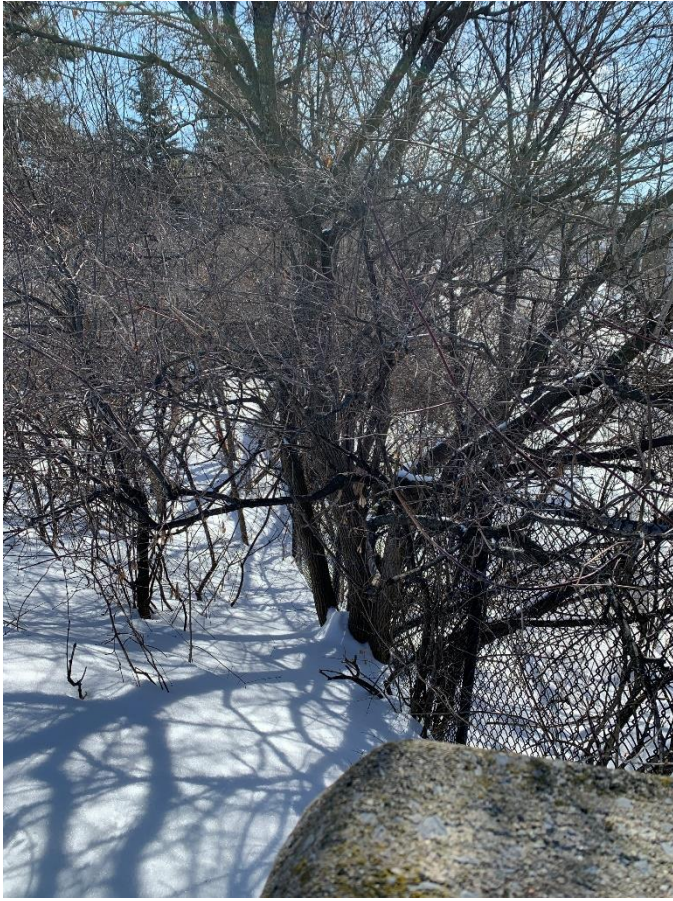
Photo 9: View of trees growing on existing fence along the boundary between TOH and City of Ottawa property, along the transitway.

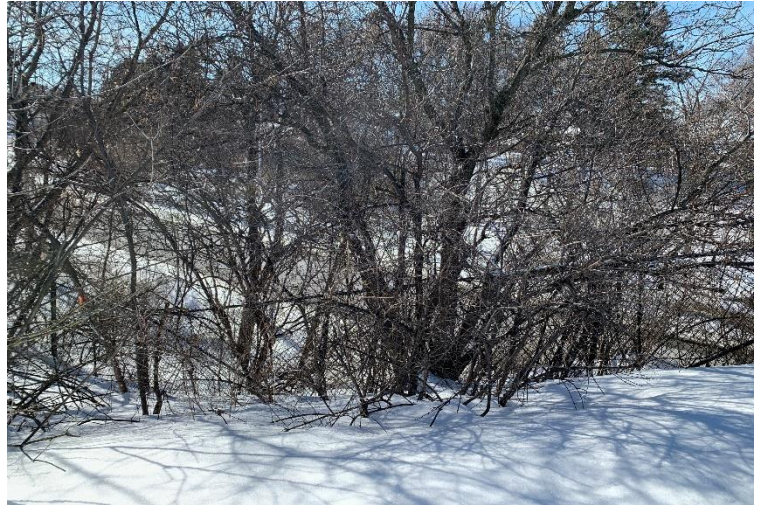
Photo 10: View of tree growing at base of existing fence along the transitway.
