# Tree Conservation Report for 6259, 6267, 6271 and 6273 Renaud Road, Ottawa

June 26, 2025

Final Report

Project Number: RICH 1637.4

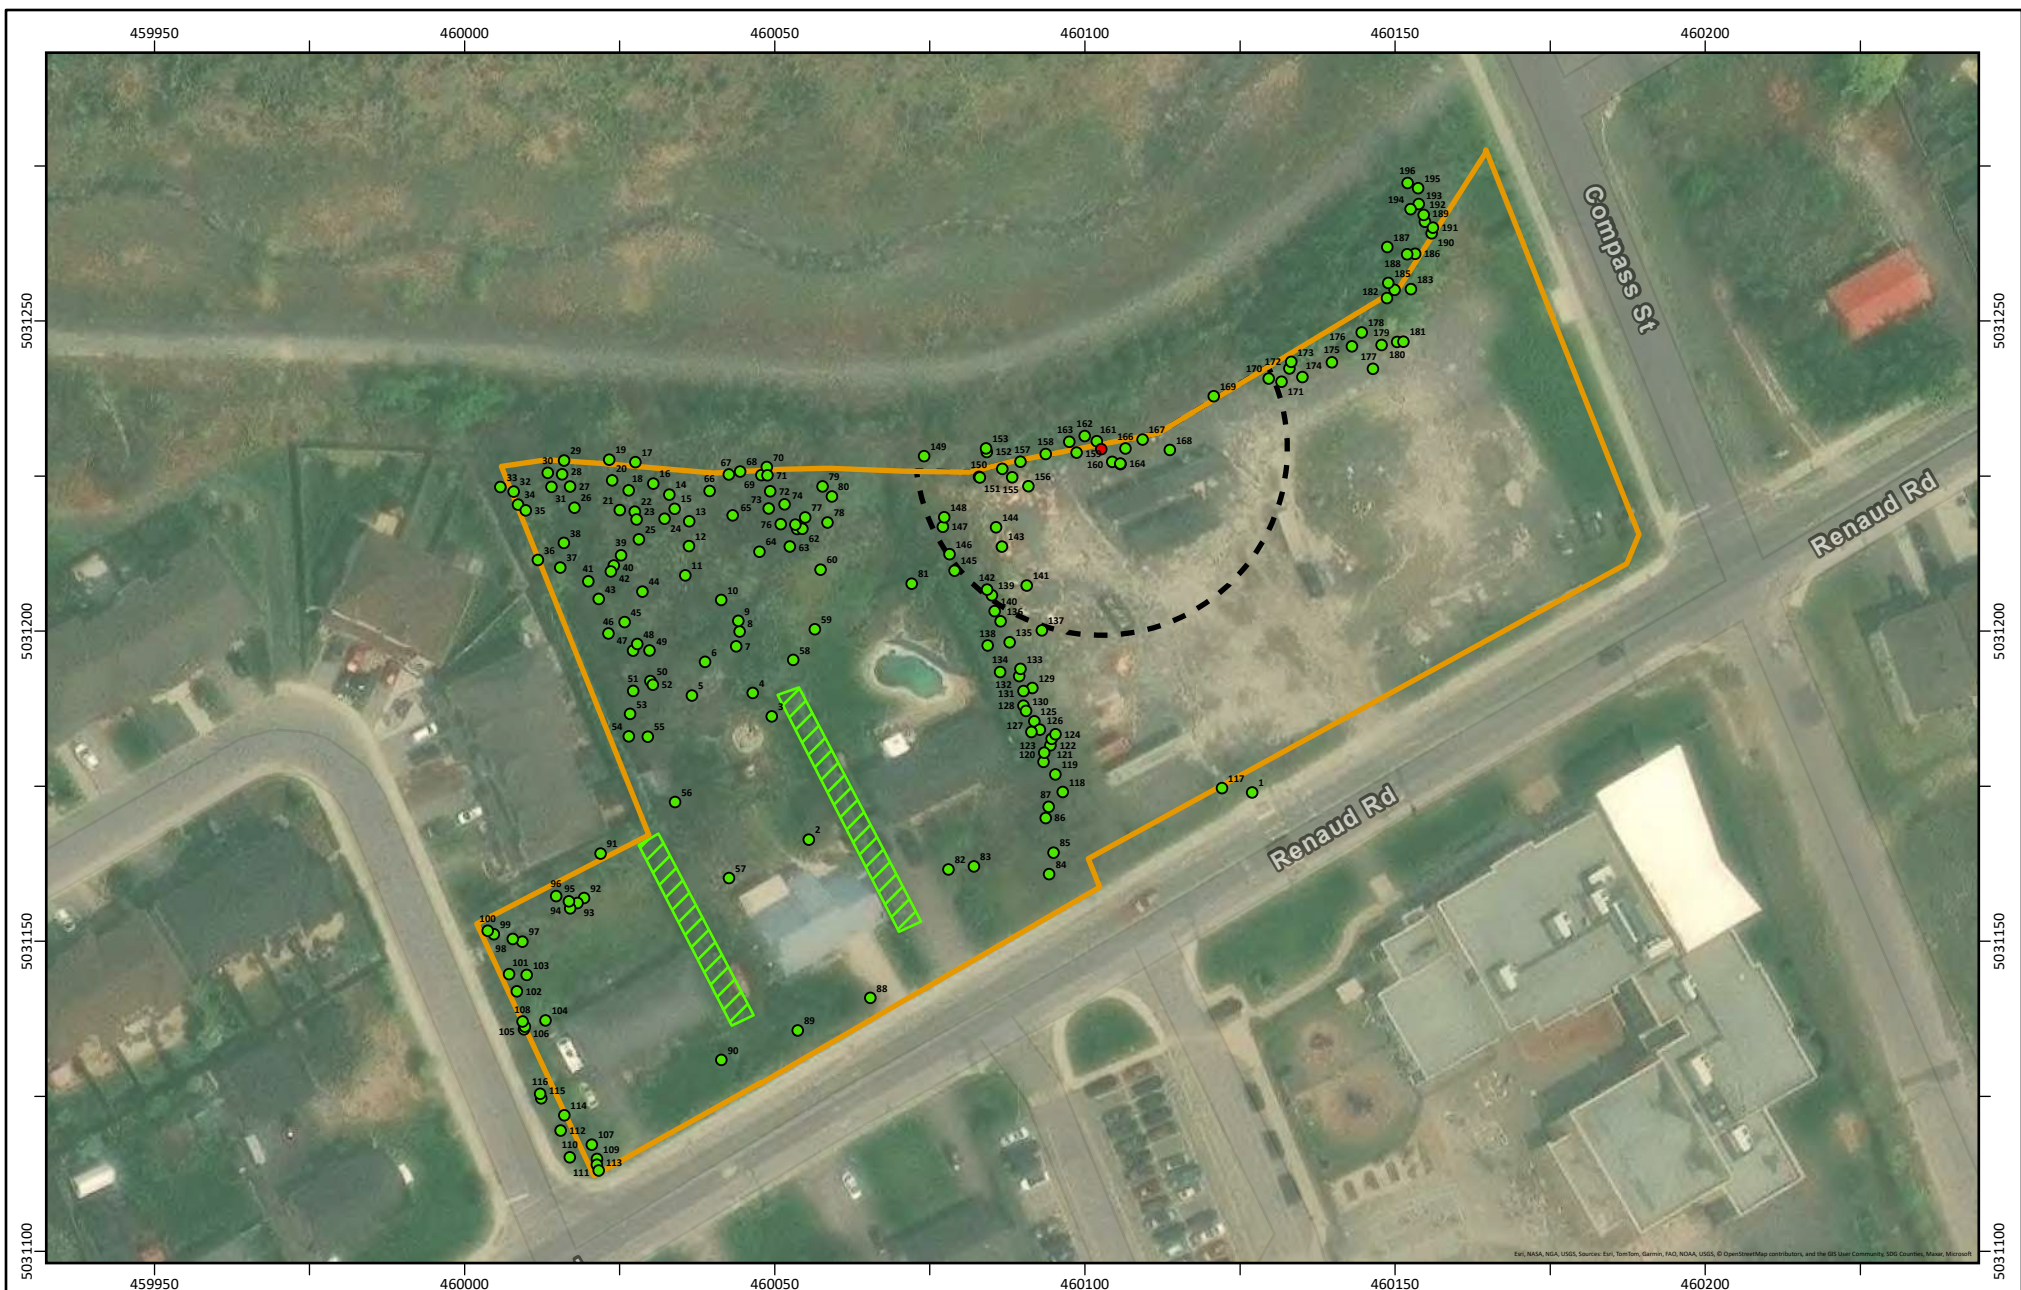
**Figure 2. Site trees**

The Site does not contain any Butternut trees (*Juglans cinerea*; listed as Endangered under the ESA and SARA). One Black Ash tree (*Fraxinus nigra*; Endangered under the ESA) was observed onsite, situated adjacent to the north property boundary (Figure 2, Figure 3). The Black Ash tree measured 9 cm DBH; winter conditions precluded a comprehensive assessment. Based on initial observations on size and condition, species and habitat protections under the ESA are anticipated to apply per O.Reg. 6.24 and O.Reg. 7.24.

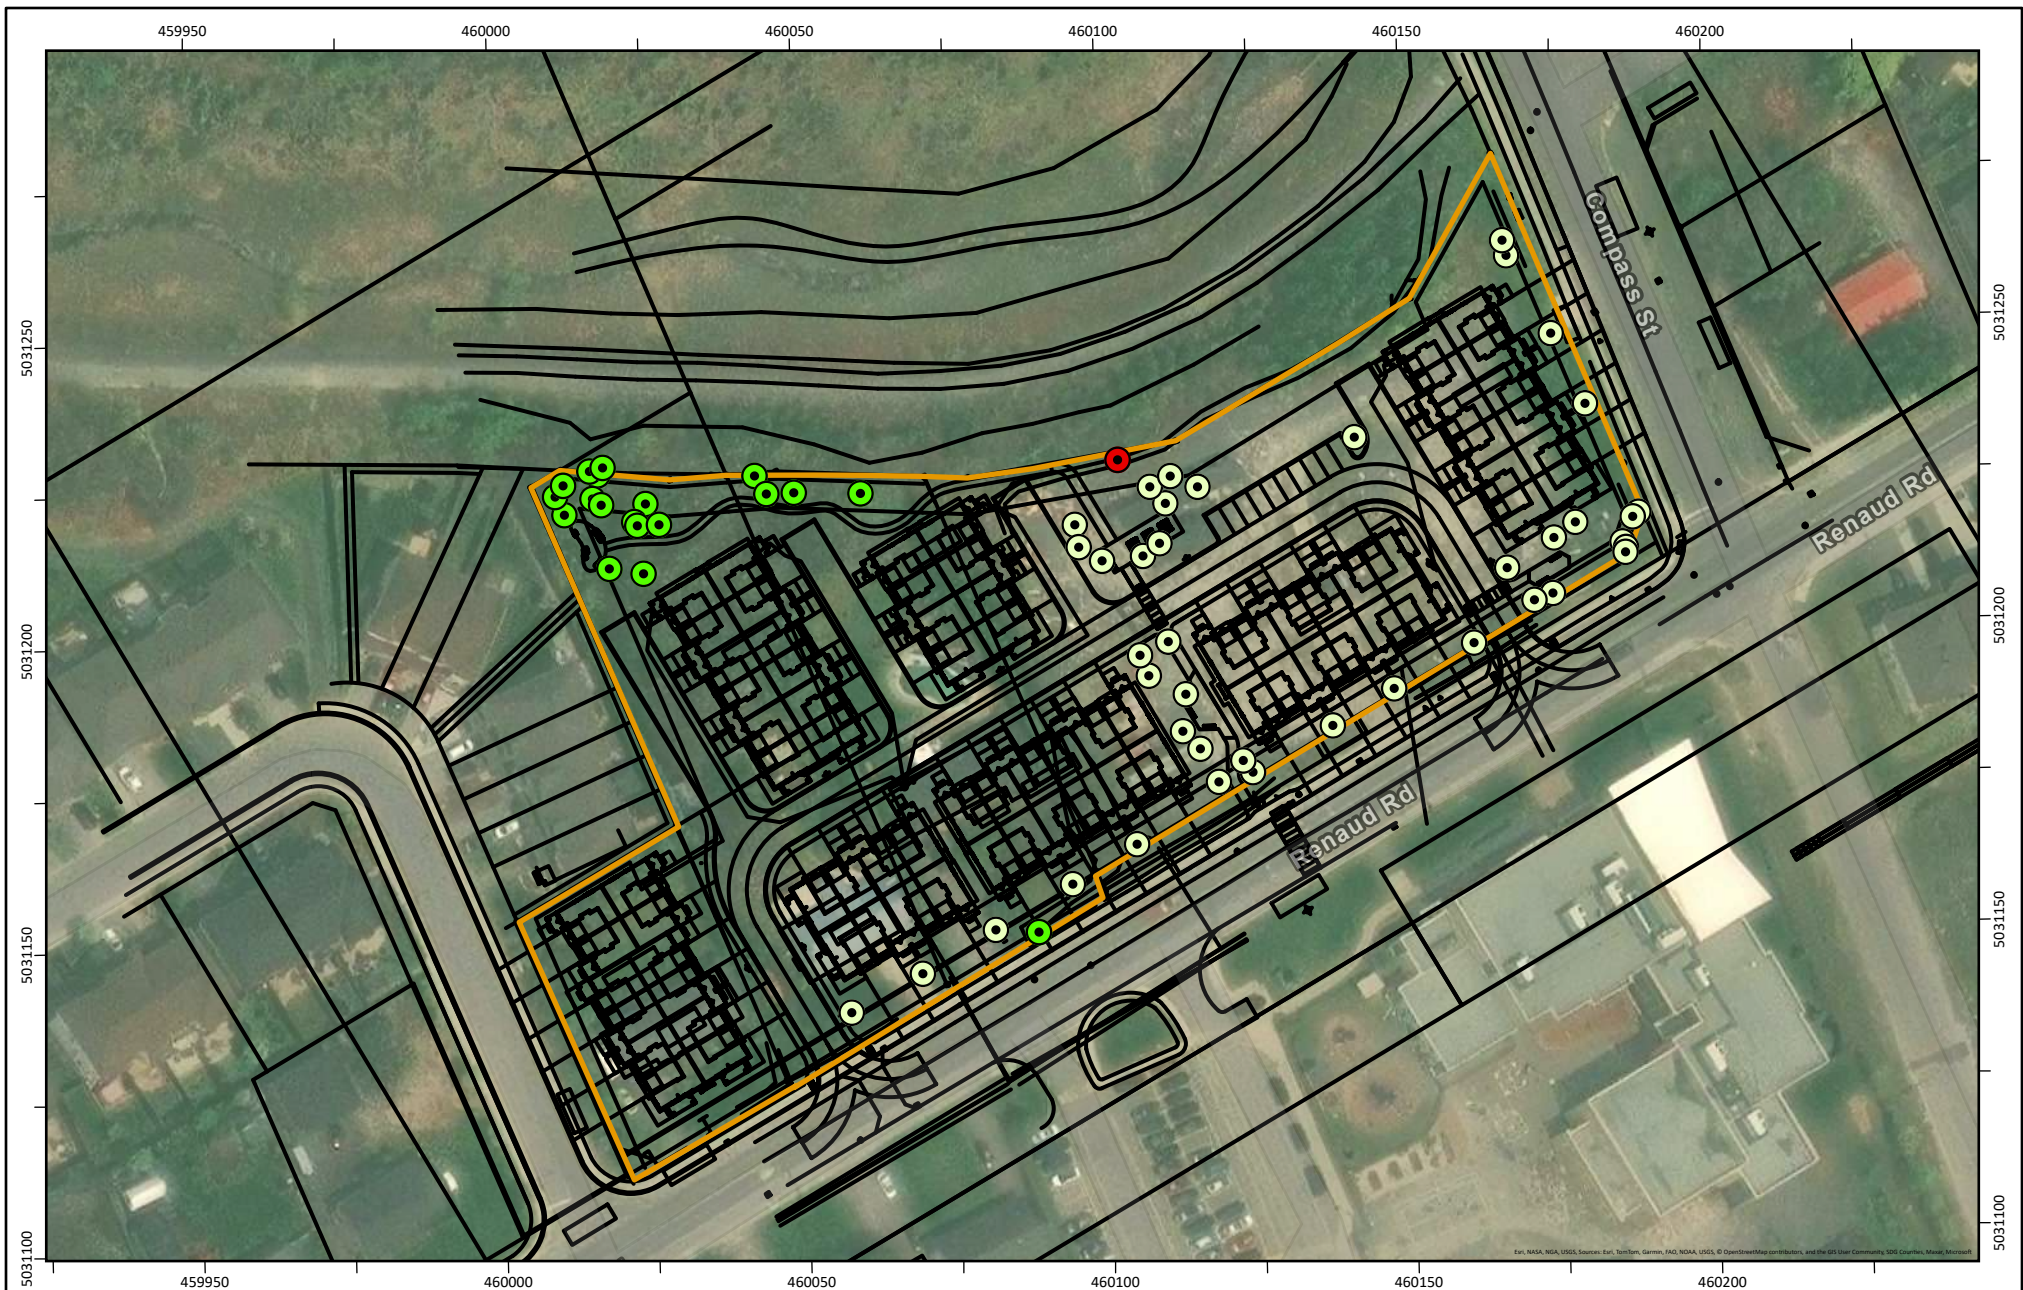
**Figure 3. Proposed Development**

The proposed Zoning Bylaw Amendment would rezone the Site as R3Z to accommodate future residential development. The proposed development plan for the Site comprises seven back-to-back townhome blocks, for a total of 76 townhome units. Roadway access will extend through the Site with two points of access along Renaud Road. Additional components include an amenity area, paved surface parking, a landscape feature, naturalized areas with a walkway along the north edge of the Site. Some existing trees, primarily in the northwest corner of the Site, are proposed to be retained as part of the naturalized area, remaining trees are anticipated to be removed; additional trees will be planted throughout the Site.

It is expected that all trees within the development footprint, except for those retained existing trees within the naturalized and landscaped areas, will need to be cleared to accommodate development. Vegetation removal on the Site should be limited to that which is necessary to accommodate construction. All retainable trees on the Site outside of the development footprint, including those off-site but adjacent to the property boundary and development footprint, should follow the general protection measures recommended during site preparation and construction (City of Ottawa, 2015):

- Erect a fence beyond the critical root zone (CRZ; i.e., 10x the diameter at breast height) of trees to be retained. The fence should be highly visible (orange construction fence) and paired with erosion control fencing. Pruning of branches is recommended in areas of potential conflict with construction equipment;
- Do not place any material or equipment within the CRZ of trees.

- Do not attach any signs, notices, or posters to any trees.
- Do not raise or lower the existing grade within the CRZ of trees without approval.
- Tunnel or bore when digging within the CRZ of a tree.
- Do not damage the root system, trunk, or branches of any remaining trees.
- Ensure that exhaust fumes from all equipment are not directed toward any tree's canopy.
- Do not extend any hard surface or significantly change landscaping within the CRZ of trees.
