# Tree Conservation Report and Species at Risk Screening

**30 Cleary Avenue**

February 12, 2026

Arcadis Canada Inc.  
333 Preston Street, Suite 500  
Ottawa, Ontario K1S 5N4  
Canada

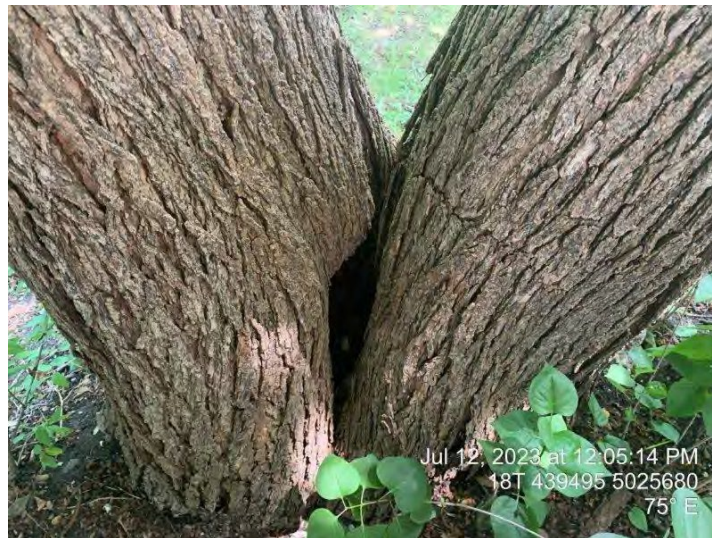
It should be noted that the condition of one (1), 2-stem northern catalpa (tree #7) situated within the community garden was assessed as Good, however is experiencing some crotch decay. It is recommended that prior to construction, an ISA certified Tree Risk Assessor (ISA TRAQ) complete a Risk Assessment for this tree, and comment on its candidacy for cabling the 2 stems to strengthen its structural integrity. **Photo 1** below displays the codominant union of the trunks of tree #7.

Photo 1: View of crotch decay and codominant leaders of Tree #7 – Northern Catalpa

A list of proposed avoidance and mitigation measures have been included in Section 7 of this report in relation to tree removals, tree protection, and tree preservation. This includes recommendation for further assessment of Tree #7 to determine the potential risk of the tree and whether it would be a good candidate for cabling to support the codominant trunk union.
