December 15, 2020

RE: TREE CONSERVATION REPORT FOR 770-774 BRONSON AVENUE, OTTAWA

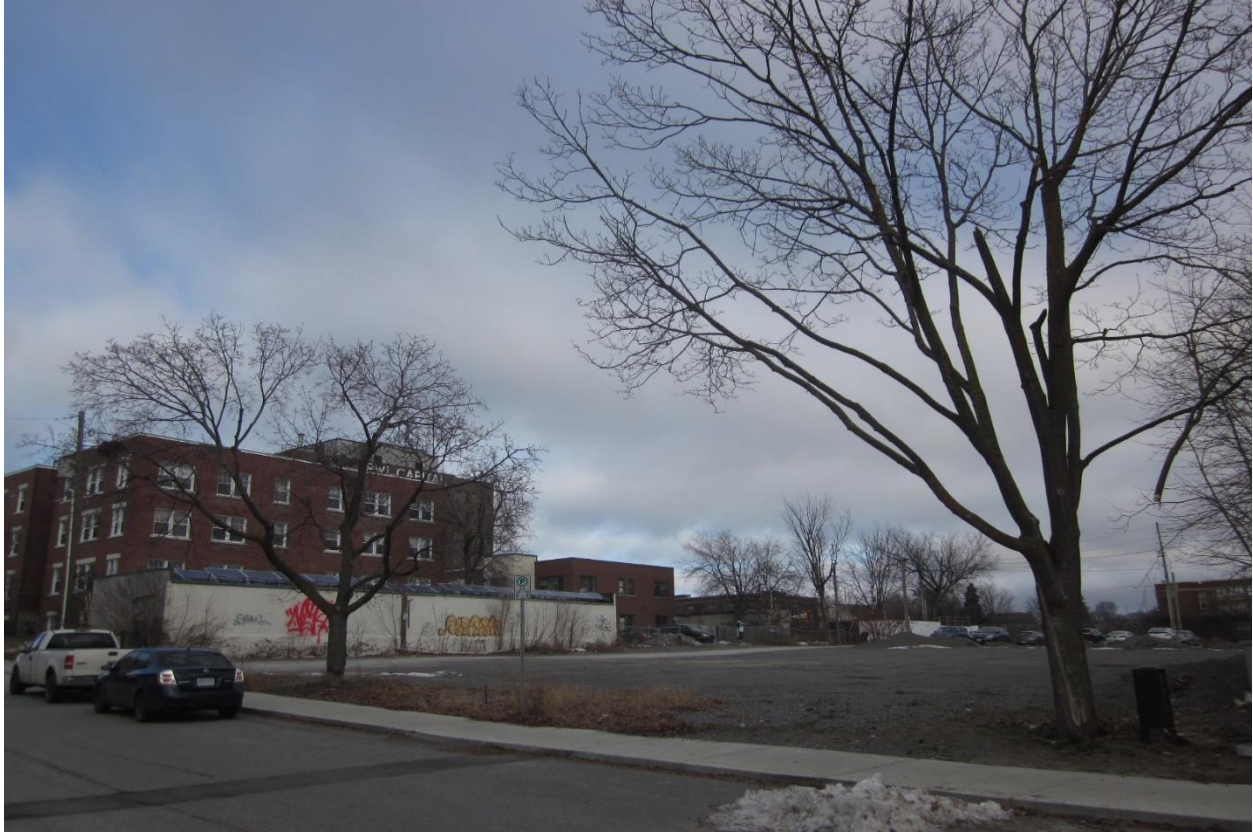
Picture 1. Trees #2 and 3 (right to left), city Norway maples located adjacent to 770-774 Bronson Avenue

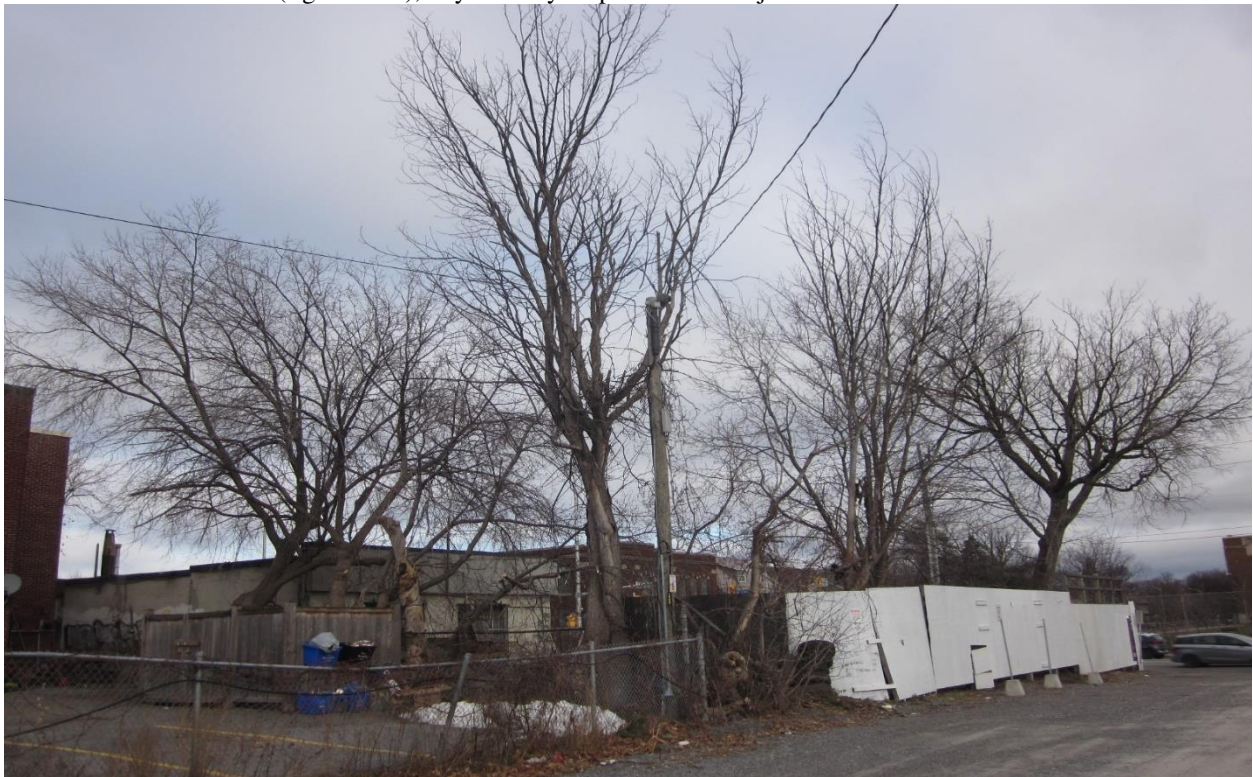
Picture 2. Trees #5 (centre) through 13 (far right) shared or fully located on 770-774 Bronson Avenue
