# TREE CONSERVATION REPORT

Tree Conservation Report submitted as Partial  
Requirements for a Site Plan Control Application  
for 1480 Richmond Rd and 2625 Carling Ave. June  
26, 2026

**Address:** 1480 Richmond Rd and 2625 Carling Ave.

**Date of Report:** June 26, 2026

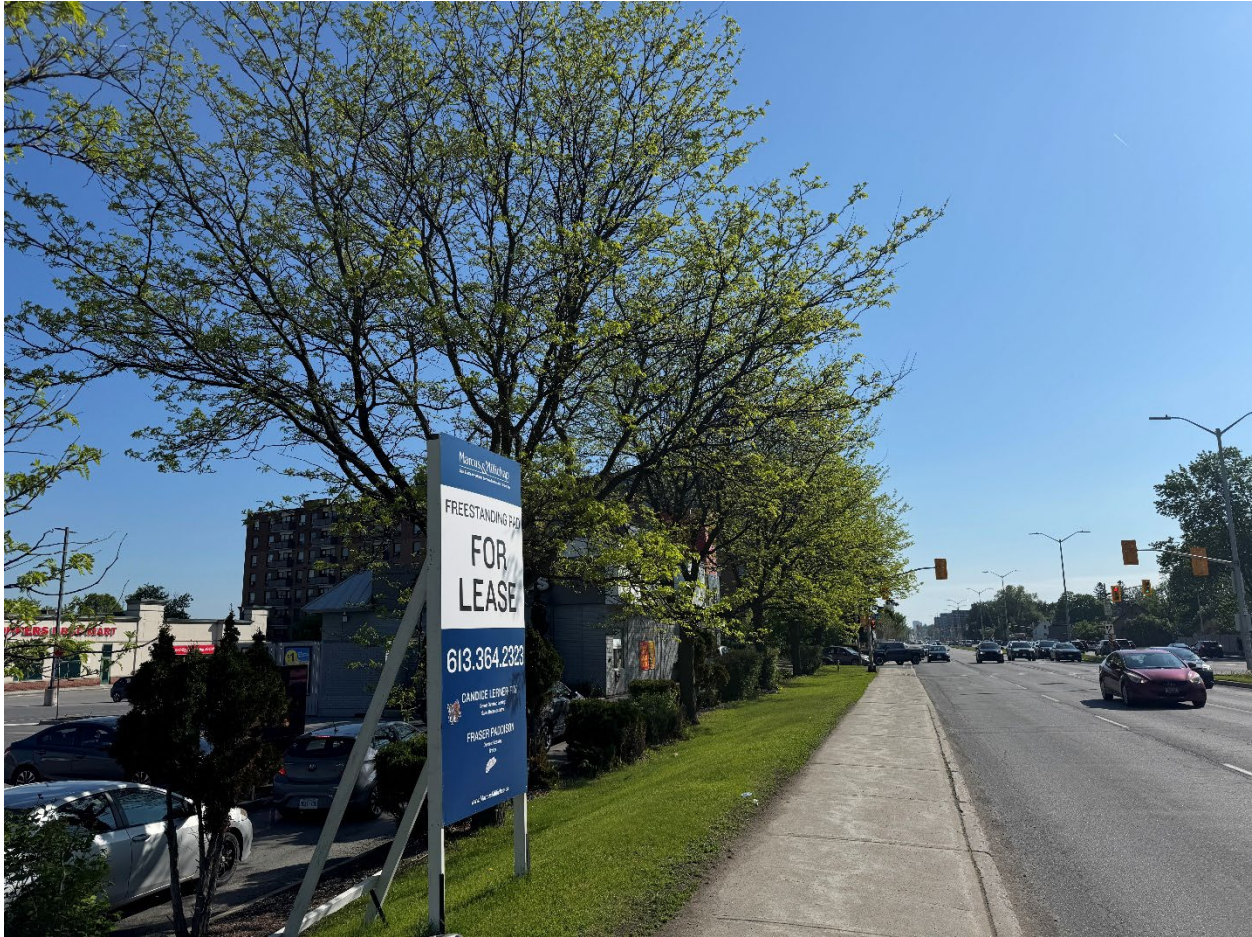
Photo 1: Honey locusts along Carling Avenue

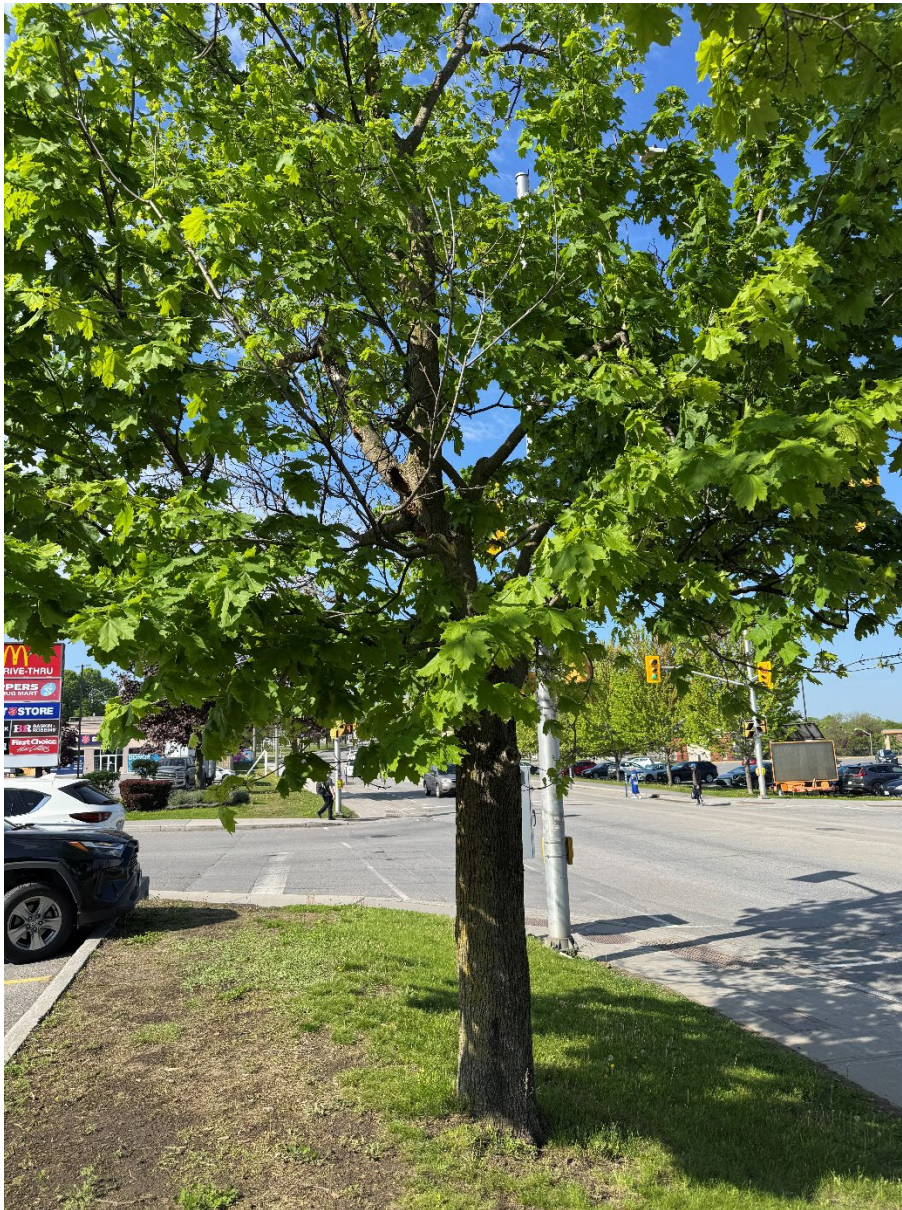
| 12 | Norway (Crimson King) maple ( <i>Acer platanoides</i> ) | 32 | City | Poor/fair; advanced crown dieback, possibly root girdling, middle codominant stem with multiple pileated woodpecker feeding cavities | Remove | Remove and replace due to poor health |

Photo 4: Tree 12, city-owned Norway maple to be removed due to poor health

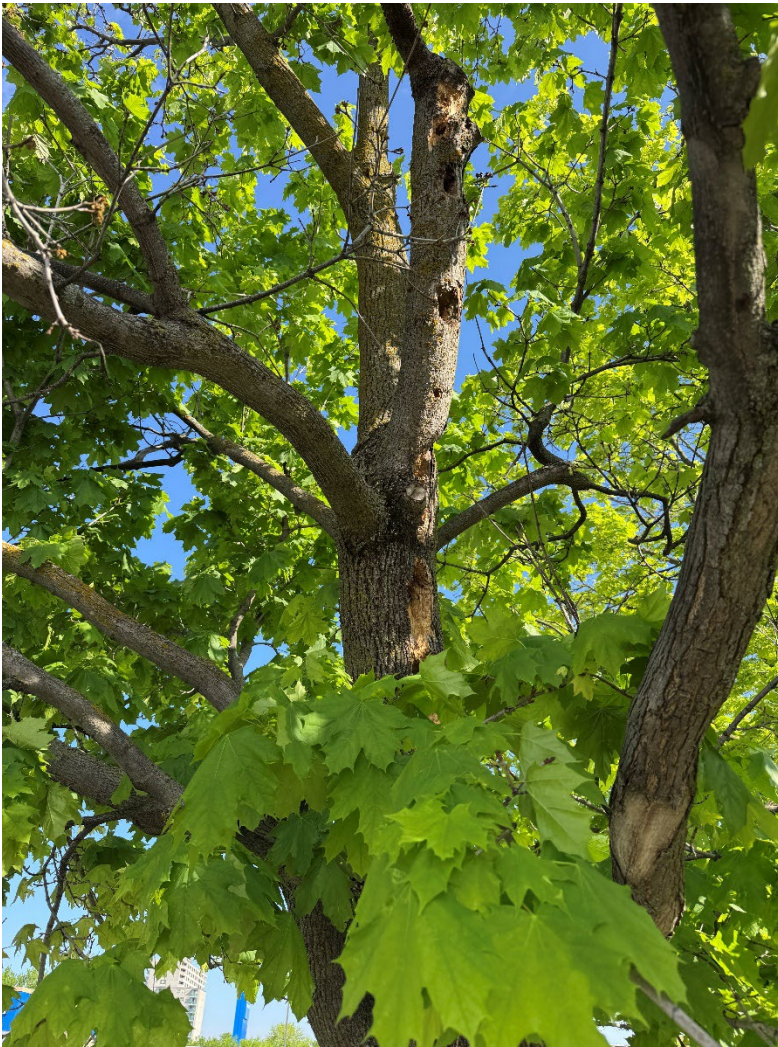
Photo 5; Crown of tree 12, note multiple pileated woodpecker feeding holes

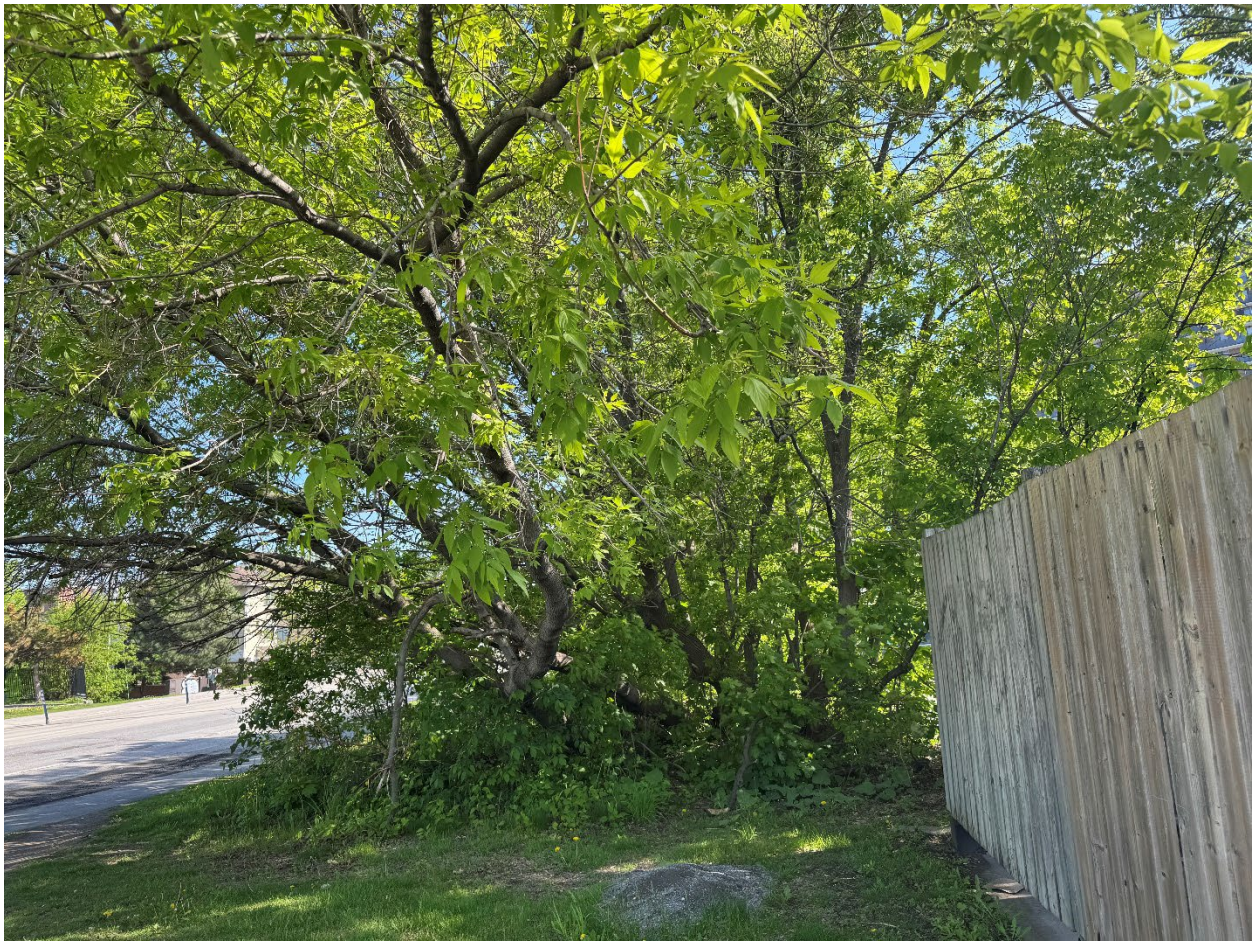
| 14 | Manitoba maple ( <i>Acer negundo</i> ) | 18 stems ranging 10-26 cm; average +/- 15 cm | Subject property | Fair; heavy leans with light dieback | Remove | Remove and replace; opportunity for beautification |

**Photo 7: Tree 14, Manitoba maple to be replaced for beautification**
