# TREE CONSERVATION REPORT

Tree Conservation Report submitted as Partial Requirements for a Site Plan Control Application, Elmwood School, 261 Buena Vista Road.

# Tree Conservation Report

**Address:** Elmwood School, 261 Buena Vista Road

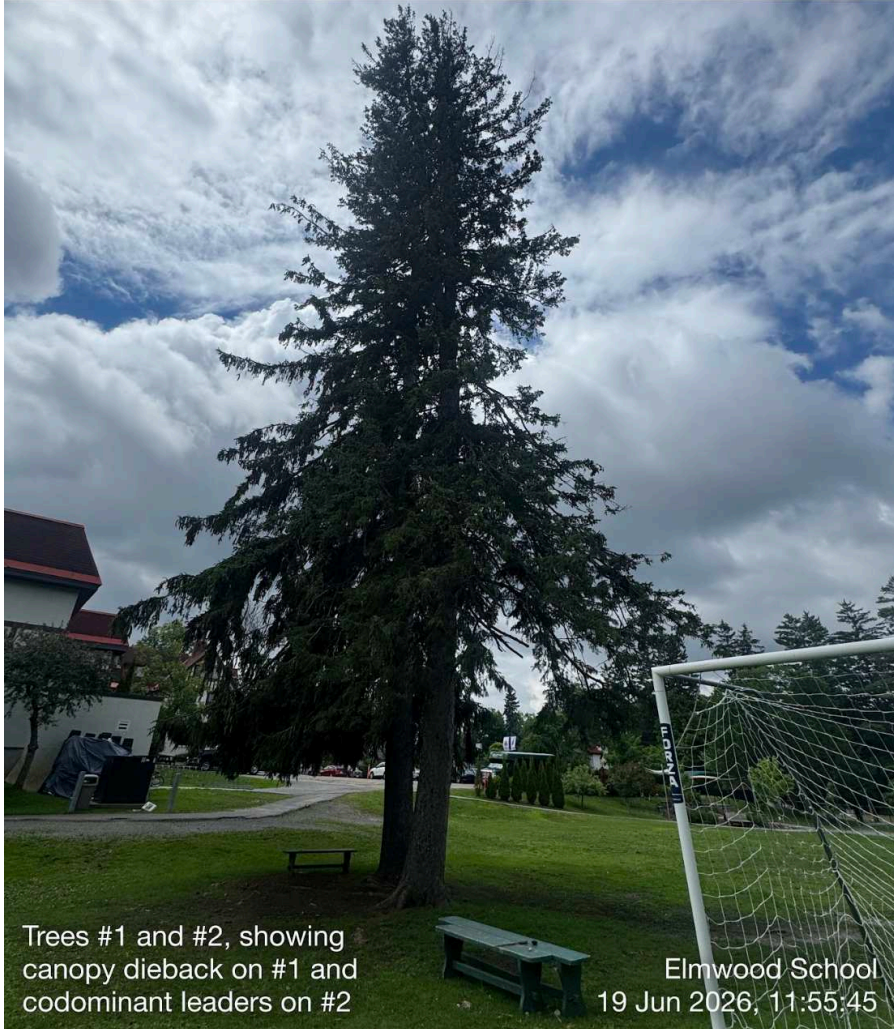
Tree #1 is located approximately 3m from the wall of the proposed addition, with excavation and grading occurring less than 1m from the tree, which is closer than 3x the dbh from the trunk. This tree was observed to have girdling roots, early signs of canopy dieback, and codominant leaders. Tree #2 is located approximately 5m from the wall of the proposed addition, and 2m from the edge of grading. While this is 3x the dbh from the trunk, tree #2 was observed to have shallow structural roots that visibly extend >5m from the trunk and would be impacted by both excavation and grading limits. Tree #2 also has codominant leaders which is a risk factor for failure in conifers. Both trees are approximately 20m in height, with the existing building, pathway, and sports field within their fall radius, and history of a third tree within this grouping failing during a wind storm. Due to the extent of impacts, large fall radius and multiple factors increasing the likelihood of failure, neither of these trees are recommended for retention.

| Tree <sup>1</sup> | Common Name | Scientific Name | DBH (cm) | Ownership <sup>2,3</sup> | Condition | Tree Health Comments | Action | Clients Reason for Removal |
|---|---|---|---|---|---|---|---|---|
| 1 | Norway Spruce | <i>Picea abies</i> | 68 | Subject Property | Declining | Girdling roots, early signs of dieback (~15%) in canopy. Codominant leader in top 6m. Tree height is >20m with building, pathway, and soccer field within fall distance. | Remove | <3x dbh from construction limits (1.5m), concerns with structure and health of tree that increase risk given extent of CRZ impact |
| 2 | White Spruce | <i>Picea glauca</i> | 66 | Subject Property | Fair/Declining | Codominant leader in top 8m. Major structural roots visibly extend to edge of CRZ, leaning towards soccer field. Tree height is >20m with building, pathway, and soccer field within fall distance. | Remove | ~3x dbh from construction limits (2m), however major structural roots extend into footprint. Concerns with structure and health of tree that increase risk given extent of CRZ impact |

Trees #1 and #2, showing canopy dieback on #1 and codominant leaders on #2

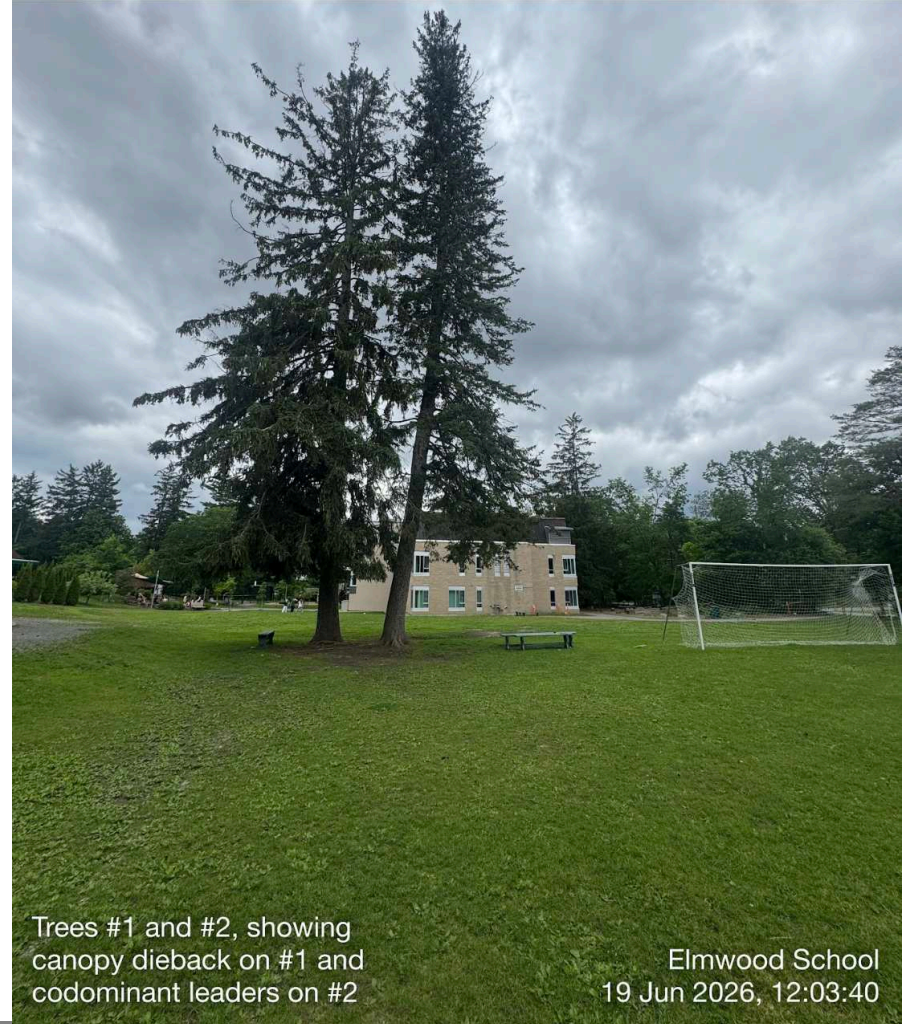
Trees #1 and #2, showing canopy dieback on #1 and codominant leaders on #2

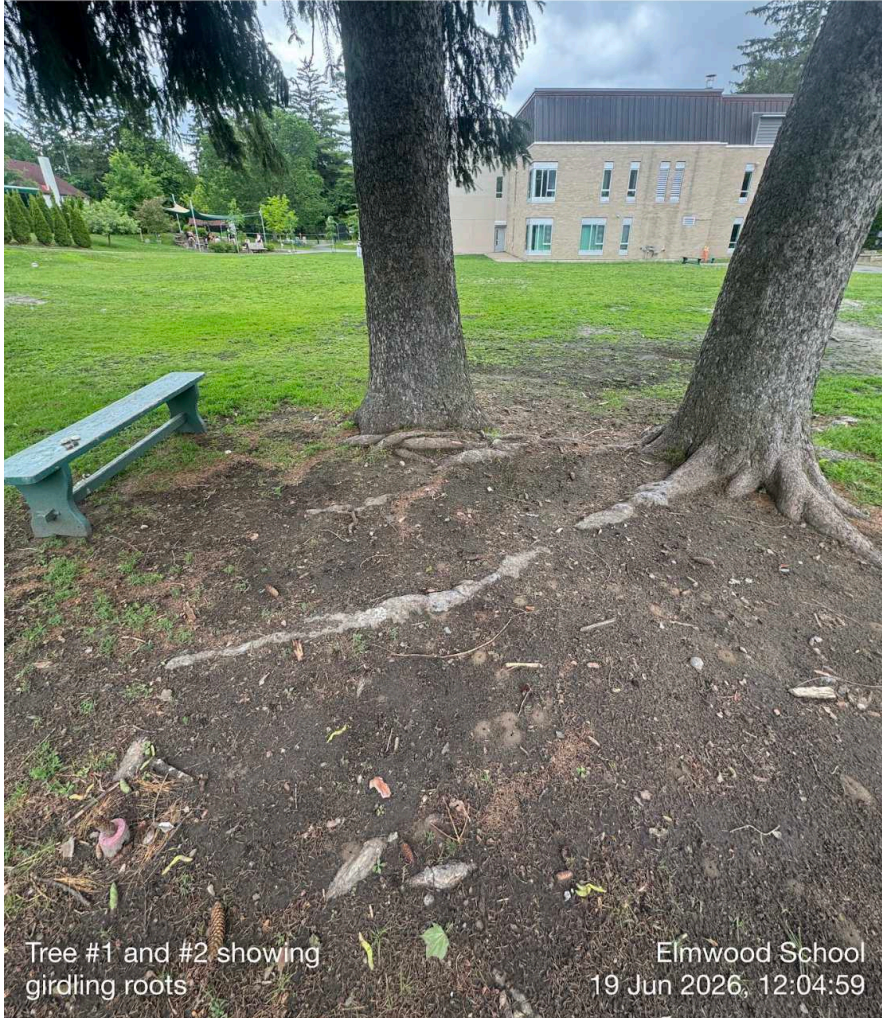
Tree #1 and #2 showing  
girdling roots

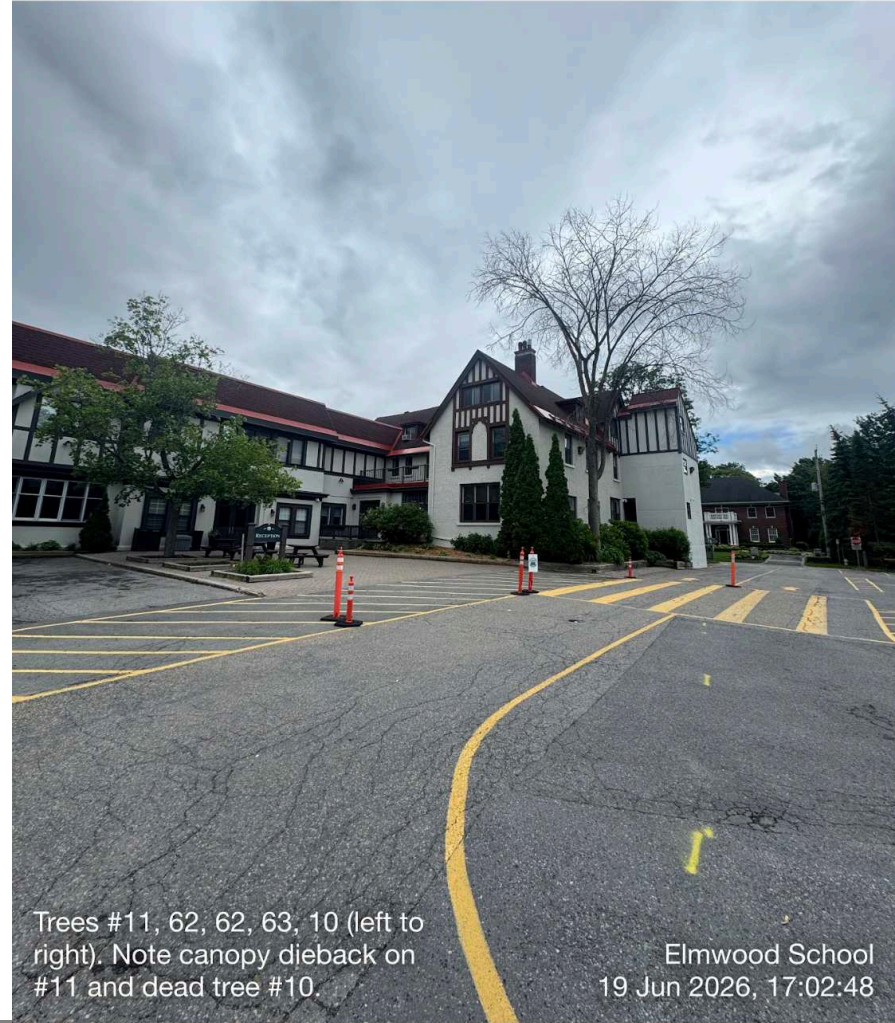
Trees #11, 62, 62, 63, 10 (left to  
right). Note canopy dieback on  
#11 and dead tree #10.

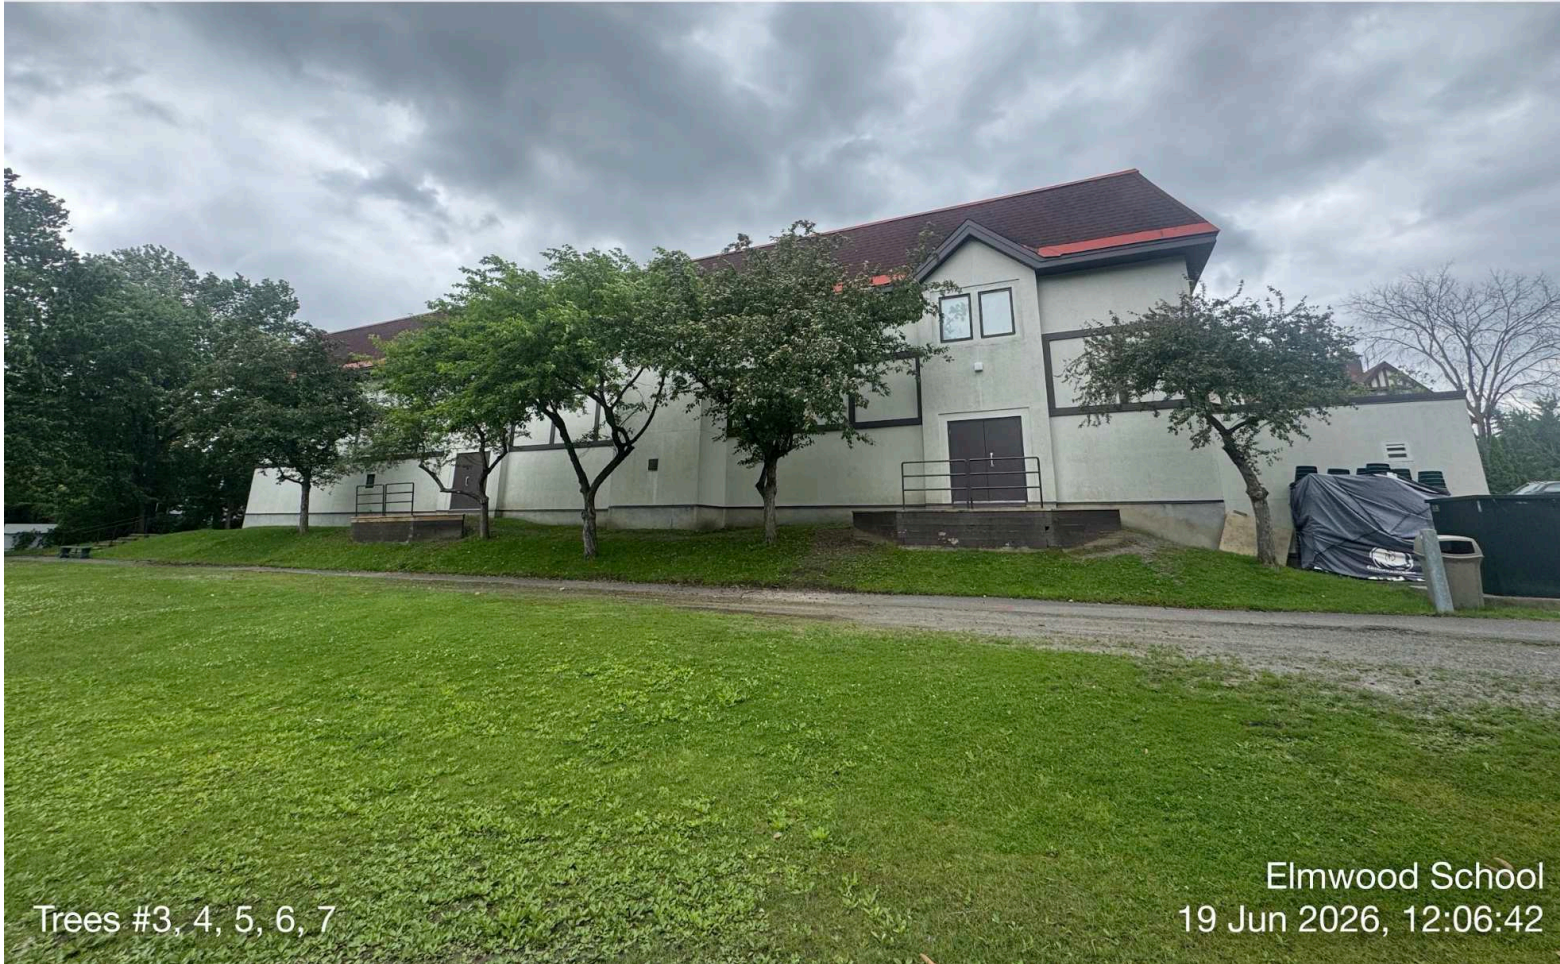
Trees #3, 4, 5, 6, 7

| Tree <sup>1</sup> | Common Name | Scientific Name | DBH (cm) | Ownership <sup>2,3</sup> | Condition | Tree Health Comments | Action | Clients Reason for Removal |
|---|---|---|---|---|---|---|---|---|
| 3 | Crabapple | <i>Malus sp.</i> | 23 | Subject Property | Fair | Large diameter pruning with limited healing, slight lean/unbalanced canopy. Growing on embankment adjacent to building. | Remove | Within project footprint |
| 4 | Crabapple | <i>Malus sp.</i> | 26 | Subject Property | Fair | Large diameter pruning with limited healing, slight lean/unbalanced canopy. Growing on embankment adjacent to building. | Remove | Within project footprint |

| 5 | Crabapple | <i>Malus sp.</i> | 26 | Subject Property | Fair | Large diameter pruning with limited healing, slight lean/unbalanced canopy. Growing on embankment adjacent to building. | Remove | Within project footprint |
| 6 | Crabapple | <i>Malus sp.</i> | 23 | Subject Property | Fair | Large diameter pruning with limited healing, slight lean/unbalanced canopy. Growing on embankment adjacent to building. | Remove | Within project footprint |
| 7 | Crabapple | <i>Malus sp.</i> | 22 | Subject Property | Fair | Large diameter pruning with limited healing, slight lean/unbalanced canopy. Growing on embankment adjacent to building. | Remove | Within project footprint |

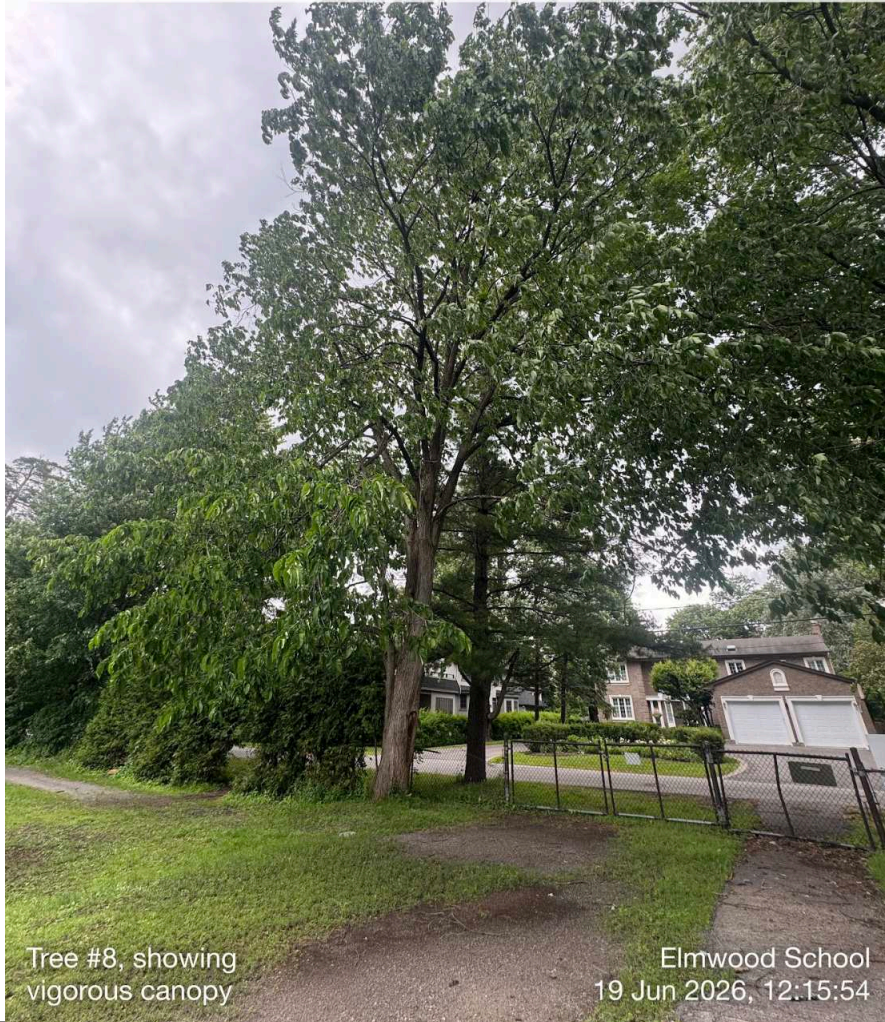
Tree #8, showing  
vigorous canopy

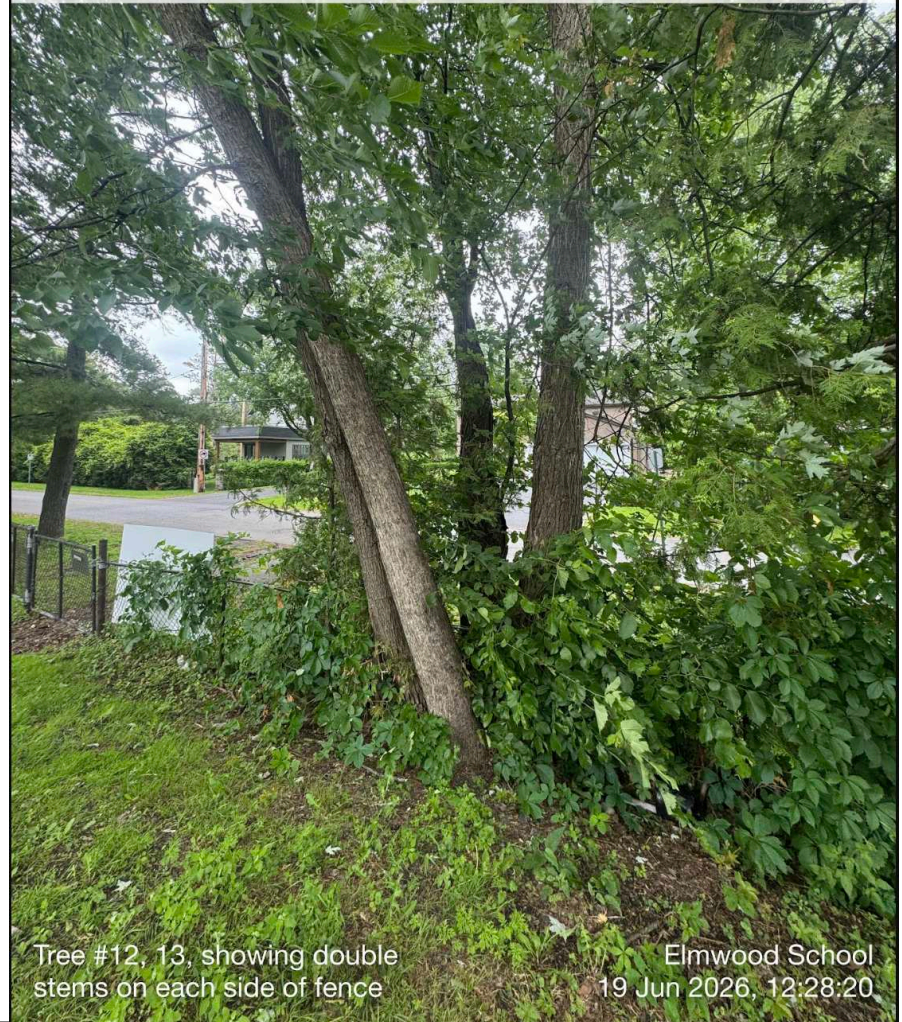
Tree #12, 13, showing double  
stems on each side of fence

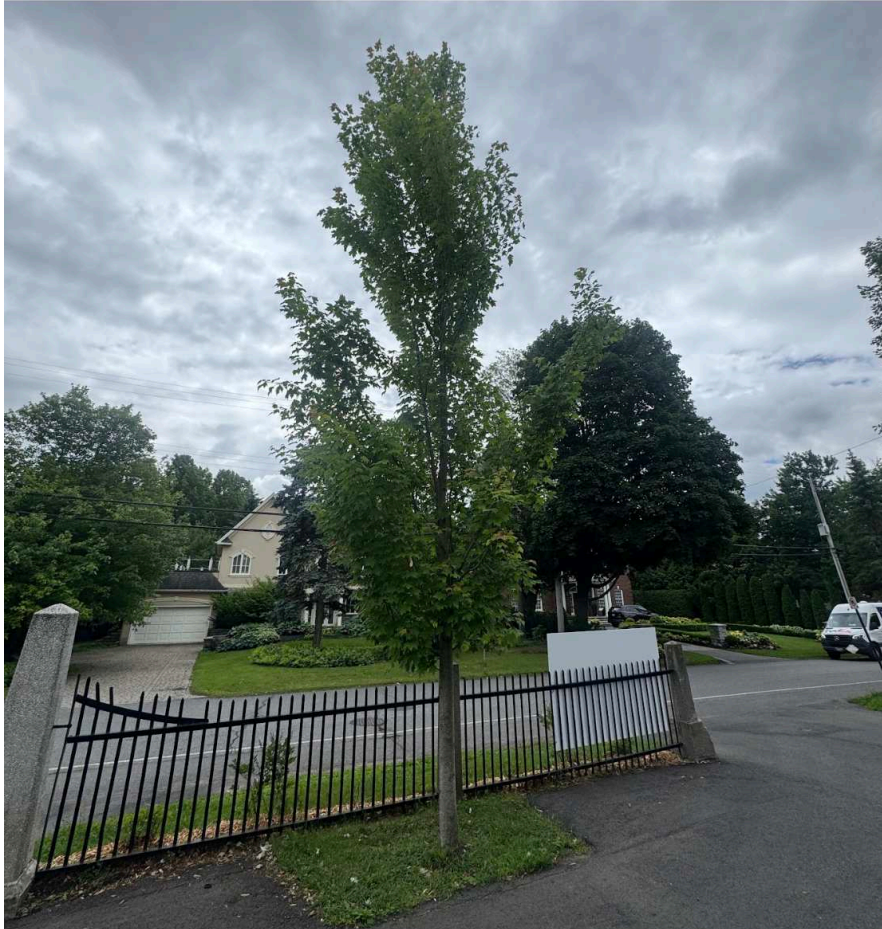
Tree #54, note tear injury and tight branch unions.

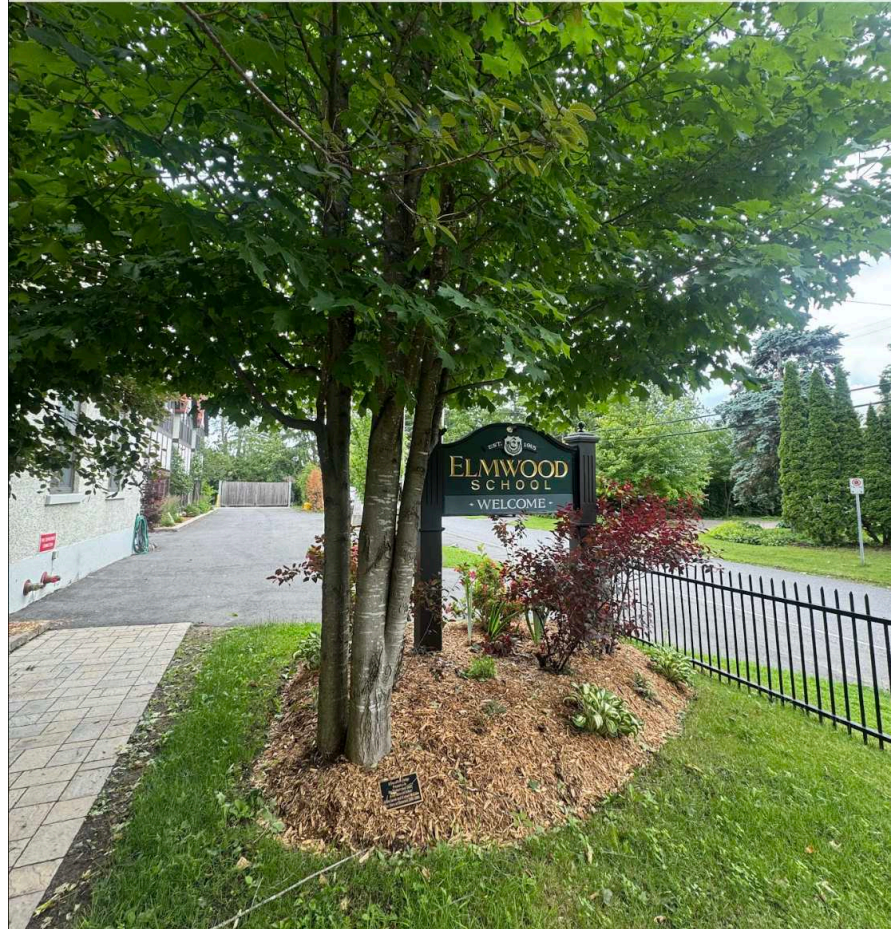
Tree #55, note tight unions.

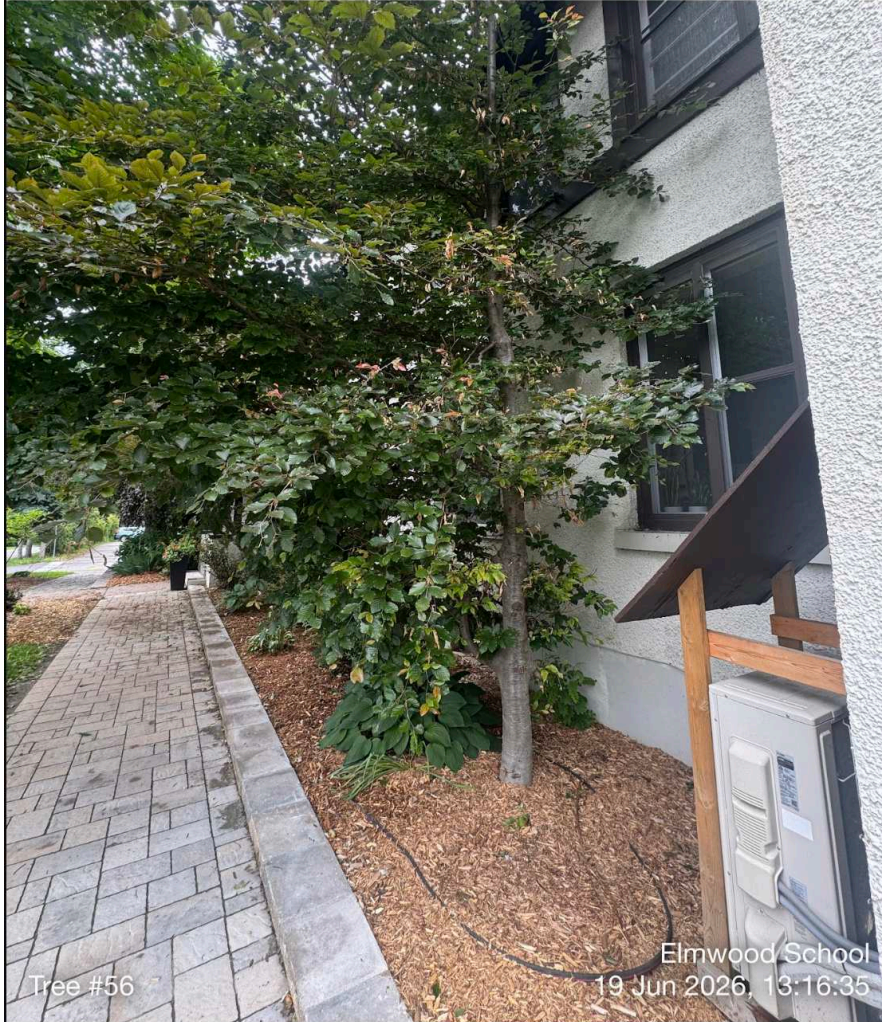
Tree #56

| 56 <sup>4</sup> | European Beech | <i>Fagus grandifolia</i> | 14 | Subject Property | Fair | Bark lesions, picnic growth, leaf browning. 1 m from building in planter | Retain | n/a |
