**TREE CONSERVATION REPORT**  
LeBreton Flats

April 26, 2024

Prepared for:  
National Capital Commission

Stantec Consulting Ltd.  
1331 Clyde Avenue  
Ottawa ON K2C 3G4  
Project No. 160401780

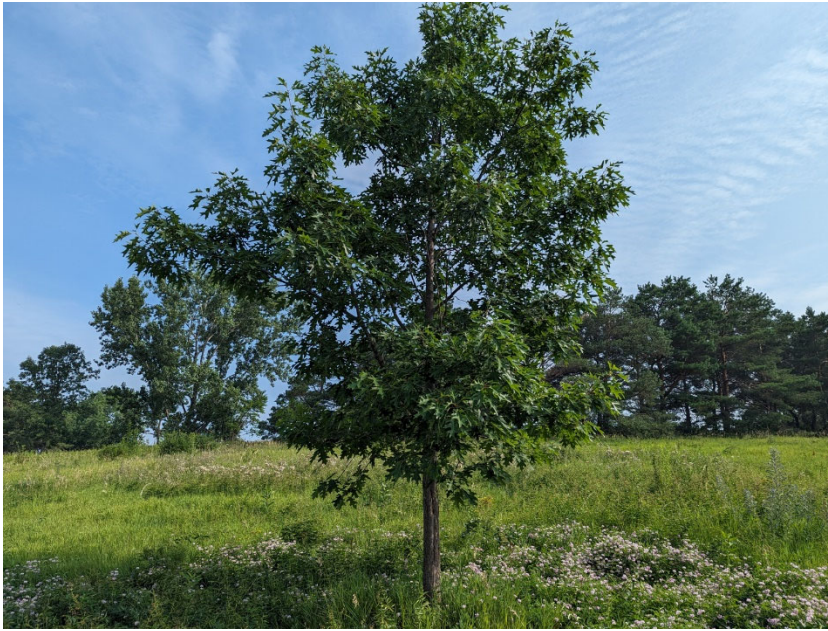
**Photograph 1:** The majority of the newly planted trees near the LRT Line 1 stations are under 10cm DBH, but a small number are reaching over 10cm DBH.

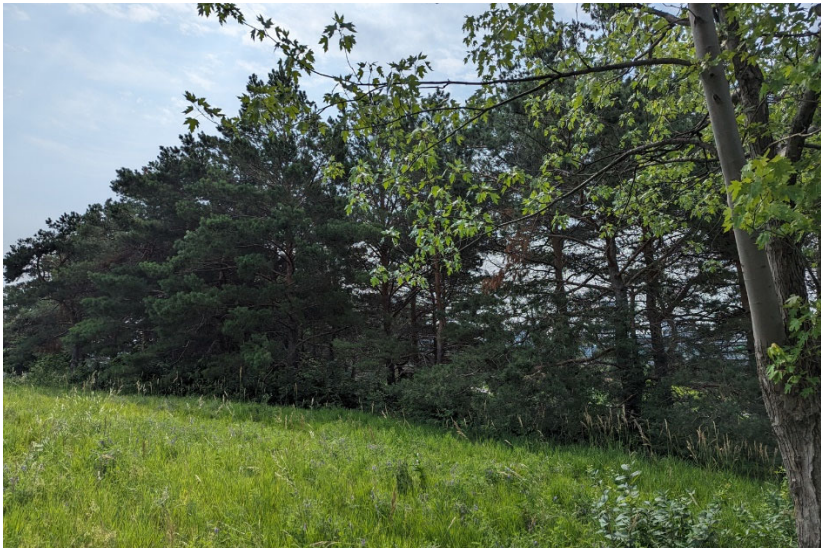
**Photograph 2:** The elevated area north-east of Bayview Station contains several large groupings of Scots Pines.

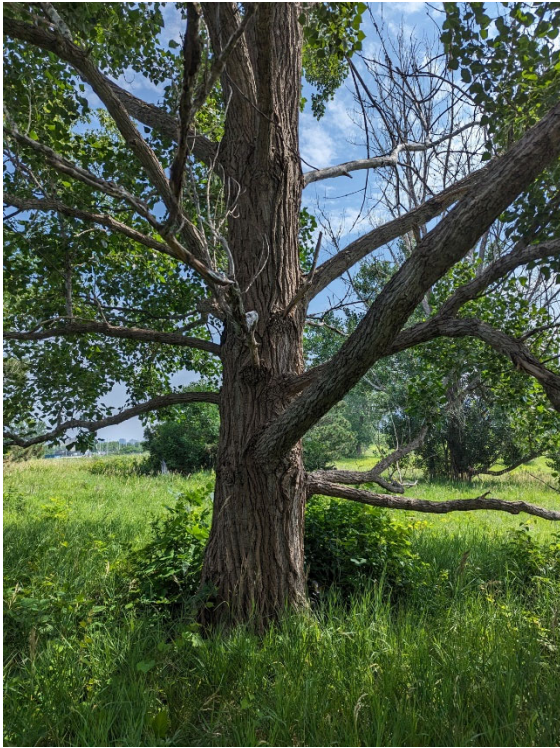
**Photograph 3:** Large Cottonwoods were also found in the elevated area

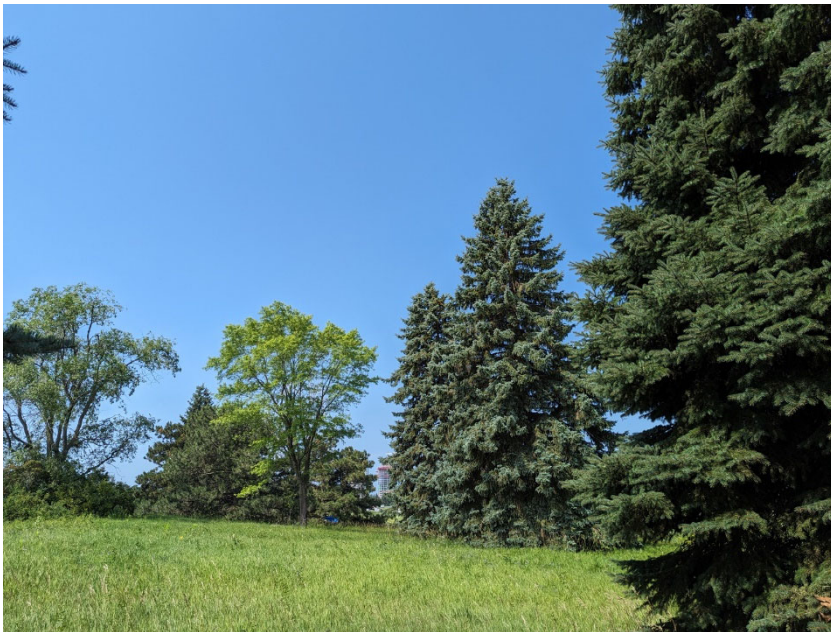
**Photograph 4:** Smaller groupings of Blue Spruce were found east of the Scots Pine groupings, along with numerous Silver Maples.

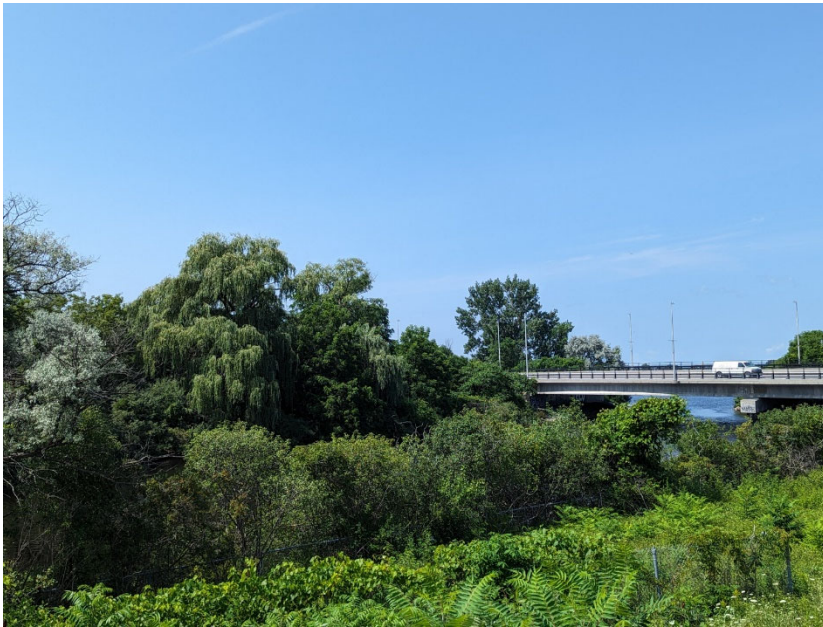
**Photograph 5:** The area with the most dense vegetation was near the water inlet on the north side of the site. The grouping contained some large trees (mainly Cottonwoods and White Willow), but primarily consisted of medium-sized Manitoba Maples.

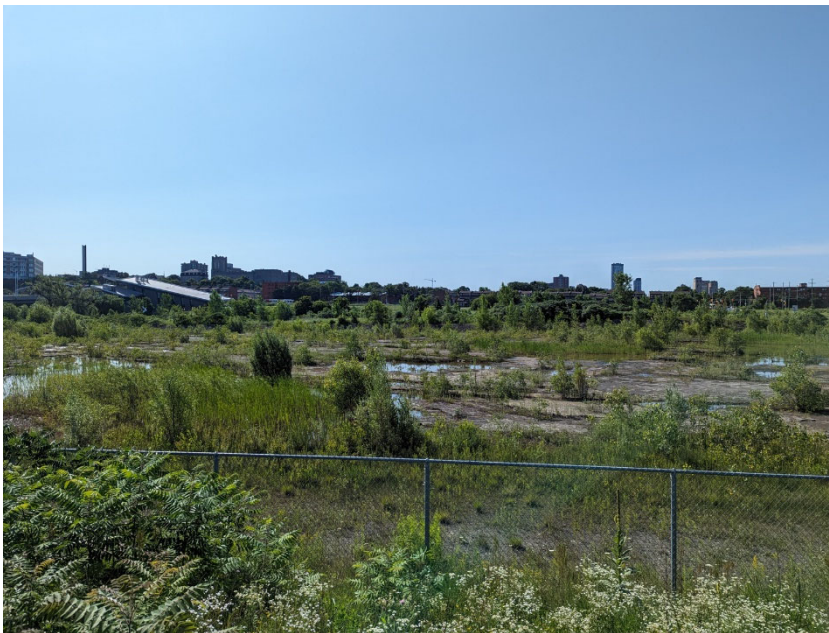
**Photograph 7:** The area north-east of Pimisi Station was scraped down to the bedrock, and most vegetation has not reached 10cm DBH.

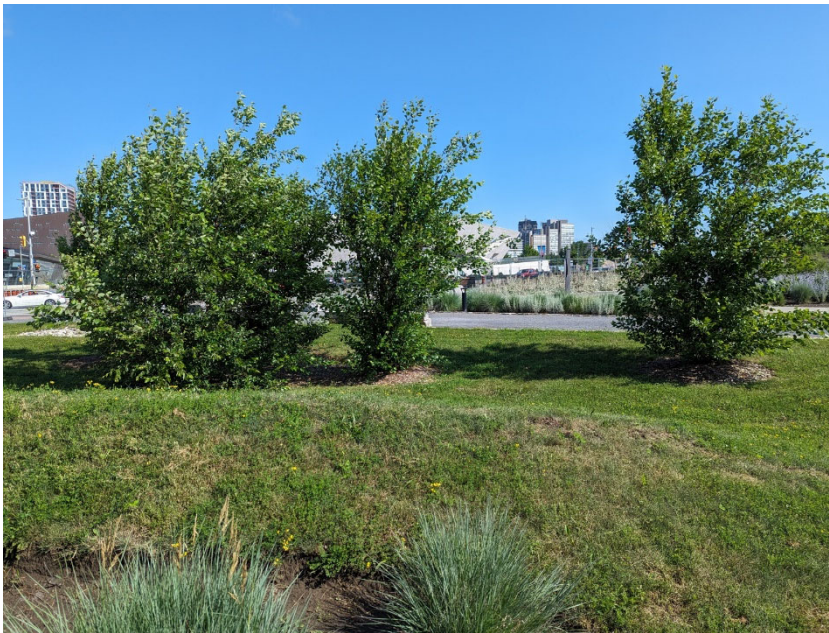
**Photograph 8:** In Pindigen Park, to the very north-east corner of the site, there are many Silver Birches planted, most of which are still under 10cm DBH.

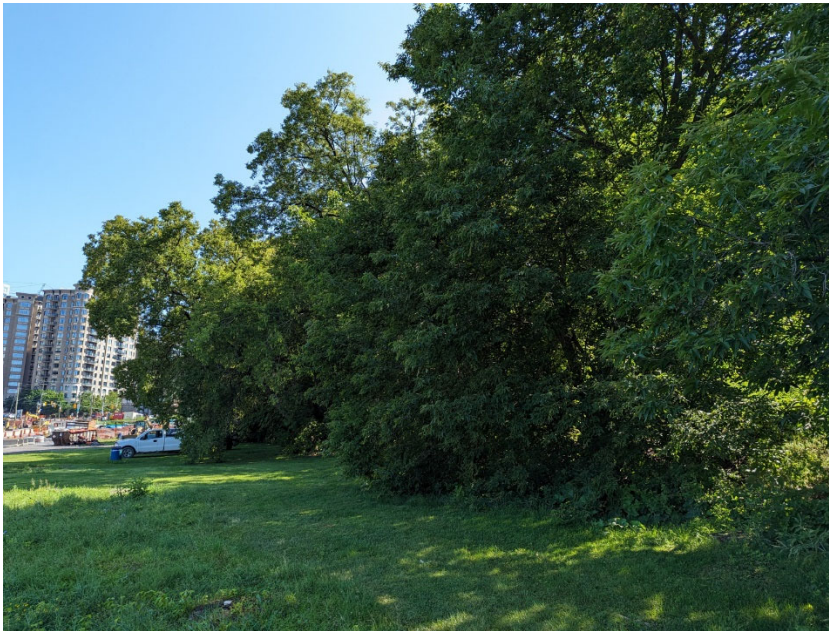
**Photograph 9:** Adjacent to Slater Street, near Bronson Ave, there is a grouping of fairly large trees, primarily Manitoba Maples and Norway Maples.
