1101 BAXTER ROAD
 1101 Baxter Rd, Ottawa, ON K2C 3R4

TREE CONSERVATION REPORT

TCR 1

Date	OCT.2025	Sheet	TCR 2
Scale	1:500	Checked	PG
Drawn	MB	Job No.	25-193

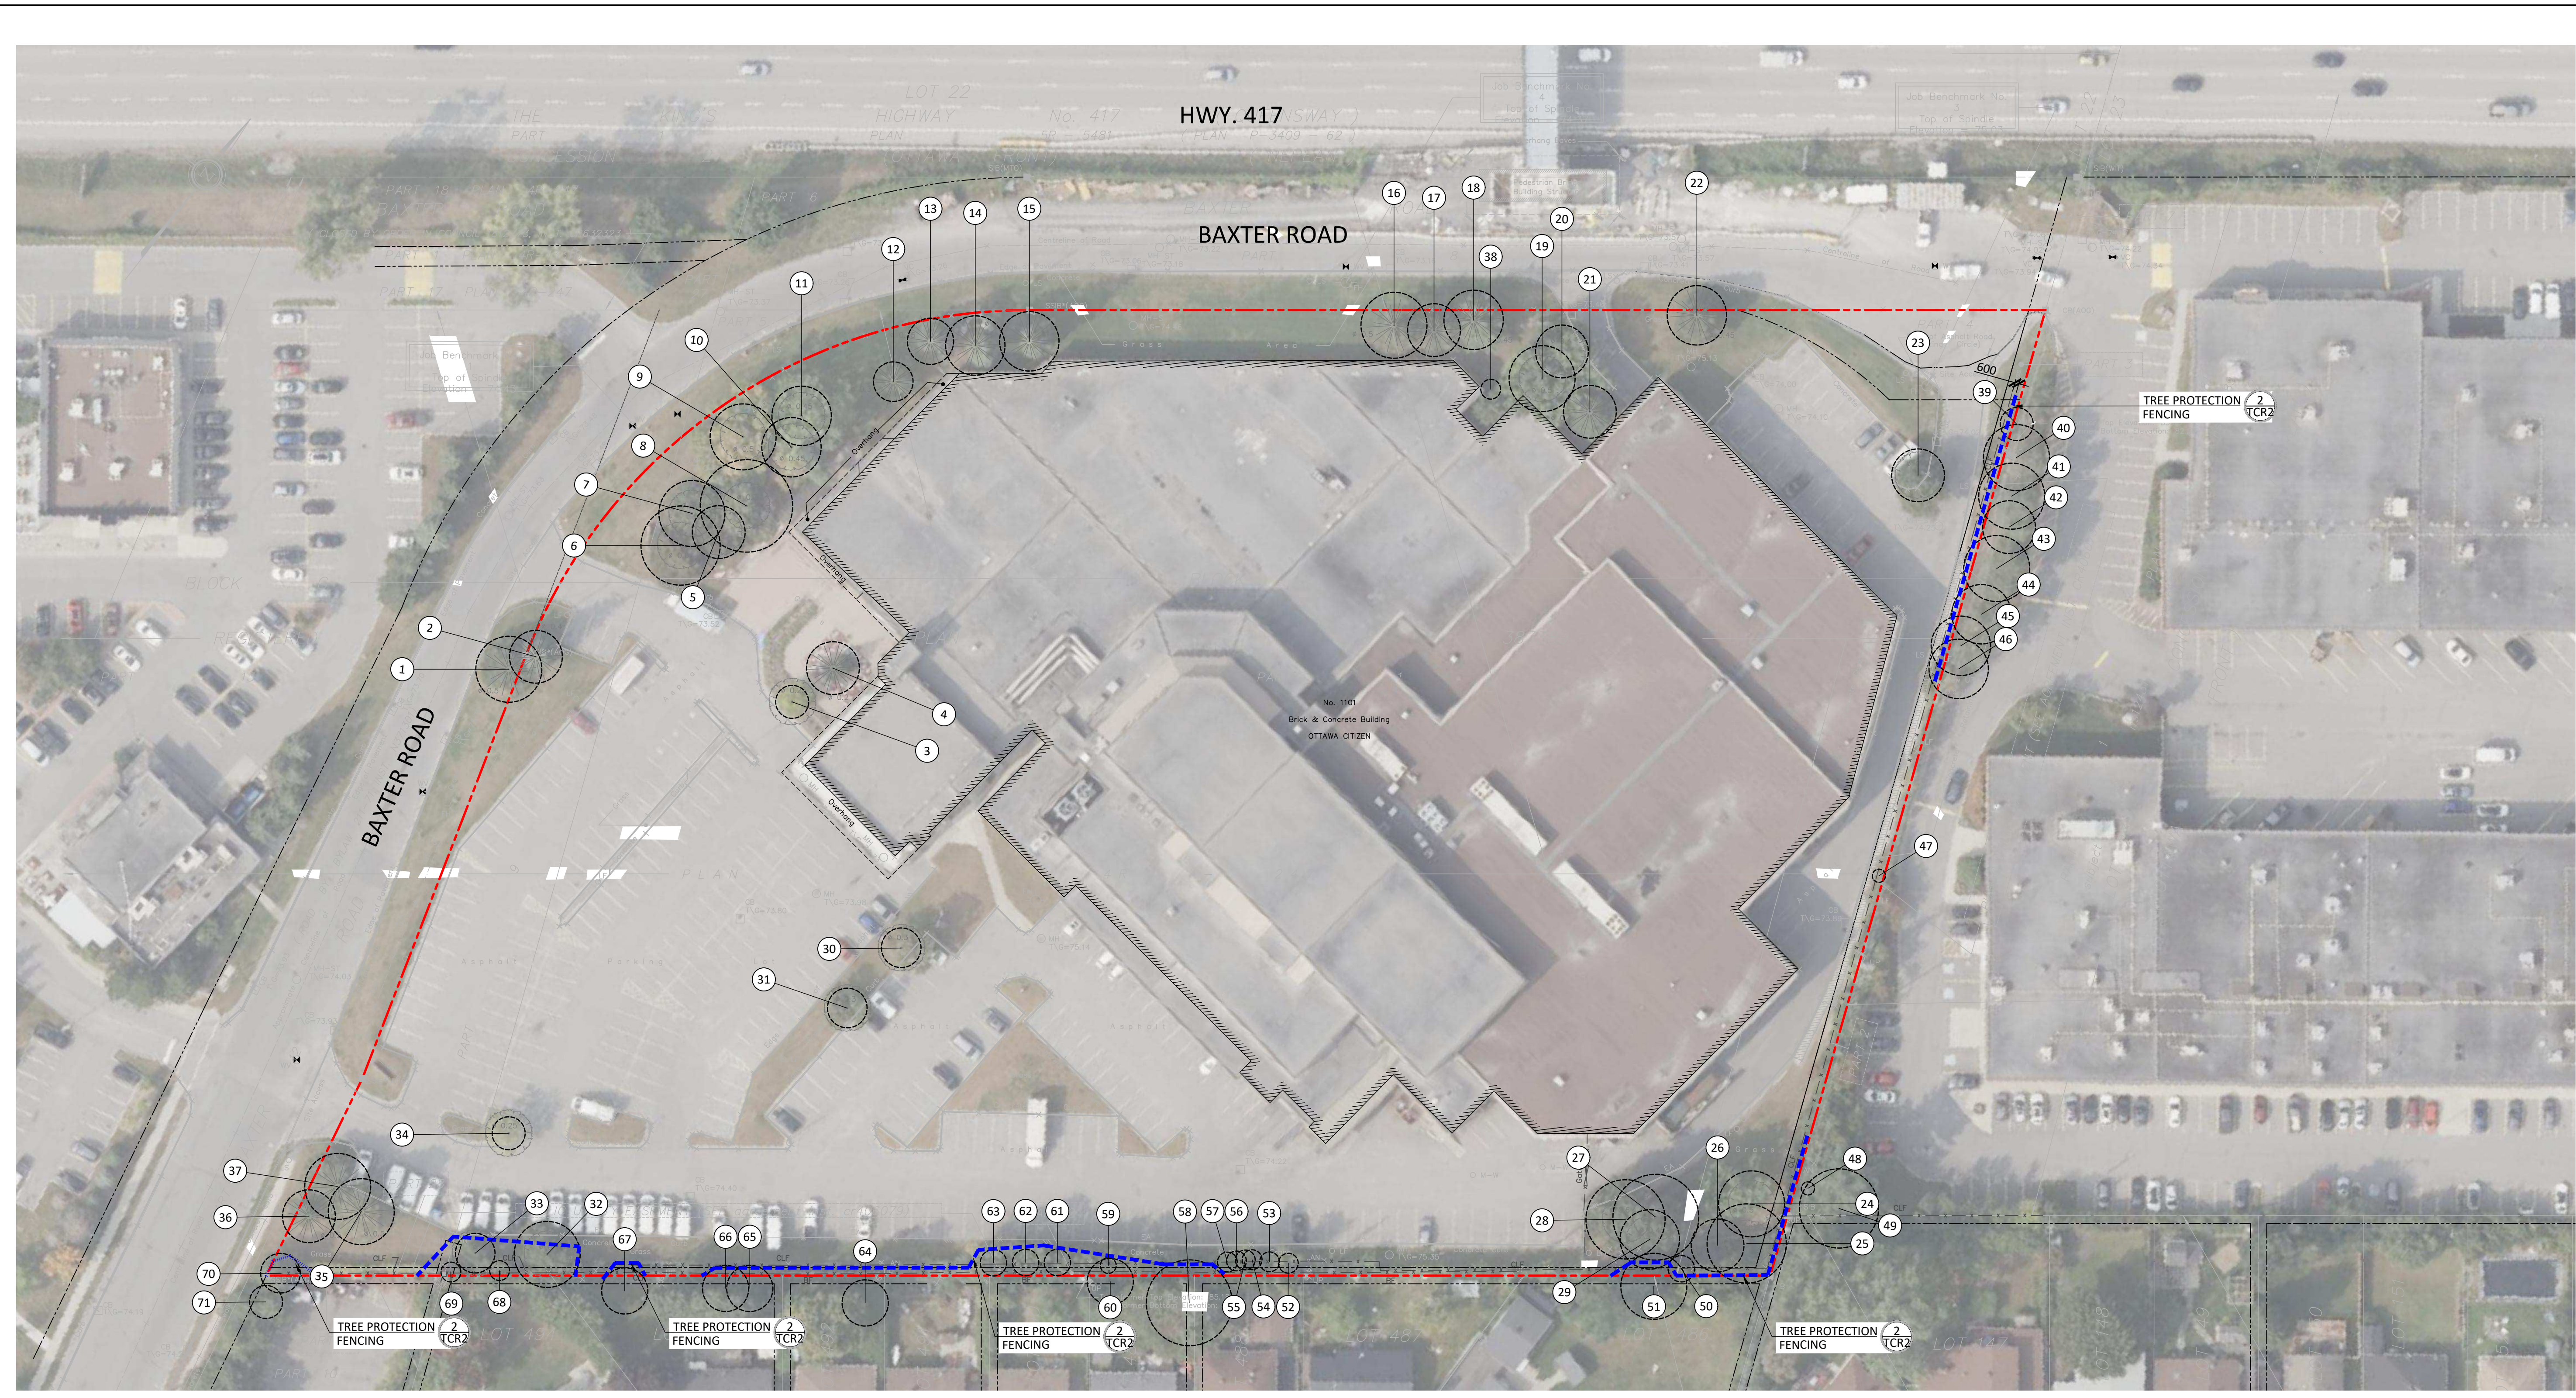
1 EXISTING VEGETATION Scale: 1:500

Tree #	Botanical Name	Common Name	DBH (cm)	Ownership	Condition	NOTE	To Be Preserved	Reason for Removal
1	Pinus nigra	Austrian Pine	50	City	Good	Asymmetrical canopy. Die back: 5% at canopy. Single stem	NO	Proposed site & ROW construction conflicts with tree location
2	Picea pungens	Colorado Spruce	40	Private 1101 Baxter	Good	Symmetrical canopy. Die back: 10% at canopy. Pruned limbs. Single stem	NO	Proposed site & ROW construction conflicts with tree location
3	Syringa Reticulata	Japanese Tree Lilac	25	Private 1101 Baxter	Good	Symmetrical canopy. Die back: 10% at canopy. Pruned limbs. Single stem. Included bark	NO	Proposed site construction conflicts with tree location
4	Picea glauca	White Spruce	20	Private 1101 Baxter	Good	Symmetrical canopy. Single stem. Has Christmas lights	NO	Proposed site construction conflicts with tree location
5	Tilia cordata	Littleleaf Linden	40	Private 1101 Baxter	Good	Asymmetrical canopy. Die back: 5% at branches. Pruned limbs. Single stem w/ 2 co-dominant leaders at 3m above grade. Included bark	NO	Proposed site construction conflicts with tree location

6	Tilia cordata	Littleleaf Linden	60	Private 1101 Baxter	Moderate	Asymmetrical canopy. Pruned limbs. Single stem w/ 2 co-dominant leaders at 2m above grade. Leaning. Included bark	NO	Proposed site construction conflicts with tree location
7	Tilia cordata	Littleleaf Linden	50	Private 1101 Baxter	Good	Asymmetrical canopy. Single stem. Bark rot at trunk	NO	Proposed site construction conflicts with tree location
8	Tilia cordata	Littleleaf Linden	70	Private 1101 Baxter	Good	Asymmetrical canopy. Die back: 10% at canopy. Pruned limbs. Single stem w/ 2 co-dominant leaders at 3m above grade	NO	Proposed site construction conflicts with tree location
9	Acer x Freemani	Freeman Maple	50	Private 1101 Baxter	Moderate	Symmetrical canopy. Die back: 10% at branches. Broken limbs. Single stem. Grided roots	NO	Proposed site construction conflicts with tree location
10	Acer x Freemani	Freeman Maple	45	Private 1101 Baxter	Moderate	Asymmetrical canopy. Die back: 15% at canopy. Broken limbs. Single stem	NO	Proposed site construction conflicts with tree location

11	Acer x Freemani	Freeman Maple	45	Private 1101 Baxter	Moderate	Symmetrical canopy. Die back: 10% at branches. Broken limbs. Single stem. Bark damage at trunk	NO	Proposed site construction conflicts with tree location
12	Picea glauca	White Spruce	30	Private 1101 Baxter	Good	Symmetrical canopy. Die back: 5% at branches. Pruned limbs. Single stem	NO	Proposed site construction conflicts with tree location
13	Picea pungens	Colorado Spruce	35	Private 1101 Baxter	Moderate	Symmetrical canopy. Pruned limbs. Single stem. Has Christmas lights. Heavy sap	NO	Proposed site construction conflicts with tree location
14	Picea pungens	Colorado Spruce	45	Private 1101 Baxter	Moderate	Symmetrical canopy. Pruned limbs. Single stem w/ 2 co-dominant leaders at 6m above grade. Leaning. Has Christmas lights	NO	Proposed site construction conflicts with tree location
15	Picea pungens	Colorado Spruce	45	Private 1101 Baxter	Good	Symmetrical canopy. Pruned limbs. Single stem. Has Christmas lights	NO	Proposed site construction conflicts with tree location

16	Pinus nigra	Austrian Pine	50	Private 1101 Baxter	Good	Asymmetrical canopy. Pruned limbs. Single stem. Has Christmas lights	NO	Proposed site construction conflicts with tree location
17	Pinus nigra	Austrian Pine	40	Private 1101 Baxter	Good	Symmetrical canopy. Pruned limbs. Single stem. Has Christmas lights	NO	Proposed site construction conflicts with tree location
18	Picea glauca	White Spruce	45	Private 1101 Baxter	Good	Symmetrical canopy. Die back: 10% at branches. Pruned limbs. Single stem. Bark rot at limbs. Grided roots	NO	Proposed site construction conflicts with tree location
19	Acer saccharinum	Silver Maple	50	Private 1101 Baxter	Good	Asymmetrical canopy. Pruned branches. Poor branch angle. Single stem	NO	Proposed site construction conflicts with tree location
20	Acer saccharinum	Silver Maple	40	Private 1101 Baxter	Good	Asymmetrical canopy. Pruned limbs. Single stem	NO	Proposed site construction conflicts with tree location

21	Pinus nigra	Austrian Pine	40	Private 1101 Baxter	Moderate	Symmetrical canopy. Die back: 20% at branches. Pruned limbs. Single stem	NO	Proposed site construction conflicts with tree location
22	Pinus nigra	Austrian Pine	45	Private 1101 Baxter	Good	Symmetrical canopy. Die back: 10% at branches. Pruned limbs. Single stem. Has Christmas lights	NO	Proposed site construction conflicts with tree location
23	Tilia cordata	Littleleaf Linden	40	Private 1101 Baxter	Good	Asymmetrical canopy. Pruned limbs. Single stem	NO	Proposed site construction conflicts with tree location
24	Acer saccharinum	Silver Maple	50	Private 1101 Baxter	Good	Asymmetrical canopy. Pruned limbs at O.H. utilities. Poor branch angle. Single stem. Leaning	NO	Proposed site construction conflicts with tree location
25	Fagus americana	American Beech	60	Private 1101 Baxter	Poor	Asymmetrical canopy. Pruned crown at O.H. utilities. Single stem	NO	Proposed site construction conflicts with tree location

26	Fagus americana	American Beech	40	Private 1101 Baxter	Moderate	Asymmetrical canopy. Pruned leader at O.H. utilities. Single stem	NO	Proposed site construction conflicts with tree location
27	Tilia americana	Basswood	65	Private 1101 Baxter	Good	Asymmetrical canopy. Pruned canopy at O.H. utilities. Poor branch angle. Single stem	YES	
28	Tilia americana	Basswood	60	Private 1101 Baxter	Good	Asymmetrical canopy. Pruned limbs. Single stem w/ 2 co-dominant leaders at 3m above grade. Bark rot at limbs	YES	
29	Tilia americana	Basswood	45	Private 1101 Baxter	Poor	Pruned leader at O.H. utilities. Single stem. Limbs over utility lines	NO	Proposed site construction conflicts with tree location
30	Acer platanoides	Norway Maple	30	Private 1101 Baxter	Moderate	Asymmetrical canopy. Die back: 20% at canopy. Pruned limbs. Single stem. Heat scorch	NO	Proposed site construction conflicts with tree location
31	Acer platanoides	Norway Maple	30	Private 1101 Baxter	Moderate	Symmetrical canopy. Die back: 10% at canopy. Pruned limbs. Single stem. Bark rot at cavities	NO	Proposed site construction conflicts with tree location

32	Tilia cordata	Littleleaf Linden	30	Private 1101 Baxter	Good	Asymmetrical canopy. Pruned branches. Single stem	YES	
33	Tilia cordata	Littleleaf Linden	30	Private 1101 Baxter	Good	Symmetrical canopy. Pruned branches. Single stem	YES	
34	Acer saccharinum	Silver Maple	25	Private 1101 Baxter	Poor	Asymmetrical canopy. Die back: 30% at canopy. Single stem. Chlorosis	NO	Proposed site construction conflicts with tree location
35	Pinus nigra	Austrian Pine	50	Private 1101 Baxter	Good	Asymmetrical canopy. Pruned limbs. Single stem	NO	Proposed site construction conflicts with tree location
36	Pinus nigra	Austrian Pine	40	Private 1101 Baxter	Good	Asymmetrical canopy. Pruned limbs. Single stem	NO	Proposed site construction conflicts with tree location
37	Pinus nigra	Austrian Pine	50	Private 1101 Baxter	Moderate	Asymmetrical canopy. Die back: 10% at branches. Poor branch union. Single stem w/ 2 co-dominant leaders at 4m above grade	NO	Proposed site construction conflicts with tree location

38	Acer platanoides	Norway Maple	15	Private 1101 Baxter	Moderate	Symmetrical canopy. Single stem. Included Bark. On a patio	NO	Proposed site construction conflicts with tree location
39	Malus spp.	Crabapple	2 x 25	Adjacent 1050 Baxter	Poor	Asymmetrical canopy. Die back: 15% at canopy. Single stem w/ 2 co-dominant leaders at 1m above grade. Heart rot at cavities	YES

Tree #	Botanical Name	Common Name	DBH (cm)	Ownership	Condition	NOTE	To Be Preserved	Reason for Removal
40	Pinus nigra	Austrian Pine	50	Adjacent 1050 Baxter	Moderate	Symmetrical canopy. Pruned branches. Single stem	YES	
41	Pinus nigra	Austrian Pine	50	Adjacent 1050 Baxter	Moderate	Asymmetrical canopy. Broken limbs. Pruned limbs	YES	
42	Pinus nigra	Austrian Pine	40	Adjacent 1050 Baxter	Moderate	Asymmetrical canopy. Broken limbs. Pruned limbs. Single stem	YES	
43	Pinus nigra	Austrian Pine	50	Adjacent 1050 Baxter	Moderate	Asymmetrical canopy. Pruned limbs. Single stem	YES	
44	Pinus nigra	Austrian Pine	45	Adjacent 1050 Baxter	Good	Asymmetrical canopy. Broken limbs. Pruned limbs. Single stem	YES	
45	Pinus nigra	Austrian Pine	45	Adjacent 1050 Baxter	Poor	Asymmetrical canopy. Broken limbs. Pruned branches at O.H. utilities. Single stem. Pruned leader	YES	
46	Pinus nigra	Austrian Pine	45	Adjacent 1050 Baxter	Moderate	Asymmetrical canopy. Pruned leader at O.H. utilities. Single stem	YES

47	Thuja occidentalis	Eastern White Cedar	10	Private 1101 Baxter	Moderate	Asymmetrical canopy. Single stem	NO	Proposed site construction conflicts with tree location
48	Tilia americana	Basswood	10	Adjacent 1050 Baxter	Poor	Asymmetrical canopy. Broken limbs. Poor branch angle. 4 multi-stem co-dominant leaders	YES	
49	Pinus strobus	White Pine	60	Adjacent 1050 Baxter	Good	Asymmetrical canopy. Broken limbs. Single stem	YES	
50	Acer negundo	Manitoba Maple	2 x 20	Private 1101 Baxter	Poor	Asymmetrical canopy. Single stem. Leaning. Grown into fence	NO	Poor condition
51	Pinus strobus	White Pine	50	Adjacent 2325 Dempsey	Good	Pruned limbs at O.H. utilities. Single stem	YES	
52	Acer platanoides	Norway Maple	15	Private 1101 Baxter	Poor	Asymmetrical canopy. Pruned at O.H. utilities. Single stem. Grown into chainlink fence	NO	Proposed site construction conflicts with tree location
53	Acer platanoides	Norway Maple	15	Private 1101 Baxter	Poor	Asymmetrical canopy. Pruned at O.H. utilities. Single stem. Grown into chainlink fence	NO	Proposed site construction conflicts with tree location

54	Acer platanoides	Norway Maple	15	Private 1101 Baxter	Poor	Asymmetrical canopy. Pruned at O.H. utilities. Single stem. Grown into chainlink fence	NO	Proposed site construction conflicts with tree location
55	Acer platanoides	Norway Maple	15	Private 1101 Baxter	Poor	Asymmetrical canopy. Pruned at O.H. utilities. Single stem. Grown into chainlink fence	NO	Proposed site construction conflicts with tree location
56	Acer negundo	Manitoba Maple	15	Private 1101 Baxter	Moderate	Asymmetrical canopy. Broken limbs. Single stem	NO	Proposed site construction conflicts with tree location
57	Acer platanoides	Norway Maple	15	Private 1101 Baxter	Poor	Asymmetrical canopy. Broken limbs. Pruned crown at O.H. utilities. Single stem. Bark rot at limbs	NO	Proposed site construction conflicts with tree location
58	Acer rubrum	Red Maple	65	Adjacent 2341 Dempsey	Good	Single stem w/ 4 co-dominant leaders at 3m above grade	YES

59	Acer platanoides	Norway Maple	12	Private 1101 Baxter	Moderate	Asymmetrical canopy. Pruned at O.H. utilities. Single stem	YES	
60	Larix laricina	Tamarack	35	Adjacent 2345 Dempsey	Moderate	Asymmetrical canopy. Single stem	YES	
61	Acer platanoides	Norway Maple	20	Private 1101 Baxter	Moderate	Asymmetrical canopy. Pruned at O.H. utilities. Single stem. Grown into chainlink fence	YES	
62	Larix laricina	Tamarack	20	Private 1101 Baxter	Moderate	Asymmetrical canopy. Pruned at O.H. utilities. Single stem. Grown into chainlink fence	YES	
63	Larix laricina	Tamarack	20	Private 1101 Baxter	Moderate	Asymmetrical canopy. Pruned at O.H. utilities. Single stem. Grown into chainlink fence	YES	
64	Acer platanoides	Norway Maple	35	Adjacent 2325 Dempsey	Good	Pruned at O.H. utilities. Single stem	YES	
65	Acer platanoides	Norway Maple	35	Adjacent 2327 Dempsey	Good	Pruned at O.H. utilities. Single stem	YES	
66	Acer platanoides	Norway Maple	3 x 35	Adjacent 2325 Dempsey	Moderate	Pruned at O.H. utilities. Single stem w/ 3 co-dominant leaders at 1m above grade	YES

67	Acer platanoides	Norway Maple	35	Adjacent 2327 Dempsey	Good	Pruned at O.H. utilities. Single stem	YES	
68	Tilia cordata	Littleleaf Linden	15	Private 1101 Baxter	Poor	Pruned limbs. Single stem. Grown into chainlink fence	YES	
69	Tilia cordata	Littleleaf Linden	15	Private 1101 Baxter	Poor	Pruned limbs. Single stem. Grown into chainlink fence	YES	
70	Pinus nigra	Austrian Pine	30	Boundary 1101/115 Baxter	Good	Symmetrical canopy. Single stem	YES	
71	Pinus nigra	Austrian Pine	25	Private	Moderate	Die back: 15% at branches. Pruned limbs. Single stem	YES

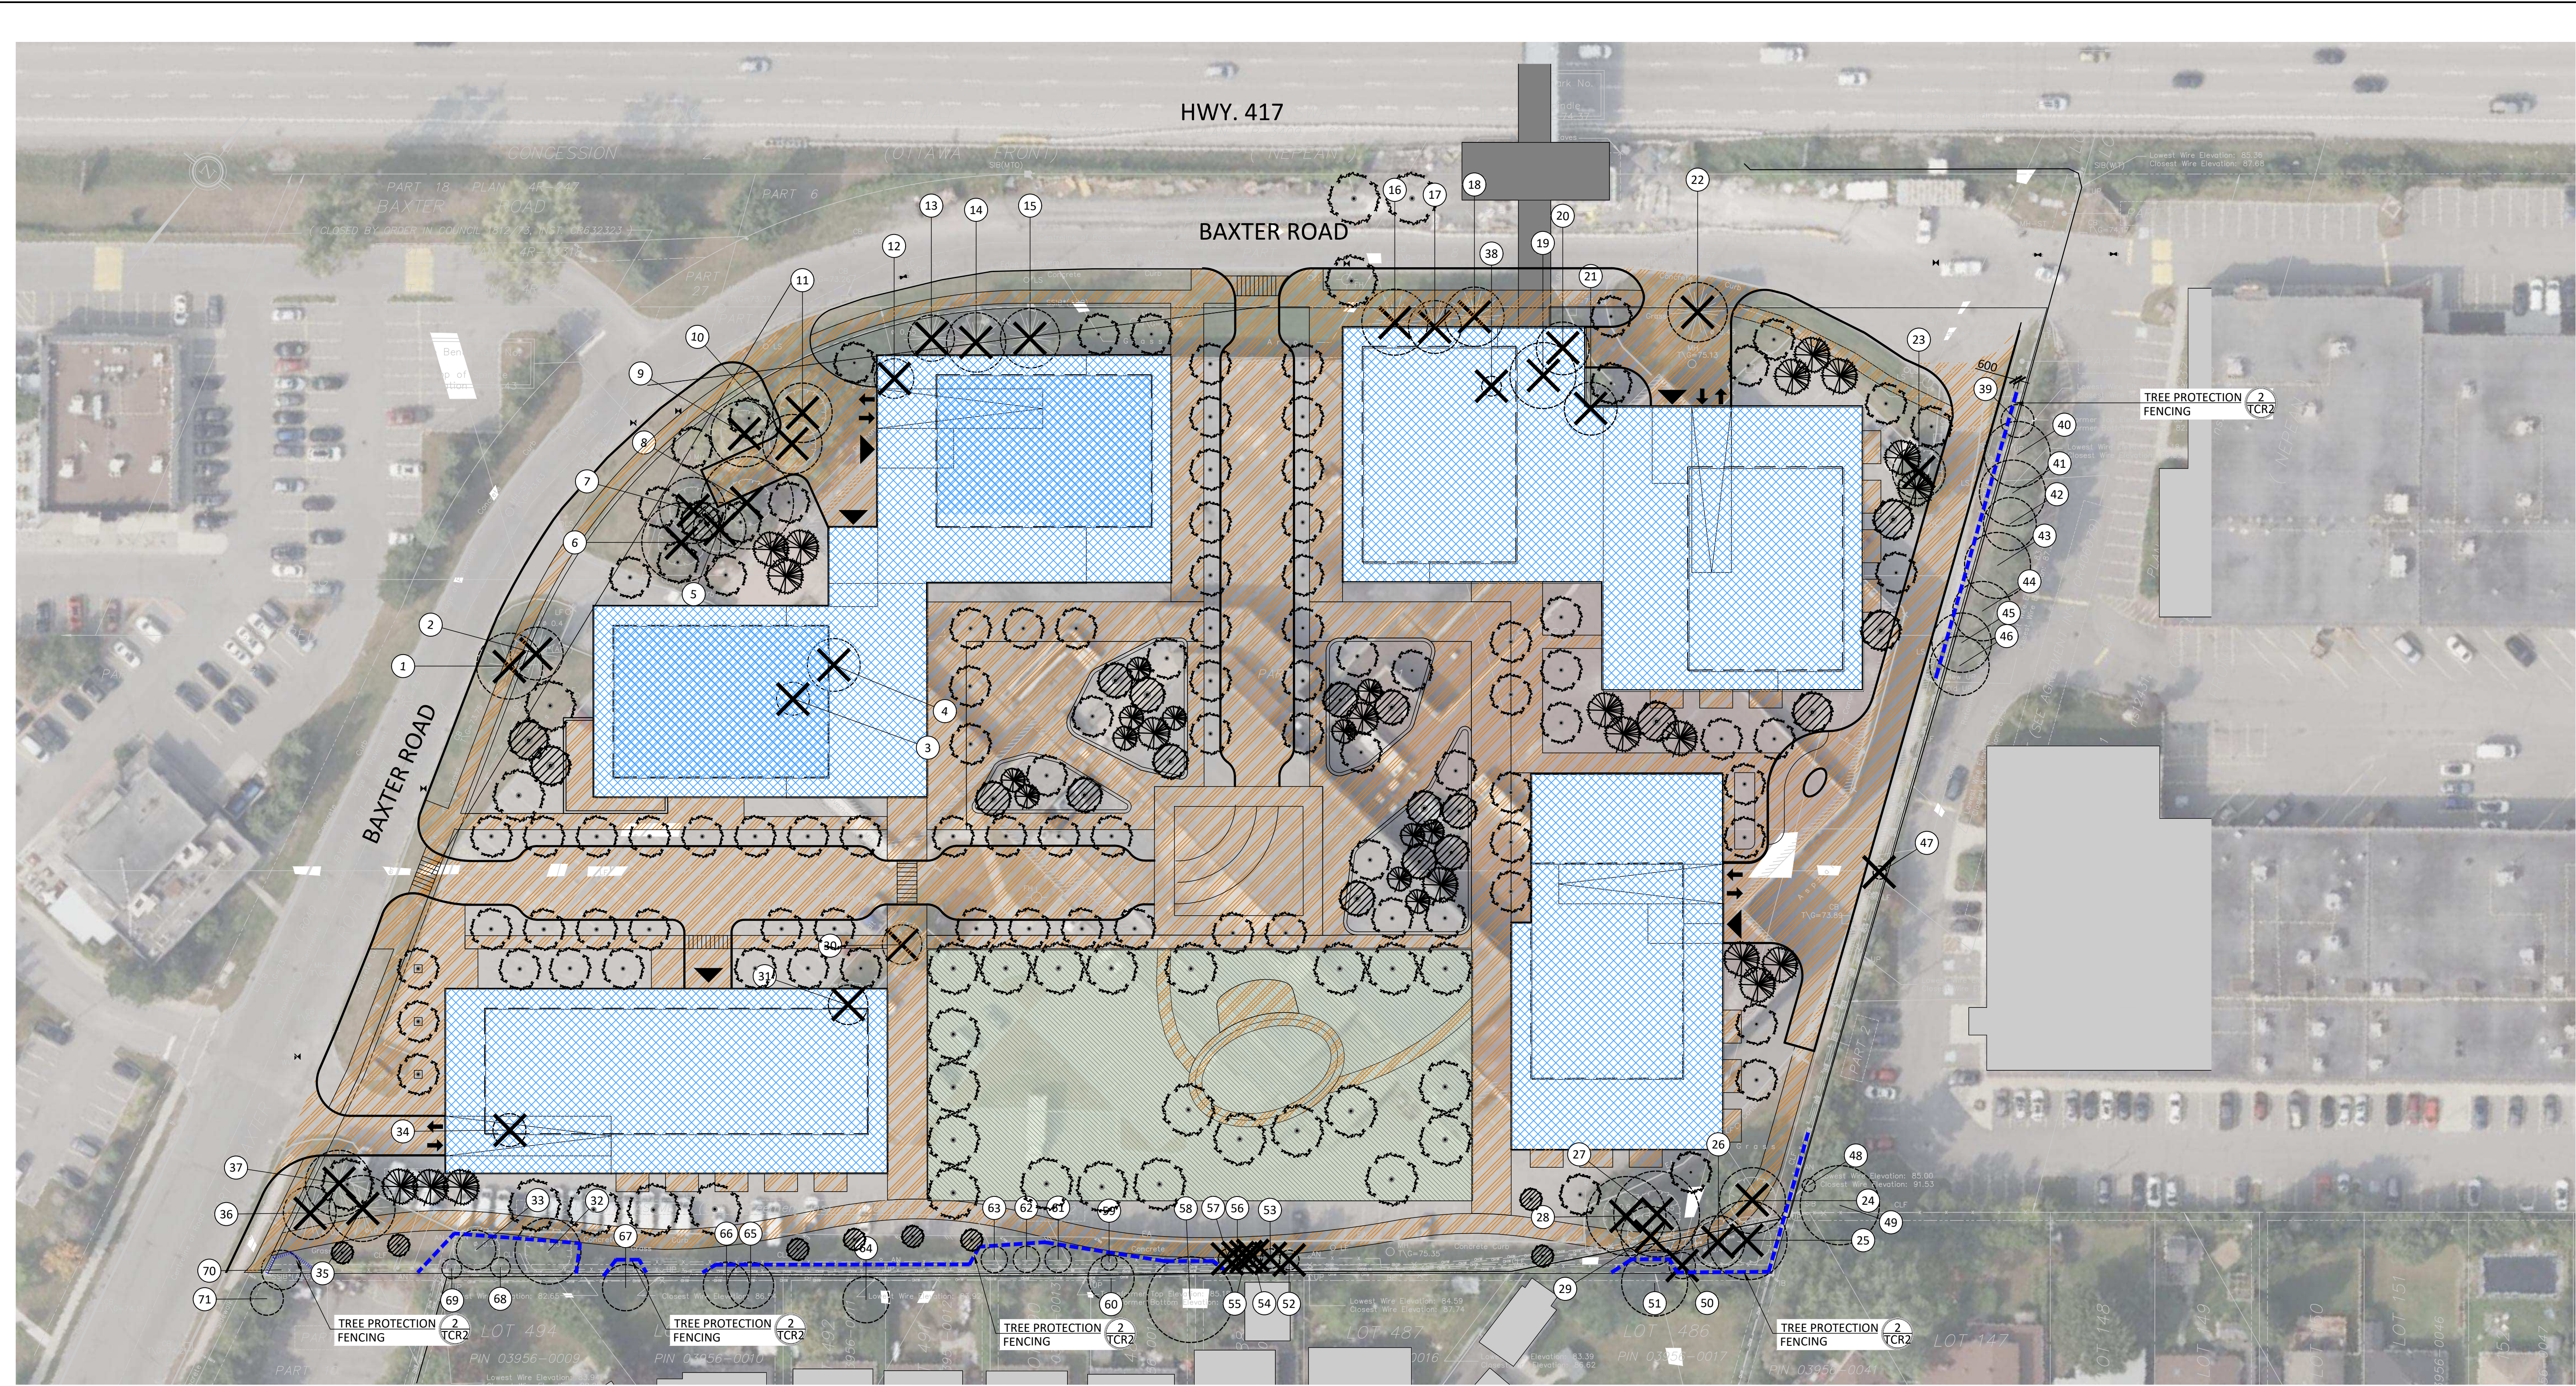
1 EXISTING VEGETATION Scale: 1:500

Tree #	Botanical Name	Common Name	DBH (cm)	Ownership	Condition	NOTE	To Be Preserved	Reason for Removal
1	Pinus nigra	Austrian Pine	50	City	Good	Asymmetrical canopy. Die back: 5% at canopy, Single stem	NO	Proposed site & ROW construction conflicts with tree location
2	Picea pungens	Colorado Spruce	40	Private 1101 Baxter	Good	Symmetrical canopy. Die back: 5% at branches, Pruned limbs, Single stem	NO	Proposed site & ROW construction conflicts with tree location
3	Syringa reticulata	Japanese Tree Lilac	25	Private 1101 Baxter	Good	Symmetrical canopy. Die back: 10% at canopy, Pruned limbs, Single stem, Included bark	NO	Proposed site construction conflicts with tree location
4	Picea glauca	White Spruce	20	Private 1101 Baxter	Good	Symmetrical canopy. Single stem, Has Christmas lights	NO	Proposed site construction conflicts with tree location
5	Tilia cordata	Littleleaf Linden	40	Private 1101 Baxter	Good	Asymmetrical canopy. Die back: 5% at branches, Pruned limbs, Single stem w/ 2 co-dominant leaders at 3m above grade, Included bark	NO	Proposed site construction conflicts with tree location

6	Tilia cordata	Littleleaf Linden	60	Private 1101 Baxter	Moderate	Asymmetrical canopy. Pruned limbs, Single stem w/ 2 co-dominant leaders at 2m above grade, Leaning, Included bark	NO	Proposed site construction conflicts with tree location
7	Tilia cordata	Littleleaf Linden	70	Private 1101 Baxter	Good	Asymmetrical canopy. Single stem, Bark rot at trunk	NO	Proposed site construction conflicts with tree location
8	Tilia cordata	Littleleaf Linden	50	Private 1101 Baxter	Good	Asymmetrical canopy. Die back: 10% at canopy, Pruned limbs, Single stem w/ 2 co-dominant leaders at 3m above grade	NO	Proposed site construction conflicts with tree location
9	Acer x Freemanii	Freeman Maple	50	Private 1101 Baxter	Moderate	Symmetrical canopy. Die back: 10% at branches, Broken limbs, Single stem, Grided roots	NO	Proposed site construction conflicts with tree location
10	Acer x Freemanii	Freeman Maple	45	Private 1101 Baxter	Moderate	Asymmetrical canopy. Die back: 15% at canopy, Broken limbs, Single stem	NO	Proposed site construction conflicts with tree location

11	Acer x Freemanii	Freeman Maple	45	Private 1101 Baxter	Moderate	Symmetrical canopy. Die back: 10% at branches, Broken limbs, Single stem, Bark damage at trunk	NO	Proposed site construction conflicts with tree location
12	Picea glauca	White Spruce	30	Private 1101 Baxter	Good	Symmetrical canopy. Die back: 5% at branches, Pruned limbs, Single stem	NO	Proposed site construction conflicts with tree location
13	Picea pungens	Colorado Spruce	35	Private 1101 Baxter	Moderate	Symmetrical canopy. Pruned limbs, Single stem, Has Christmas lights, Heavy sap	NO	Proposed site construction conflicts with tree location
14	Picea pungens	Colorado Spruce	45	Private 1101 Baxter	Moderate	Symmetrical canopy. Pruned limbs, Single stem w/ 2 co-dominant leaders at 6m above grade, Leaning, Has Christmas lights	NO	Proposed site construction conflicts with tree location
15	Picea pungens	Colorado Spruce	45	Private 1101 Baxter	Good	Symmetrical canopy. Pruned limbs, Single stem, Has Christmas lights	NO	Proposed site construction conflicts with tree location

16	Pinus nigra	Austrian Pine	50	Private 1101 Baxter	Good	Asymmetrical canopy. Pruned limbs, Single stem, Has Christmas lights	NO	Proposed site construction conflicts with tree location
17	Pinus nigra	Austrian Pine	40	Private 1101 Baxter	Good	Symmetrical canopy. Pruned limbs, Single stem, Has Christmas lights	NO	Proposed site construction conflicts with tree location
18	Picea glauca	White Spruce	45	Private 1101 Baxter	Good	Symmetrical canopy. Die back: 10% at branches, Pruned limbs, Single stem, Bark rot at limbs, Grided roots	NO	Proposed site construction conflicts with tree location
19	Acer saccharinum	Silver Maple	50	Private 1101 Baxter	Good	Asymmetrical canopy. Pruned branches, Poor branch angle, Single stem	NO	Proposed site construction conflicts with tree location
20	Acer saccharinum	Silver Maple	40	Private 1101 Baxter	Good	Asymmetrical canopy. Pruned limbs, Single stem	NO	Proposed site construction conflicts with tree location

21	Pinus nigra	Austrian Pine	40	Private 1101 Baxter	Moderate	Symmetrical canopy. Die back: 20% at branches, Pruned limbs, Single stem	NO	Proposed site construction conflicts with tree location
22	Pinus nigra	Austrian Pine	45	Private 1101 Baxter	Good	Symmetrical canopy. Die back: 10% at branches, Pruned limbs, Single stem, Has Christmas lights	NO	Proposed site construction conflicts with tree location
23	Tilia cordata	Littleleaf Linden	40	Private 1101 Baxter	Good	Asymmetrical canopy. Pruned limbs, Single stem	NO	Proposed site construction conflicts with tree location
24	Acer saccharinum	Silver Maple	50	Private 1101 Baxter	Good	Asymmetrical canopy. Pruned limbs at O.H. utilities, Poor branch angle, Single stem, Leaning	NO	Proposed site construction conflicts with tree location
25	Fagus americana	American Beech	40	Private 1101 Baxter	Poor	Asymmetrical canopy. Pruned crown at O.H. utilities, Single stem	NO	Proposed site construction conflicts with tree location

26	Fagus americana	American Beech	40	Private 1101 Baxter	Moderate	Asymmetrical canopy. Pruned leader at O.H. utilities, Single stem	NO	Proposed site construction conflicts with tree location
27	Tilia americana	Basswood	65	Private 1101 Baxter	Good	Asymmetrical canopy. Pruned canopy at O.H. utilities, Poor branch angle, Single stem	YES	
28	Tilia americana	Basswood	60	Private 1101 Baxter	Good	Asymmetrical canopy. Pruned limbs, Single stem w/ 2 co-dominant leaders at 3m above grade, Bark rot at limbs	YES	
29	Tilia americana	Basswood	40	Private 1101 Baxter	Poor	Pruned leader at O.H. utilities, Single stem, Limbs over utility lines	NO	Proposed site construction conflicts with tree location
30	Acer platanoides	Norway Maple	30	Private 1101 Baxter	Moderate	Asymmetrical canopy. Die back: 20% at canopy, Pruned limbs, Single stem, Heat scorch	NO	Proposed site construction conflicts with tree location
31	Acer platanoides	Norway Maple	30	Private 1101 Baxter	Moderate	Symmetrical canopy. Die back: 10% at canopy, Pruned limbs, Single stem, Bark rot at cavities	NO	Proposed site construction conflicts with tree location

32	Tilia cordata	Littleleaf Linden	30	Private 1101 Baxter	Good	Asymmetrical canopy. Pruned branches, Single stem	YES	
33	Tilia cordata	Littleleaf Linden	30	Private 1101 Baxter	Good	Symmetrical canopy. Pruned branches, Single stem	YES	
34	Acer saccharinum	Silver Maple	25	Private 1101 Baxter	Poor	Asymmetrical canopy. Die back: 30% at canopy, Single stem, Chlorosis	NO	Proposed site construction conflicts with tree location
35	Pinus nigra	Austrian Pine	50	Private 1101 Baxter	Good	Asymmetrical canopy. Pruned limbs, Single stem	NO	Proposed site construction conflicts with tree location
36	Pinus nigra	Austrian Pine	40	Private 1101 Baxter	Good	Asymmetrical canopy. Pruned limbs, Single stem	NO	Proposed site construction conflicts with tree location
37	Pinus nigra	Austrian Pine	50	Private 1101 Baxter	Moderate	Asymmetrical canopy. Die back: 10% at branches, Poor branch union, Single stem w/ 2 co-dominant leaders at 4m above grade	NO	Proposed site construction conflicts with tree location

38	Acer platanoides	Norway Maple	15	Private 1101 Baxter	Moderate	Symmetrical canopy. Single stem, Included bark, On a patio	NO	Proposed site construction conflicts with tree location
39	Malus spp.	Crabapple	2 x 25	Adjacent 1050 Baxter	Poor	Asymmetrical canopy. Die back: 15% at canopy, Single stem w/ 2 co-dominant leaders at 1m above grade, Heart rot at cavities	YES

Tree #	Botanical Name	Common Name	DBH (cm)	Ownership	Condition	NOTE	To Be Preserved	Reason for Removal
40	Pinus nigra	Austrian Pine	50	Adjacent 1050 Baxter	Moderate	Symmetrical canopy. Pruned branches, Single stem	YES	
41	Pinus nigra	Austrian Pine	50	Adjacent 1050 Baxter	Moderate	Asymmetrical canopy. Broken limbs, Pruned limbs	YES	
42	Pinus nigra	Austrian Pine	40	Adjacent 1050 Baxter	Moderate	Asymmetrical canopy. Broken limbs, Pruned limbs, Single stem	YES	
43	Pinus nigra	Austrian Pine	50	Adjacent 1050 Baxter	Moderate	Asymmetrical canopy. Pruned limbs, Single stem	YES	
44	Pinus nigra	Austrian Pine	45	Adjacent 1050 Baxter	Good	Asymmetrical canopy. Broken limbs, Pruned limbs, Single stem	YES	
45	Pinus nigra	Austrian Pine	45	Adjacent 1050 Baxter	Poor	Asymmetrical canopy. Broken limbs, Pruned branches at O.H. utilities, Single stem	YES	
46	Pinus nigra	Austrian Pine	45	Adjacent 1050 Baxter	Moderate	Asymmetrical canopy. Pruned leader at O.H. utilities, Single stem	YES

47	Thuja occidentalis	Eastern White Cedar	10	Private 1101 Baxter	Moderate	Asymmetrical canopy. Single stem	NO	Proposed site construction conflicts with tree location
48	Tilia americana	Basswood	10	Adjacent 1050 Baxter	Poor	Asymmetrical canopy. Broken limbs, Poor branch angle, 4 multi-stem co-dominant leaders	YES	
49	Pinus strobus	White Pine	60	Adjacent 1050 Baxter	Good	Asymmetrical canopy. Broken limbs, Single stem	YES	
50	Acer negundo	Manitoba Maple	2 x 20	Private 1101 Baxter	Poor	Asymmetrical canopy. Single stem, Leaning, Grown into fence	NO	Poor condition
51	Pinus strobus	White Pine	50	Adjacent 2320 Dempsey	Good	Pruned limbs at O.H. utilities, Single stem	YES	
52	Acer platanoides	Norway Maple	15	Private 1101 Baxter	Poor	Asymmetrical canopy. Pruned at O.H. utilities, Single stem, Grown into chainlink fence	NO	Proposed site construction conflicts with tree location
53	Acer platanoides	Norway Maple	15	Private 1101 Baxter	Poor	Asymmetrical canopy. Pruned at O.H. utilities, Single stem, Grown into chainlink fence	NO	Proposed site construction conflicts with tree location

54	Acer platanoides	Norway Maple	15	Private 1101 Baxter	Poor	Asymmetrical canopy. Pruned at O.H. utilities, Single stem, Grown into chainlink fence	NO	Proposed site construction conflicts with tree location
55	Acer platanoides	Norway Maple	15	Private 1101 Baxter	Poor	Asymmetrical canopy. Pruned at O.H. utilities, Single stem, Grown into chainlink fence	NO	Proposed site construction conflicts with tree location
56	Acer negundo	Manitoba Maple	15	Private 1101 Baxter	Moderate	Asymmetrical canopy. Broken limbs, Single stem	NO	Proposed site construction conflicts with tree location
57	Acer platanoides	Norway Maple	15	Private 1101 Baxter	Poor	Asymmetrical canopy. Broken limbs, Pruned crown at O.H. utilities, Single stem, Bark rot at limbs	NO	Proposed site construction conflicts with tree location
58	Acer rubrum	Red Maple	65	Adjacent 2341 Dempsey	Good	Single stem w/ 4 co-dominant leaders at 3m above grade	YES

59	Acer platanoides	Norway Maple	12	Private 1101 Baxter	Moderate	Asymmetrical canopy. Pruned at O.H. utilities, Single stem	YES	
60	Larix laricina	Tamarack	35	Adjacent 2345 Dempsey	Moderate	Asymmetrical canopy. Single stem	YES	
61	Acer platanoides	Norway Maple	20	Private 1101 Baxter	Moderate	Asymmetrical canopy. Pruned at O.H. utilities, Single stem, Grown into chainlink fence	YES	
62	Larix laricina	Tamarack	20	Private 1101 Baxter	Moderate	Asymmetrical canopy. Pruned at O.H. utilities, Single stem, Grown into chainlink fence	YES	
63	Larix laricina	Tamarack	20	Private 1101 Baxter	Moderate	Asymmetrical canopy. Pruned at O.H. utilities, Single stem, Grown into chainlink fence	YES	
64	Acer platanoides	Norway Maple	35	Adjacent 2357 Dempsey	Good	Pruned at O.H. utilities, Single stem	YES	
65	Acer platanoides	Norway Maple	35	Adjacent 2357 Dempsey	Good	Pruned at O.H. utilities, Single stem	YES	
66	Acer platanoides	Norway Maple	3 x 35	Adjacent 2357 Dempsey	Moderate	Pruned at O.H. utilities, Single stem w/ 3 co-dominant leaders at 1m above grade	YES

67	Acer platanoides	Norway Maple	35	Adjacent 2357 Dempsey	Good	Pruned at O.H. utilities, Single stem	YES	
68	Tilia cordata	Littleleaf Linden	15	Private 1101 Baxter	Poor	Pruned limbs, Single stem, Grown into chainlink fence	YES	
69	Tilia cordata	Littleleaf Linden	15	Private 1101 Baxter	Poor	Pruned limbs, Single stem, Grown into chainlink fence	YES	
70	Pinus nigra	Austrian Pine	30	Boundary 1101/119 Baxter	Good	Symmetrical canopy, Single stem	YES	
71	Pinus nigra	Austrian Pine	25	Private	Moderate	Die back 15% at branches, Pruned limbs, Single stem	YES
