# Findlay Creek Conceptual Channel Design

**4795 Bank Street Subdivision**  
Ottawa, Ontario

Prepared for:  
Caivan Communities  
3713 Borrisokane Road  
Ottawa, ON K2J 4J4

GEO Morphix Project No. 26028

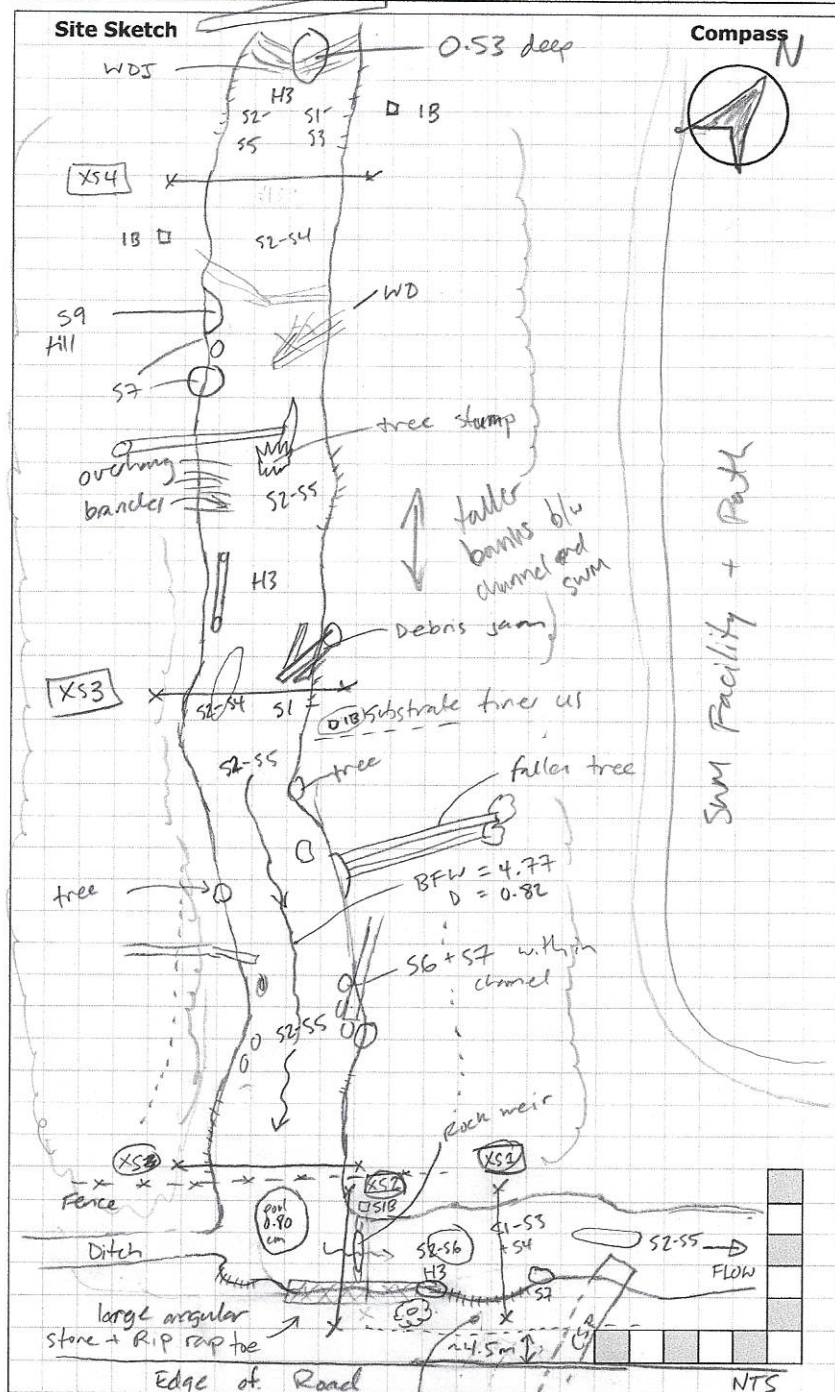
Notes: generally straight, coarser materials DS

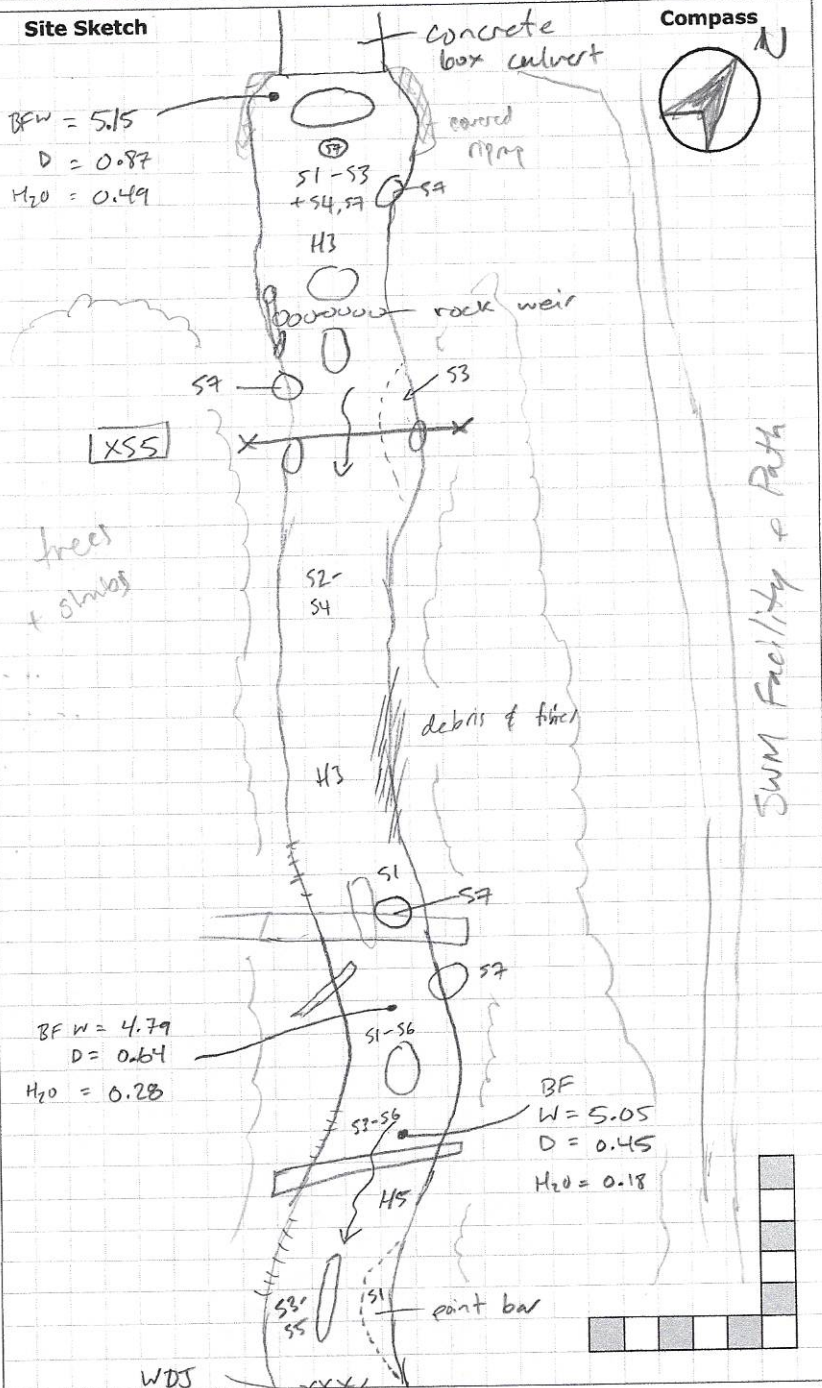
**Notes:** more fines recent further up + observed on banks,

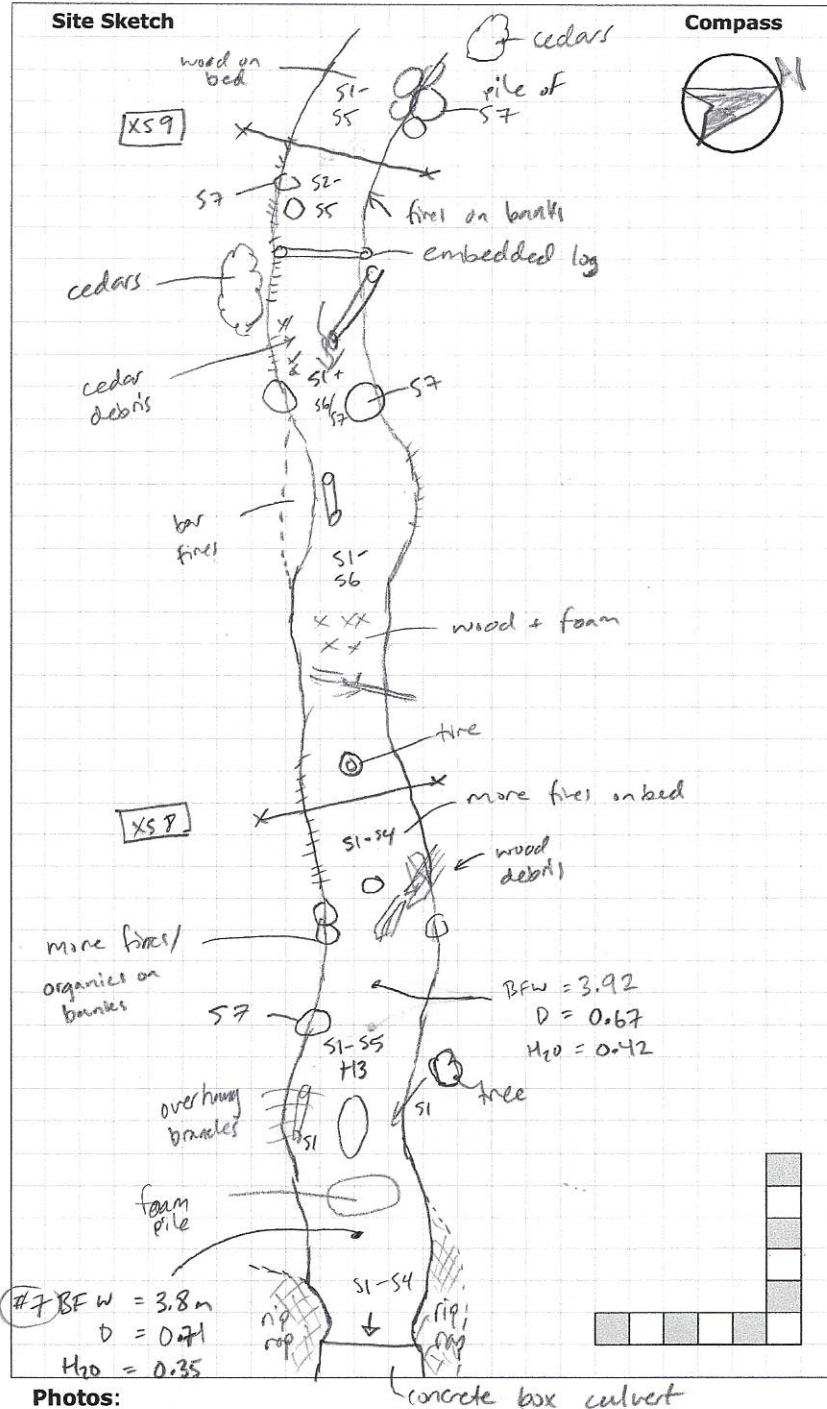
**Notes:** more woody debris on bed + banks,  
if large boulders
