CITY OF OTTAWA

# Phase One Environmental Site Assessment

1010 Somerset Street West, Ottawa, Ontario

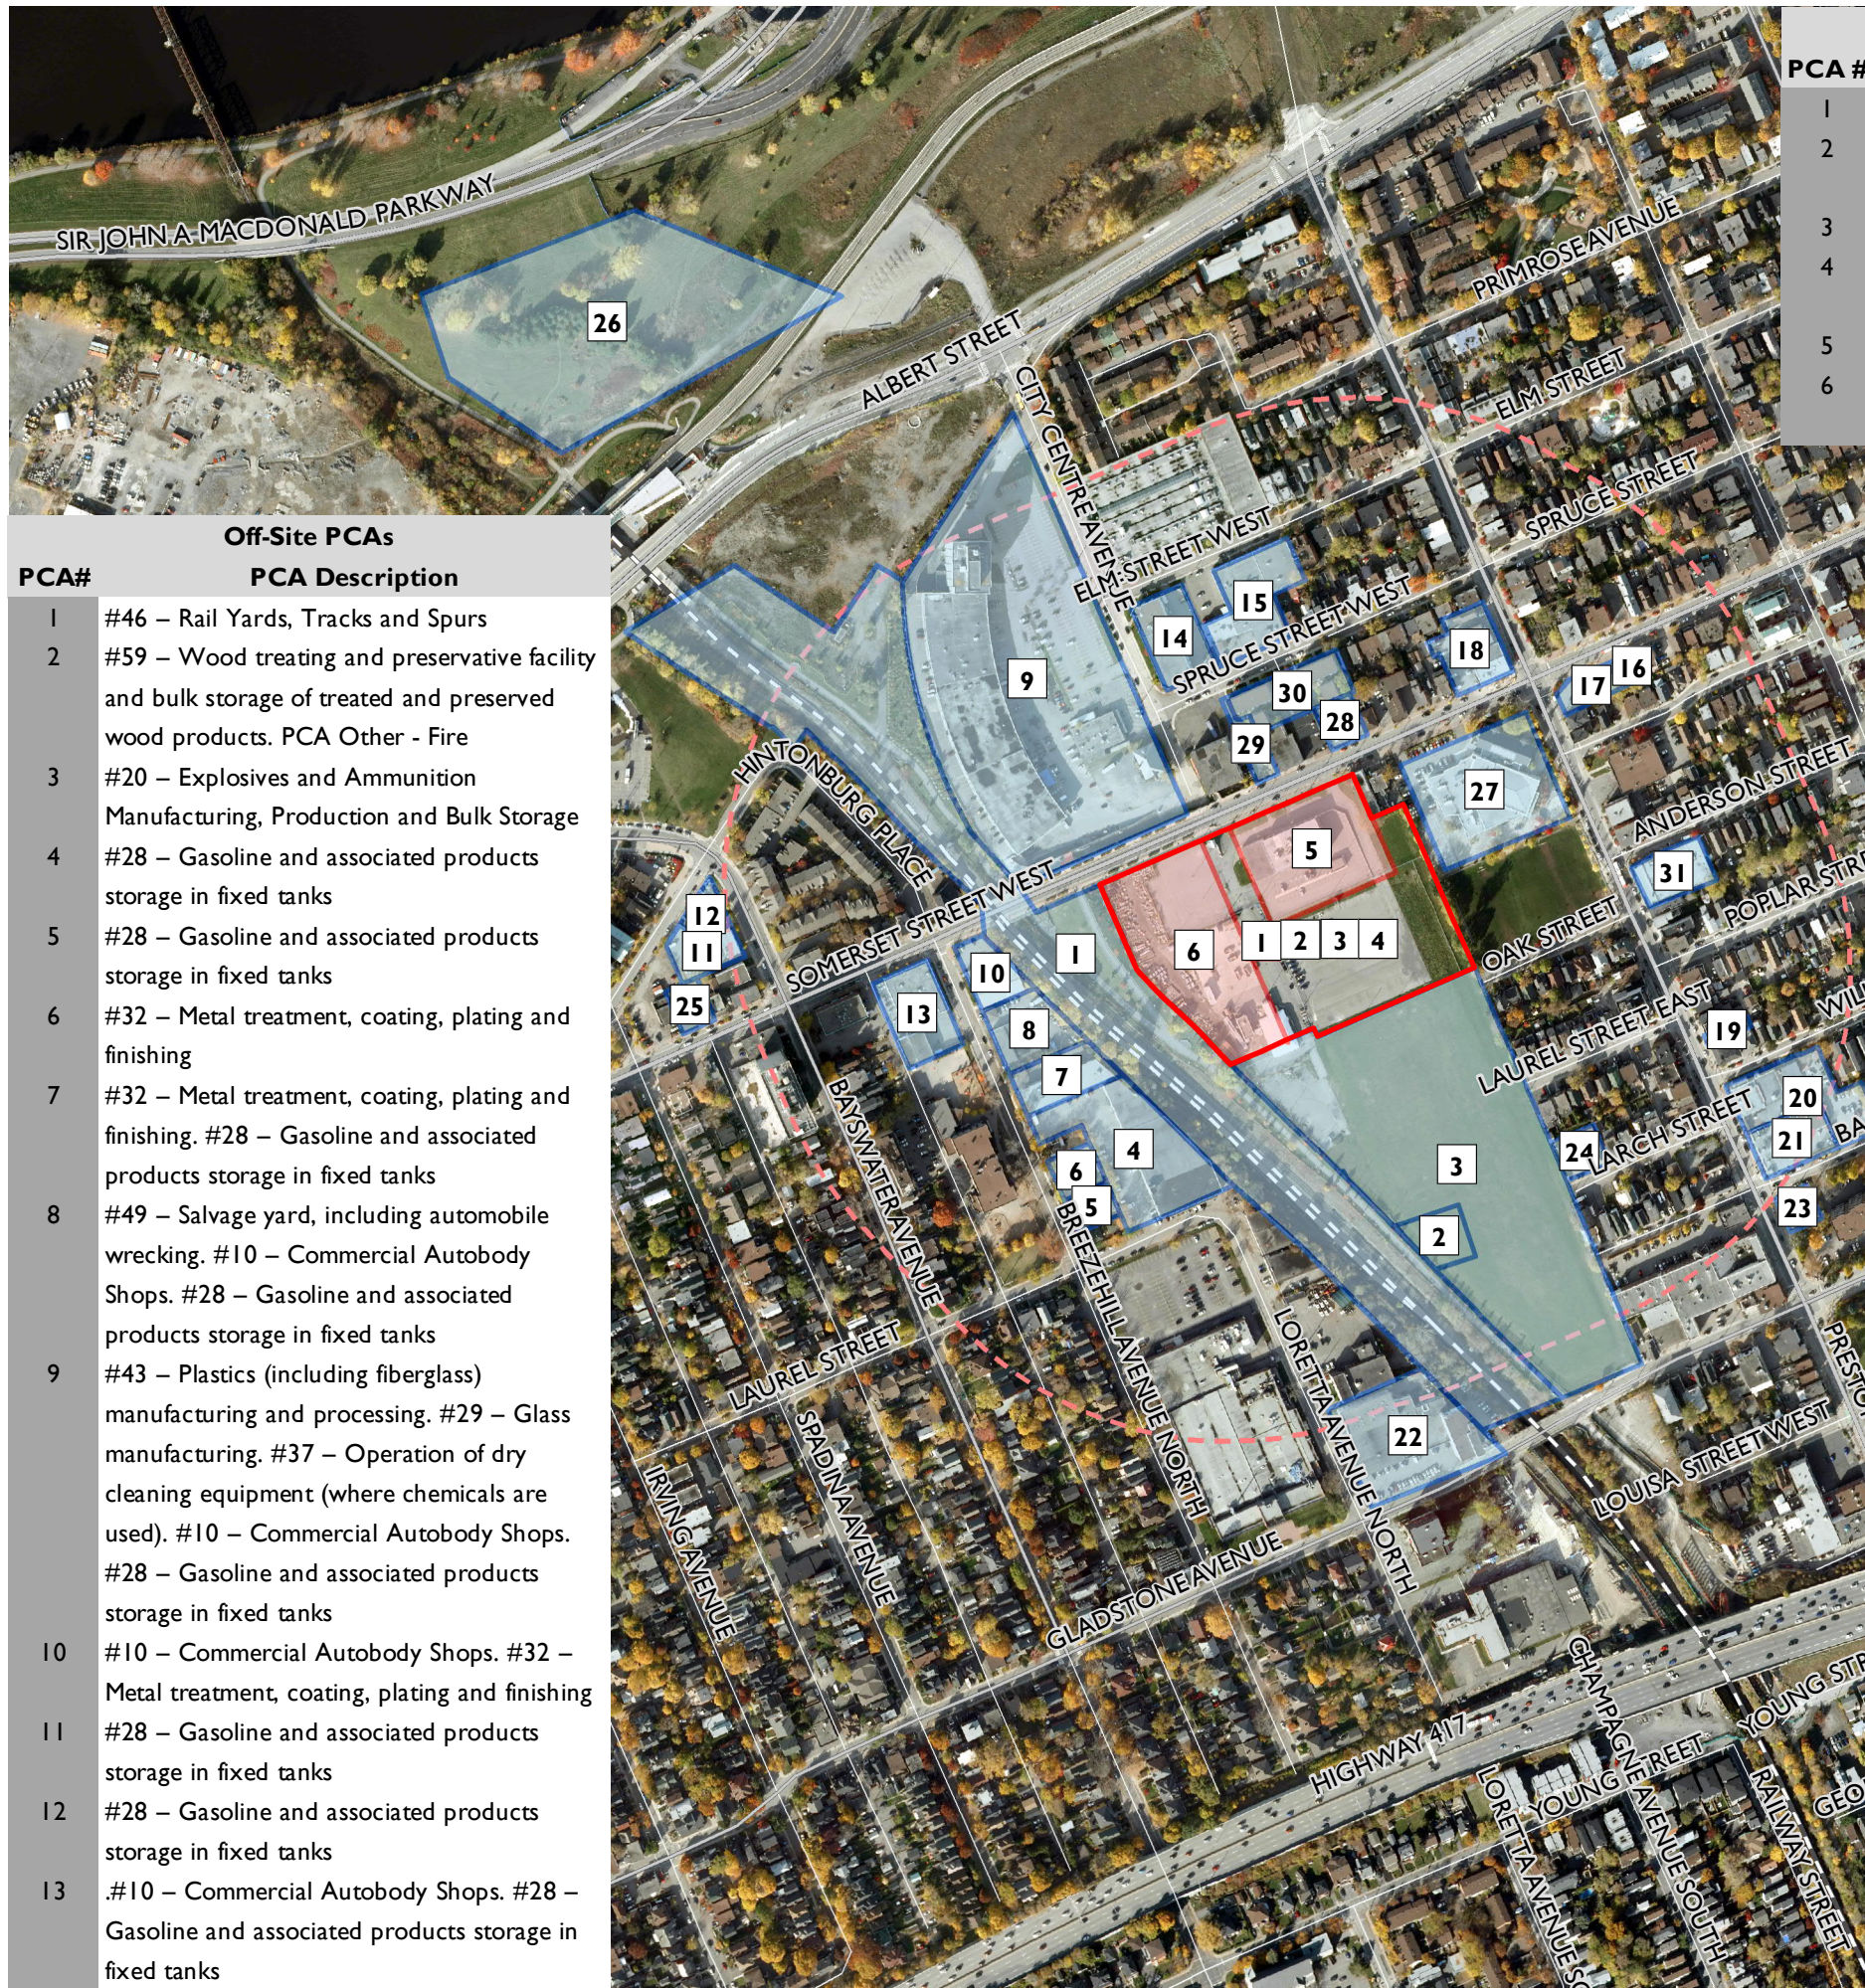
PCA #	PCA Description
1	#30 – Importation of fill material of unknown quality
2	#20 – Explosives and Ammunition Manufacturing, Production and Bulk Storage
3	#46 – Railyards, tracks and spurs
4	#59 – Wood treating and preservative facility and bulk storage of treated and preserved wood products
5	PCA Other - Fire
6	PCA Other – Storage of maintenance equipment, fuel, and chemicals

PCA#	PCA Description
14	#28 – Gasoline and associated products storage in fixed tanks
15	#28 – Gasoline and associated products storage in fixed tanks. #32 – Metal treatment, coating, plating and finishing
16	#37 – Operation of dry cleaning equipment (where chemicals are used). #28 – Gasoline and associated products storage in fixed tanks
17	#28 – Gasoline and associated products storage in fixed tanks
18	#37 – Operation of dry cleaning equipment (where chemicals are used)
19	#28 – Gasoline and associated products storage in fixed tanks
20	#28 – Gasoline and associated products storage in fixed tanks
21	#28 – Gasoline and associated products storage in fixed tanks
22	#28 – Gasoline and associated products storage in fixed tanks. #32 – Metal treatment, coating, plating and finishing
23	#28 – Gasoline and associated products storage in fixed tanks
24	#32 – Metal treatment, coating, plating and finishing

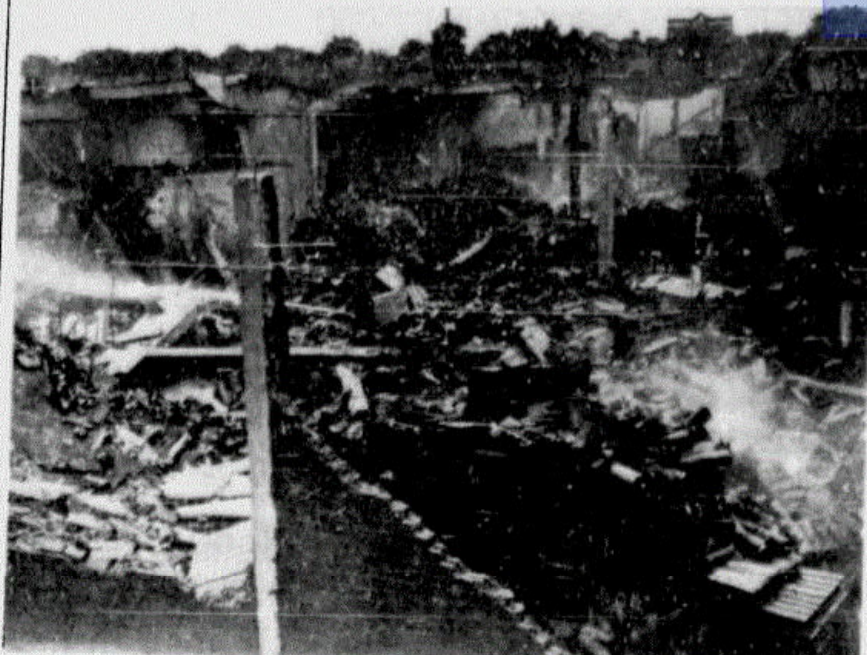
Fire Causes Tremendous Destruction—Stocks of army clothing, paints, oil, domestic alcohol and other materials were lost in Saturday night's fire which charred a 150-foot section of the Central Ordnance Depot at Plouffe

Park. The ruins of the gutted depot section are shown above. Exploding oil and paint supplies added to the fierceness of the blaze and threatened homes on the north side of Somerset Street.

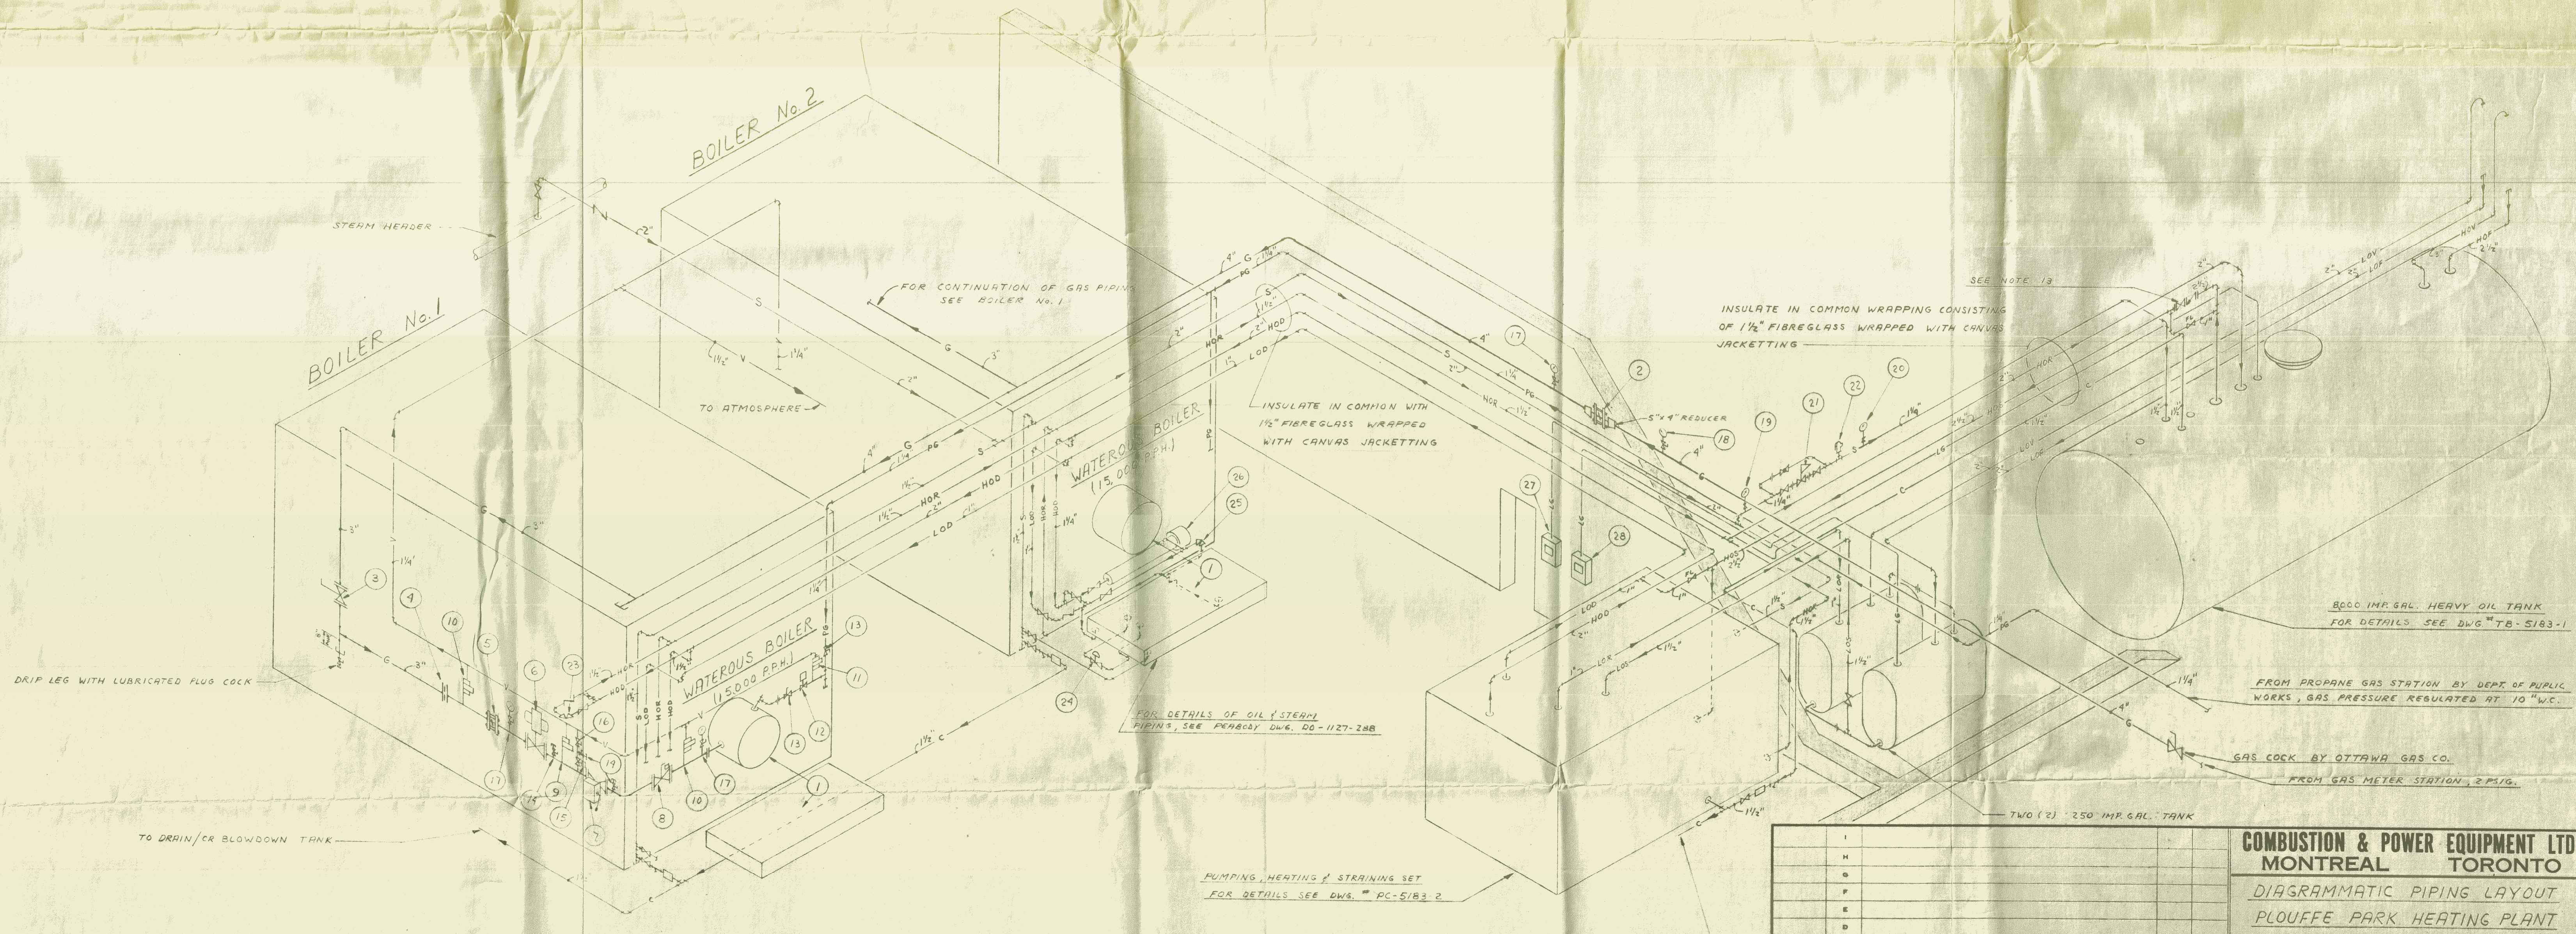
**COMBUSTION & POWER EQUIPMENT LTD.**  
**MONTREAL TORONTO**  
 DIAGRAMMATIC PIPING LAYOUT  
 PLOUFFE PARK HEATING PLANT  
 DEPARTMENT OF PUBLIC WORKS  
 OTTAWA ONTARIO

C	CONDENSATE
G	GAS SUPPLY
S	STEAM LINE
V	VENT LINE
LG	LEVEL GAUGE TUBING
PG	PROPANE GAS LINE
HOD	HEAVY OIL DISCHARGE
HOF	...
HOR	...
HOS	...
HOD	...
LVD	...
LOF	...
LOR	...
LOS	...
LOV	...
GV	GATE VALVE
CV	CHECK
GL	GLOBE
GC	GAS COCK
YS	"Y" STRAINER
ST	STEAM TRAP
FL	FLUSHING CONNECTION

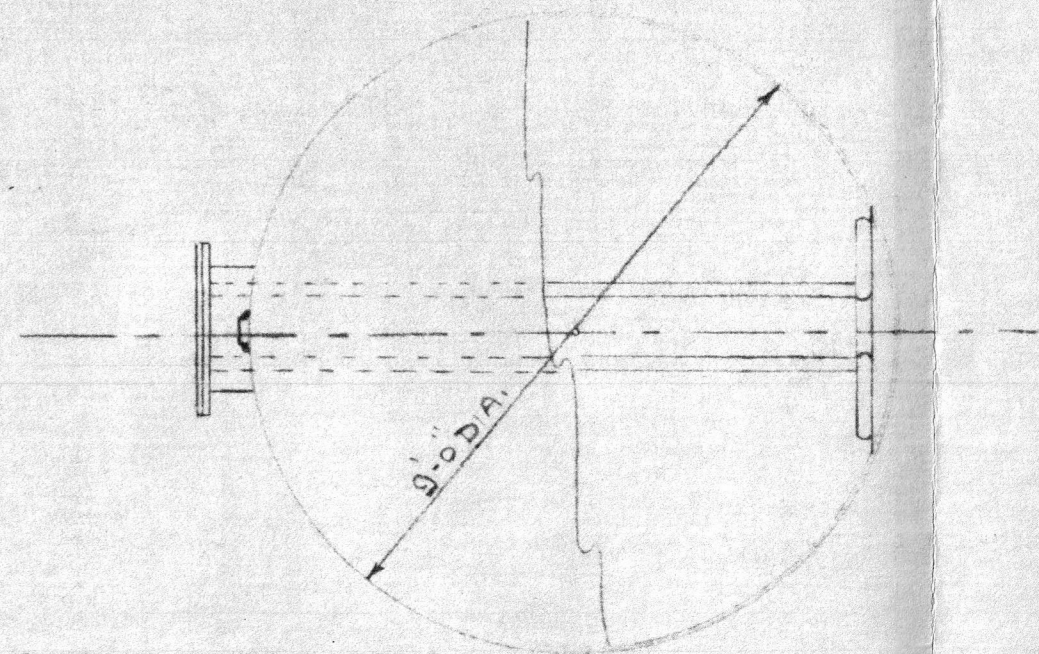
PIPING DETAIL

100'-0" OF 1/2" EXTRA HEAVY SEAMLESS PIPE COIL
