**Phase One Environmental Site Assessment:  
Proposed Development Hamilton Avenue,  
Spencer Avenue, Parkdale Avenue, Armstrong Street,  
Ottawa, Ontario**

Final Report

Prepared for:  
Taggart Realty Management/ 1000147699 Ontario Inc.

Prepared by:  
Stantec Consulting Ltd.

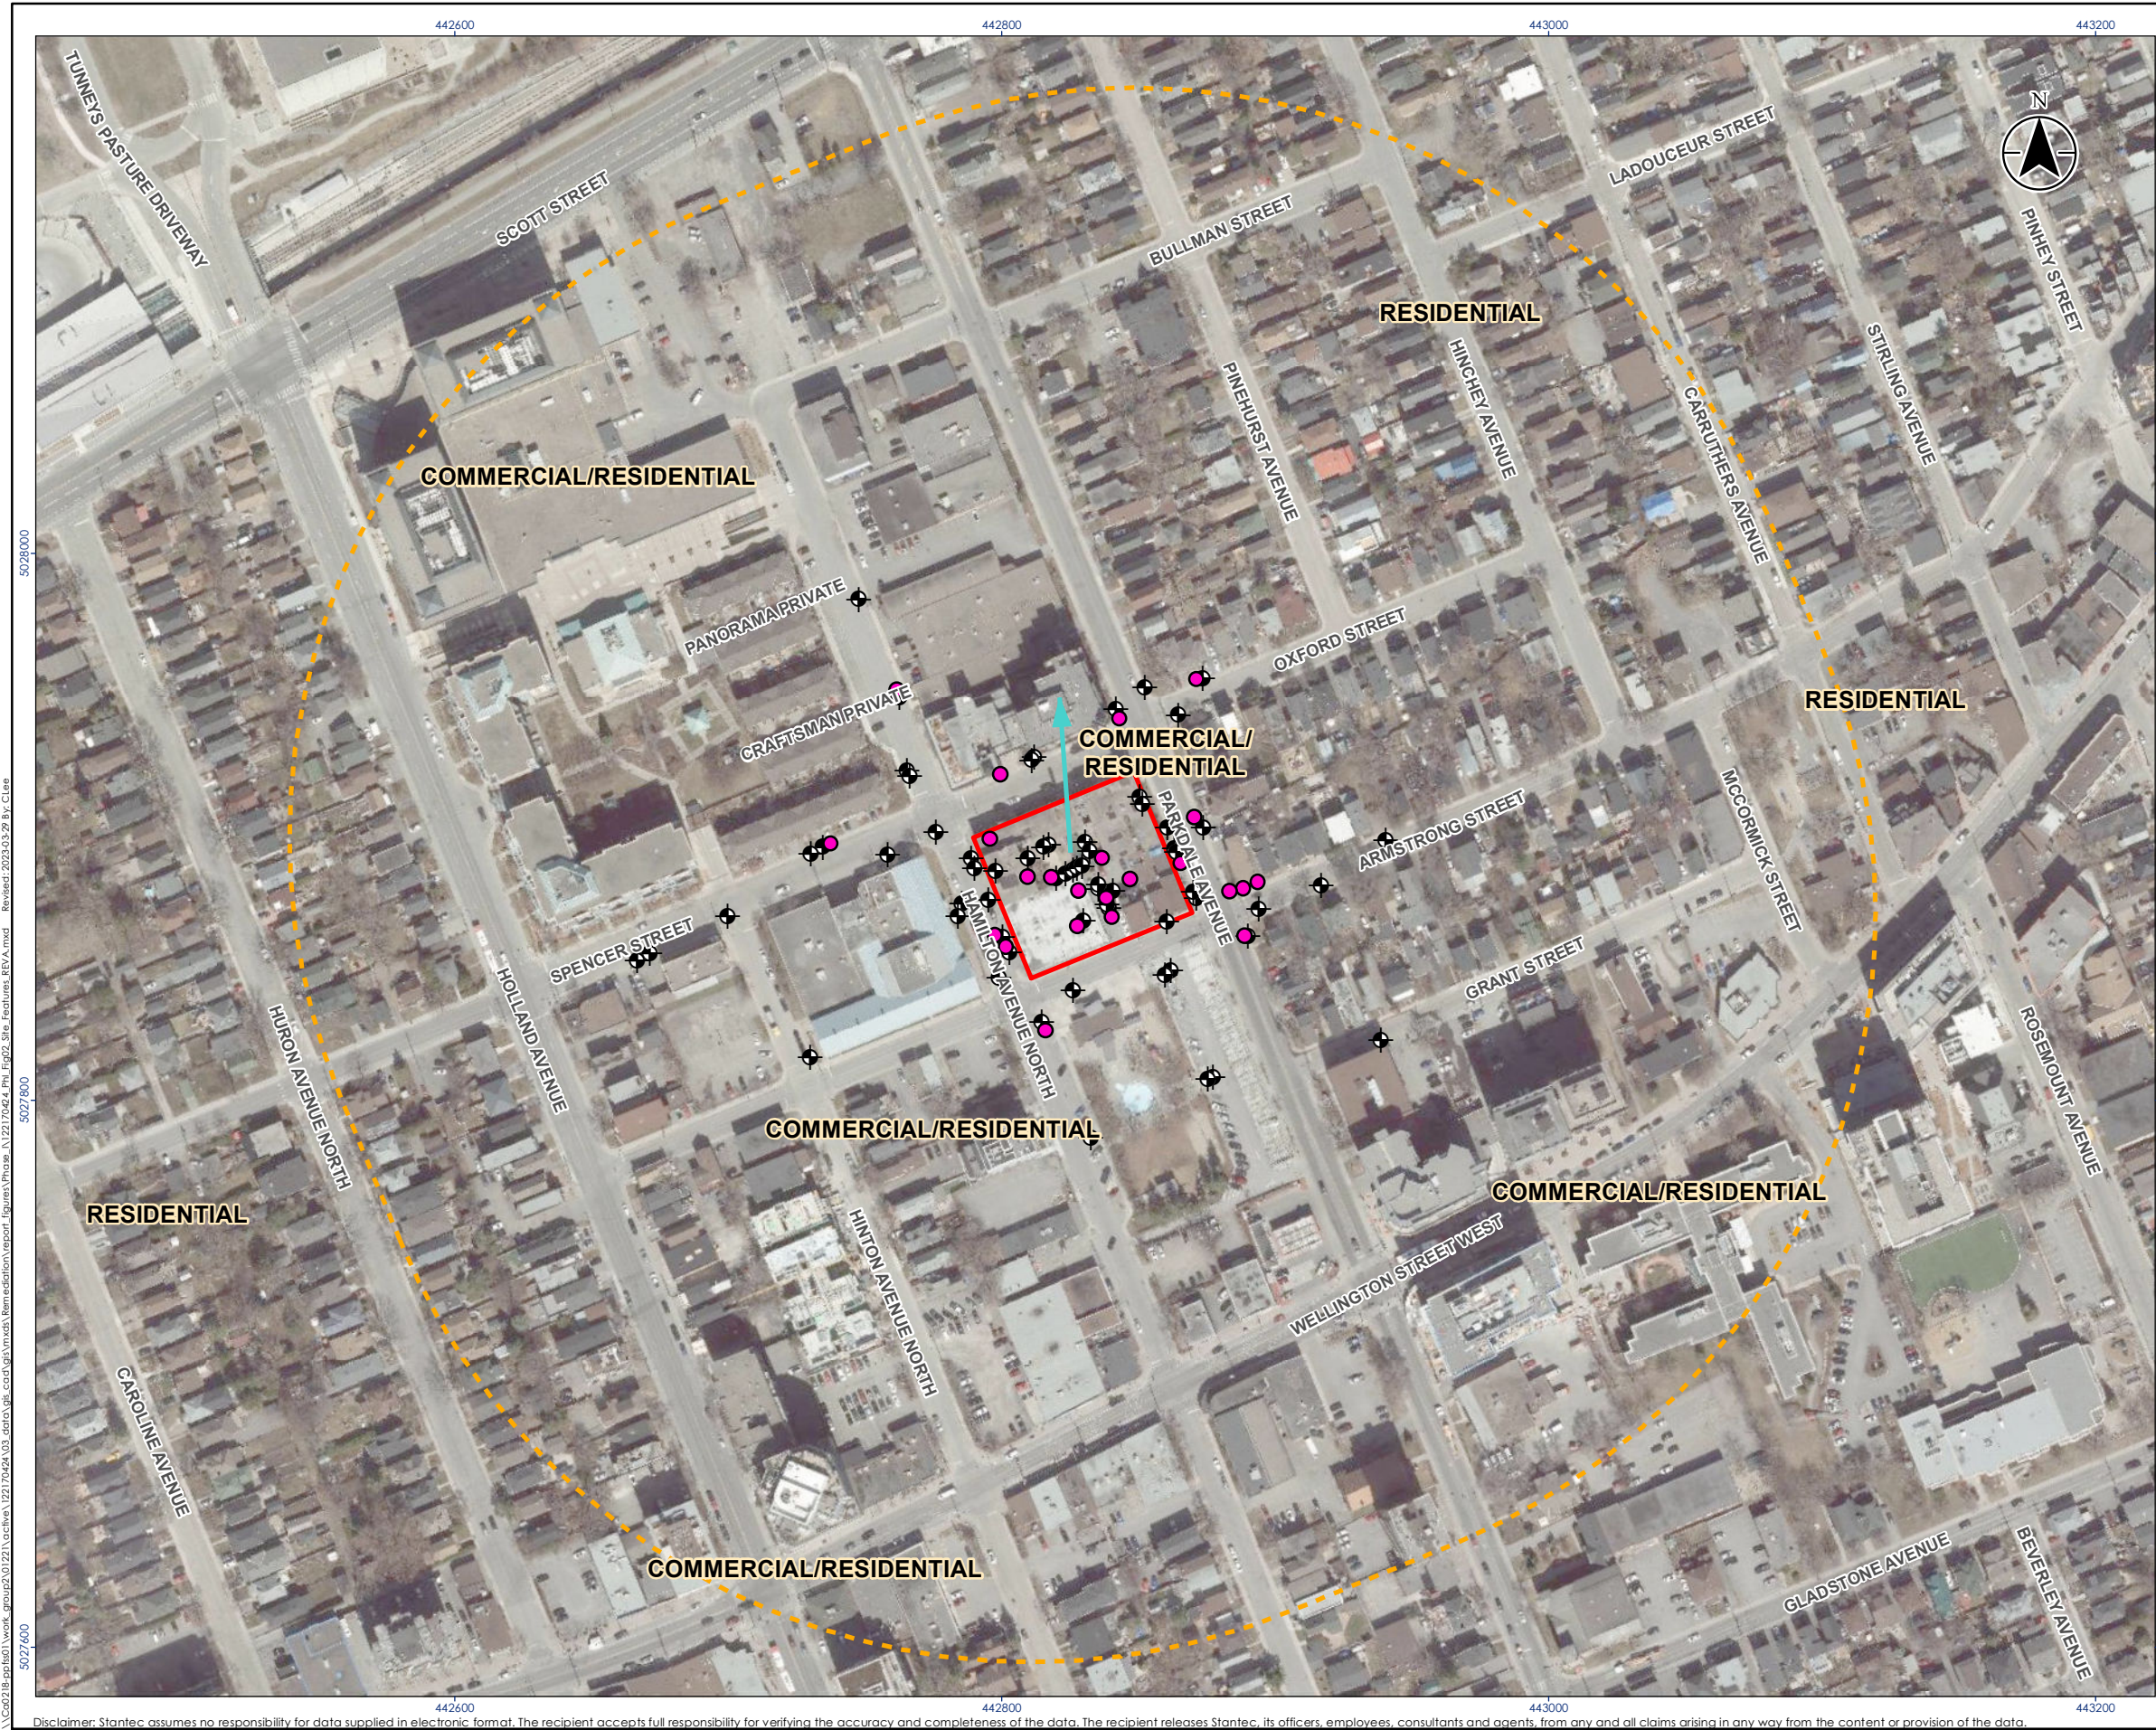
- Approximate Monitoring Well Location
- Approximate Vapour Probe Location
- Inferred Shallow Groundwater Flow Direction
- Approximate Site Boundary
- Phase One Study Area (250 m)

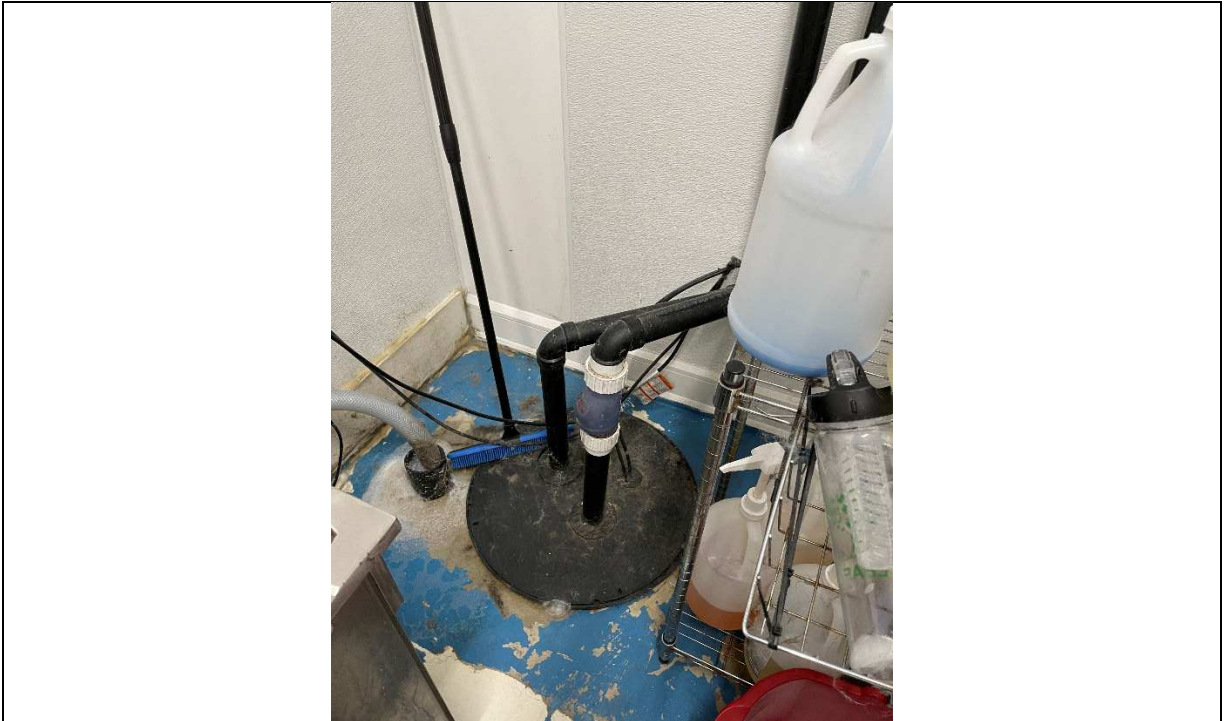
**Photo 001** View of sump in The Barking Barber located at 233B Armstrong Street (the Phase One Property) (facing west).

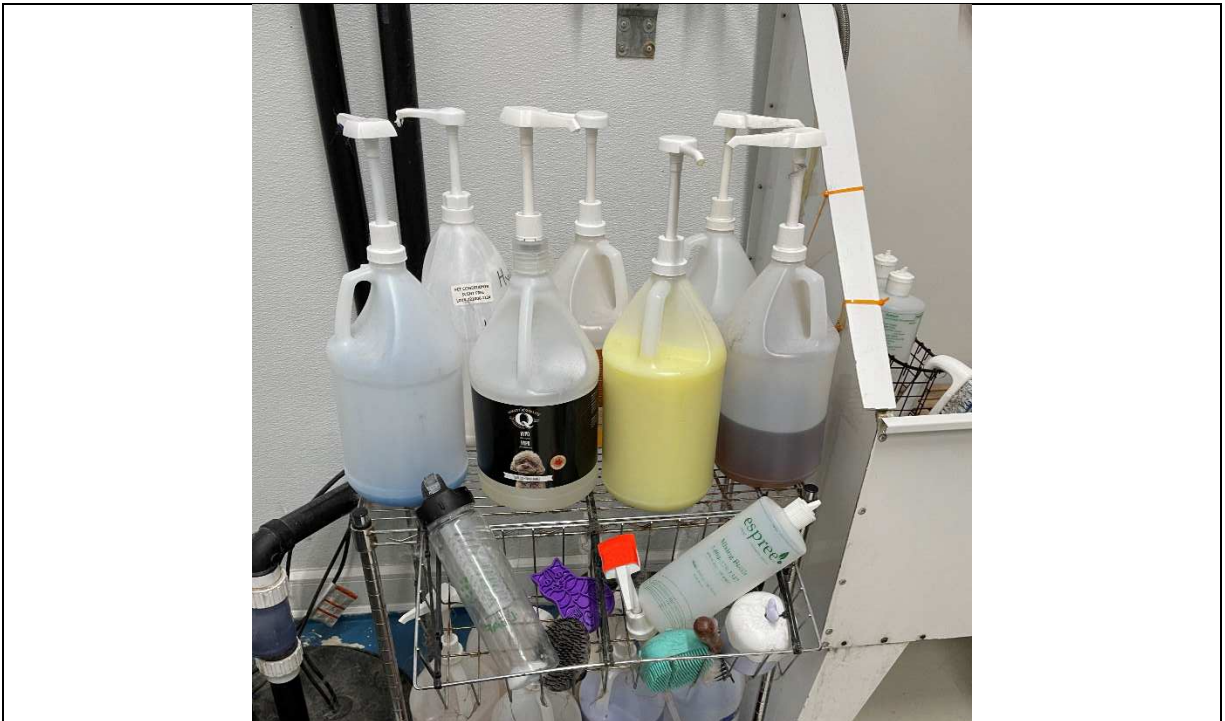
**Photo 002** View of pet shampoos in The Barking Barber located at 233B Armstrong Street (the Phase One Property) (facing west).

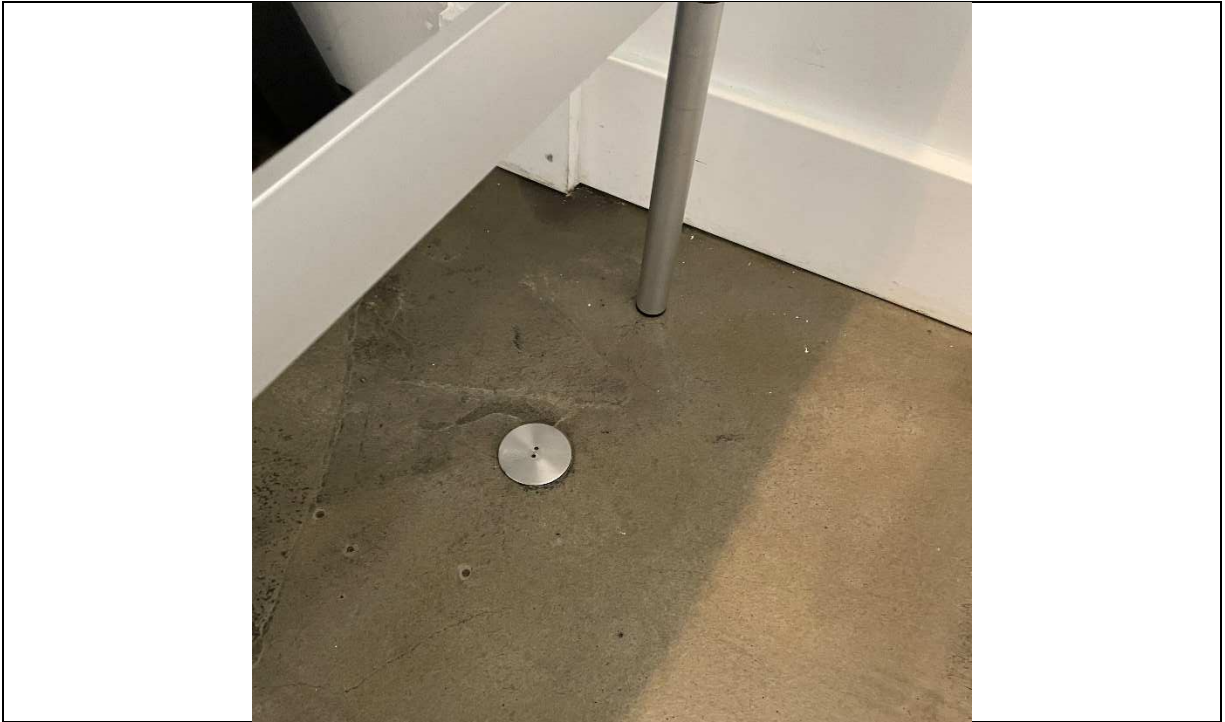
**Photo 005** View of suspected soil vapour probe under tattooing table in Railbender Tattoo and Shades & Art Gallery located at 3 Hamilton Avenue North (the Phase One Property) (facing down).

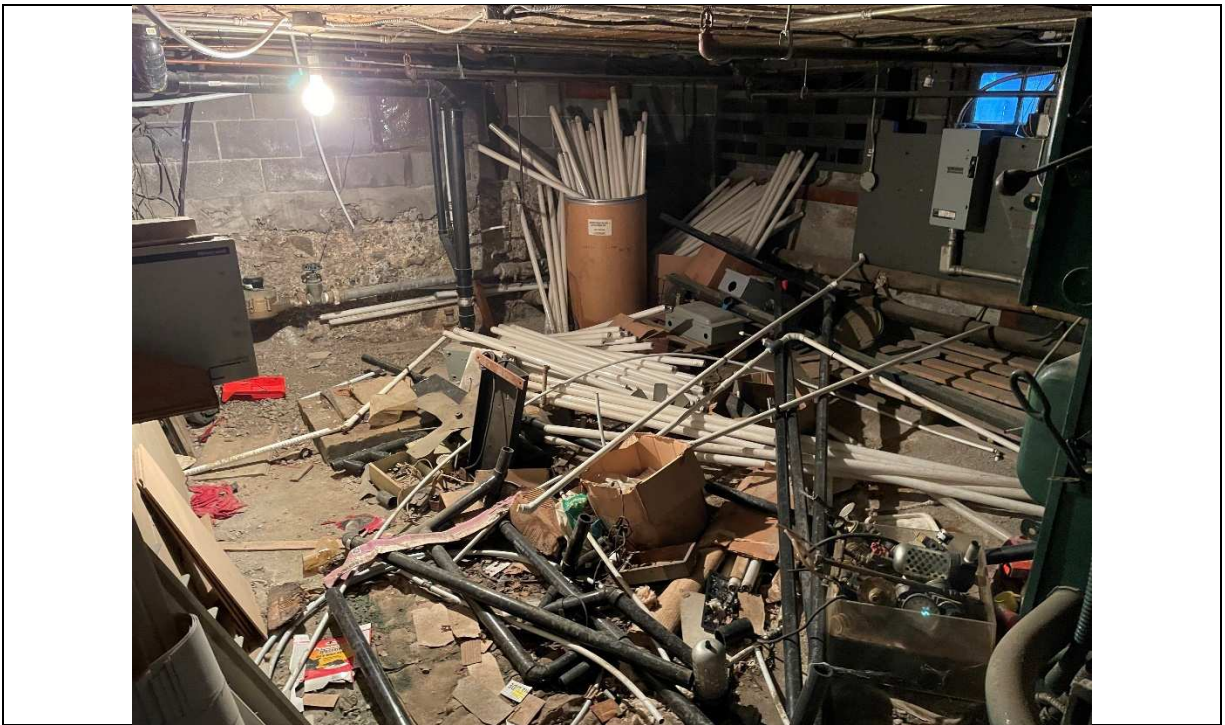
**Photo 006** View of poorly managed waste overlying building foundation/subsurface in northeast corner of basement of Parkdale Mini Storage located at 340 Parkdale Avenue (the Phase One Property) (facing northeast).

| APEC | Location of APEC on Phase One Property | PCA | Location of PCA (on-site or off-site) | Contaminants of Potential Concern <sup>1</sup> | Media Potentially Impacted (Ground water, soil and/or sediment) |
|---|---|---|---|---|---|
| 7 | Northeast portion of the Site | <i>PCA No. 5</i><br>Poorly managed waste in basement directly overlying eroded building foundation (O.Reg.153/04 PCA Undefined) | On-Site | <ul style="list-style-type: none"> <li>• PAHs</li> <li>• VOCs</li> <li>• BTEX</li> <li>• PHCs</li> <li>• Metals</li> </ul> | Soil<br>Ground water |

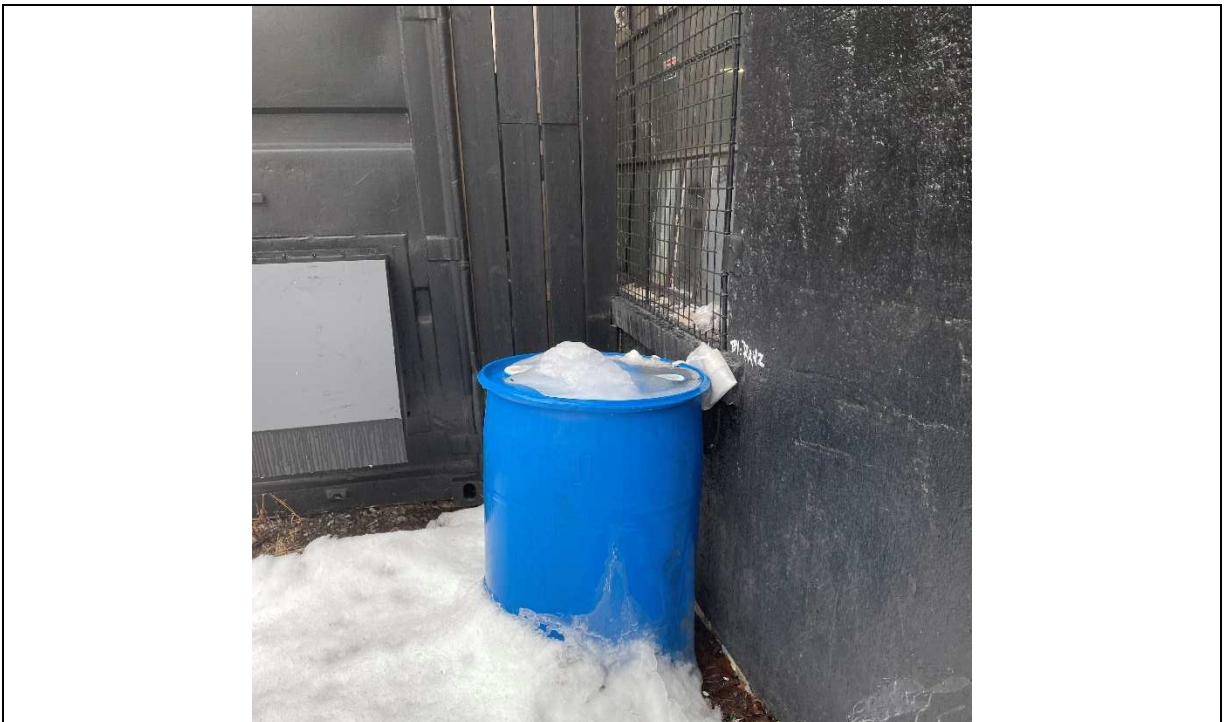
**Photo 008** View of PVC drum along the northern boundary of the Phase One Property, adjacent to the west of Golder Associates container (facing west).

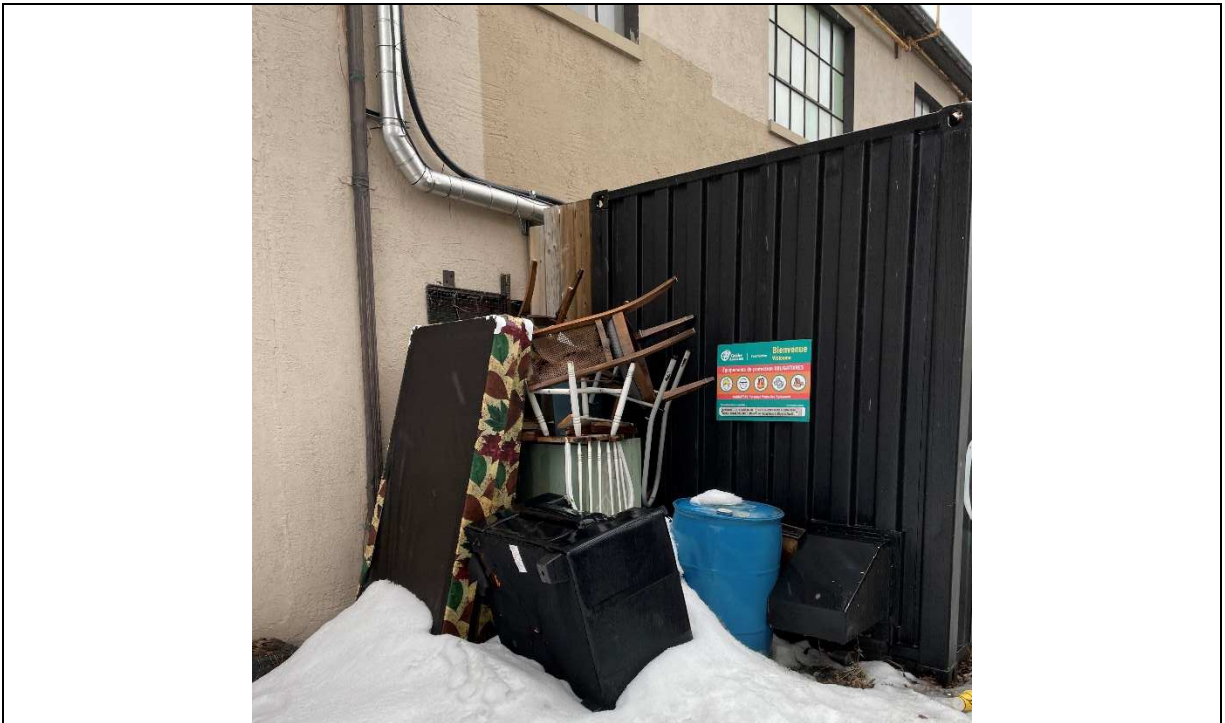
**Photo 009** View of PVC drum and disposed furniture propped against Golder Associates container, likely from Jack's Upholstery and Re-finishing located along the northern boundary of the Phase One Property (340 Parkdale Avenue) (facing southwest).

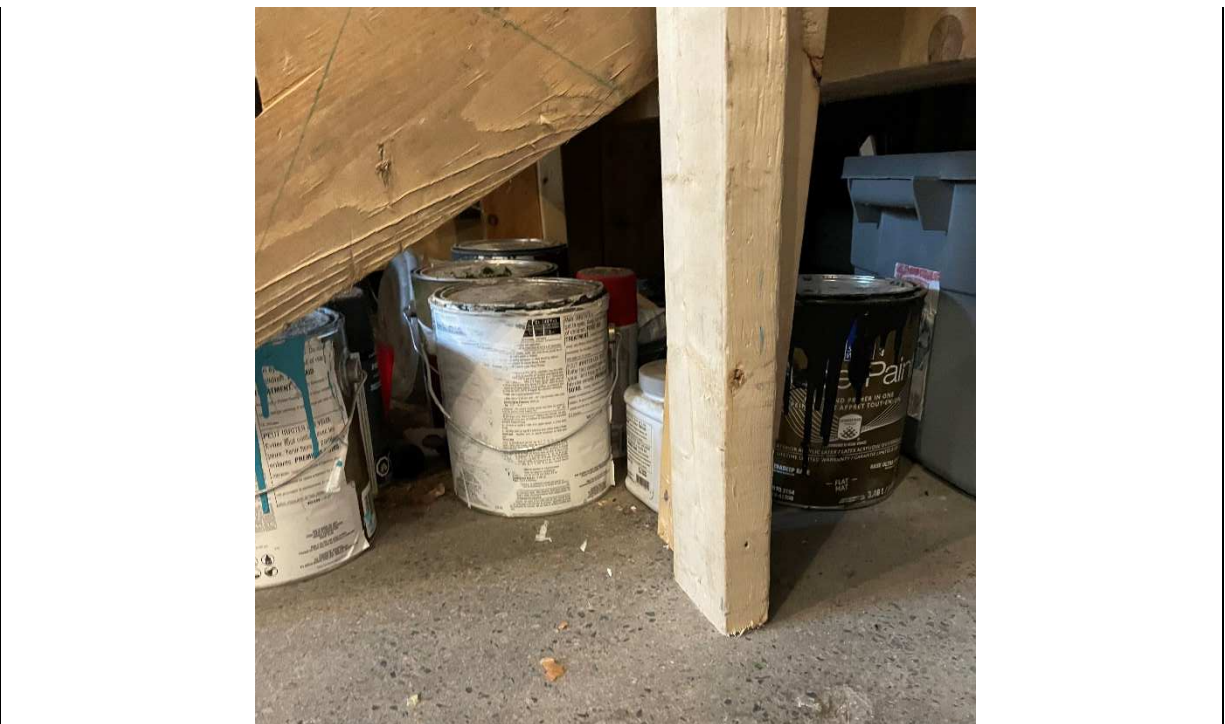
**Photo 012** View of paint stored inside Mino'Weesini located at 5 Hamilton Avenue North (the Phase One Property) (facing east).

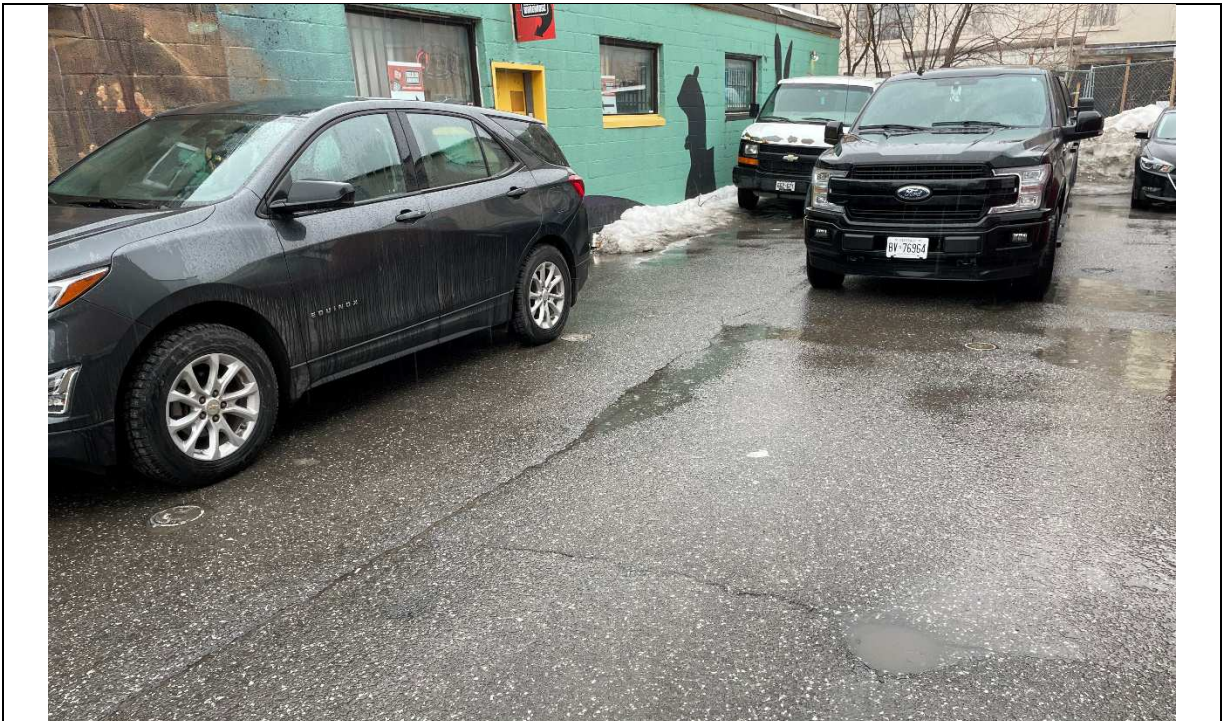
**Photo 014** View of numerous groundwater monitoring wells in the parking area near the centre of the Phase One Property (facing north).

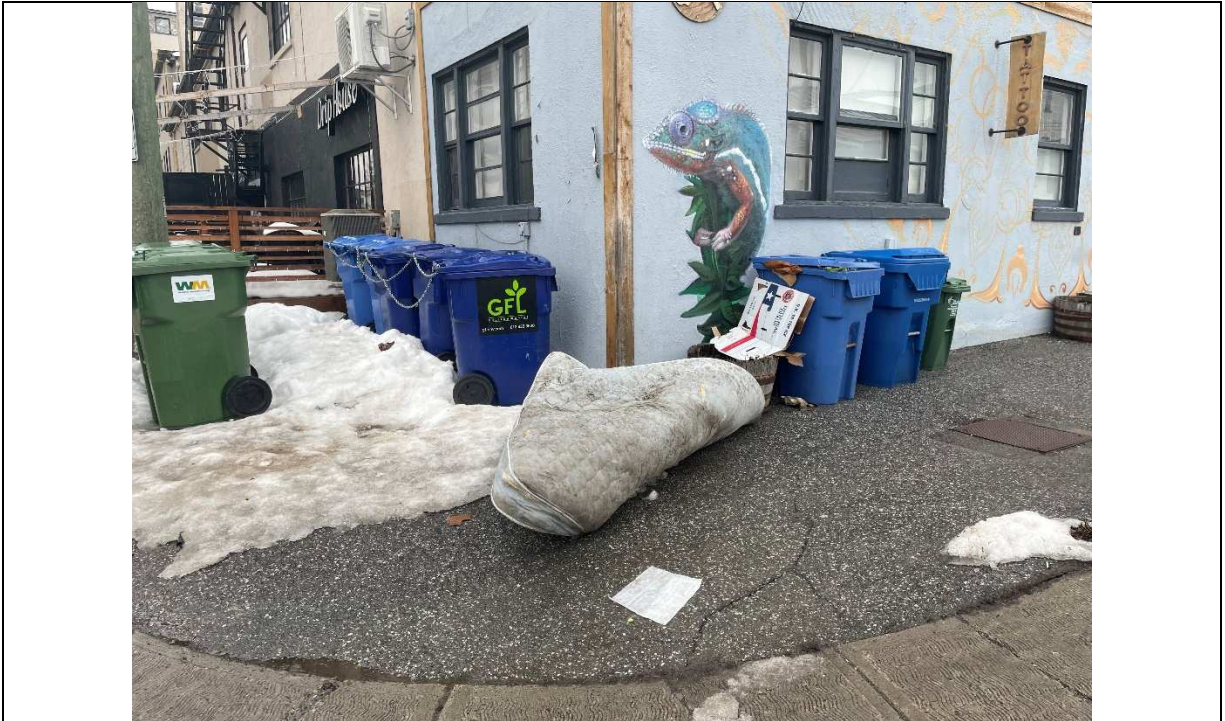
**Photo 015** View of domestic waste at the northwest corner of the Phase One Property (facing southeast).

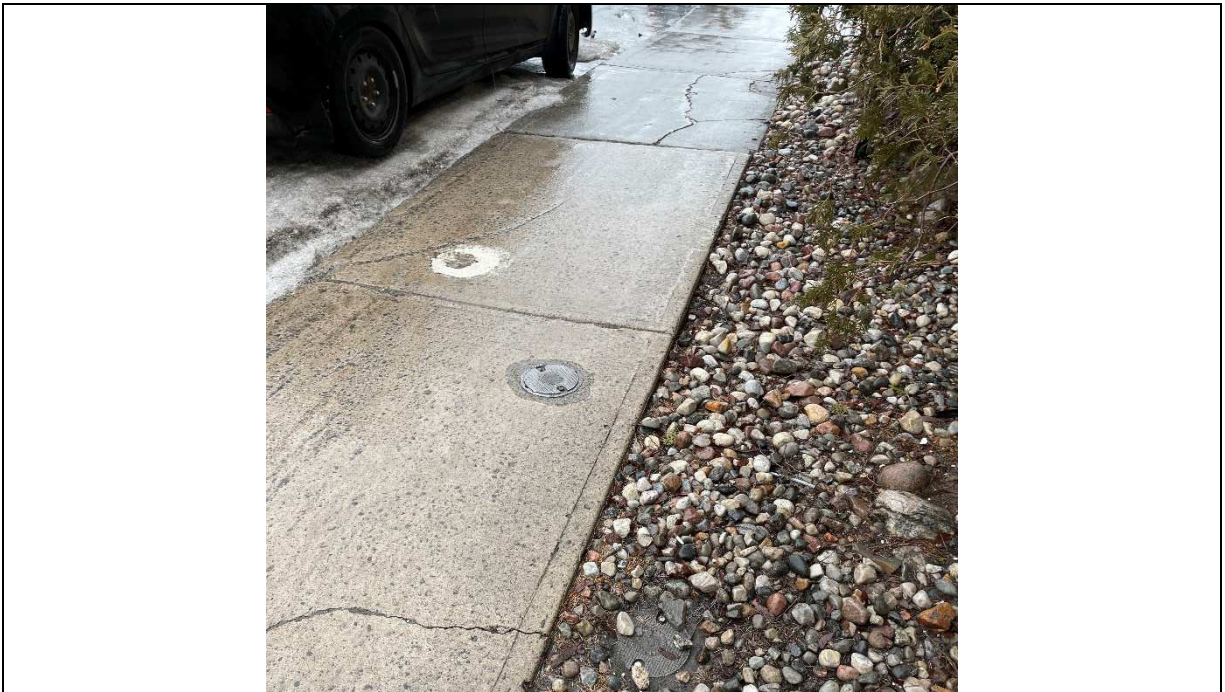
**Photo 016** View of multiple groundwater monitoring wells along the eastern sidewalk of the Phase One Property (along Parkdale Avenue) (facing south).

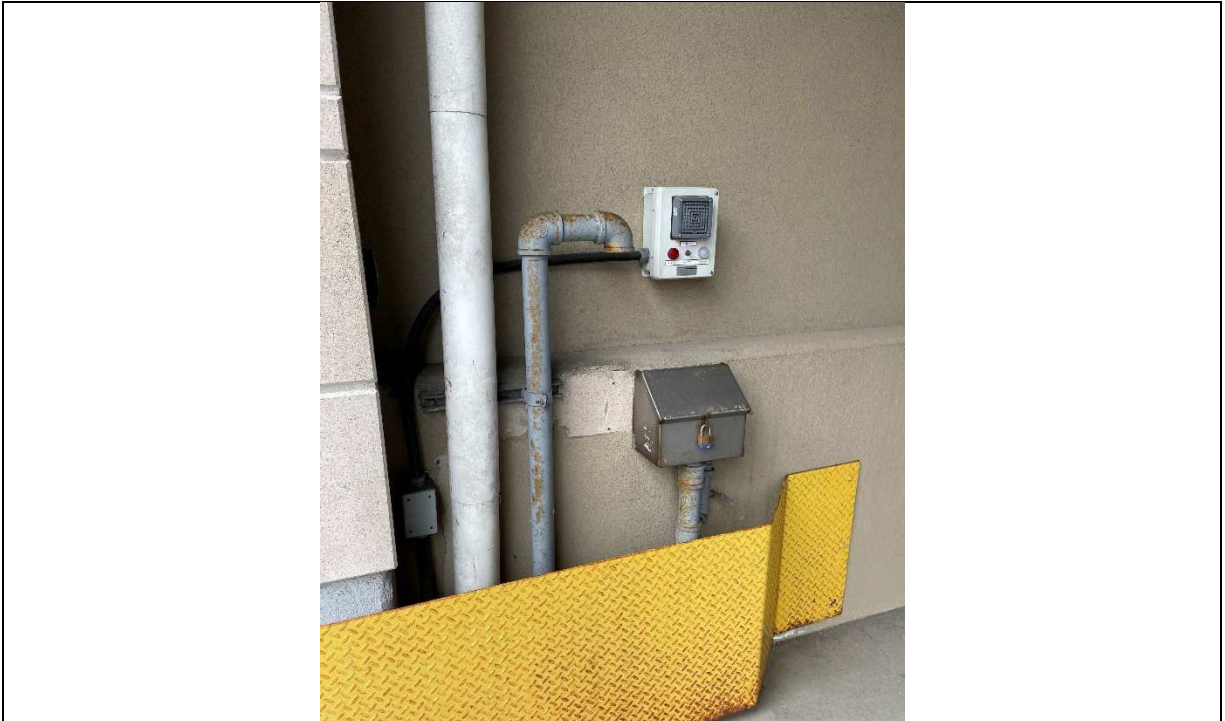
**Photo 021** View of fill and vent pipes at the apartment building directly north of the Phase One Property located at 320 Parkdale Avenue (facing northwest).

| Location | Summary |
|---|---|
| 320 Parkdale Avenue<br>(adjacent to the north of the Phase One Property) | <ul style="list-style-type: none"> <li>A fuel oil leak of unknown quantity was reported in October 2016 at the apartment building.</li> </ul> <p>Although the volume was not disclosed in the ERIS report, it is possible that it was a significant quantity as the source of the leak was piping from a multi-unit residential building's storage tank. As a result, and due to the proximity of the property to the Phase One Property, this incident is considered a PCA that has contributed to an APEC at the Site (<b>APEC 2</b>).</p> |
