# Phase One Environmental Site Assessment

Parkdale 3 Lands  
131 & 139 Parkdale Avenue  
and 122 Forward Avenue  
Ottawa, Ontario

Prepared for:  
11034936 Canada Inc.

LOP26-035A

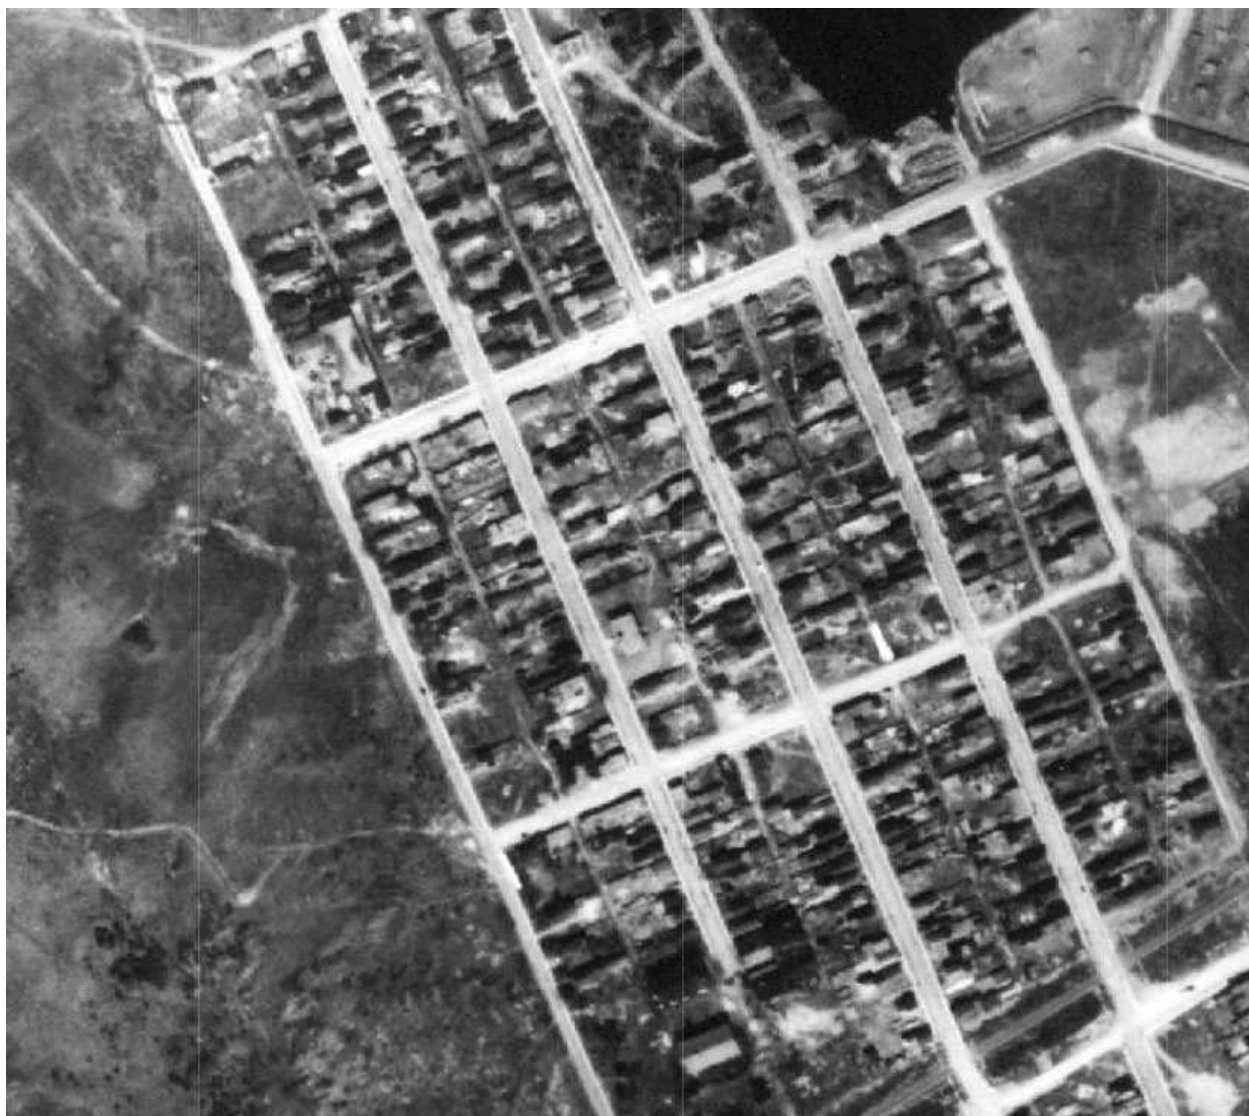
1928 Aerial Photograph

The presence of historical residential buildings present at the Phase One Property was observed from at least 1928 to 1965. Several of these structures were demolished prior to redevelopment of the northwest portion of the Property in the 1960's; historical demolition and backfilling practices have included backfilling foundations and grading with demolition debris and other fill materials of unknown environmental quality. Several of these structures are located outside of the existing building footprints and are suspected to have remnant demolition materials and/or other poor environmental quality fill material within their historical footprints. The fill material represents PCA #1 and is associated with the O.Reg. 153/04 PCA: Importation of Fill Material of Unknown Quality. This represents APEC #1 for the Phase One Property.

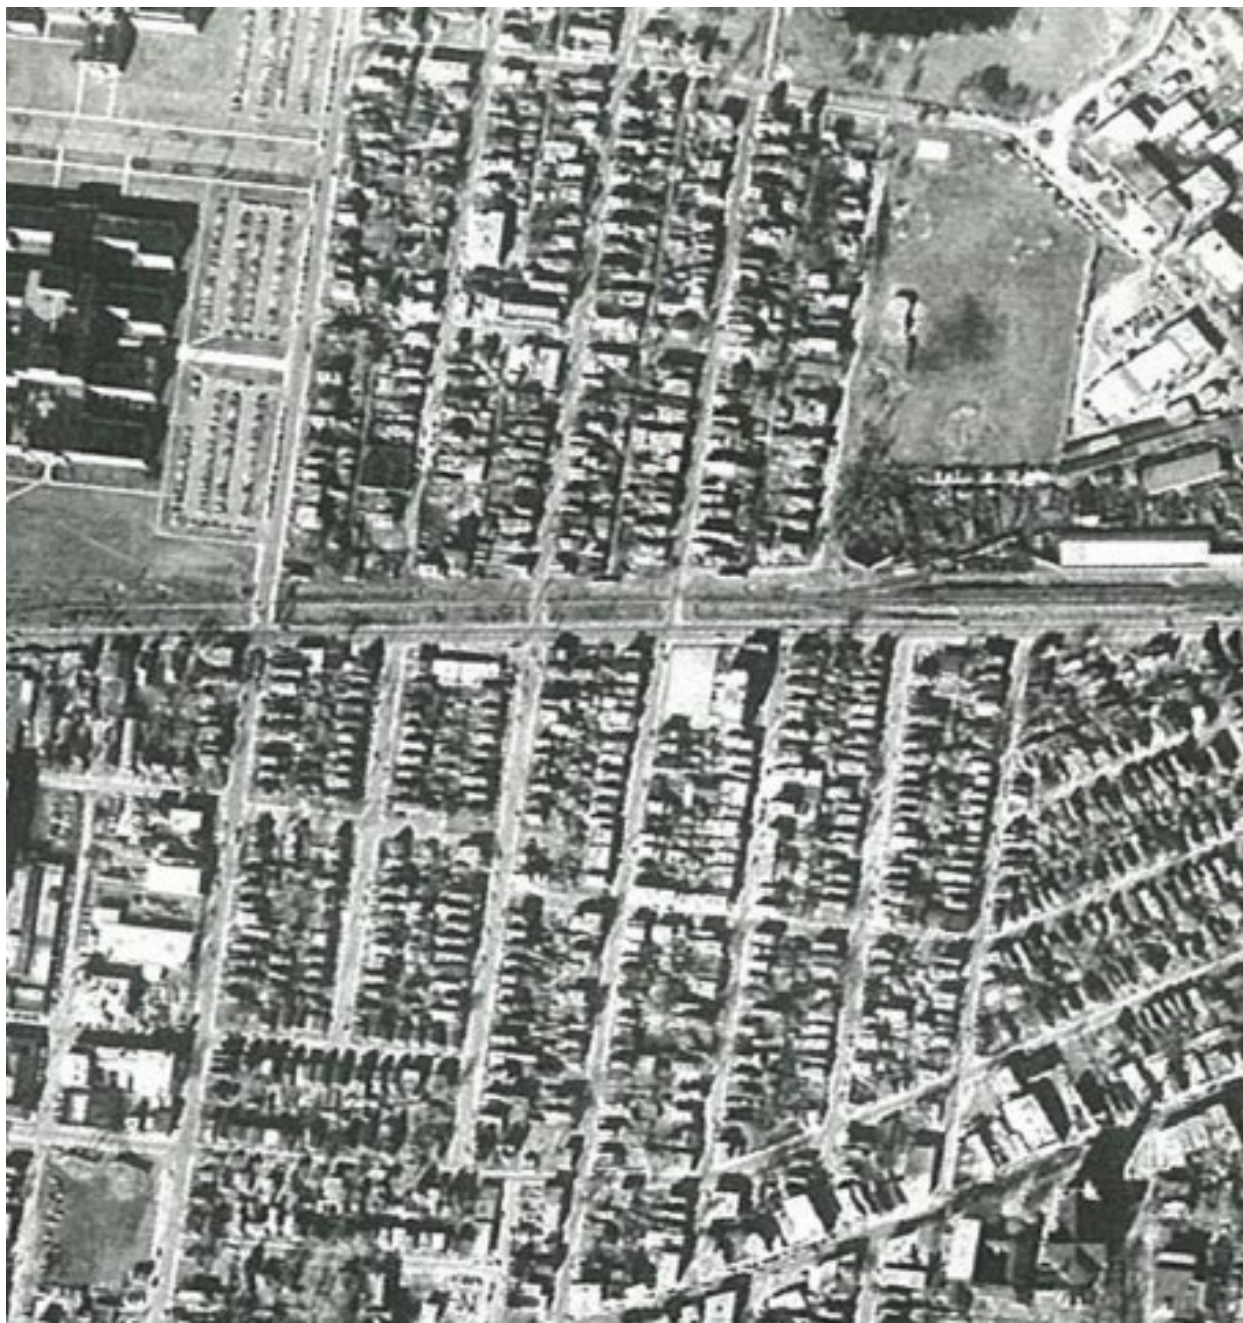
1958 Aerial Photograph

The presence of historical residential buildings present at the Phase One Property was observed from at least 1912 to 1958. These historical structures were demolished prior to redevelopment of the northeast portion Property in the 1960's and clearing of the southeast portion of Property in the 1980's; historical demolition and backfilling practices have included backfilling foundations and grading with demolition debris and other fill materials of unknown environmental quality. These original structures were located outside of the existing and redeveloped building footprints. The fill material represents PCA #1 and is associated with the

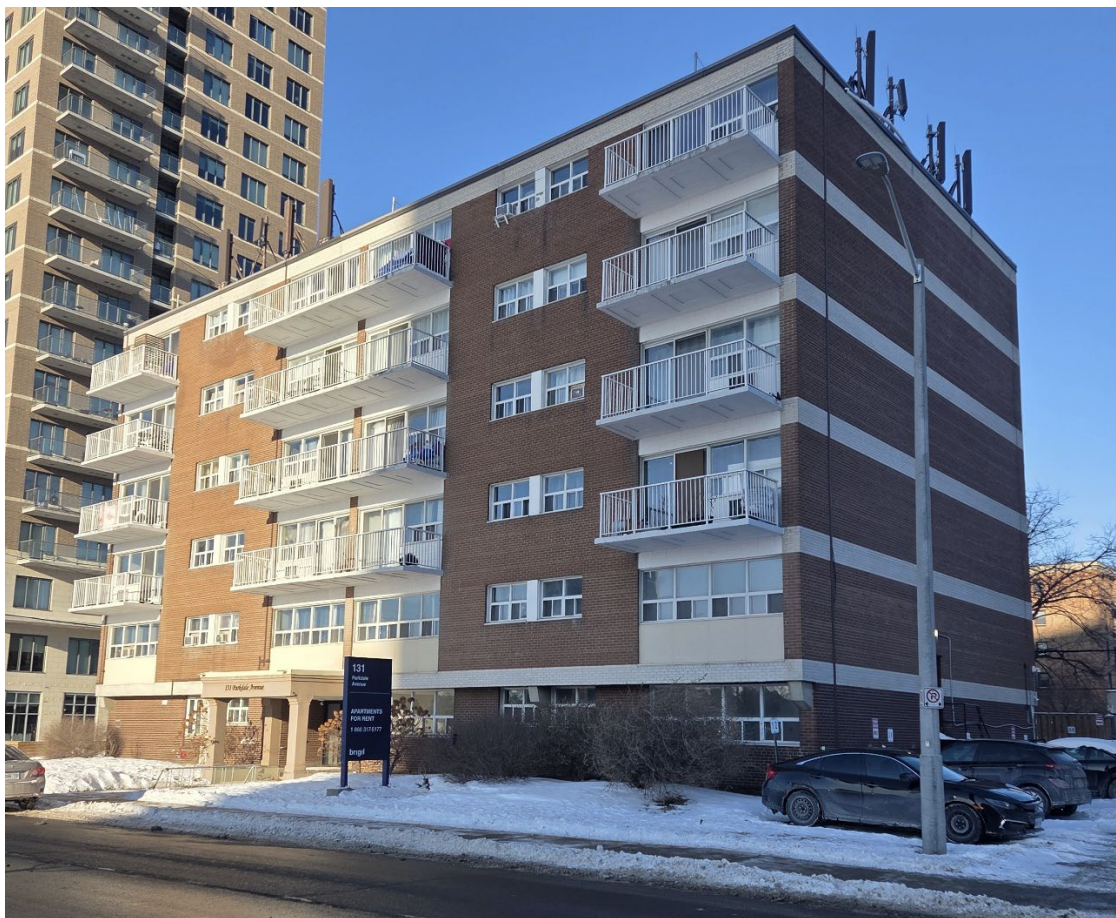
Photograph 1: View of the of the northwest portion of the Phase One Property looking northeast. View shows the residential apartment building at 131 Parkdale Avenue.

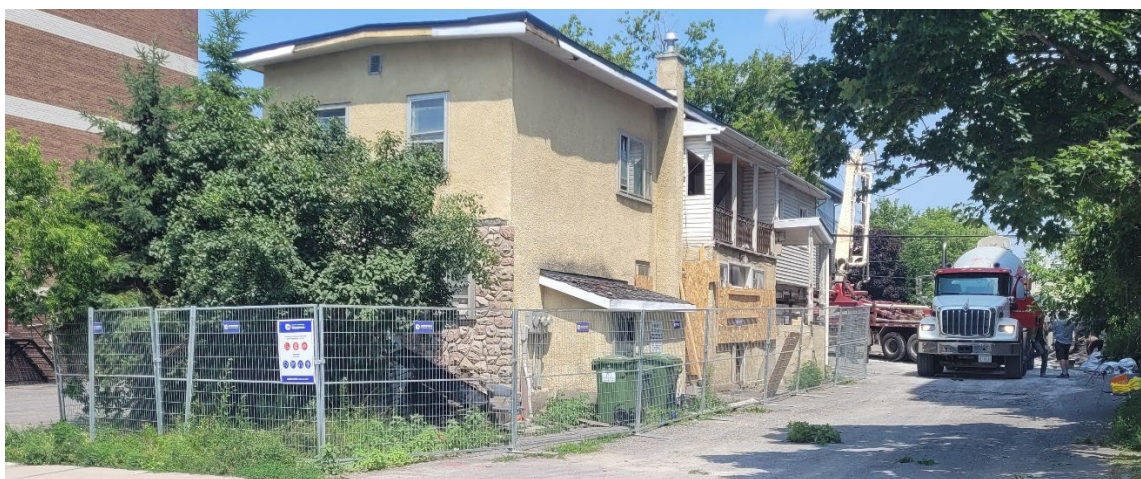
Photograph 2: View of the of the southwest portion of the Phase One Property looking northeast. View shows the vacant residential dwelling at 139 Parkdale Avenue.

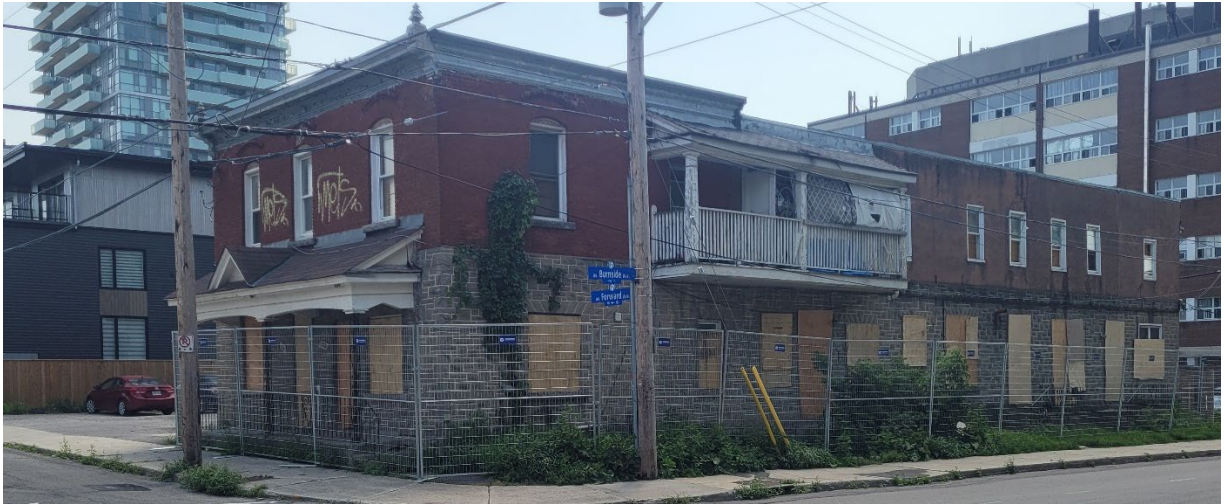
Photograph 3: View of the of the northeast portion of the Phase One Property looking southwest. View shows the vacant residential rooming house building at 122 Forward Avenue.

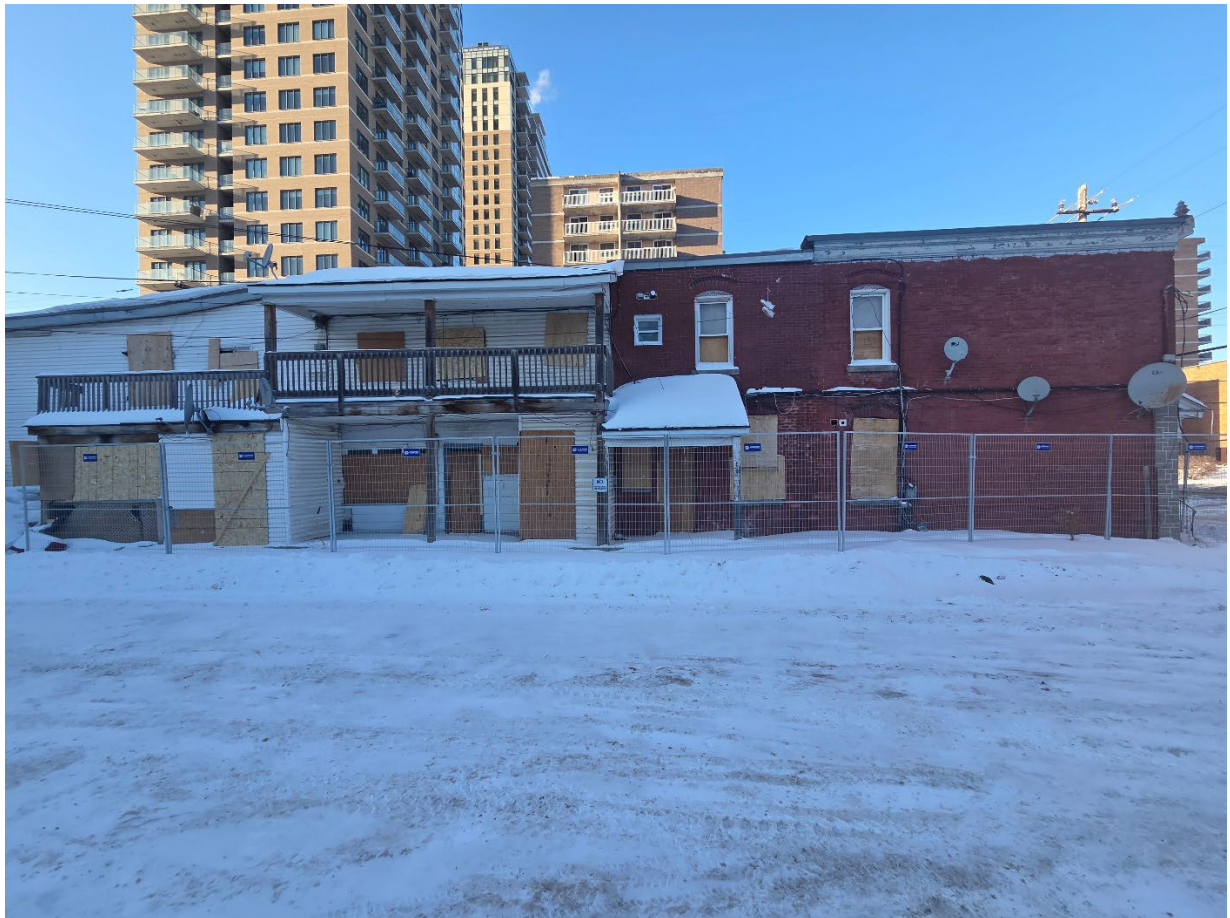
Photograph 4: View of the of the east portion of the Phase One Property looking north. View shows the vacant residential rooming house building at 122 Forward Avenue and adjacent parking area to the south.

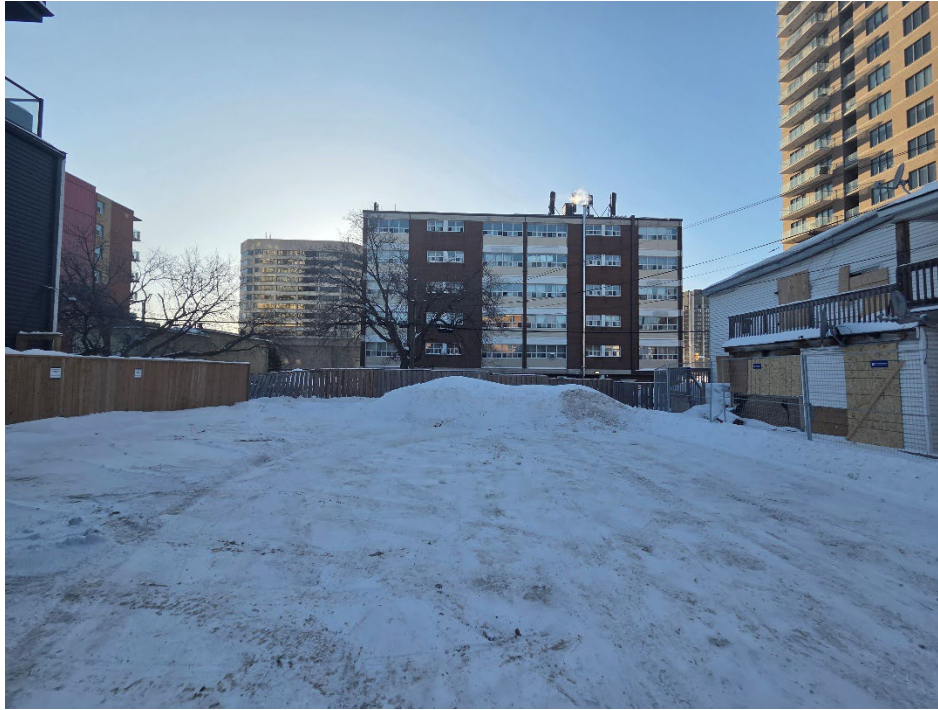
Photograph 5: View of the of the east portion of the Phase One Property looking west. View shows the parking area on the southeast portion of the Property and the apartment building further west, on the northwest portion of the Property.

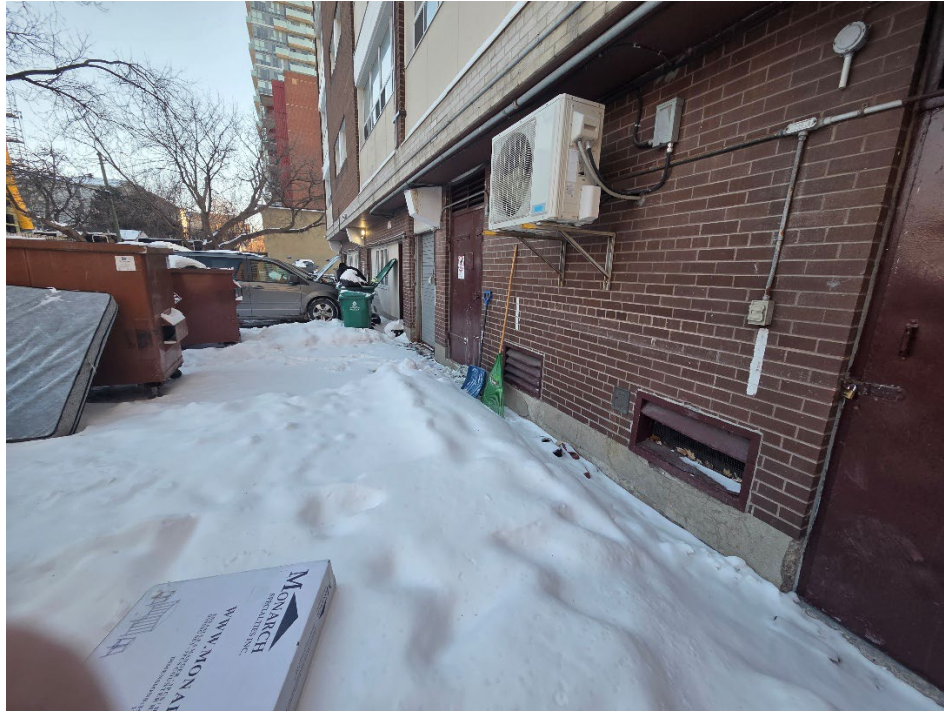
Photograph 7: View hydro Ottawa room on the ground floor of the residential apartment at 131 Parkdale Avenue, view is looking south.

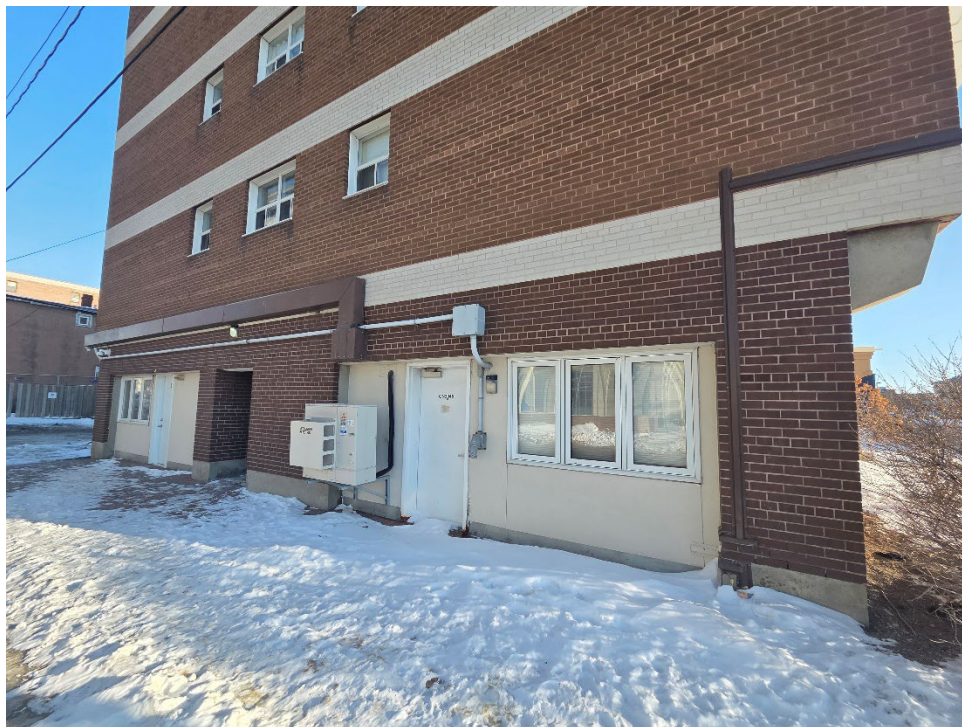
Photograph 8: View of north side of the residential apartment building at 131 Parkdale; view is looking southeast.
