# **Phase I Environmental Site Assessment**

466 Tremblay Road and 1440 St. Laurent Boulevard  
Ottawa, Ontario

Prepared for Rohit Homes

Report: PE7622-1  
August 4, 2026

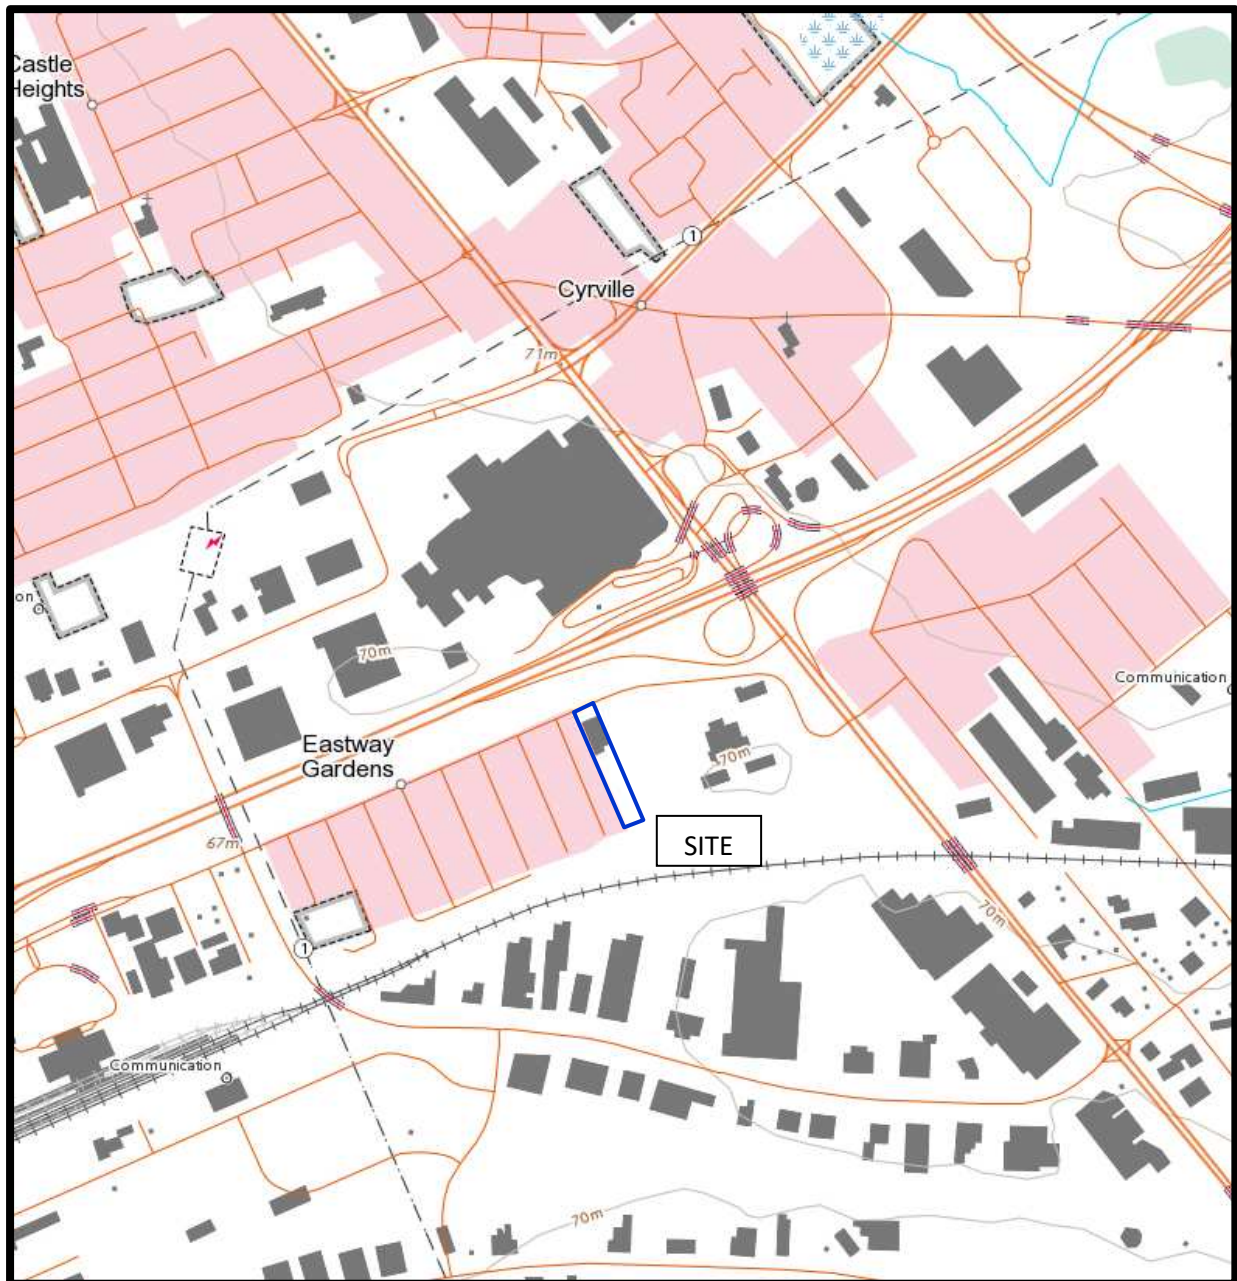
FIGURE 2  
TOPOGRAPHIC MAP

A topographic map of the Phase I Property was obtained from the Natural Resources Canada – The Atlas of Canada website and reviewed as part of this assessment. The topographic map indicates that the general elevation of the Phase I Property is approximately 69 m above sea level, while the regional topography within the greater area is generally sloping down to the west, towards the Rideau River. An illustration of the reference topographic map is presented on Figure 2 – Topographic Map, appended to this report. It should be noted that the attached figure also illustrates the current extent of the subject building.

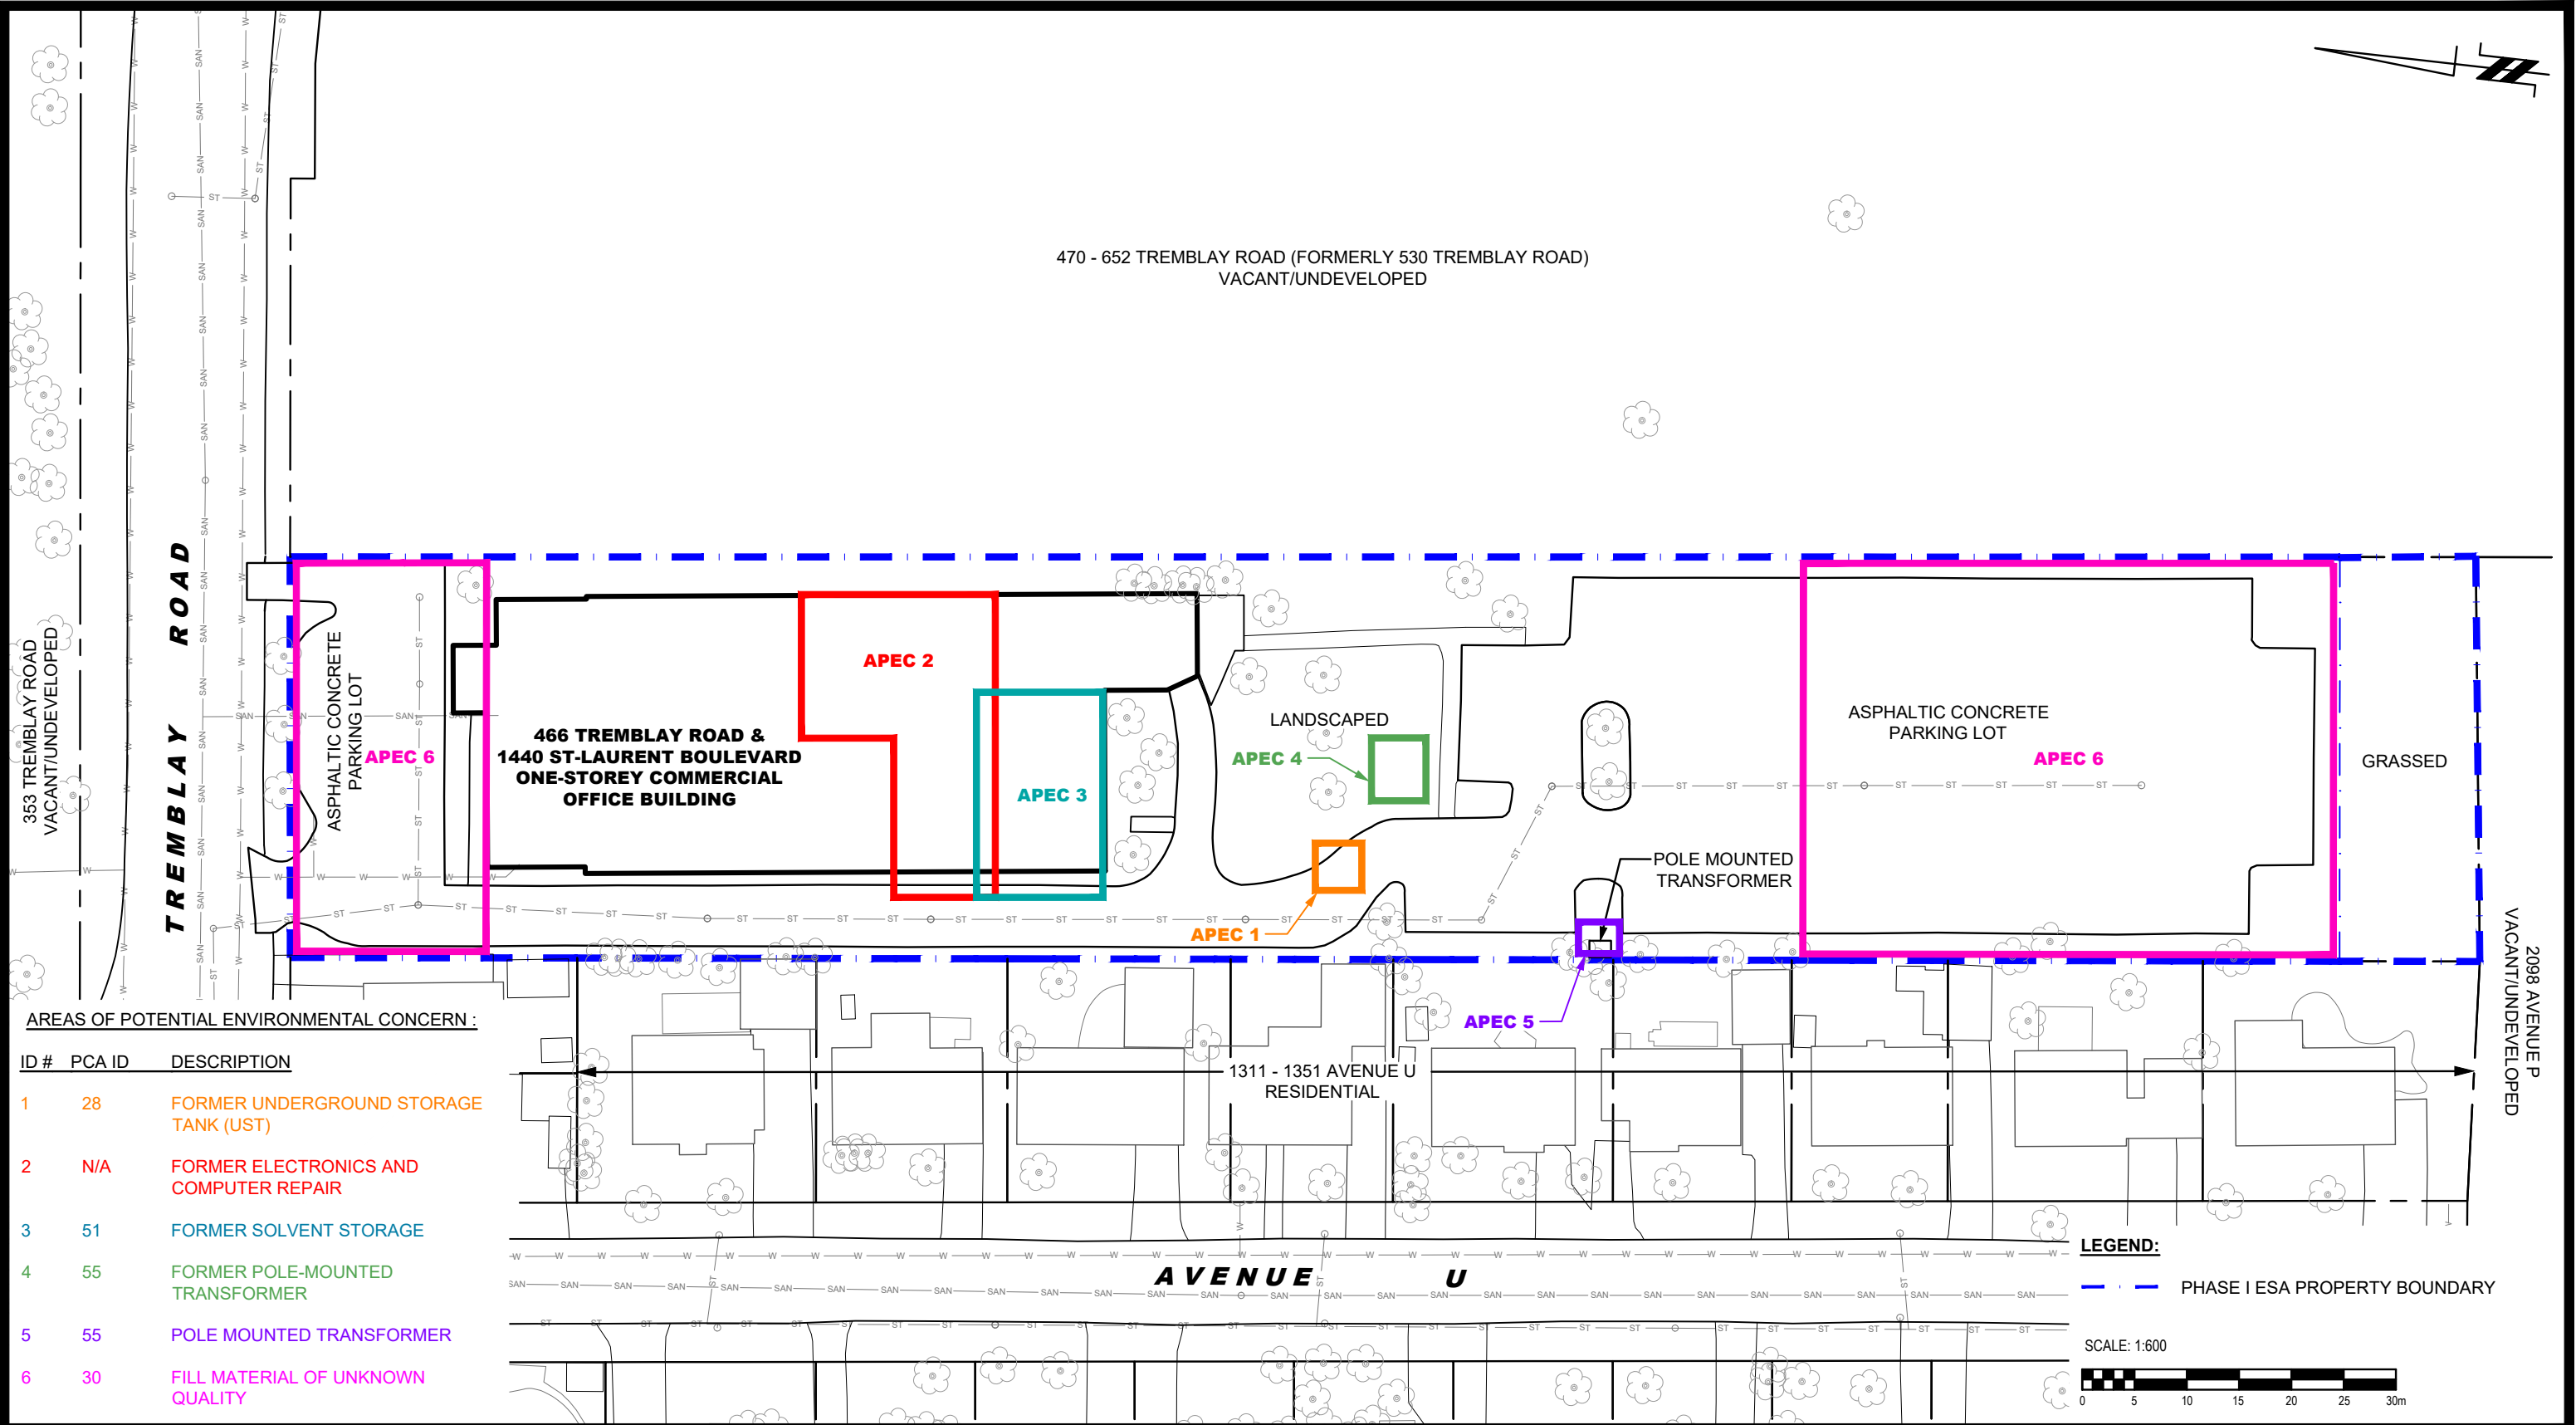
**DRAWING PE7622-1 – SITE PLAN**

| ID # | PCA ID | DESCRIPTION |
|---|---|---|
| 2 | N/A | FORMER ELECTRONICS AND COMPUTER REPAIR |

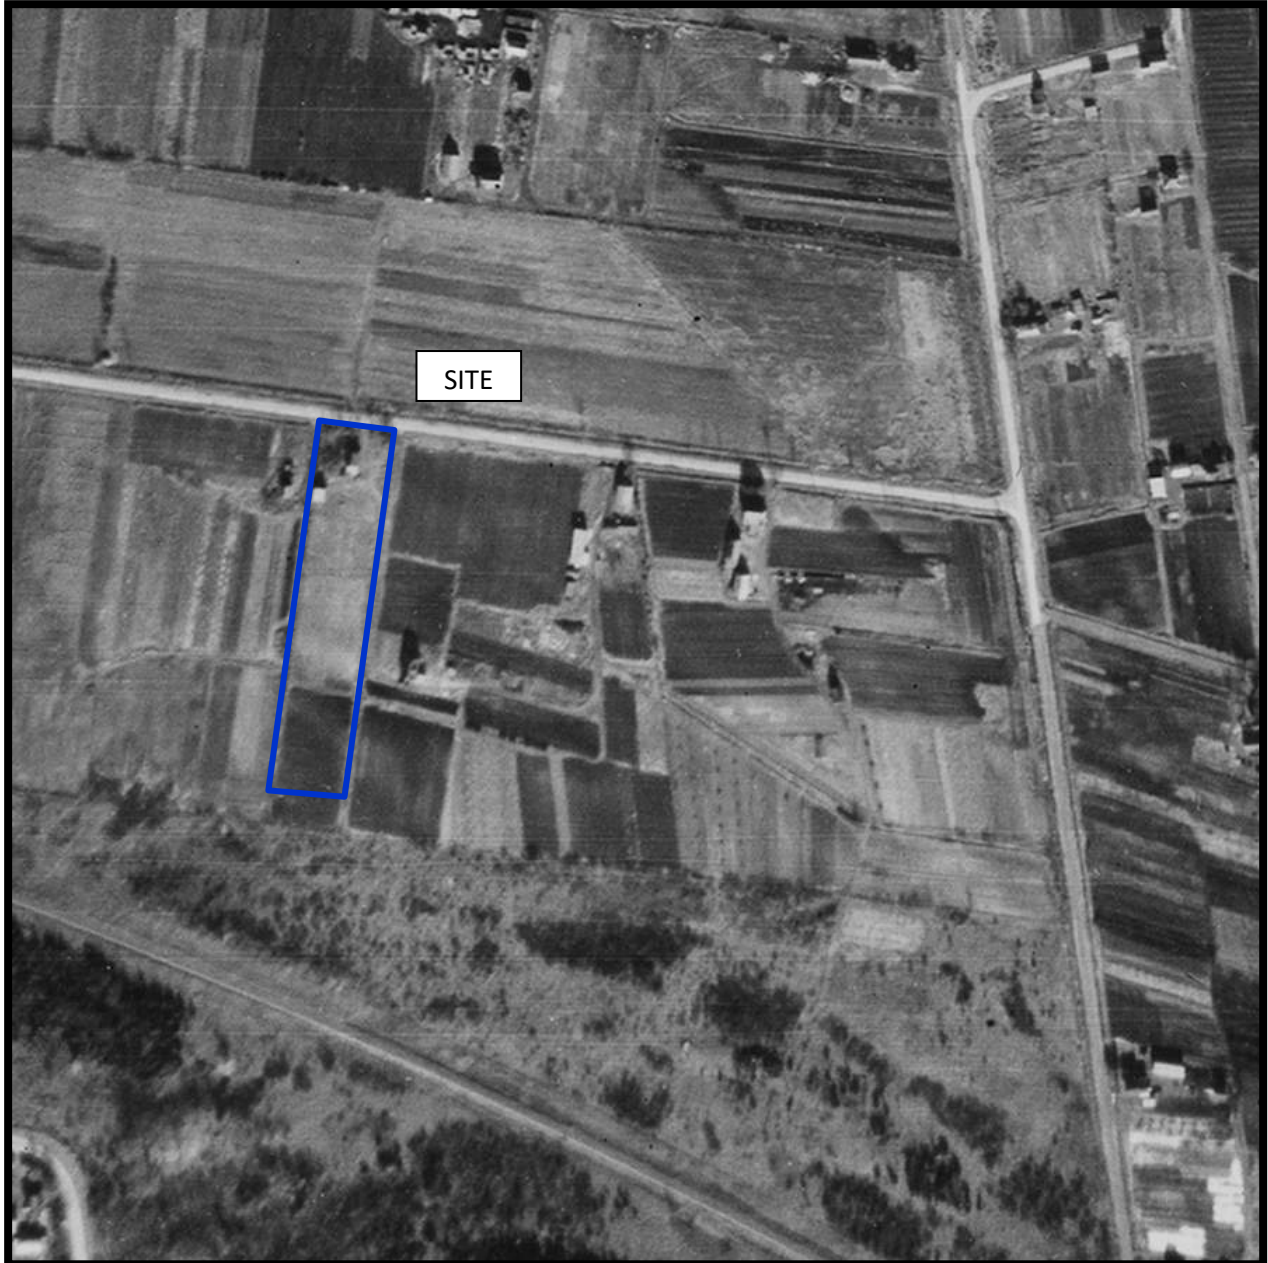
AERIAL PHOTOGRAPH  
1945

- 1945 No significant changes are apparent with respect to the Phase I Property or surrounding lands since the previous aerial photograph.
- 1958 (geoOttawa) The buildings previously observed in the northern portion of the Phase I Property have been demolished. The Phase I Property remains used for agricultural purposes. Land to the west of the Phase I Property has been developed with the current day residential dwellings along Avenue R through Avenue U. Adjacent to east of the Phase I Property, the former agricultural land has been developed with a commercial/industrial operation, associated with the Ministry of Transportation. Early stages of construction are observed further to the north of the Phase I Property, associated with the construction of Highway 417. No other significant changes are apparent with respect to the surrounding lands since the previous aerial photograph.

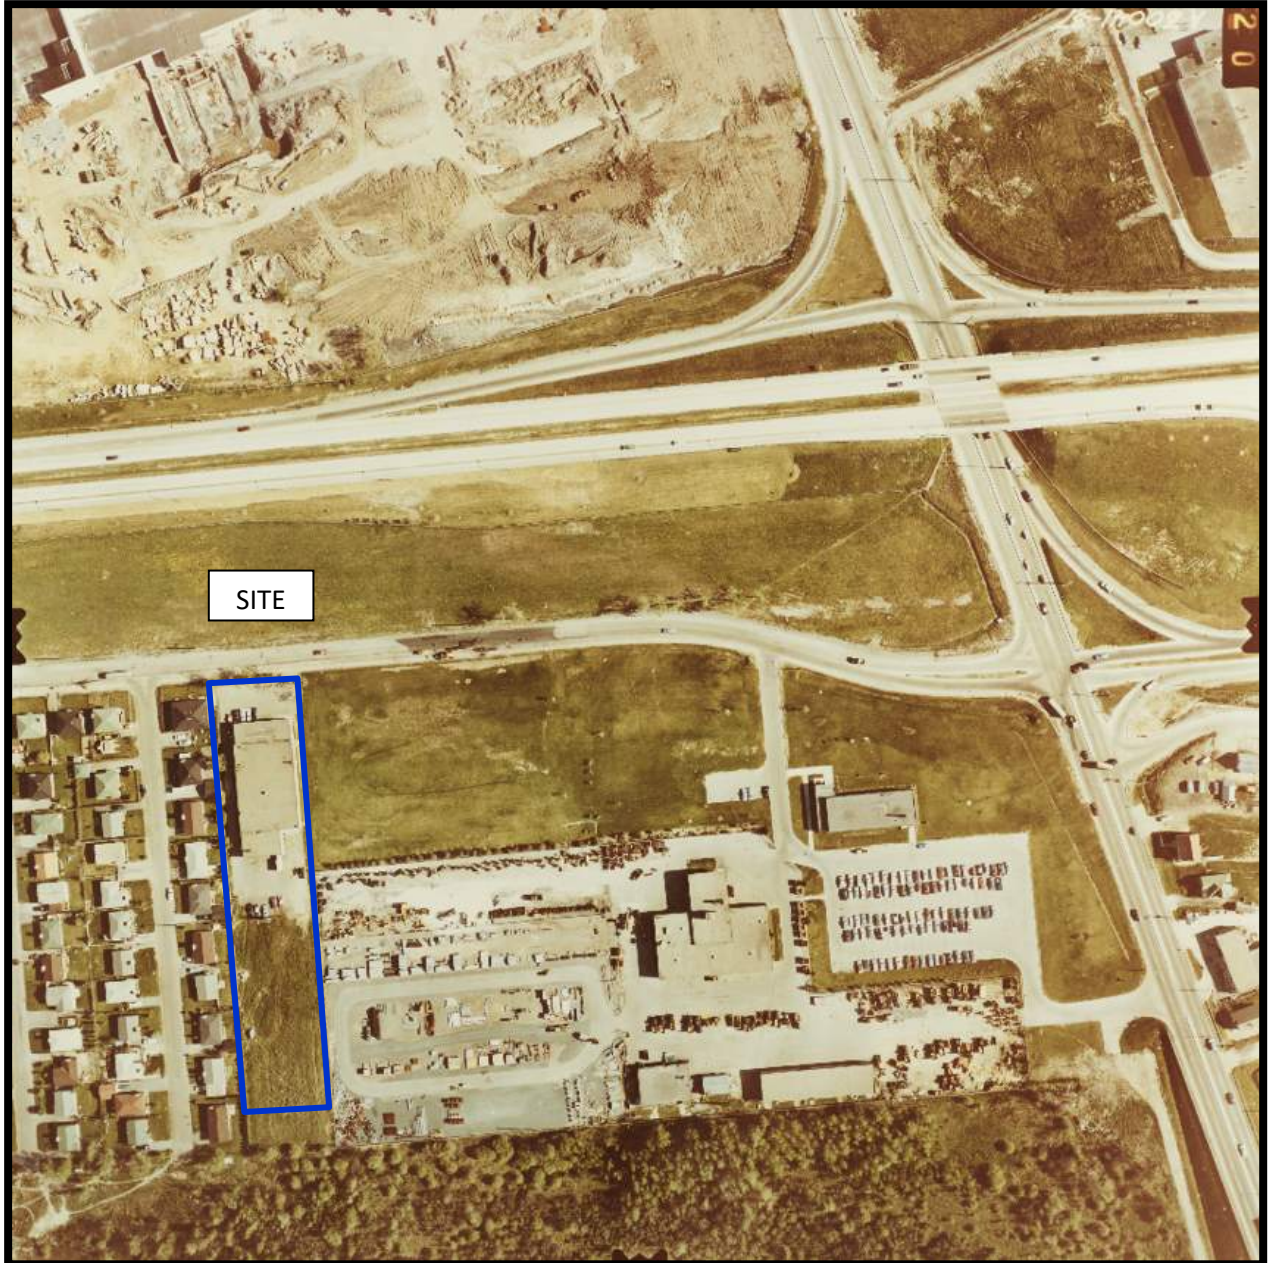
AERIAL PHOTOGRAPH  
1967

- 1967 The Phase I Property has been developed with the current day commercial office building. Several additional buildings and associated site infrastructure have been constructed on the neighbouring MTO property. Highway 417 has been constructed further to the north. On-going site development is observed north of Highway 417, associated with the construction of the St. Laurent Shopping Centre. No other significant changes are apparent with respect to the surrounding lands since the previous aerial photograph.

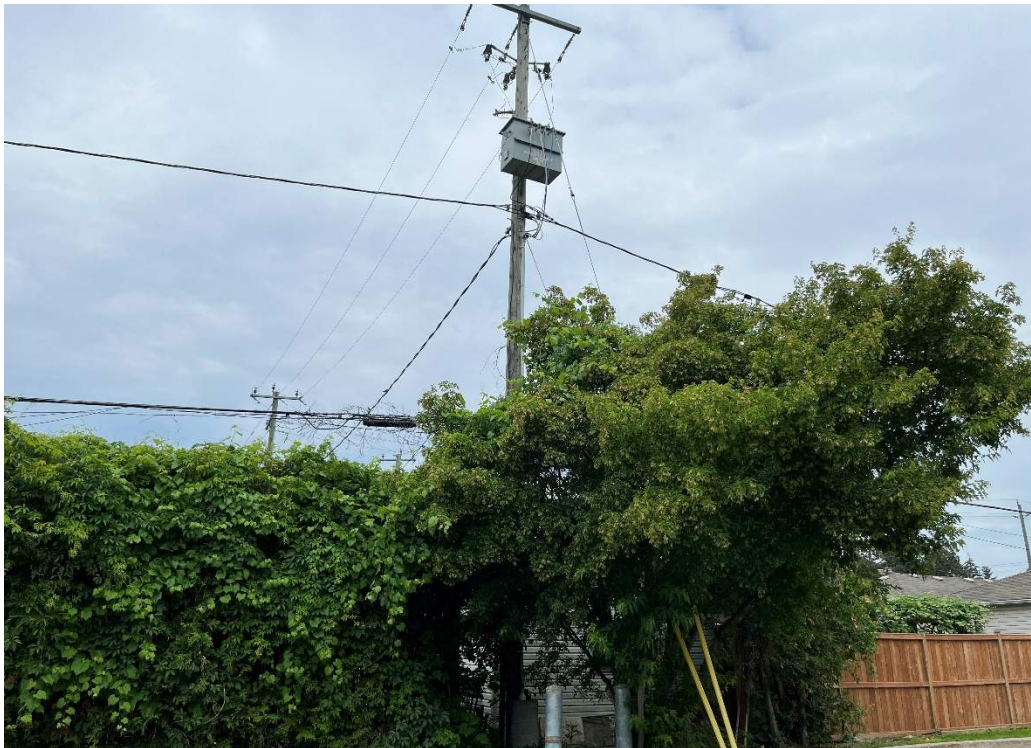
One pole-mounted transformer was observed along the western property limits south of the subject building. No signs of surficial staining, abnormal odours, stressed vegetation, or any other indications of subsurface contamination were present at the time of the site inspection. Based on the age of this transformer, PCBs are not considered to be present within this equipment.

Photograph 4: Pole-mounted transformer along western property limits.
