January 31, 2025  
File: PE4914-LET.04

Subject: **Phase I - Environmental Site Assessment Update**  
**267 O'Connor Street**  
**Ottawa, Ontario**

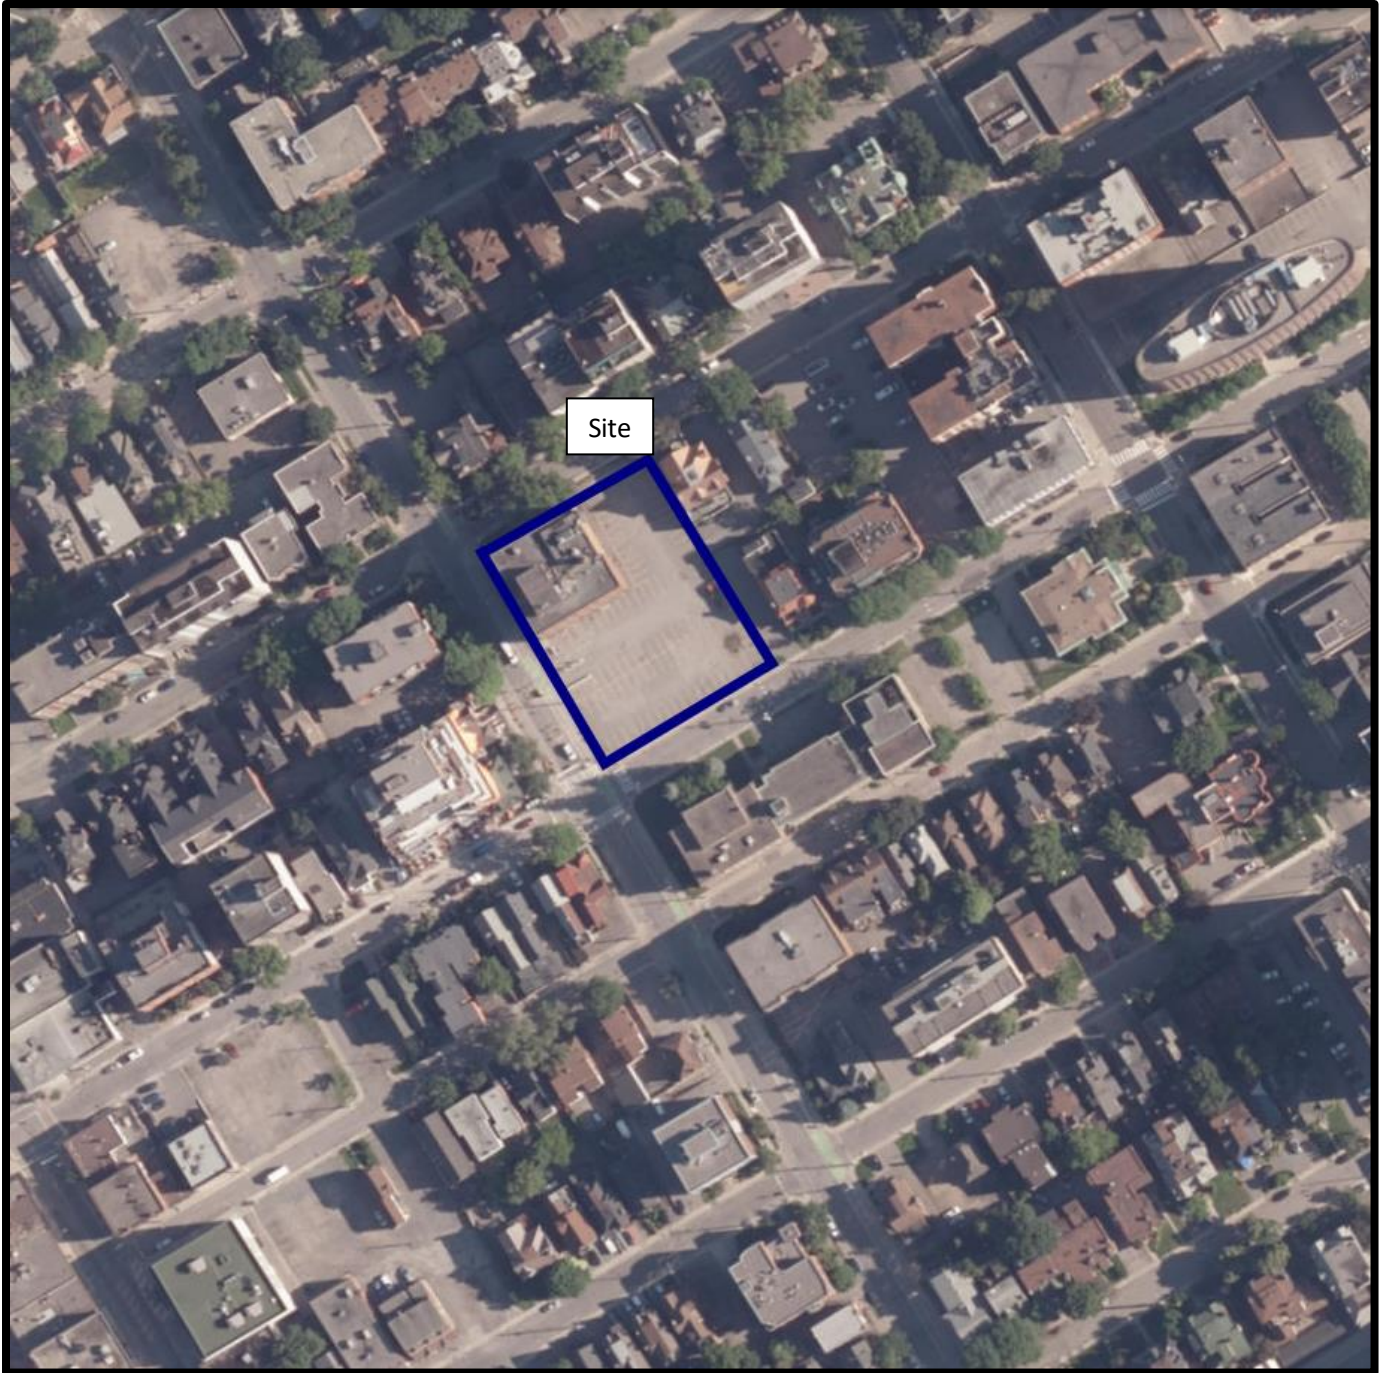
AERIAL PHOTOGRAPH  
2022

Based on aerial photographs and the documentation reviewed, the subject property (or a portion of it) was developed for residential purposes as early as 1890. For the purposes of this report, the first developed use of the subject site is considered to be residential, in 1890.
